BAFFINLAND IRON MINES CORPORATION

MARY RIVER PROJECT

**APPENDIX 4. DETAILED HABITAT ASSESSMENTS AND SUMMARY OF RESULTS FOR RAILWAY AND TOTE ROAD REALIGNMENT STREAM CROSSINGS**

## Phase 2 Milne Rail Corridor Aquatic Habitat Assessment

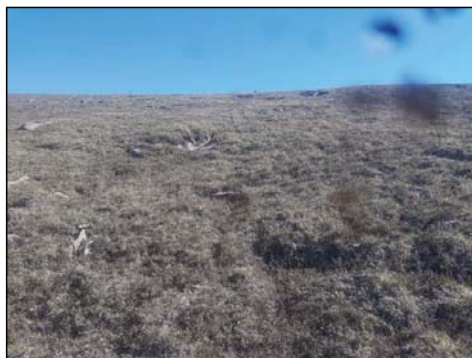
**A**

This is a dry, low point on a hillside. There is never aquatic habitat at this crossing.

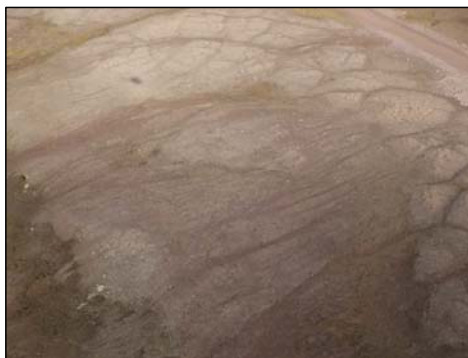
**Figure 1.** Views of CV-10-3 at the rail crossing during summer (A) and aerially during fall (B). CV-10-2 and 10-3 are both on the same hillside.

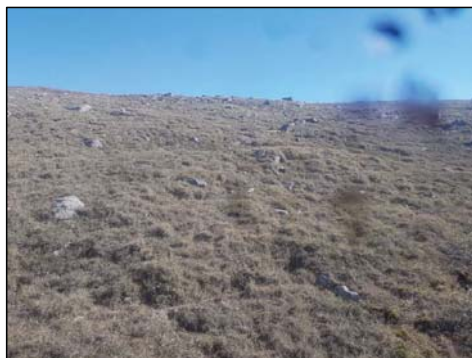
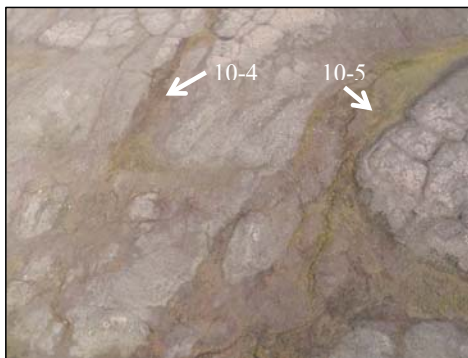
**Crossing ID:** CV-10-4

This is a dry, low point on a hillside. There is never aquatic habitat at this crossing.

**Figure 1.** Views of CV-10-4 at the rail crossing during summer (A) and aerially, with 10-5, during fall (B).

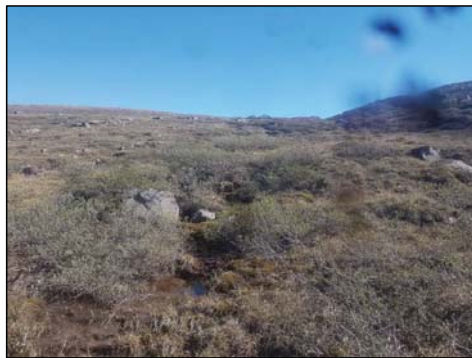
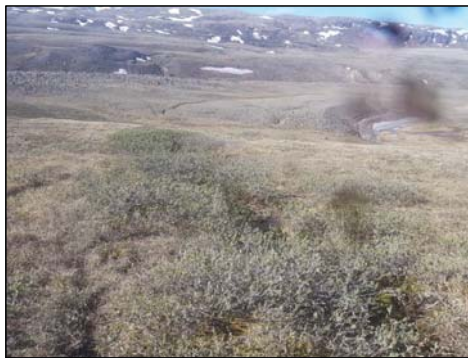
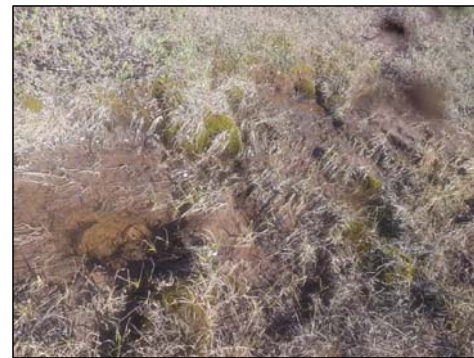
**Crossing ID:** CV-10-5

This site on a steep hillside was nearly dry in 2018. In addition to the soft barrier of the steep gradient, there is a large vertical drop barrier downstream between the crossing and Phillips Creek. There is never aquatic habitat at this crossing.

**Figure 1.** Views of CV-10-5 at the rail crossing during summer, looking upstream (A), downstream (B), and across (C).

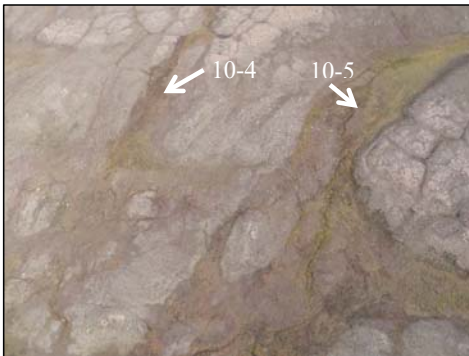
<p>A</p><p><b>Figure 2.</b> Aerial view of CV-10-5, with nearby CV-10-4, during fall.</p></div>			
Baffinland Iron Mines Mary River Project

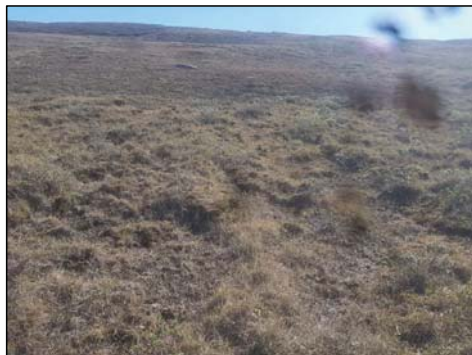
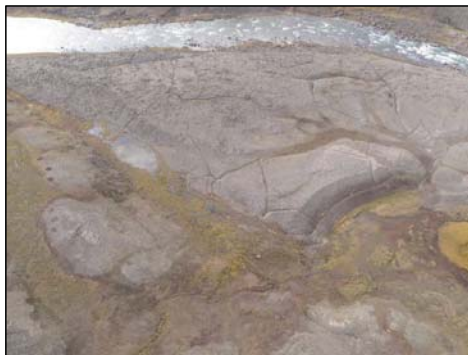
**Crossing ID:** CV-11-1

This was a nearly dry low point on a steep hillside. In addition to the soft barrier of the steep gradient, there is a large vertical drop barrier downstream between the crossing and Phillips Creek. There is never aquatic habitat at this crossing.

**Figure 1.** Views of CV-11-1 at the rail crossing during summer (A) and aerially during the fall (B).

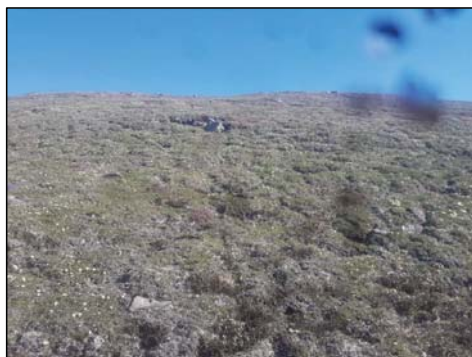
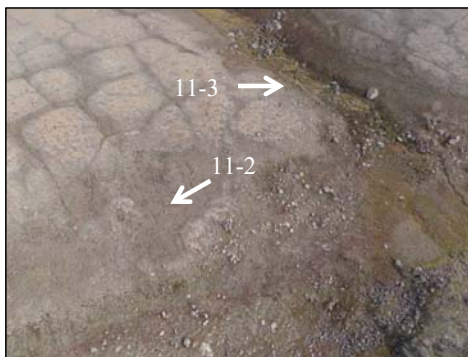
**Crossing ID:** CV-11-2

This was a dry, low point on a steep hillside. In addition, there is a large vertical barrier downstream between the crossing and Phillips Creek. There is never aquatic habitat at this crossing.

**Figure 1.** Views of CV-11-2 at the rail crossing during summer (A) and aerially, with nearby 11-3, during the fall (B).

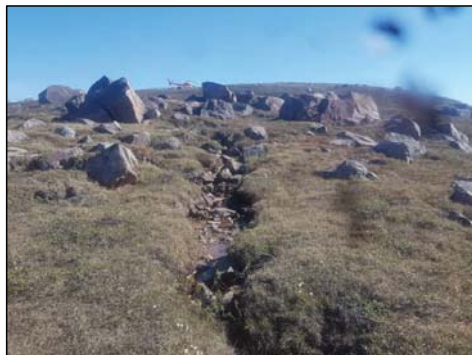
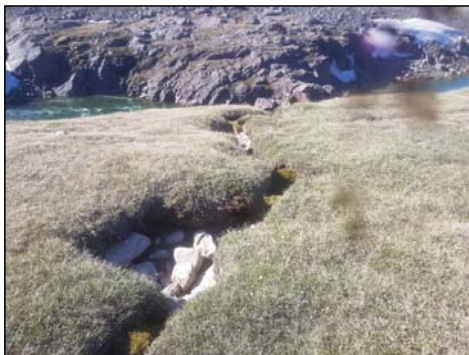
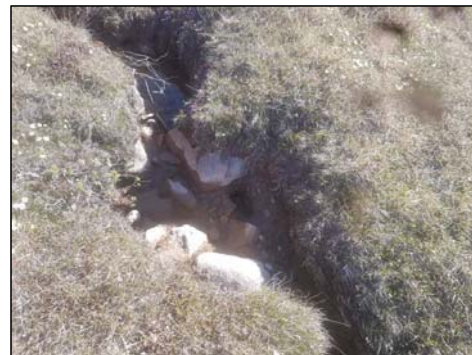
This was a nearly dry stream on a steep hillside. In addition, there is a large vertical barrier downstream between the crossing and Phillips Creek. There is never aquatic habitat at this crossing.

**Figure 1.** Views of CV-11-3 at the rail crossing during summer, looking upstream (A) downstream (B) and across (C).

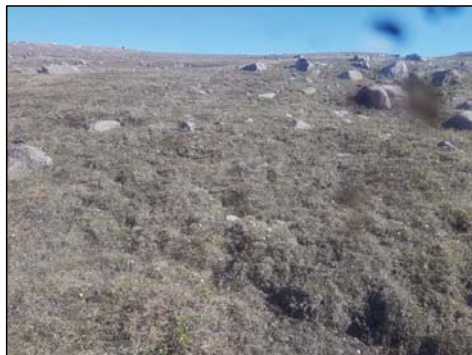
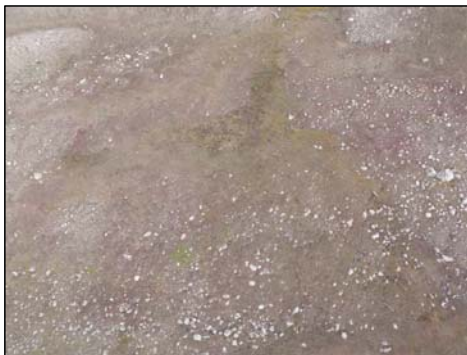
This was a dry, low point on a steep hillside. In addition, there is a large vertical barrier downstream between the crossing and Phillips Creek. There is never aquatic habitat at this crossing.

**Figure 1.** Views of CV-11-4 at the rail crossing during summer (A) and aerially during fall (B). CV-11-5 is in the same dry hillside area.

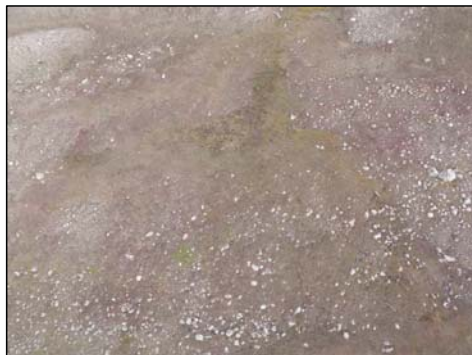
This was a dry, low point on a steep hillside. In addition, there is a large vertical barrier downstream between the crossing and Phillips Creek. There is never aquatic habitat at this crossing.

**Figure 1.** Aerial view of CV-11-5 at the rail crossing during fall. CV-11-4 is in the same dry hillside area.

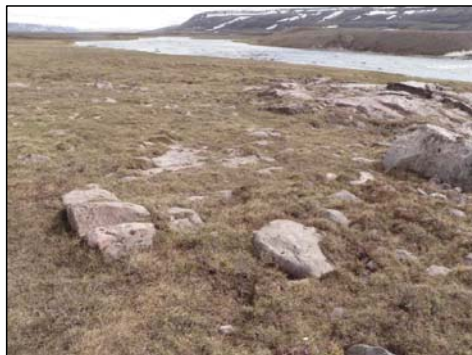
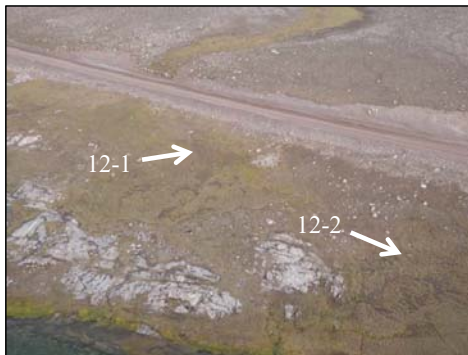
This was a dry, low point on a steep hillside. In addition, there is a large vertical barrier downstream between the crossing and Phillips Creek. There is never aquatic habitat at this crossing.

**Figure 1.** Views of CV-12-1 at the rail crossing during summer (A) and aerially, with 12-2, during fall (B).

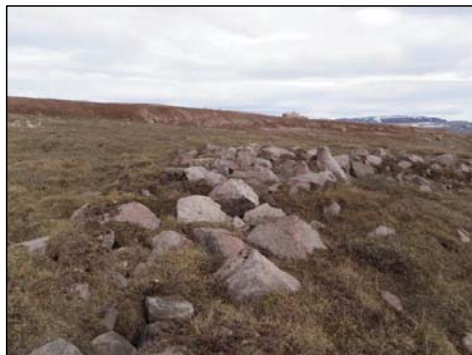
This was a dry, low point on a steep hillside. In addition, there is a large vertical barrier downstream between the crossing and Phillips Creek. There is never aquatic habitat at this crossing.

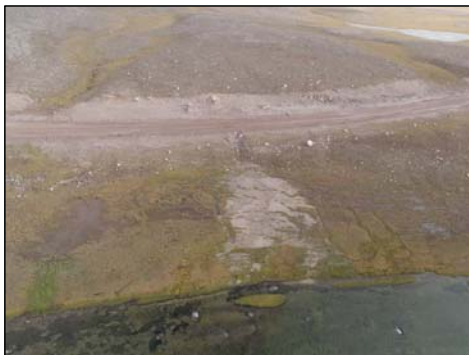
This was a dry, pile of rocks on a steep hillside downstream of the Tote Road in summer and barely wetted during fall 2018. The soft gradient barrier and consistent lack of sufficient water (as noted during previous Tote Road surveys) prevent fish access to the crossing. There is never aquatic habitat at this crossing.

**Figure 1.** Views of CV-12-3 at the rail crossing during summer (A) and aerially during fall (B).

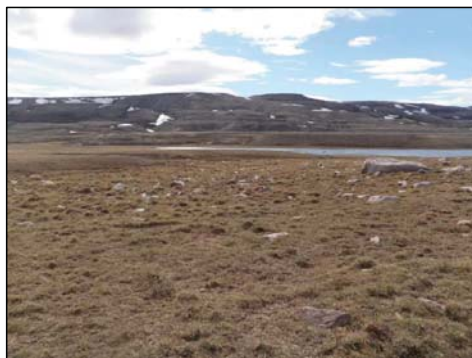
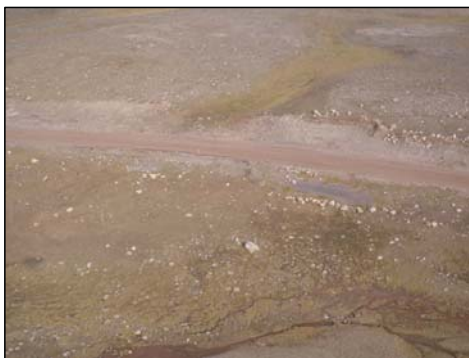
This site is a dry, low point downstream of the Tote Road. There is never aquatic habitat at this crossing.

**Figure 1.** Views of CV-12-4 at the rail crossing during summer (A) and aerially during fall (B).

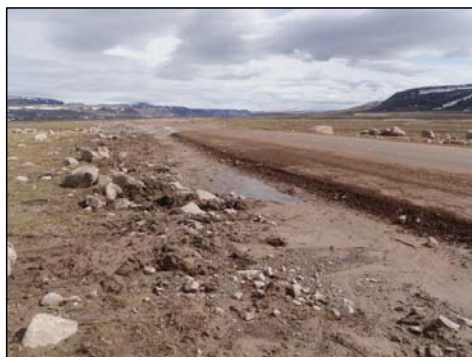
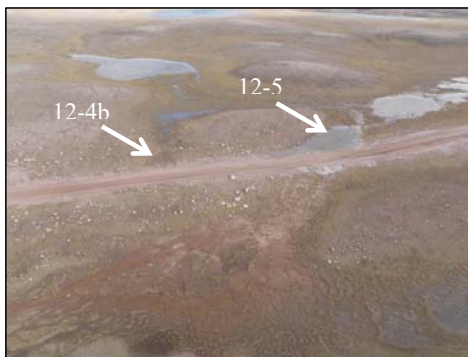
This site was nearly dry in 2018 and is largely a roadside ditch. None of the upstream ponds are fish-bearing and there are multiple barrier types (subsurface flow, lack of a channel) downstream to Phillips Creek that prevent fish access. There is never aquatic habitat at this crossing.

**Figure 1.** Views of CV-12-4b at the rail crossing during summer (A) and aerially, with nearby 12-5, during fall (B).

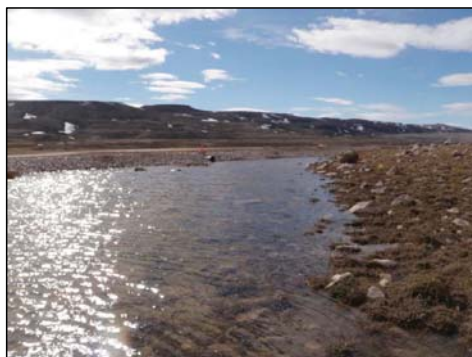
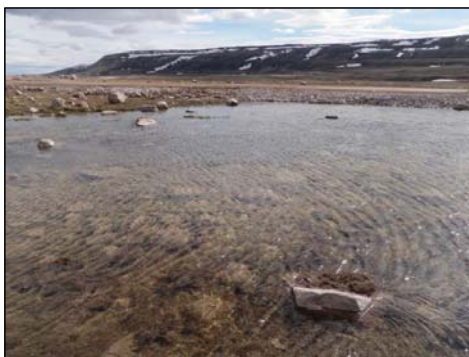
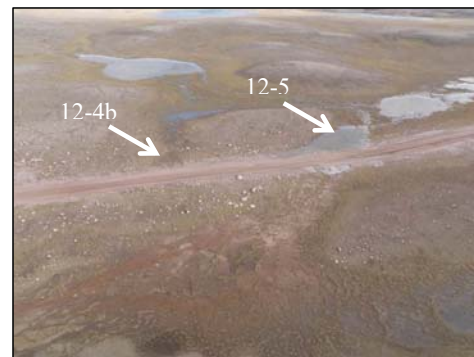
This site is a shallow fishless pond that formed on the upstream side of the Tote Road. None of the adjacent ponds are fish-bearing and downstream of the road, flows disperse across the tundra with no channel, insufficient depths for fish use and lack of connectivity to Phillips Creek. There is never aquatic habitat at this crossing.

**Figure 1.** Views of CV-12-5 at the rail crossing during summer (A) and (B) and aerially, with nearby 12-4b, during fall (C).

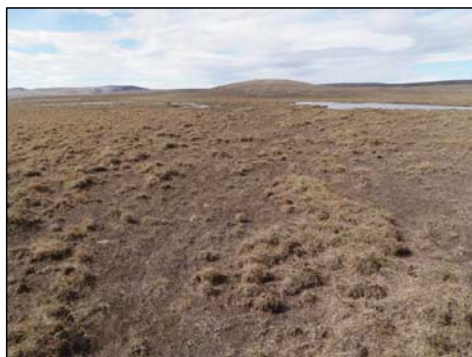
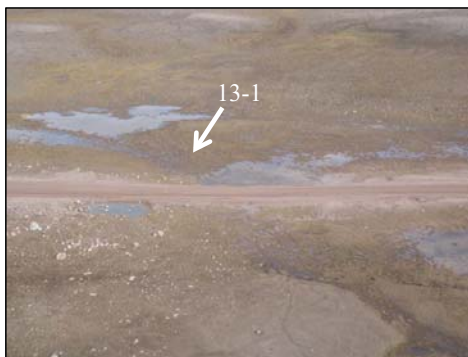
This site was a dry low point during the summer survey and nearly so during the fall survey in 2018. Nearby ponds are fishless and there is no downstream connectivity to Phillips Creek due to several barriers, including lack of surface flow and water dispersed across the tundra. There is never aquatic habitat at this crossing.

**Figure 1.** Views of CV-13-1 at the rail crossing during summer (A) and aerially during fall (B).

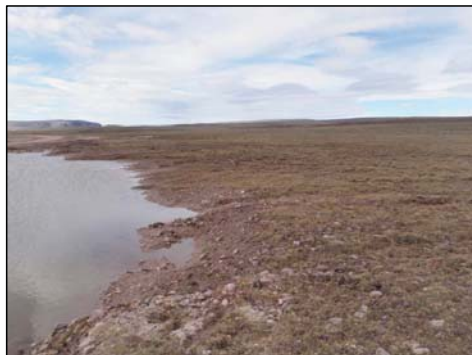
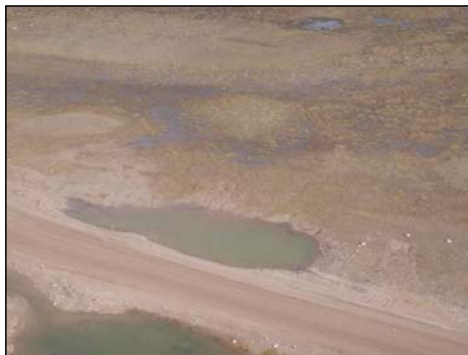
This site is a low point where water has ponded alongside the Tote Road. It is shallow, fishless, and not connected to any fish-bearing habitat. There is never aquatic habitat at this crossing.

**Figure 1.** Views of CV-13-2 at the rail crossing during summer (A) and aerially during fall (B).

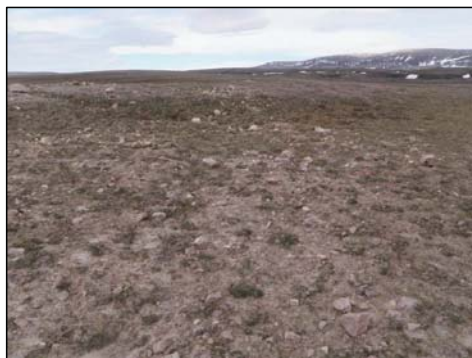
This site was a dry low point in 2018. There is never aquatic habitat at this crossing.

**Figure 1.** View of CV-13-3 at the rail crossing during summer (A).

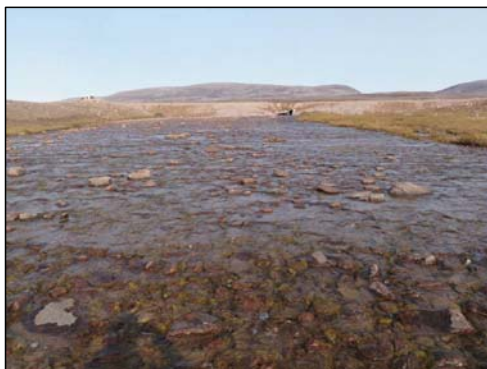
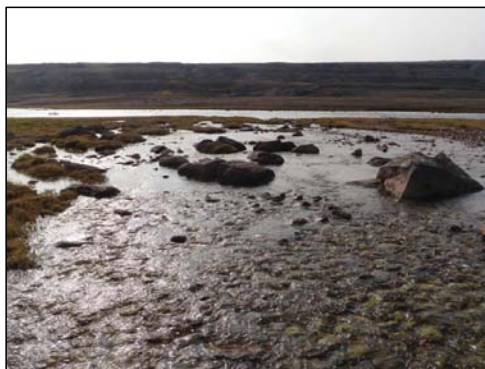
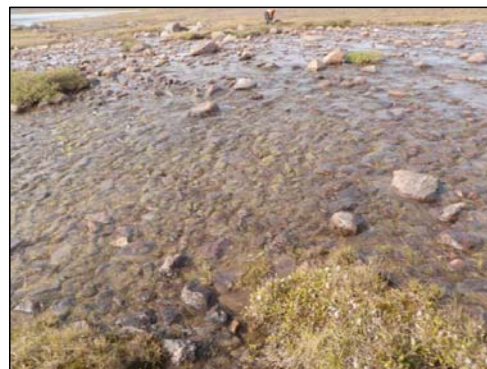
**Figure 1.** Summer (top) and fall (bottom) views of CV-13-4 at the 100 m downstream cross-section; (A) looking upstream; (B) looking downstream; and (C) looking across.

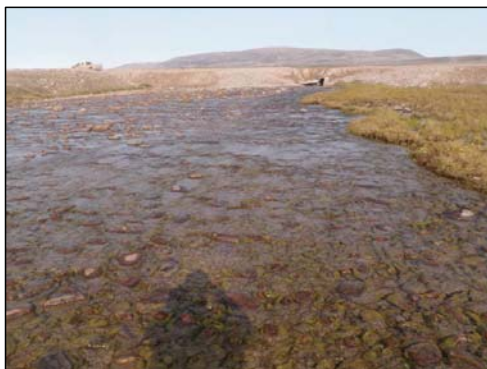
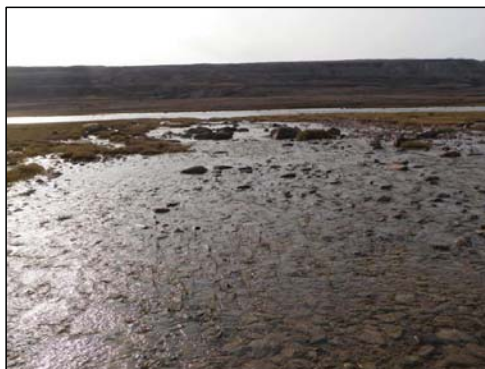
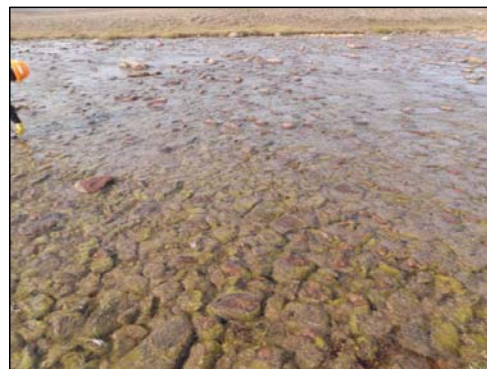
**Figure 2.** Summer (top) and fall (bottom) views of CV-13-4 at the 80 m downstream cross-section; (A) looking upstream; (B) looking downstream; and (C) looking across.

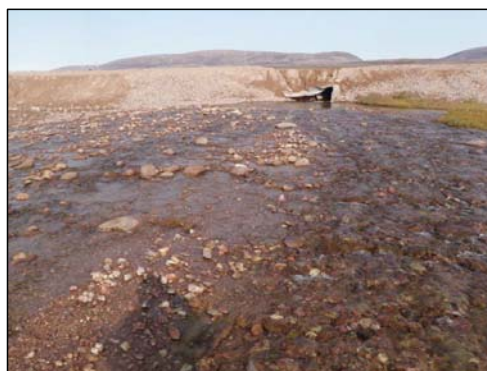
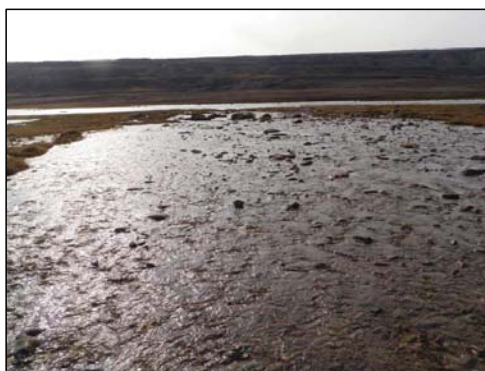
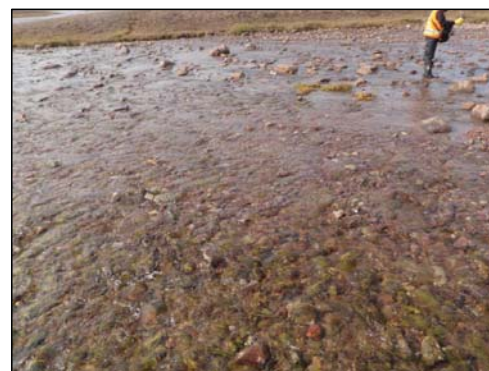
**Figure 3.** Summer (top) and fall (bottom) views of CV-13-4 at the 60 m downstream cross-section; (A) looking upstream; (B) looking downstream; and (C) looking across.

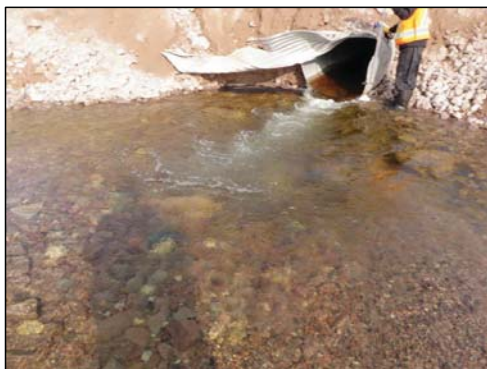
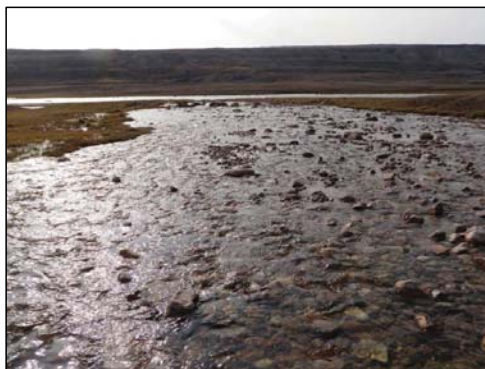
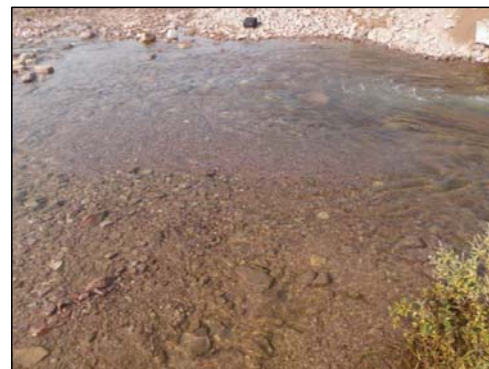
**Figure 4.** Summer (top) and fall (bottom) views of CV-13-4 at the 40 m downstream cross-section; (A) looking upstream; (B) looking downstream; and (C) looking across.

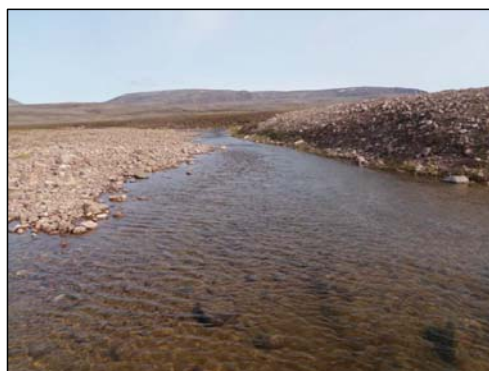
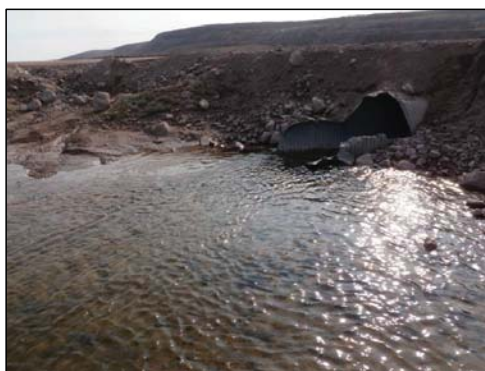
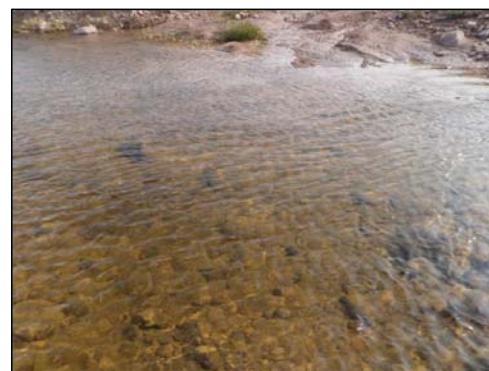
**Figure 5.** Summer (top) and fall (bottom) views of CV-13-4 at the 20 m downstream cross-section; (A) looking upstream; (B) looking downstream; and (C) looking across.

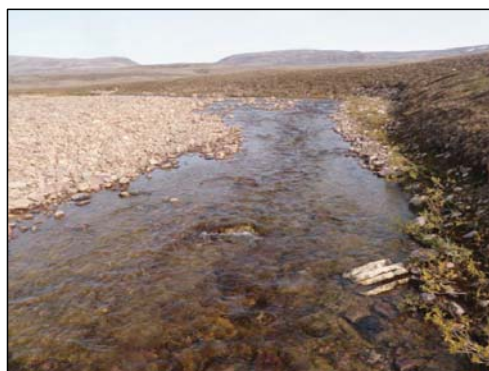
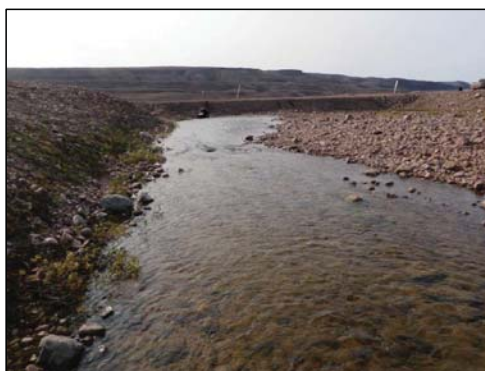
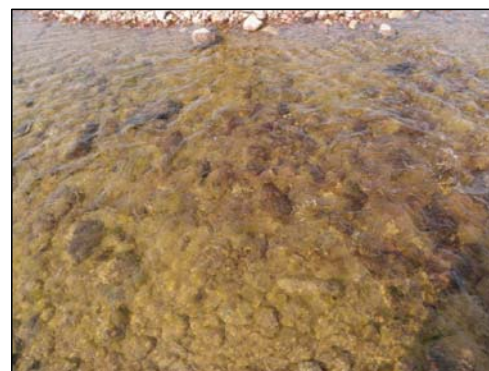
**Figure 7.** Summer (top) and fall (bottom) views of CV-13-4 at the 20 m upstream cross-section; (A) looking upstream; (B) looking downstream; and (C) looking across.

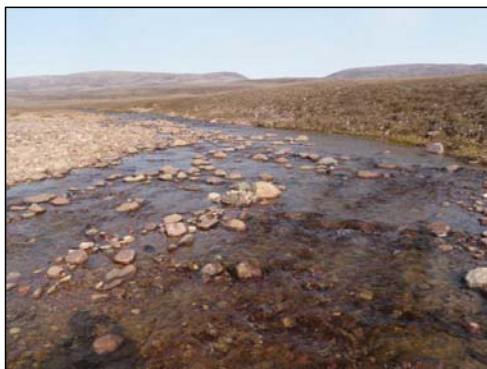
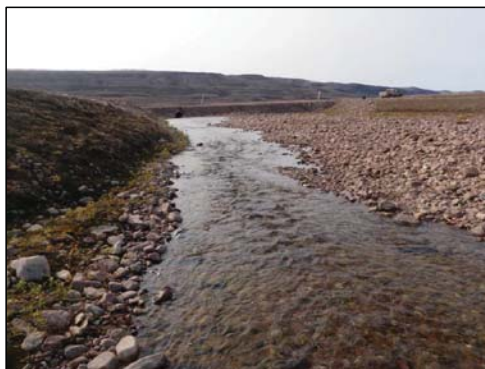
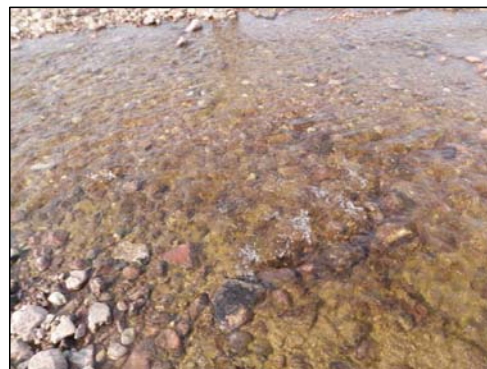
**Figure 8.** Summer (top) and fall (bottom) views of CV-13-4 at the 40 m upstream cross-section; (A) looking upstream; (B) looking downstream; and (C) looking across.

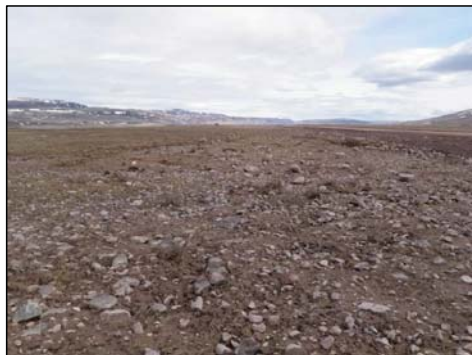
A

This site was a dry low point in summer and slightly wetted marshy terrain during fall. There is no connectivity to overwintering habitat. There is never aquatic habitat at this crossing.

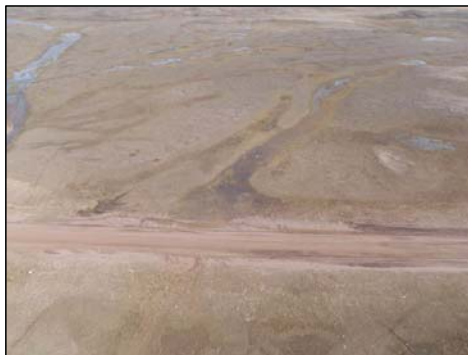
B

**Figure 1.** View of CV-13-5 at the rail crossing during summer (A) and aerially during fall (B).

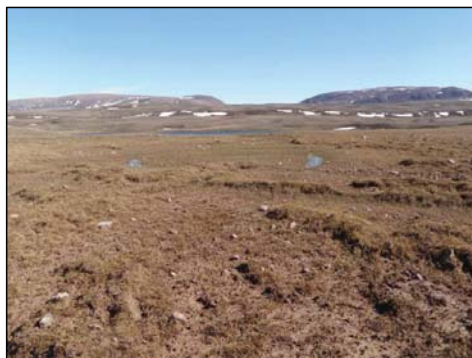
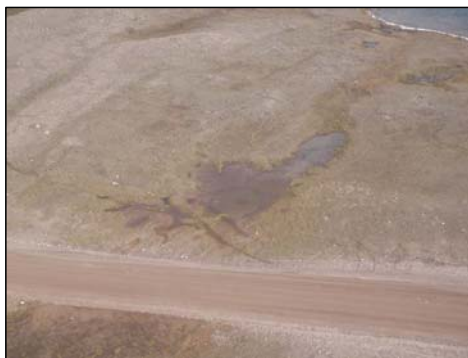
This site was a nearly dry low point in summer and a wetter low point during fall. There is no connectivity to overwintering habitat. There is never aquatic habitat at this crossing.

**Figure 1.** View of CV-14-1 at the rail crossing during summer (A) and aerially during fall (B).

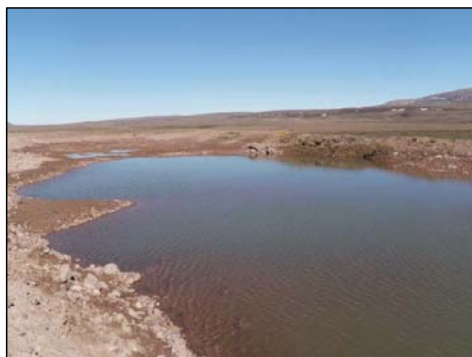
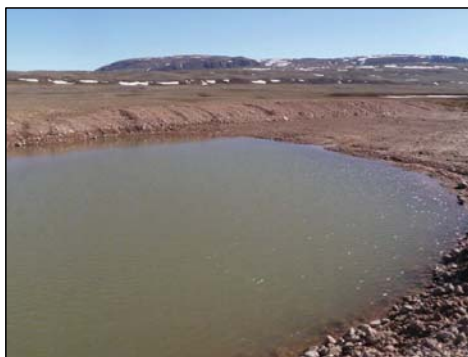
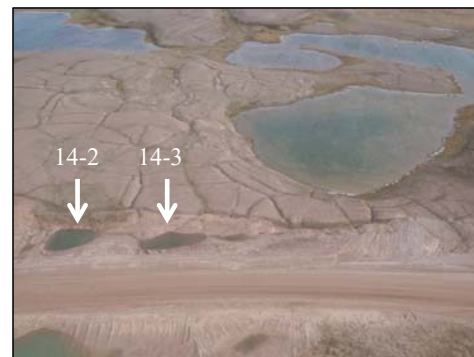
This site is a small shallow pond connected to a similar pond at CV-14-3, but with no other connections. There is no connectivity to overwintering habitat and never aquatic habitat at this crossing.

**Figure 1.** View of CV-14-2 at the rail crossing during summer (A) and (B), and aerially, with nearby 14-3, during fall (C).

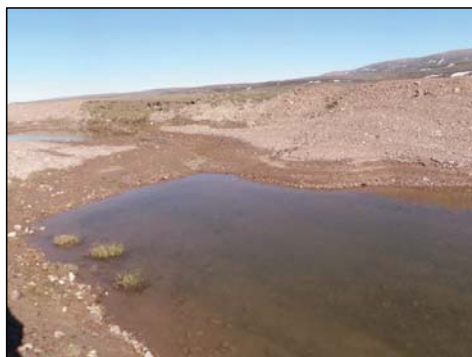
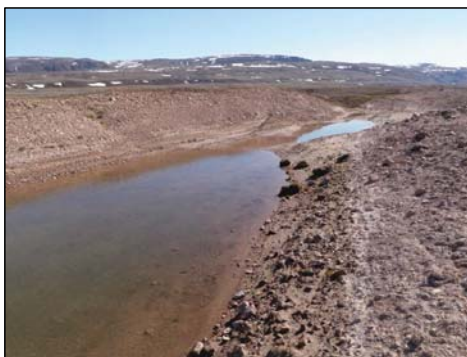
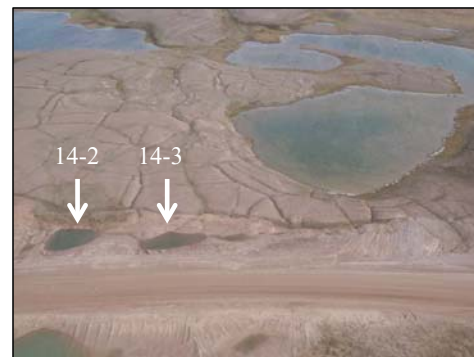
This site is a small shallow pond connected to a similar pond at CV-14-2, but with no other connections. There is no connectivity to overwintering habitat and never aquatic habitat at this crossing.

**Figure 1.** View of CV-14-3 at the rail crossing during summer (A) and (B), and aerially, with nearby 14-2, during fall (C).

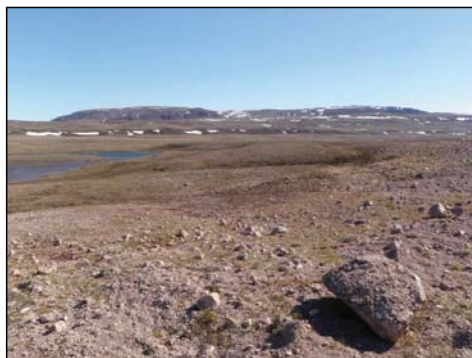
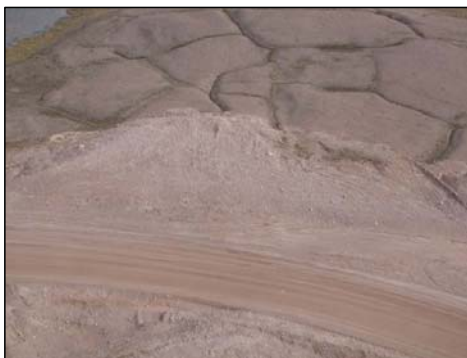
This site was a dry low point in 2018. There is never aquatic habitat at this crossing.

**Figure 1.** View of CV-15-1 at the rail crossing during summer (A) and aerially during fall (B).

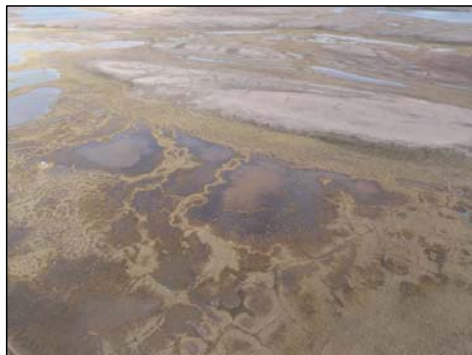
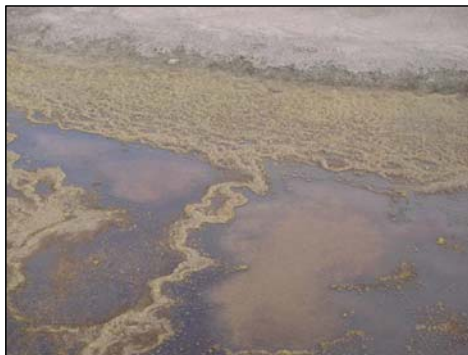
This site is a shallow, fishless pond/marshy area that is unconnected to nearby fish habitat at 15-2, 15-3, or 15-5 even under high flows. There is never aquatic habitat at this crossing.

**Figure 1.** Aerial views of CV-15-4 at the rail crossing during fall (A) and (B).

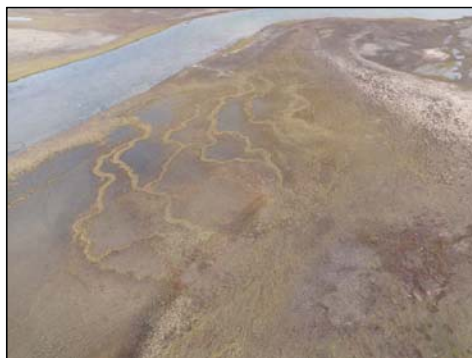
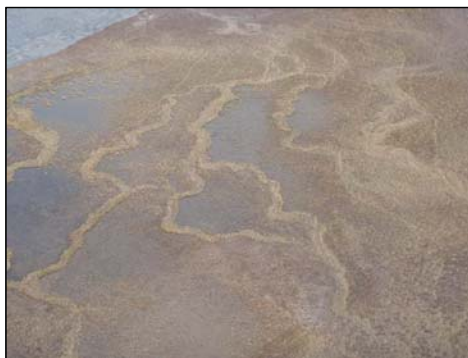
This site is a shallow, fishless low point/marshy area that is unconnected to nearby fish habitat at 15-5 unless that large river were to exceed its bank-full width.

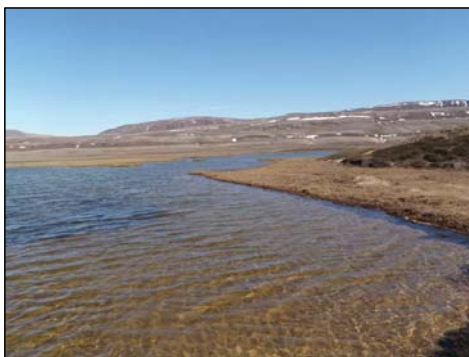
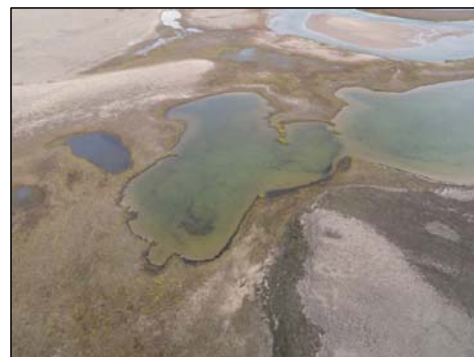
**Figure 1.** Views of CV-16-2 at the rail crossing during summer (A) and (B), and aerially during fall (C).

This pond was fished in 2017 and no fish were captured or observed. It is too shallow for overwintering and is unconnected to CV-15-5 upstream due to a permanent vertical barrier at the confluence. There is no fish habitat at this crossing.

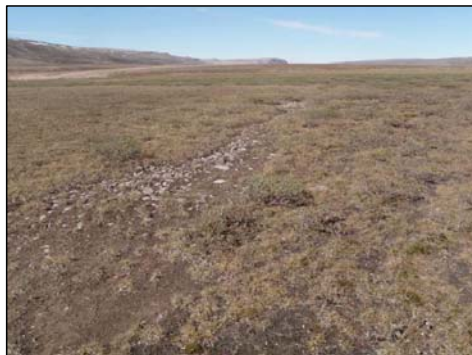
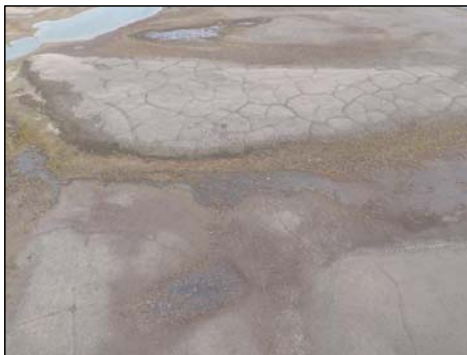
**Figure 1.** Views of CV-16-3 at the rail crossing during summer (A) and aerially during fall (B).

This was a dry creek bed in summer and nearly dry in fall. It is unconnected to fish-bearing habitat due to several soft and permanent barriers between the crossing and both upstream and downstream habitat. There is no fish habitat at this crossing.

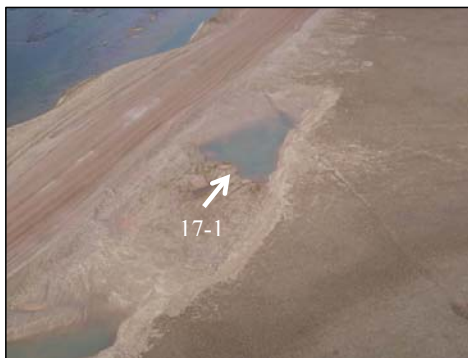
**Figure 1.** Views of CV-17-1 at the rail crossing during summer (A) and aerially during fall (B).

This is a small, shallow, isolated pond beside the Tote Road. Fish were not observed and overwintering is not possible. There is no fish habitat at this crossing.

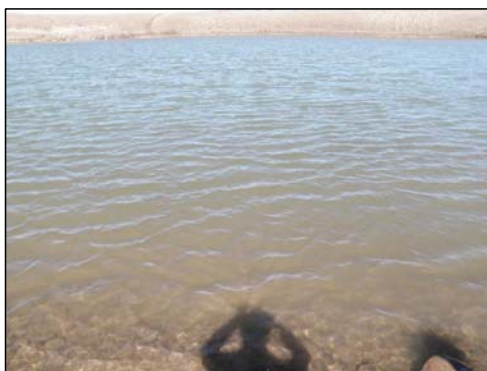
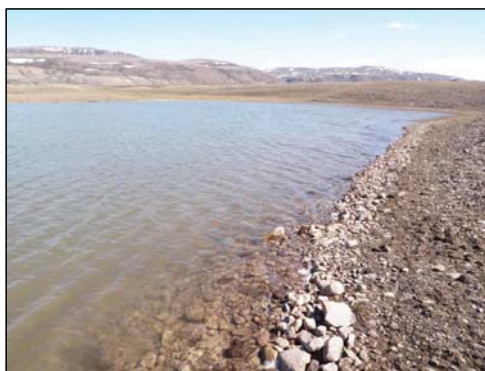
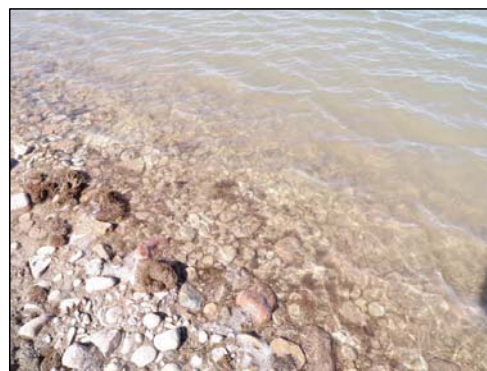
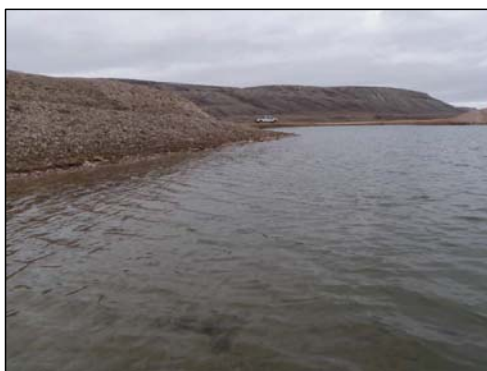
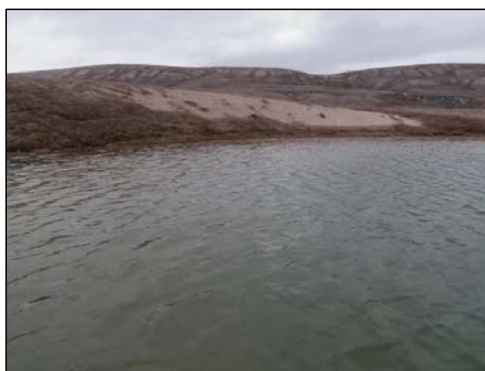
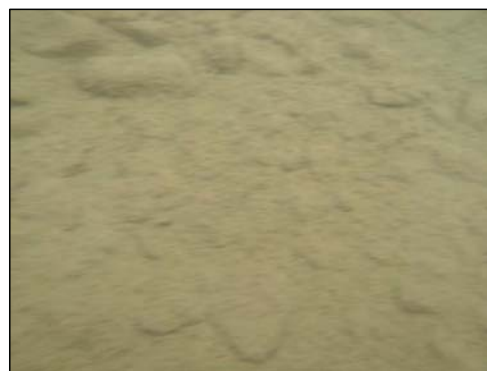
**Figure 1.** Summer (top) and fall (bottom) views of CV-18-1 shoreline habitat (A and B) and substrate (C).

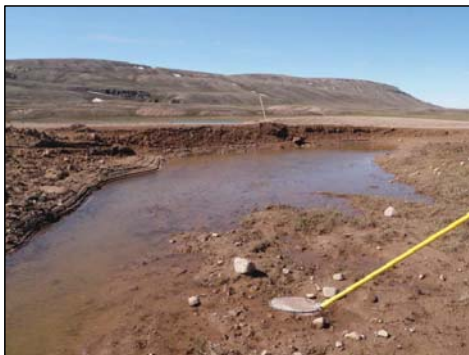
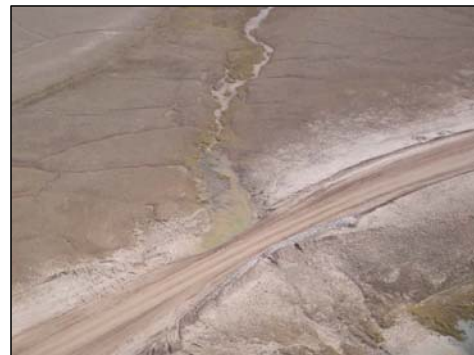
This site is an area of shallow ponding on the upstream side of the Tote Road. There is a steep gradient and no channel downstream of the road, creating a barrier under all flow conditions. There is no fish habitat at this crossing.

**Figure 1.** Views of CV-18-2 at the rail crossing during summer (A) and (B), and aerially during fall (C).

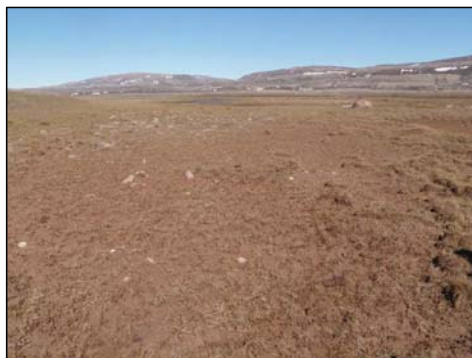
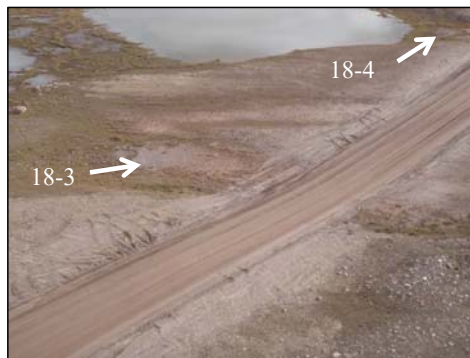
This was a dry low point during summer and nearly dry during fall. There are no connections to other habitat. There is no fish habitat at this crossing.

**Figure 1.** Views of CV-18-3 at the rail crossing during summer (A) and (B), and aerially, with nearby 18-4 during fall (C).

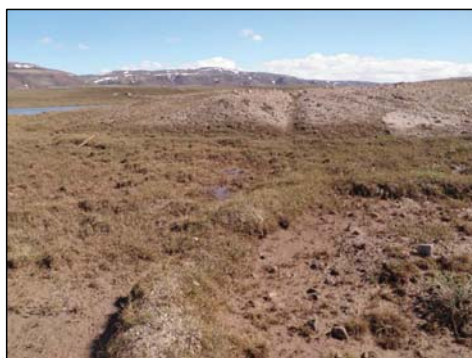
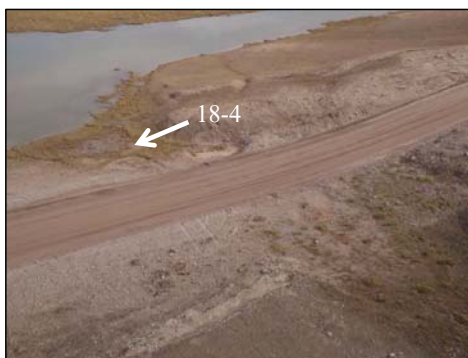
This was a nearly dry low point during summer and fall 2018. There are no connections to other fish-bearing habitat. There is no fish habitat at this crossing.

**Figure 1.** Views of CV-18-4 at the rail crossing during summer (A) and aerially during fall (B).

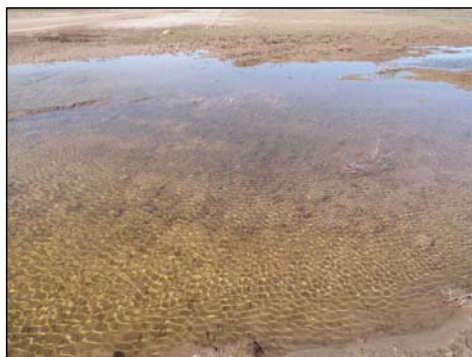
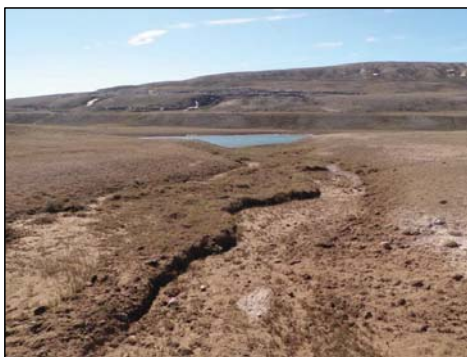
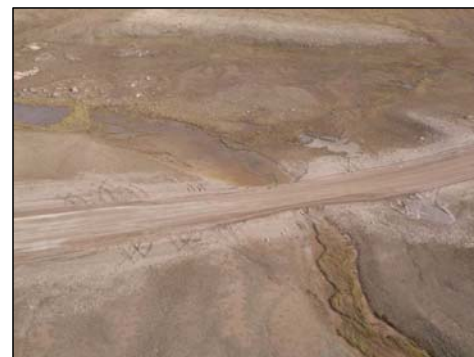
This is an area of shallow ponding upstream of the Tote Road. There are no connections to other fish-bearing habitat due to downstream subsurface flow barriers. There is no fish habitat at this crossing.

**Figure 1.** Views of CV-19-1 at the rail crossing (A) and downstream of the Tote Road (B) during summer, and aerially during fall (C).

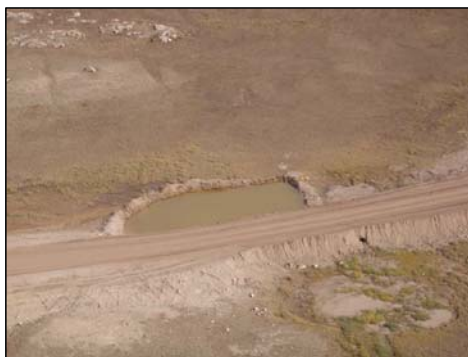
This is a shallow, isolated pond upstream of the Tote Road. Fish were not observed. It does not provide overwintering habitat and there are no connections to other fish-bearing waterbodies. There is no fish habitat at this crossing.

**Figure 1.** Views of CV-19-2 at the rail crossing during summer (A) and aerially during fall (B).

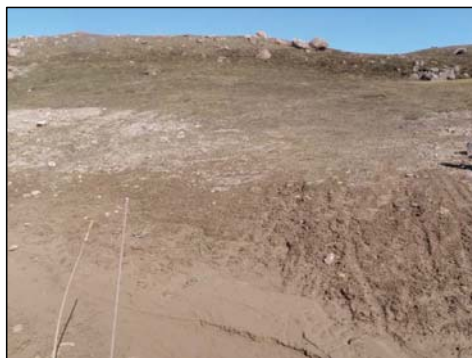
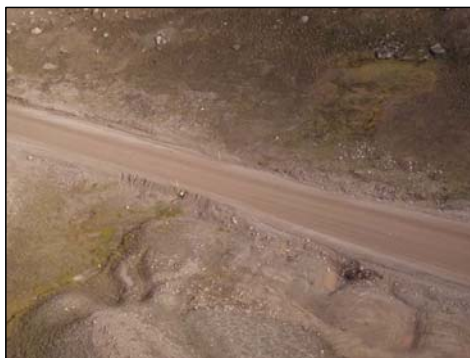
This was a dry low point in 2018. There is no fish habitat at this crossing.

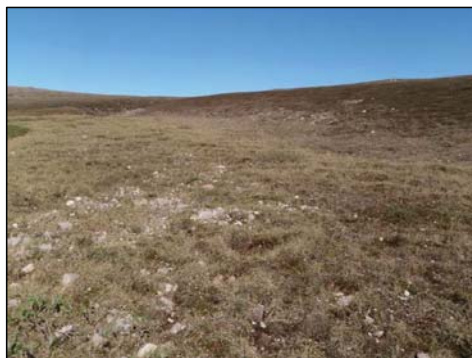
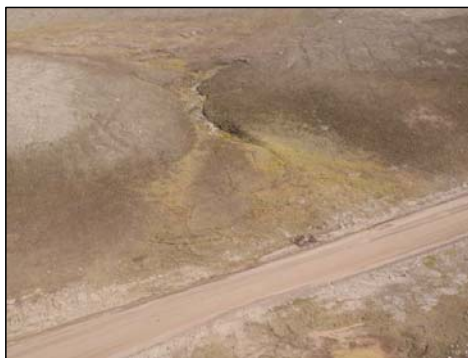
This was a dry low point in 2018. There is no fish habitat at this crossing.

**A**  
**Figure 1.** Views of CV-20-1 at the rail crossing during summer (A) and aerially during fall (B).

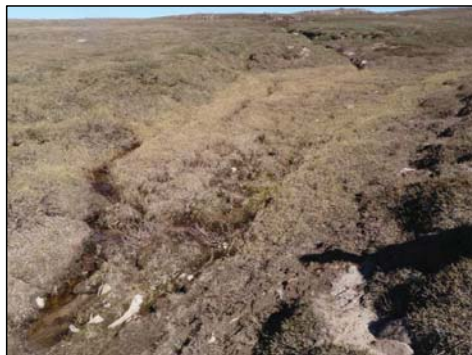
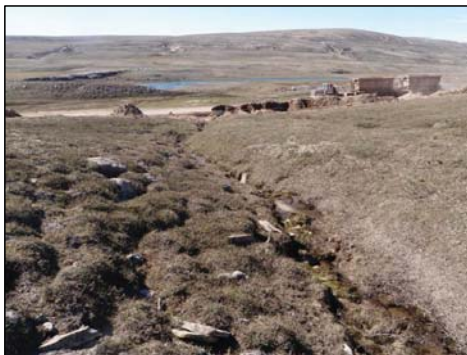
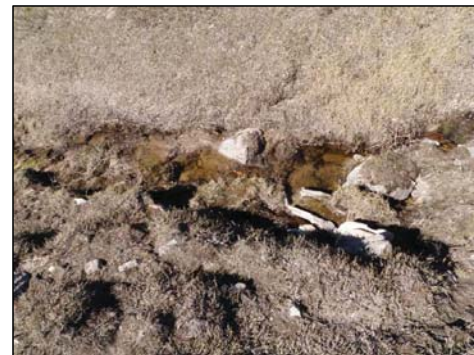
Water levels were very low at this site during both surveys. In addition, there are multiple soft barriers to fish movement (subsurface flow, high gradient), and impassable vertical drops between the crossing and Phillips Creek downstream. There is no fish habitat at this crossing.

**Figure 1.** Views of CV-20-2 at the rail crossing during summer, looking upstream (A) downstream (B) and across (C).
