Phase 2 Milne Rail Corridor Aquatic Habitat Assessment

Crossing ID: CV-54-2

**Baffinland Iron Mines
Mary River Project**

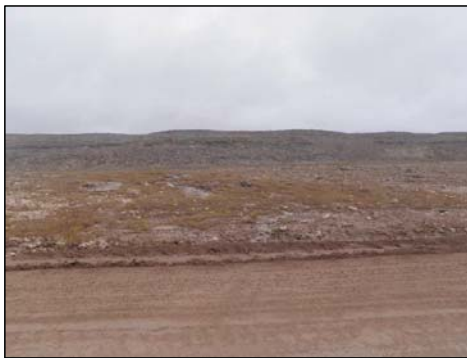
This site was nearly dry in 2018 with multiple soft barriers to fish movement and no connectivity with overwintering habitat under any flow condition. There is never fish habitat at this crossing.

Figure 1. Views of CV-54-2 at the rail crossing during summer (A) and fall (B).

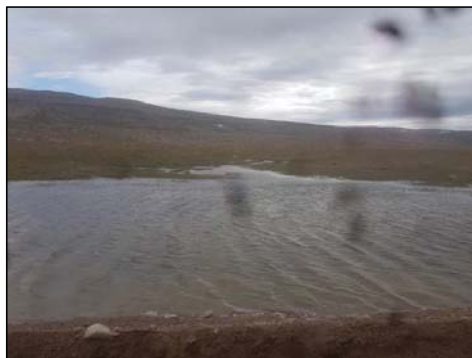
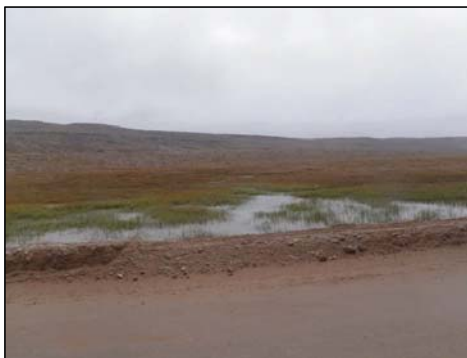
This site was a shallow, isolated, low point at the Tote Road that showed some ponding in 2018. There is never fish habitat at this crossing.

Figure 1. Views of CV-55-1 at the rail crossing during summer (A) and fall (B).

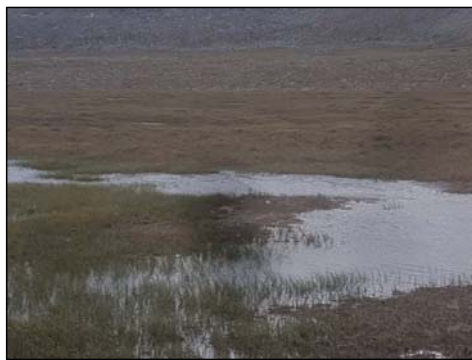
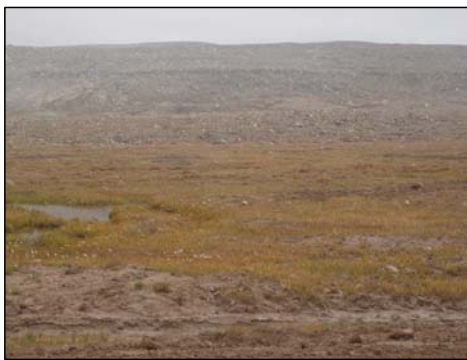
This site was a shallow, isolated, fishless pond that had nearly dried up by fall. There is never fish habitat at this crossing.

Figure 1. Views of CV-55-2 at the rail crossing during summer (A) and fall (B).

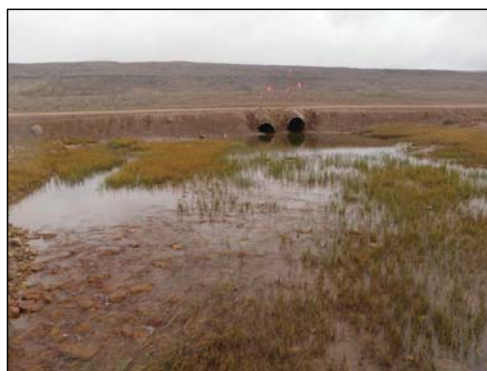
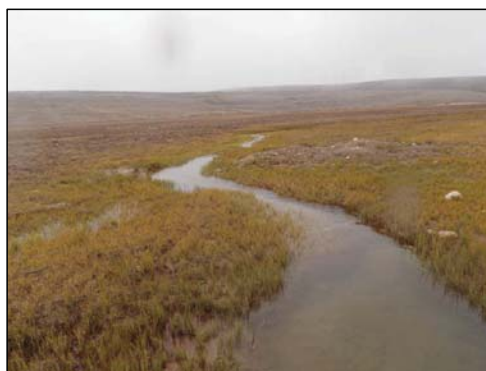
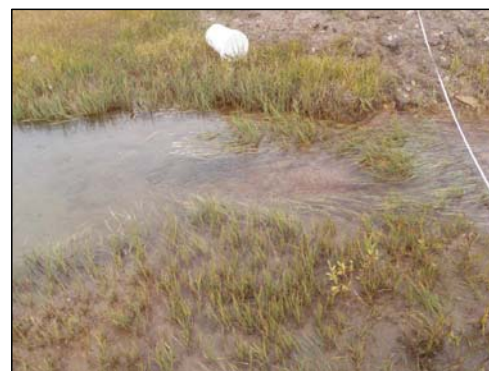
Figure 3. Summer (top) and fall (bottom) views of CV-55-3 at the 60 m downstream cross-section; (A) looking upstream; (B) looking downstream; and (C) looking across.

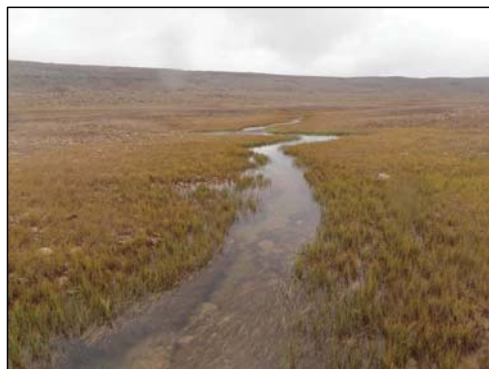
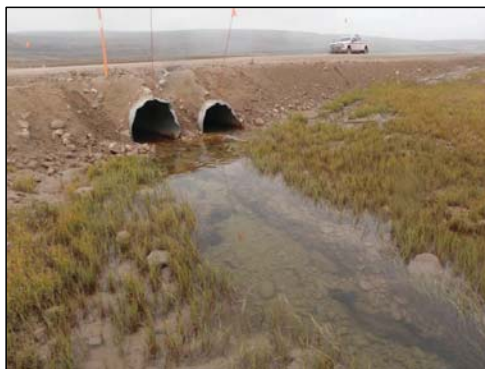
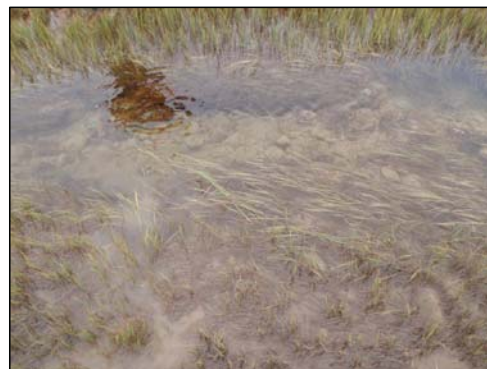
Figure 5. Summer (top) and fall (bottom) views of CV-55-3 at the 20 m downstream cross-section; (A) looking upstream; (B) looking downstream; and (C) looking across.

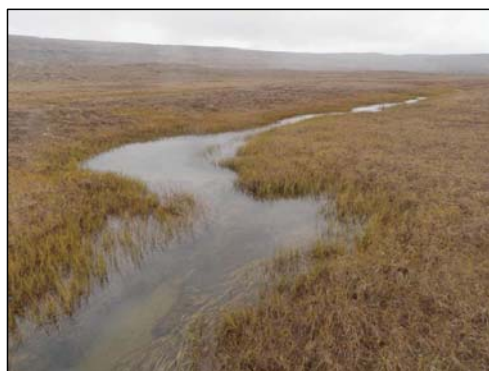
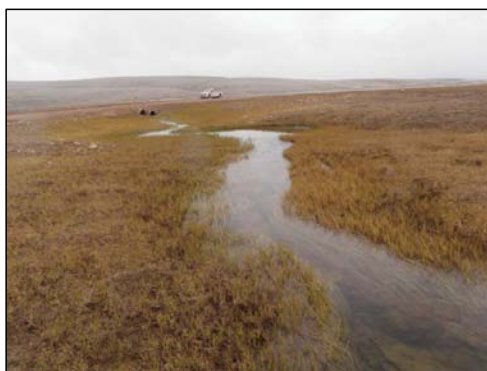
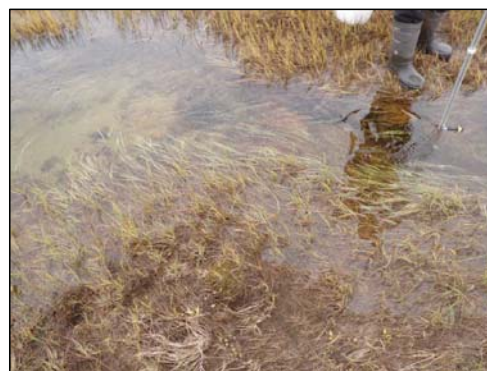
Figure 7. Summer (top) and fall (bottom) views of CV-55-3 at the 20 m upstream cross-section; (A) looking upstream; (B) looking downstream; and (C) looking across.

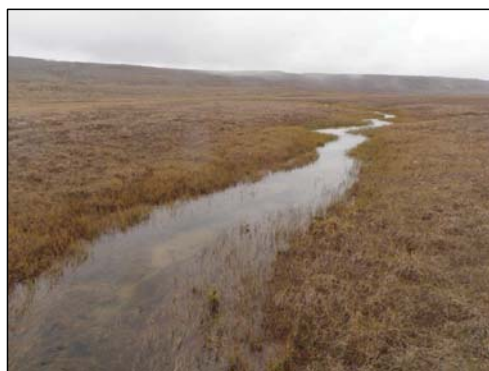
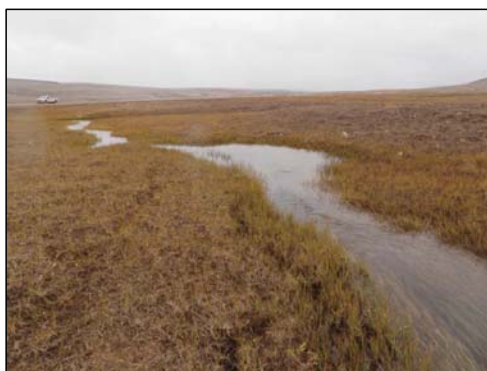
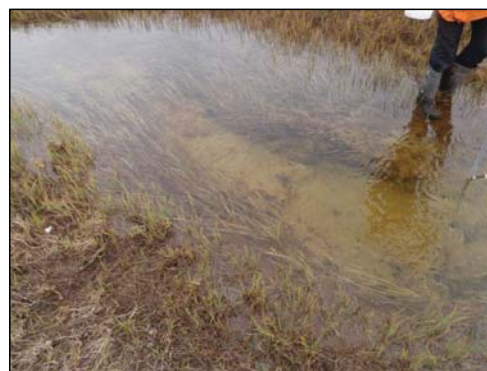
Figure 8. Summer (top) and fall (bottom) views of CV-55-3 at the 40 m upstream cross-section; (A) looking upstream; (B) looking downstream; and (C) looking across.

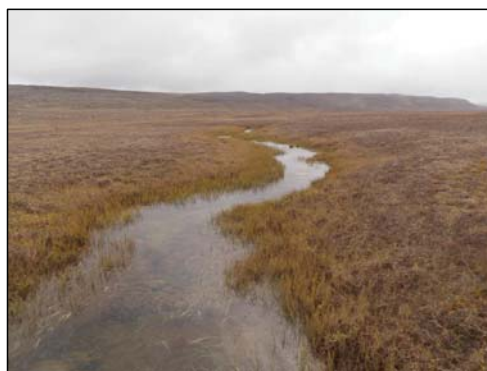
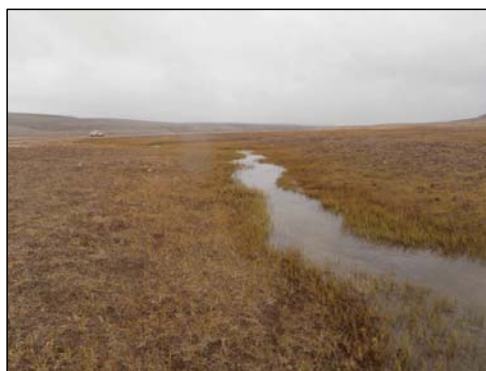
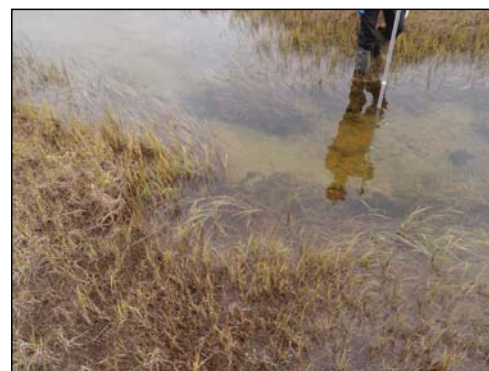
Figure 10. Summer (top) and fall (bottom) views of CV-55-3 at the 60 m upstream cross-section; (A) looking upstream; (B) looking downstream; and (C) looking across.

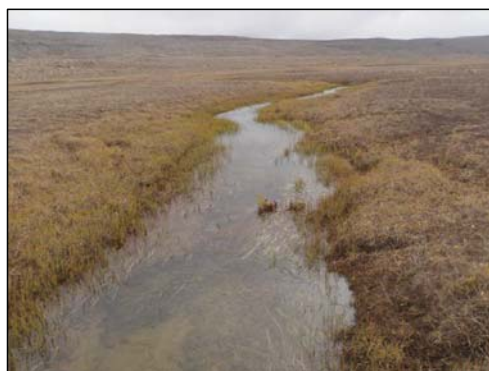
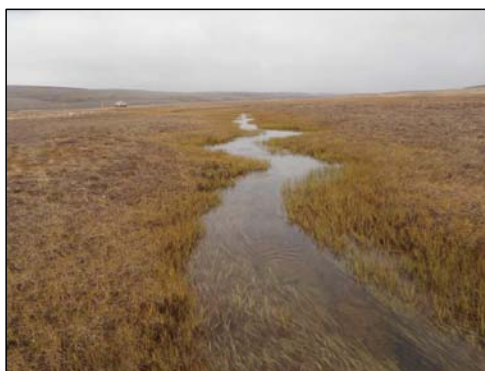
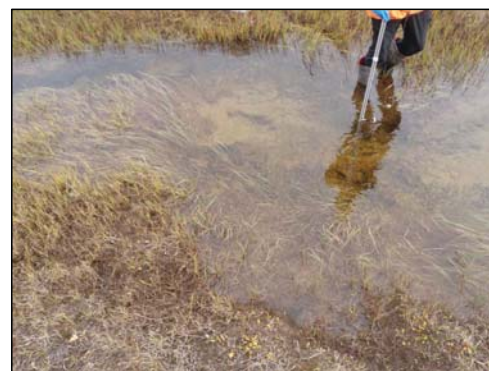
Figure 11. Summer (top) and fall (bottom) views of CV-55-3 at the 80 m upstream cross-section; (A) looking upstream; (B) looking downstream; and (C) looking across.

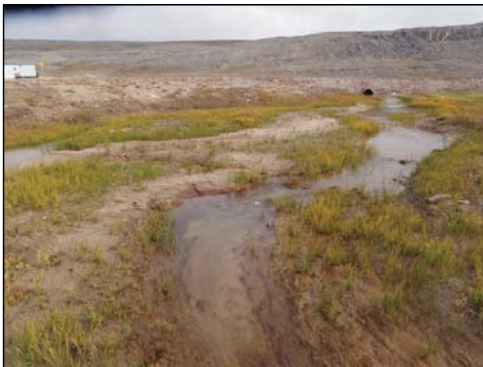
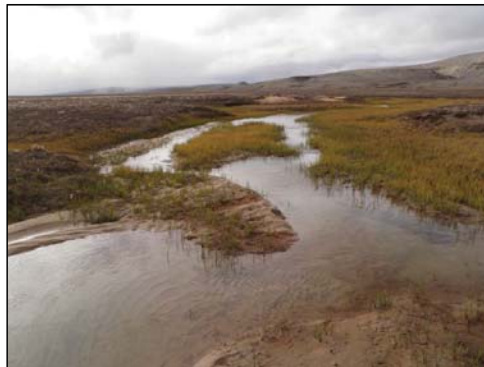
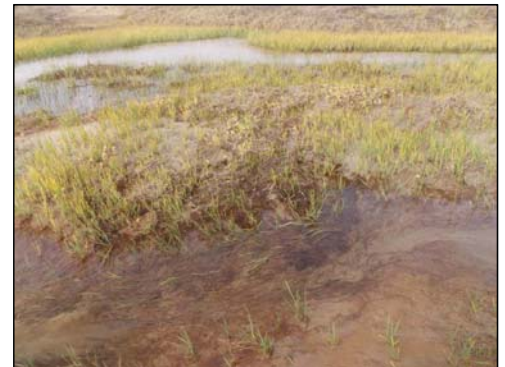
Figure 5. Summer (top) and fall (bottom) views of CV-57-1 at the 40 m downstream cross-section; (A) looking upstream; (B) looking downstream; and (C) looking across.

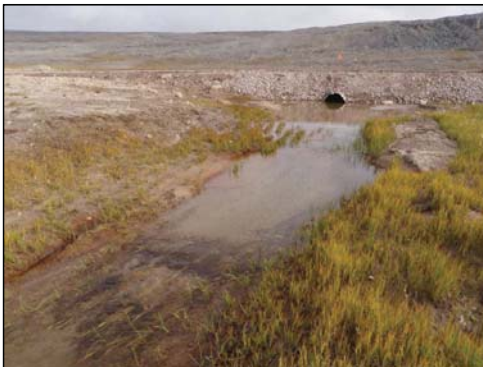
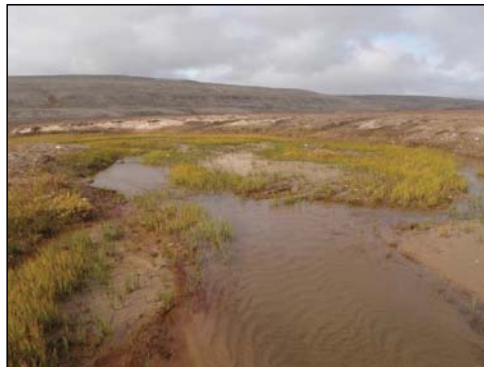
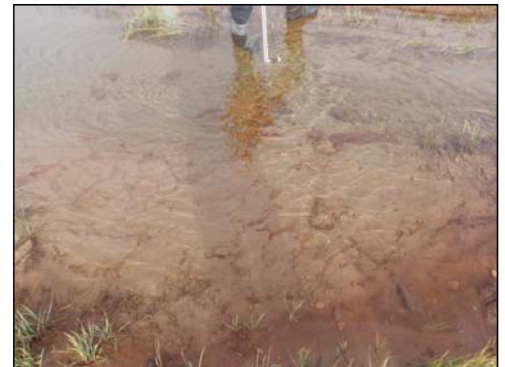
Figure 6. Summer (top) and fall (bottom) views of CV-57-1 at the 20 m downstream cross-section; (A) looking upstream; (B) looking downstream; and (C) looking across.

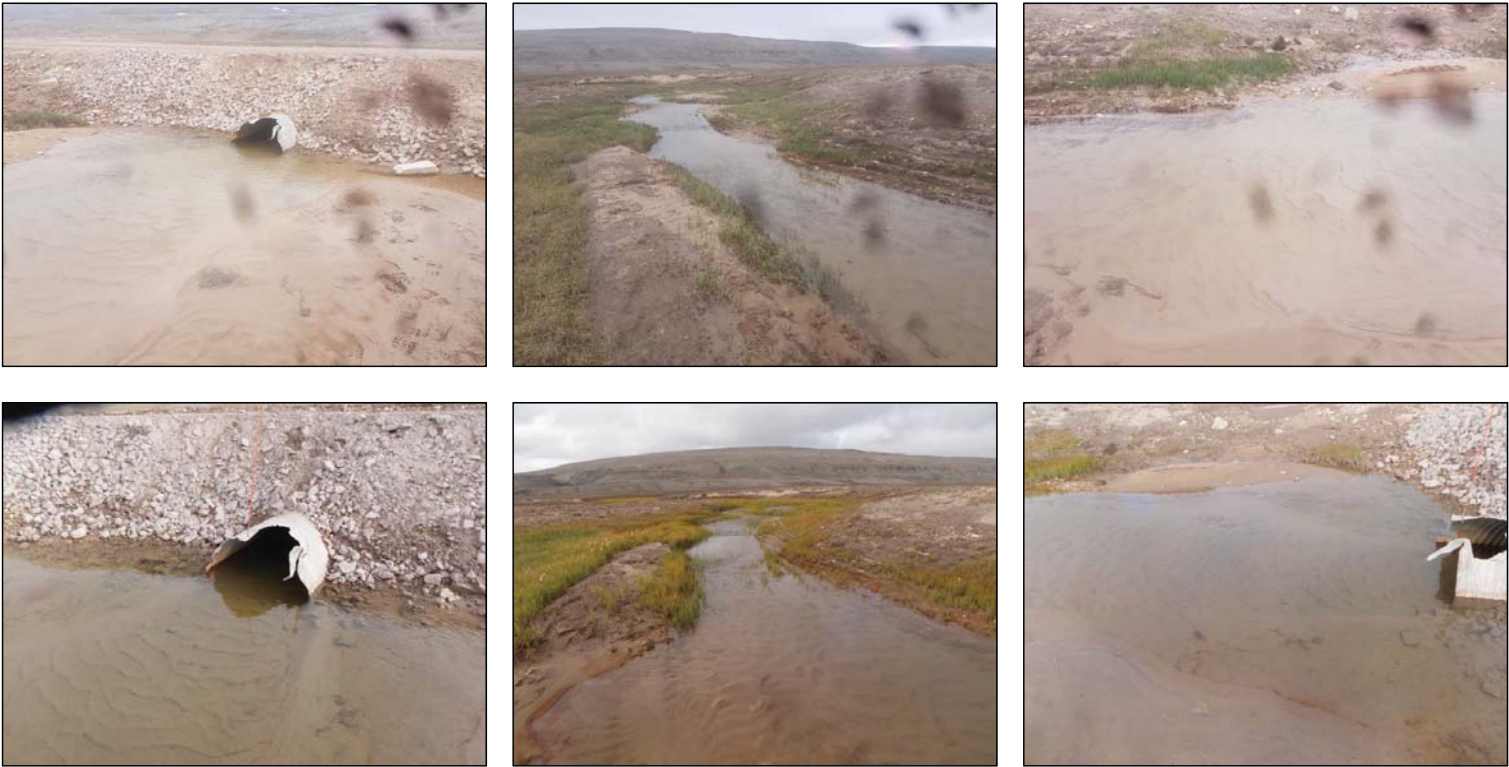
Figure 7. Summer (top) and fall (bottom) views of CV-57-1 at the rail crossing; (A) looking upstream; (B) looking downstream; and (C) looking across.

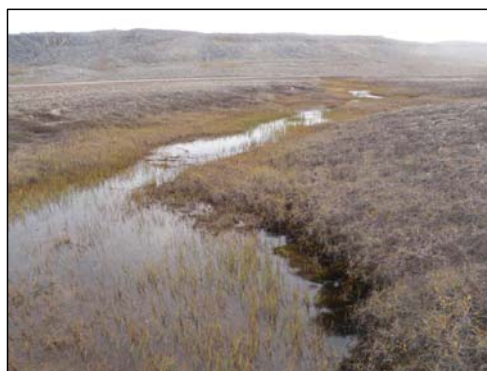
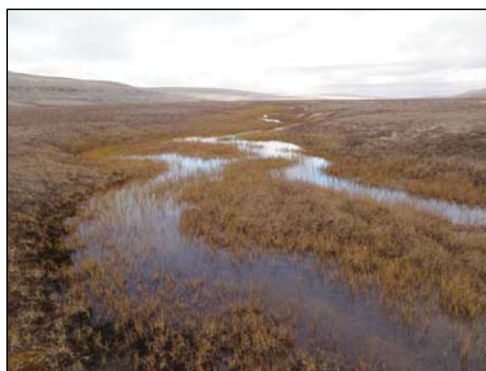
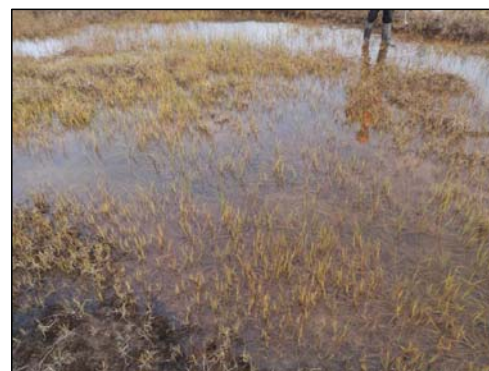
Figure 2. Summer (top) and fall (bottom) views of CV-57-2 at the 80 m downstream cross-section; (A) looking upstream; (B) looking downstream; and (C) looking across.

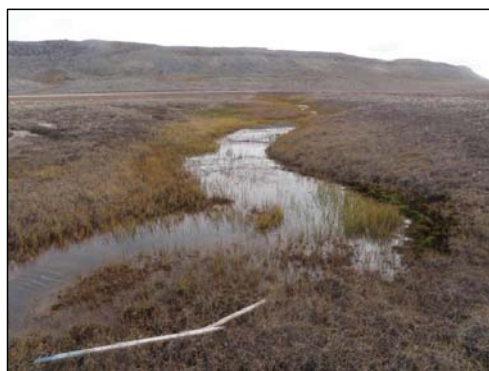
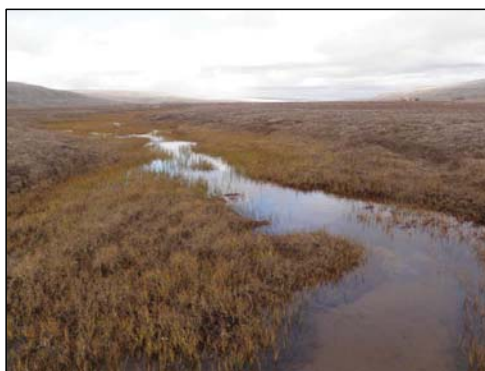
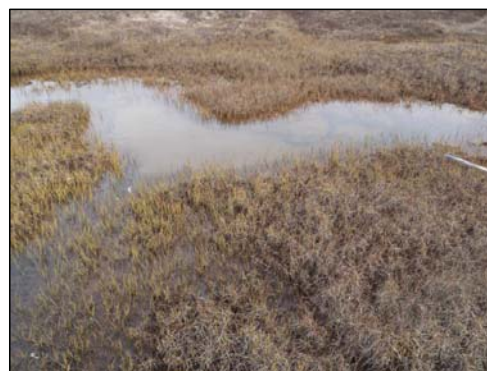
Figure 3. Summer (top) and fall (bottom) views of CV-57-2 at the 60 m downstream cross-section; (A) looking upstream; (B) looking downstream; and (C) looking across.

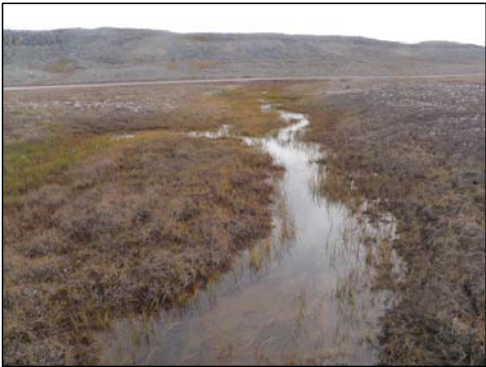
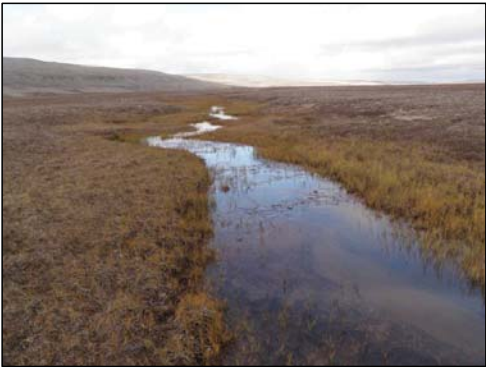
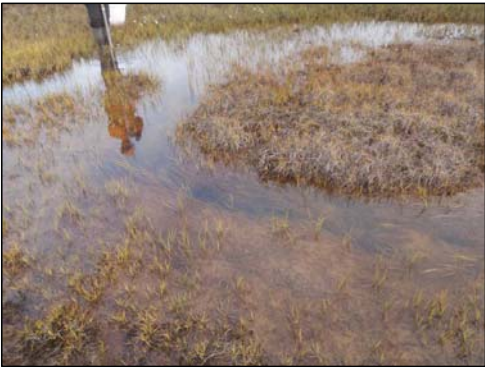
Figure 5. Summer (top) and fall (bottom) views of CV-57-2 at the 40 m downstream cross-section; (A) looking upstream; (B) looking downstream; and (C) looking across.

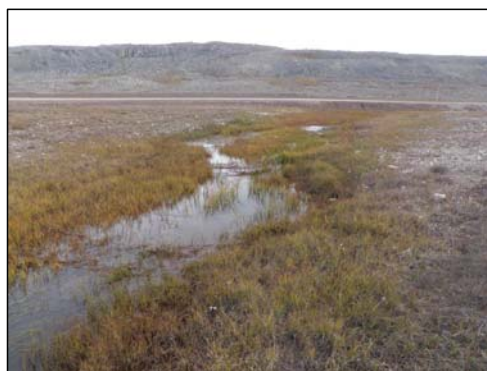
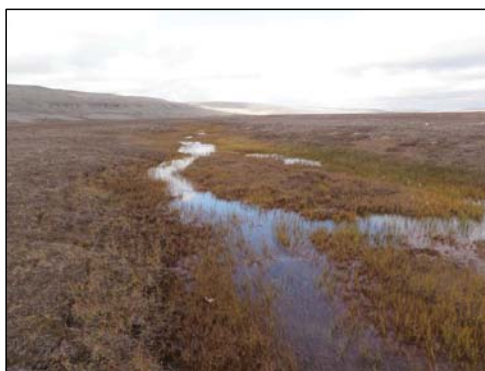
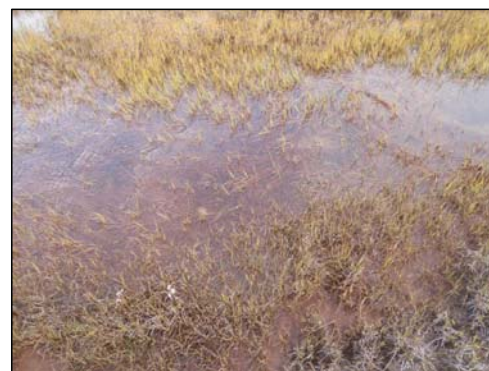
Figure 6. Summer (top) and fall (bottom) views of CV-57-2 at the 20 m downstream cross-section; (A) looking upstream; (B) looking downstream; and (C) looking across.

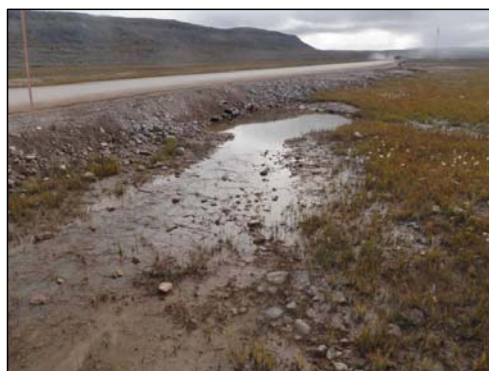
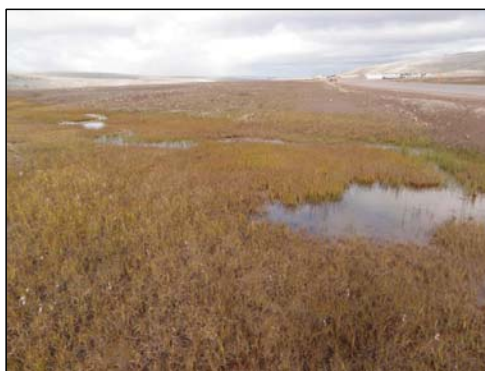
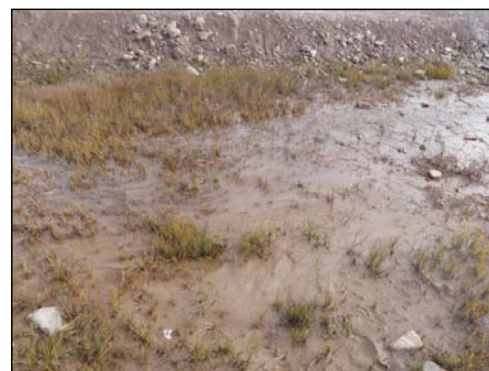
Figure 8. Summer (top) and fall (bottom) views of CV-57-2 at the 20 m upstream cross-section; (A) looking upstream; (B) looking downstream; and (C) looking across.

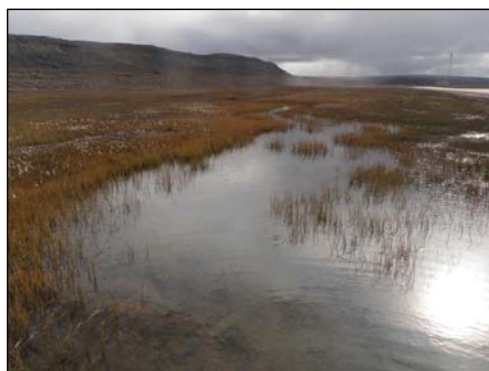
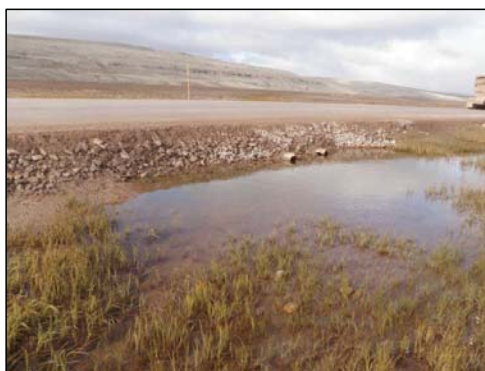
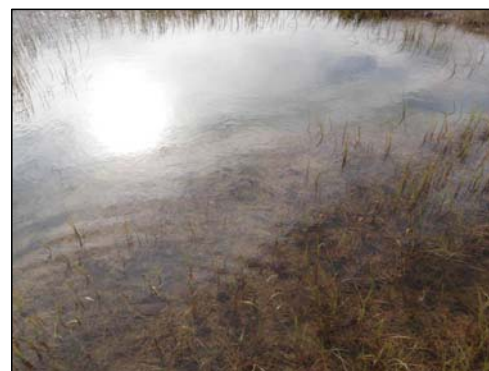
Figure 9. Summer (top) and fall (bottom) views of CV-57-2 at the 40 m upstream cross-section; (A) looking upstream; (B) looking downstream; and (C) looking across.

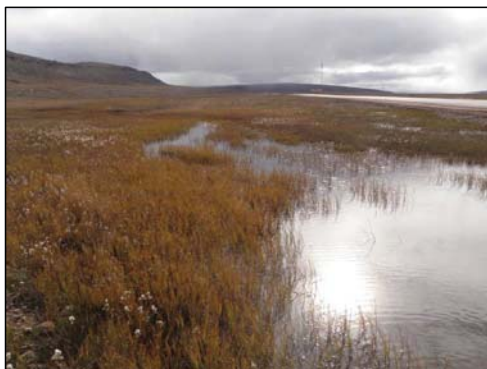
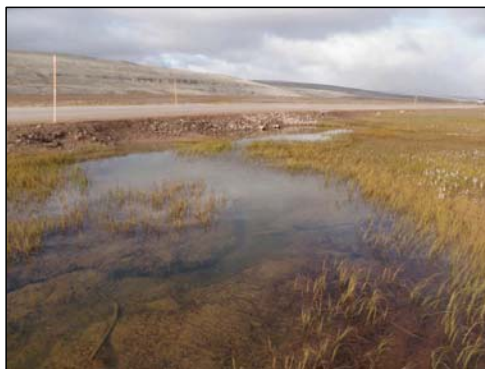
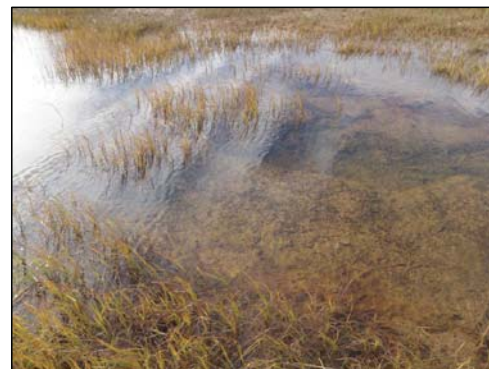
Figure 11. Summer (top) and fall (bottom) views of CV-57-2 at the 60 m upstream cross-section; (A) looking upstream; (B) looking downstream; and (C) looking across.

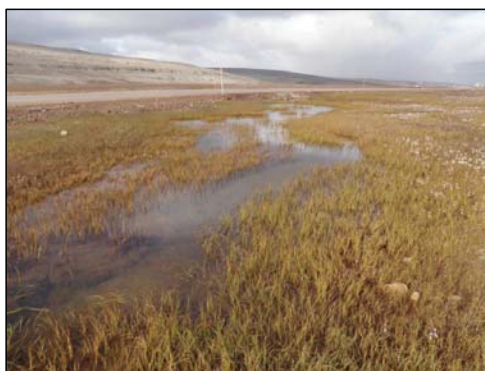
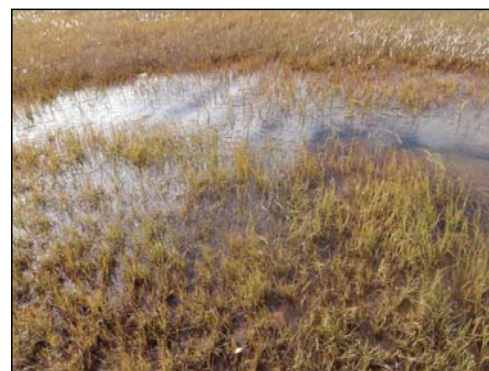
Figure 12. Summer (top) and fall (bottom) views of CV-57-2 at the 80 m upstream cross-section; (A) looking upstream; (B) looking downstream; and (C) looking across.

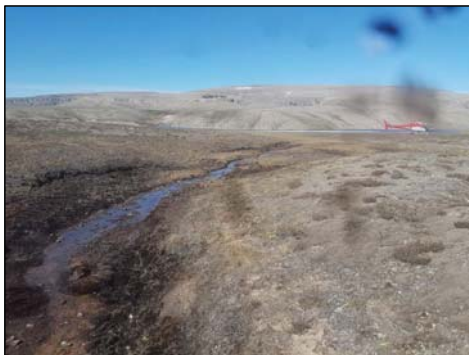
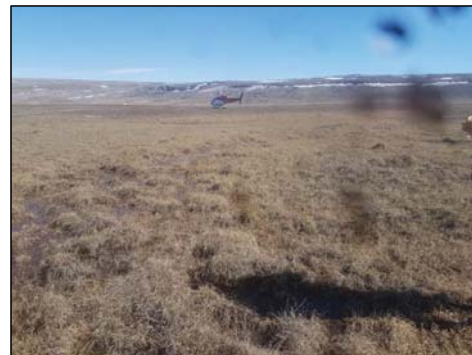
This stream was shallow (1 cm maximum depth) with almost no flow in 2018. In addition, there is a soft barrier downstream (lack of surface flow and no channel) preventing access from a possible overwintering lake. The barrier may be sufficient to prevent access to the rail crossing under all flow conditions.

Figure 1. Views of CV-58-2 at the rail crossing during summer, looking upstream (A), downstream (B), and at the barrier near the confluence with a downstream lake (C).

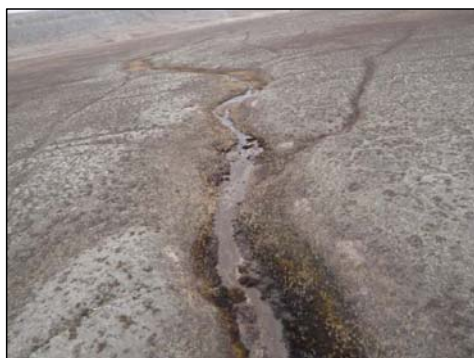
A
Figure 2. Aerial view of CV-58-2 during fall.

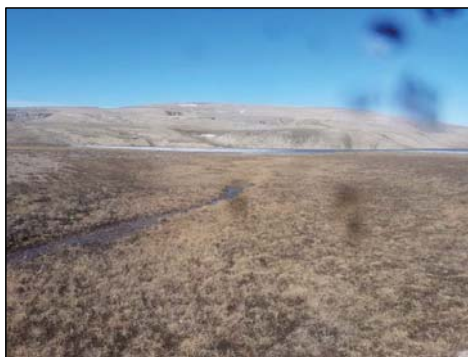
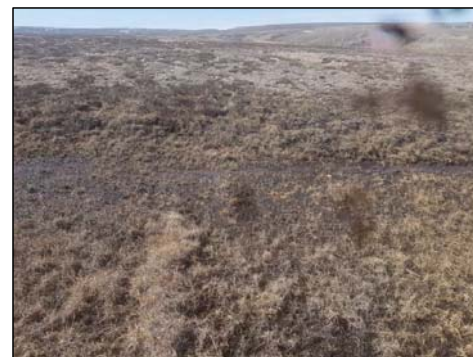
This stream was nearly dry at the rail crossing in both June and August and no fish were observed. In addition, there were several downstream locations where there was no surface water or the channel disappeared and water dispersed across the tundra, creating a soft barrier to fish movements.

Figure 1. Summer views of CV-58-3 at the rail crossing; (A) looking upstream; (B) looking downstream; and (C) looking across.

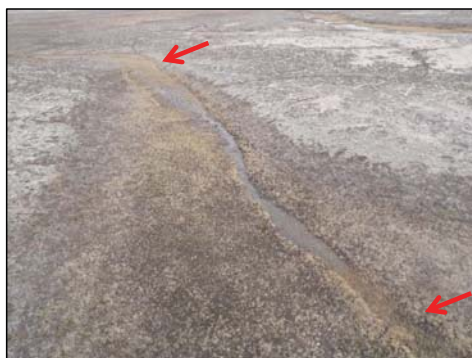
Figure 2. Aerial view of CV-58-3 during fall, showing subsurface flows both upstream and downstream of the crossing (red arrows).

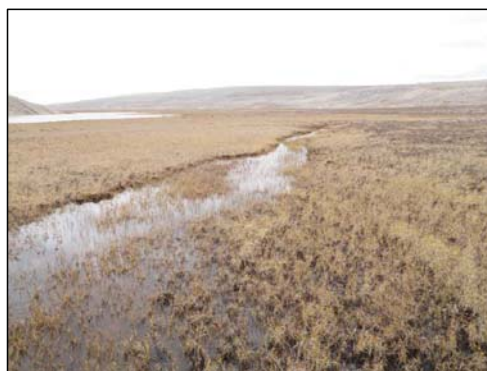
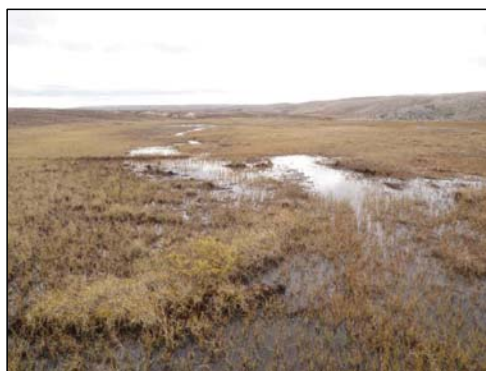
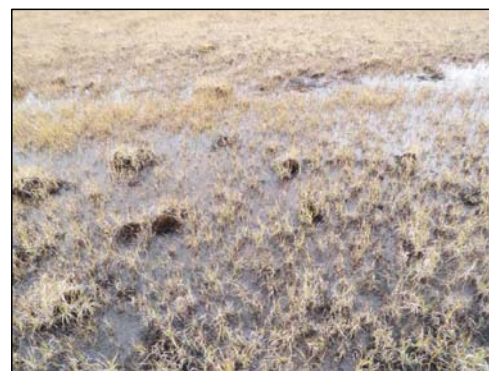
Figure 1. Summer (top) and fall (bottom) views of CV-58-4 at the 100 m downstream cross-section; (A) looking upstream; (B) looking downstream; and (C) looking across.

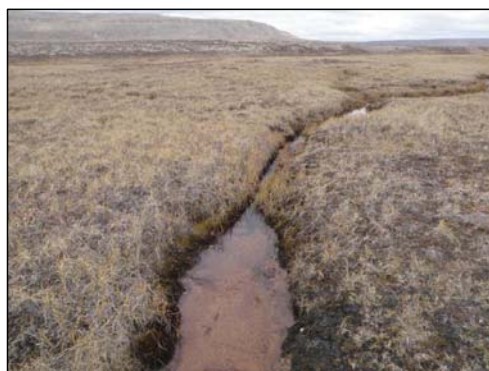
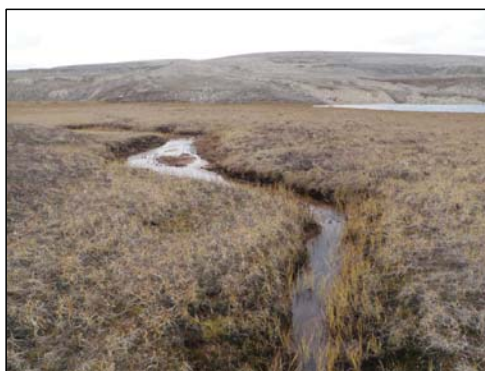
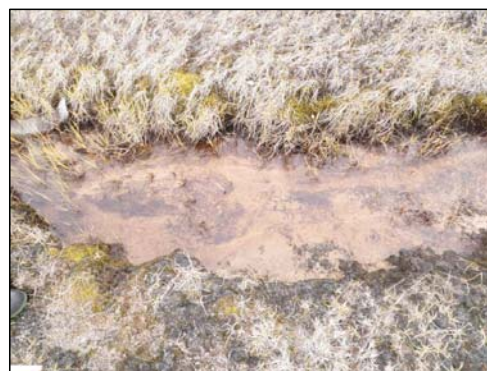
Figure 2. Summer (top) and fall (bottom) views of CV-58-4 at the 50 m downstream cross-section; (A) looking upstream; (B) looking downstream; and (C) looking across.

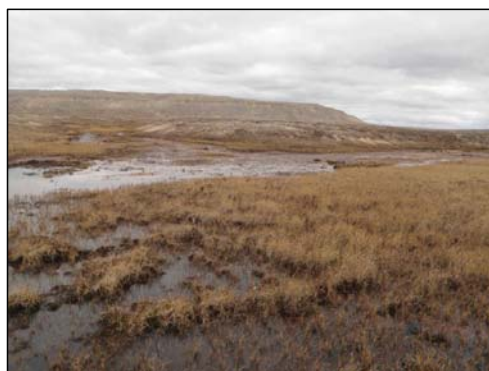
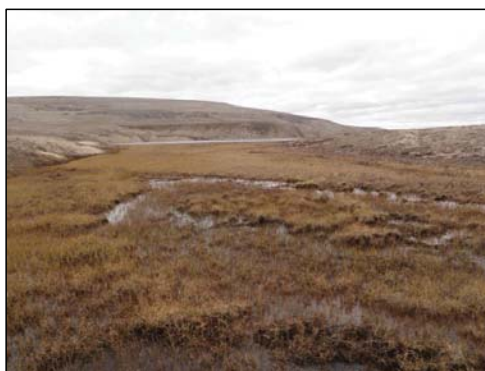
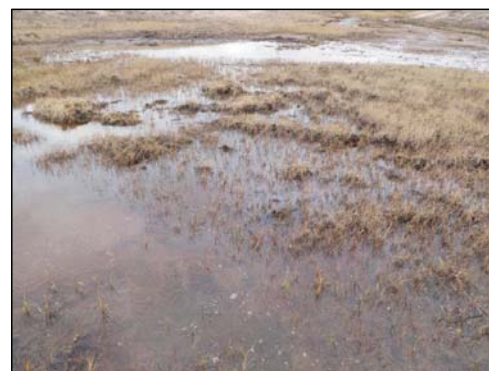
Figure 4. Summer (top) and fall (bottom) views of CV-58-4 at the 50 m upstream cross-section; (A) looking upstream; (B) looking downstream; and (C) looking across.

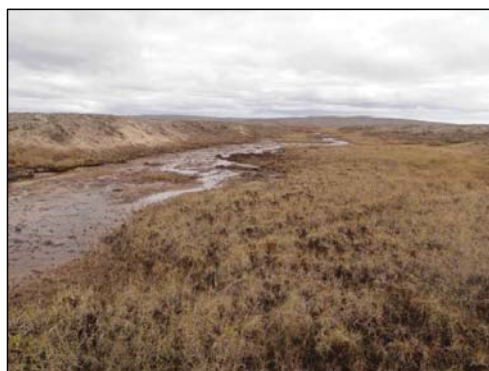
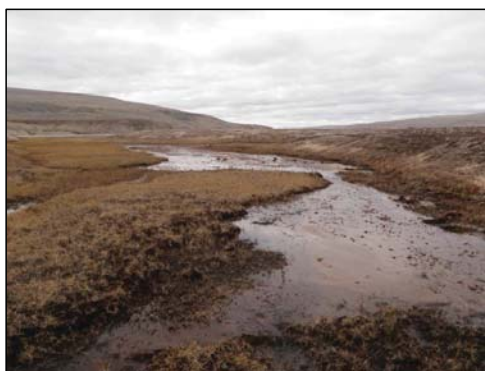
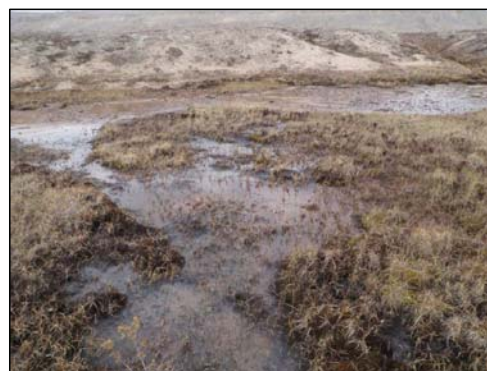
Figure 5. Summer (top) and fall (bottom) views of CV-58-4 at the 100 m upstream cross-section; (A) looking upstream; (B) looking downstream; and (C) looking across.

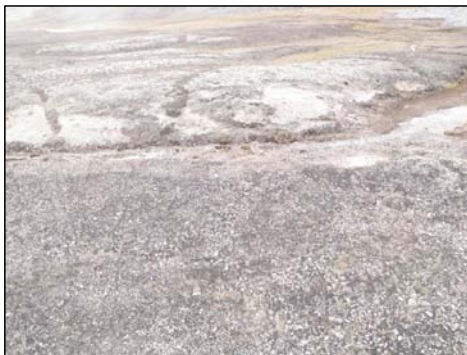
B

This stream was nearly dry at the rail crossing in 2018. In addition, there were several soft barriers downstream and no access from other waterbodies. There is likely no fish habitat at this site under all flow conditions.

Figure 1. Views of CV-58-4a at the rail crossing during summer (A) and fall (B).

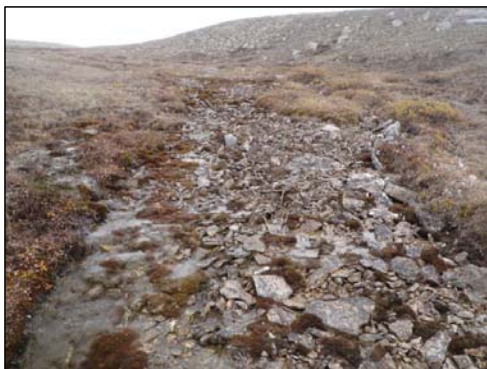
Figure 3. View of the barrier to fish movement in CV-58-6 approximately 50 m upstream from the rail crossing.

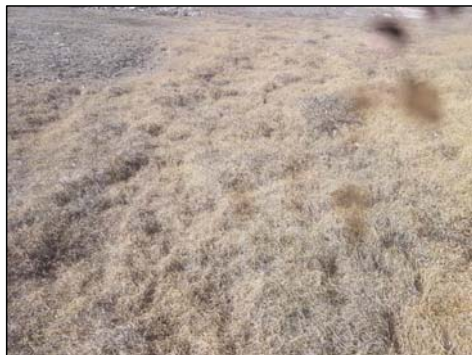
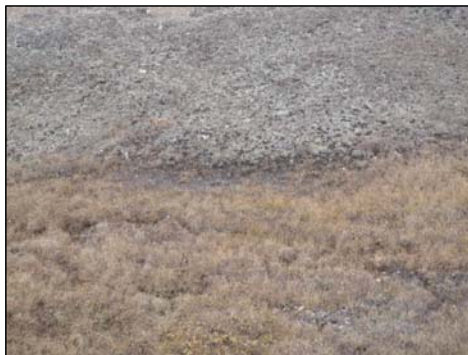
This was a dry hillside down to the confluence with fish-bearing CV-58-5. Vertical barriers would likely prevent access under all flow scenarios. There is never fish habitat at this rail crossing.

Figure 1. Views of CV-58-7 at the rail crossing during summer (A) and fall (B).

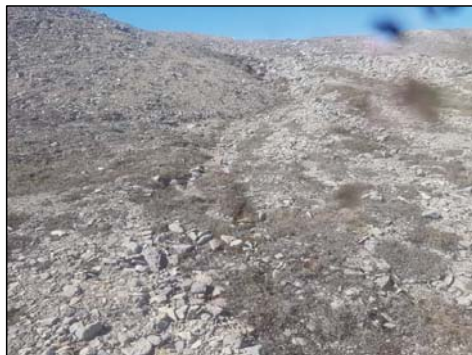
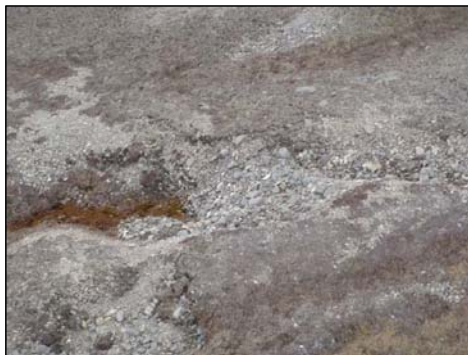
This was a dry, rocky hillside down to the confluence with CV-59-1 in 2018. Vertical barriers would likely prevent access to the crossing under all flow scenarios. There is never fish habitat at this rail crossing.

Figure 1. Views of CV-58-8 at the rail crossing during summer (A) and fall (B).

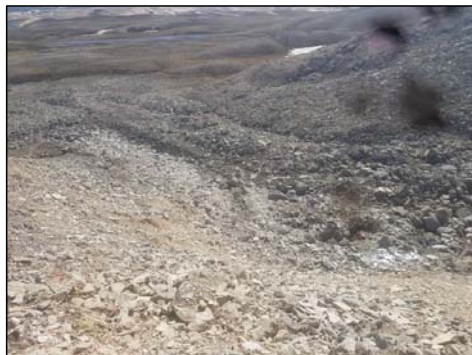
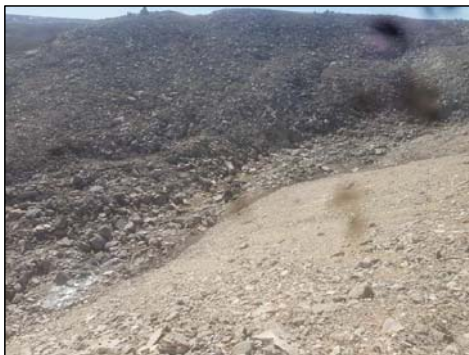
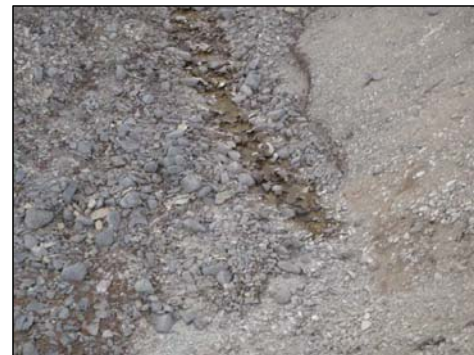
This stream had low water in 2018 with multiple locations of subsurface flow. There were also permanent vertical barriers to fish movement between the rail and fish-bearing 58-5 downstream. There is never fish habitat at this rail crossing.

Figure 1. Views of CV-59-1 at the rail crossing during summer (A) and (B), and fall (C). Note the multiple locations where flow is subsurface.

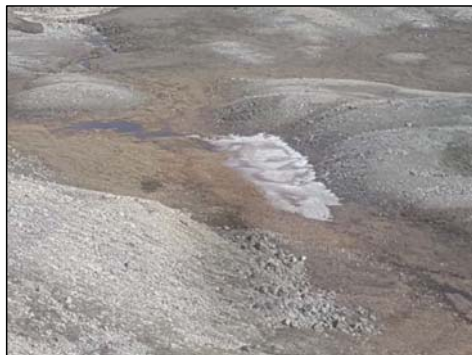
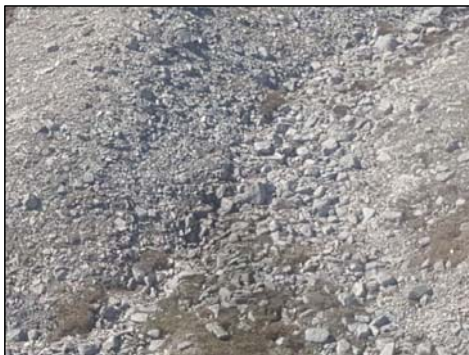
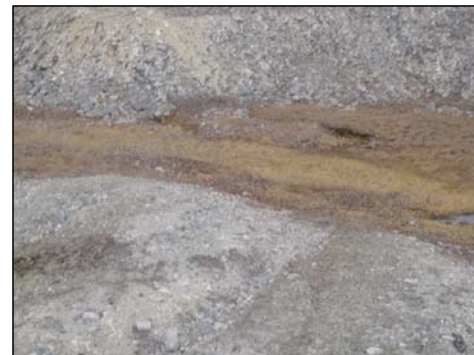
This stream had low water in 2018 with multiple locations of subsurface flow. There were also permanent vertical barriers to fish movement between the rail and fish-bearing 58-5 downstream. There is never fish habitat at this rail crossing.

Figure 1. Views of CV-59-2 at the rail crossing during summer (A) and (B), and fall (C). Note the locations where flow is subsurface.

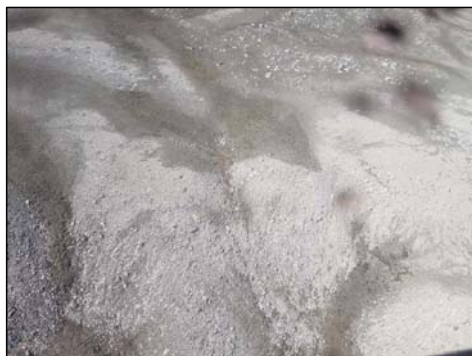
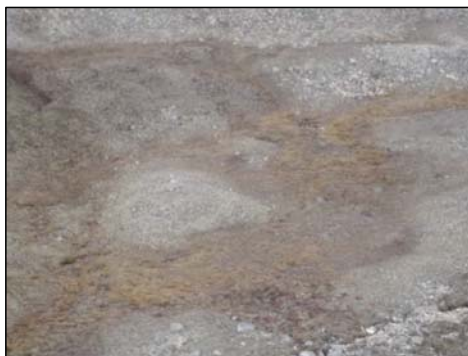
This was a dry hillside valley in 2018. The very steep gradient would likely prevent any access even under much higher flows. There is never fish habitat at this rail crossing.

Figure 1. Views of CV-59-3 at the rail crossing during summer (A) and fall (B).

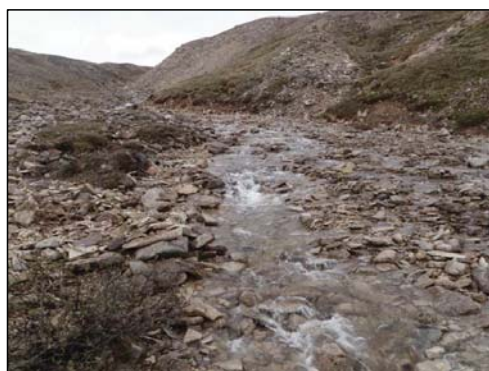
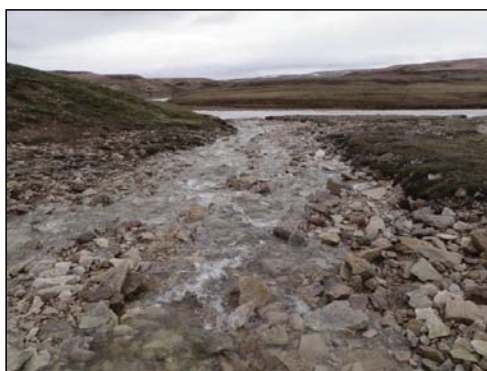
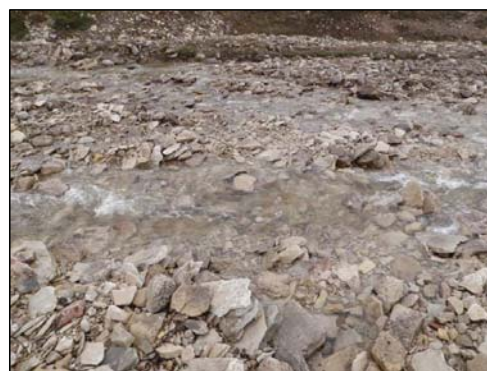
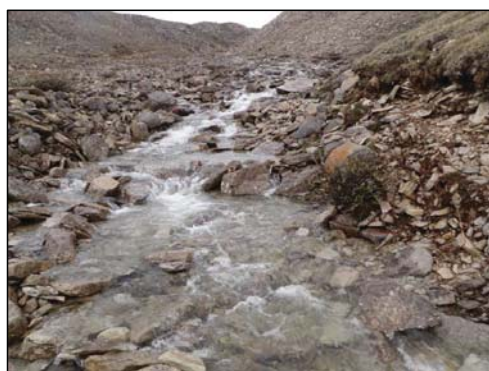
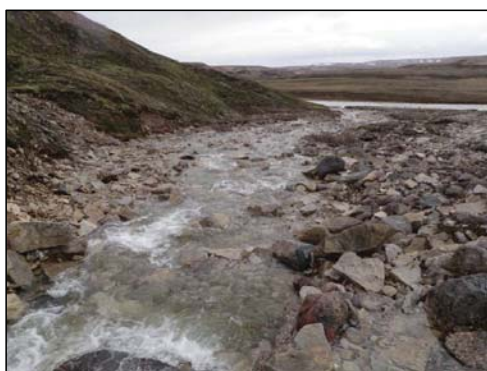
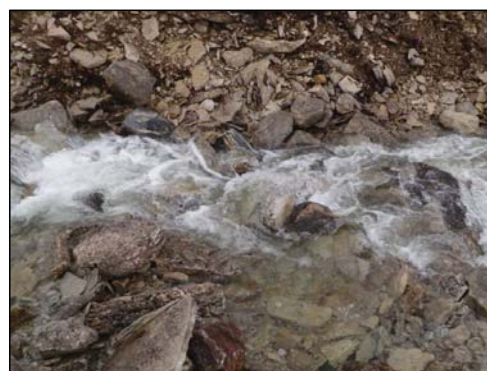
Figure 1. Summer views of CV-59-4 at the 100 m (top) and 50 m (bottom) downstream cross-sections; (A) looking upstream; (B) looking downstream; and (C) looking across.

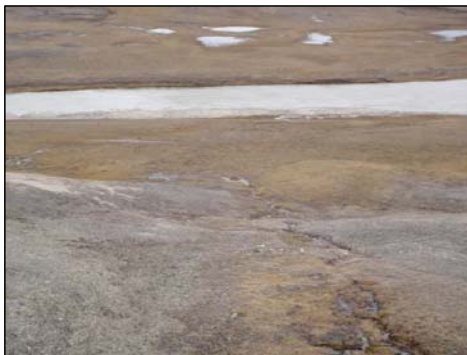
B

This stream was nearly dry in 2018. Lack of surface flow downstream and a steep gradient near the crossing likely combine to prevent access during all flow conditions. There is probably never fish habitat at this rail crossing.

Figure 1. Views of CV-59-4a at the rail crossing during summer (A) and fall (B). Note the loss of surface flow downstream in the fall image.

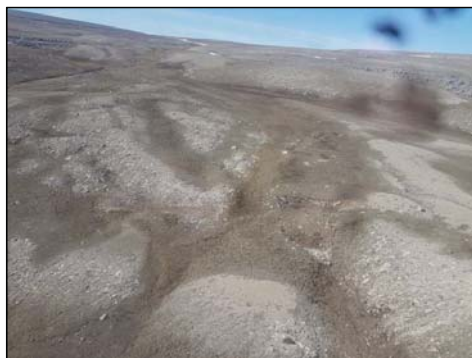
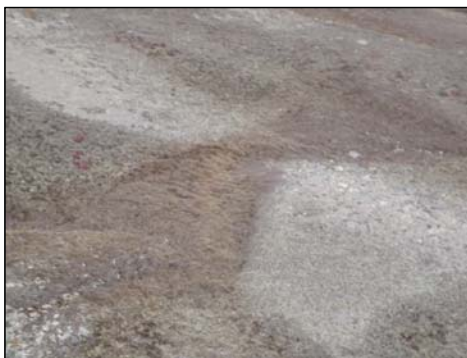
This was a dry low point in 2018. There is never fish habitat at this rail crossing.

Figure 1. Views of CV-59-4b at the rail crossing during summer (A) and fall (B).

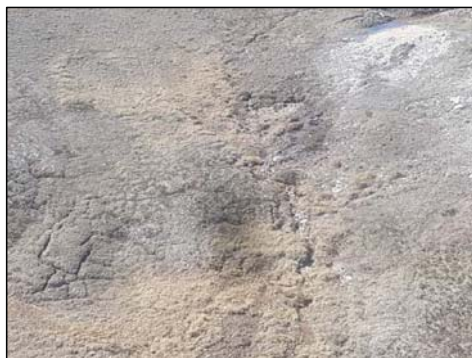
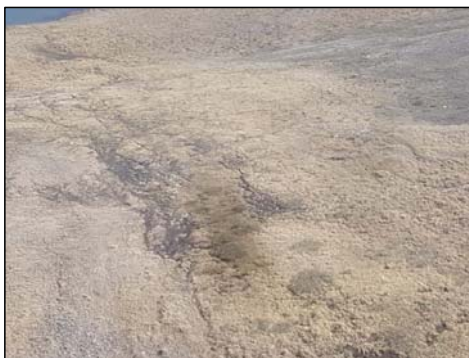
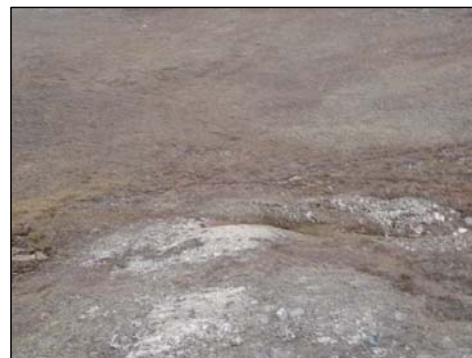
This stream was nearly dry in 2018. Multiple movement barriers would exist downstream even under high flows. There is never fish habitat at this rail crossing.

Figure 1. Views of CV-59-5 at the rail crossing during summer (A) and (B), and fall (C). Note the lack of surface flow in multiple locations.

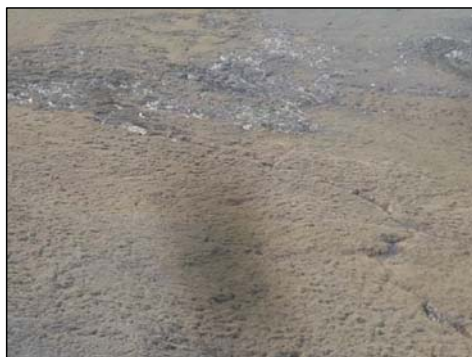
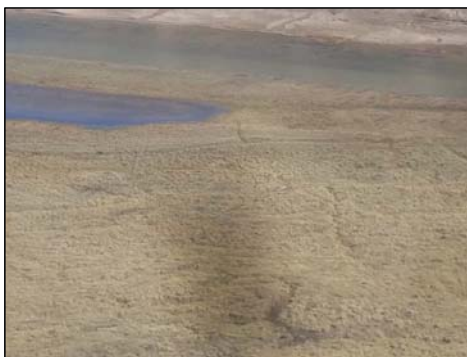
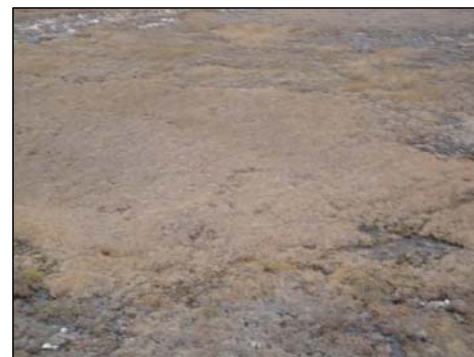
This stream was nearly dry in 2018. No connection with the downstream river and multiple movement barriers would exist even under high flows. There is never fish habitat at this rail crossing.

Figure 1. Views of CV-60-1 at the rail crossing during summer (A) and (B), and fall (C). Note the lack of surface flow in multiple locations.

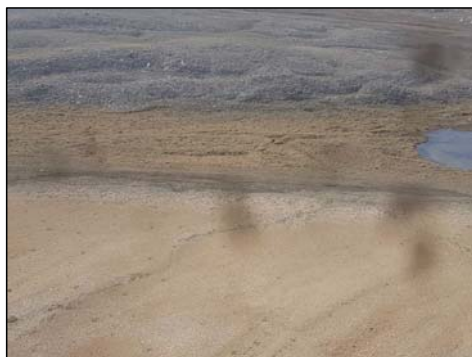
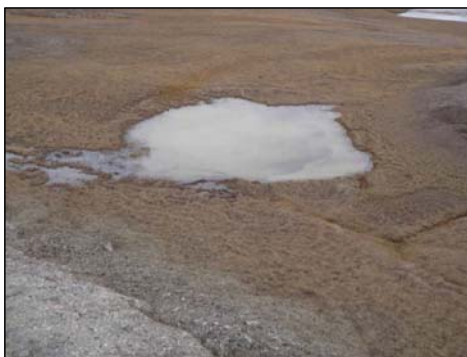
This stream was nearly dry in 2018 while the adjacent pond was shallow and isolated. No connection with a downstream river and a lack of surface flow over a large area likely prevent fish access even under high flows. There is never fish habitat at this rail crossing.

Figure 1. Views of CV-60-2 at the rail crossing during summer (A) and fall (B). Note the general lack of surface flow.

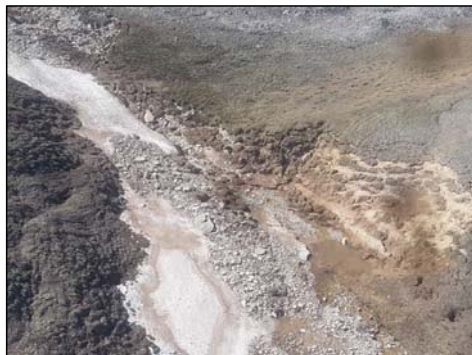
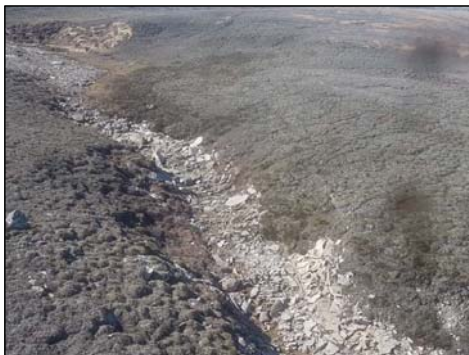
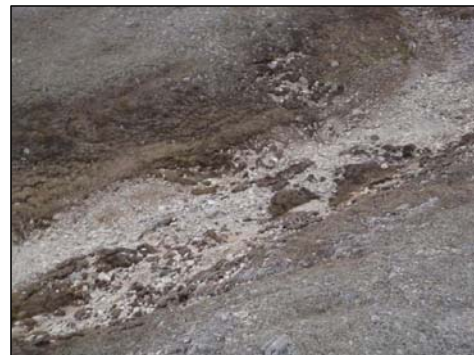
This was very little water at or near the crossing in 2018 and multiple locations with subsurface flow and steep vertical drops. These barriers likely prevent fish access even under high flows. There is never fish habitat at this rail crossing.

Figure 1. Views of CV-60-3 at the rail crossing during summer (A) and (B), and fall (C). Note the frequent lack of surface flow.

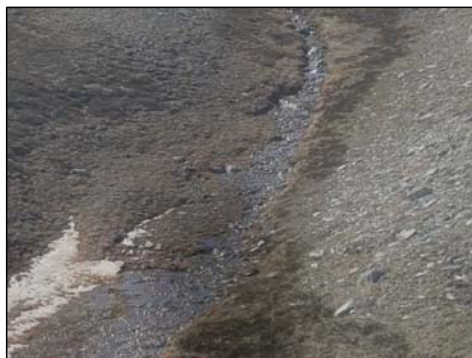
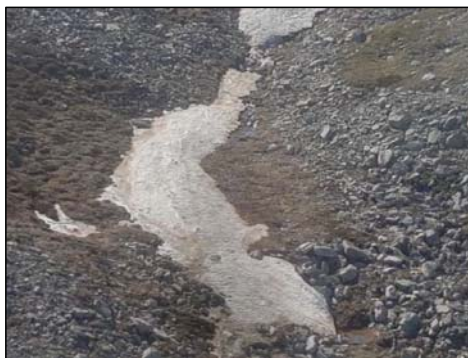
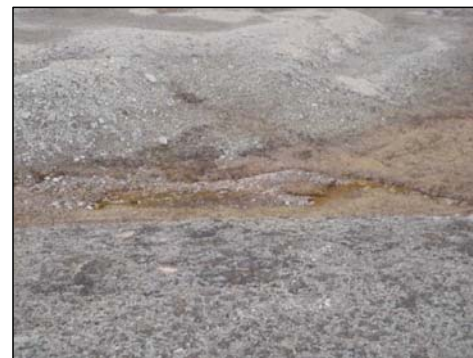
This stream had low water levels in summer and was nearly dry in fall 2018. In addition, there were multiple locations with subsurface flow and vertical drops. These barriers likely prevent fish access even under high flows. There is never fish habitat at this rail crossing.

Figure 1. Views of CV-60-4 at the rail crossing during summer (A), a downstream barrier (B), and the crossing during fall (C).
