Phase 2 Milne Rail Corridor Aquatic Habitat Assessment

Crossing ID: CV-54-2

**Baffinland Iron Mines
Mary River Project**

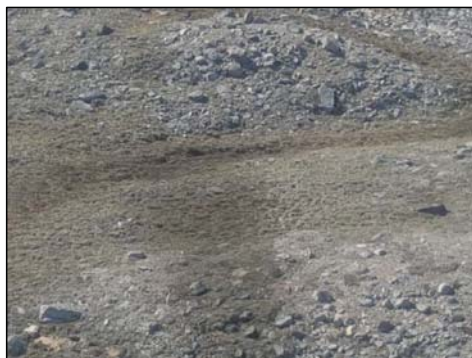
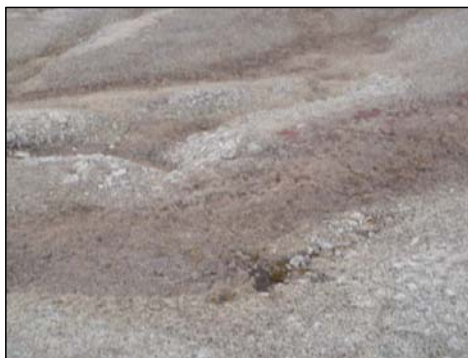
This site was dry in 2018 with no obvious channel and multiple barriers to movement even if there were flows. There is never fish habitat at this rail crossing.

Figure 1. Views of CV-60-4a at the rail crossing during summer (A) and fall (B).

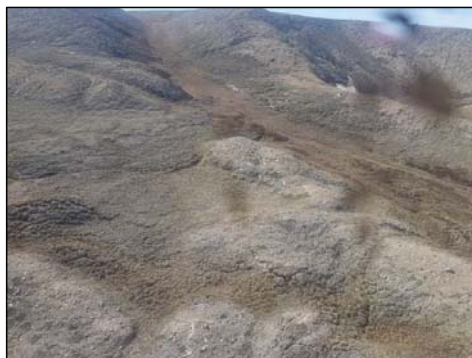
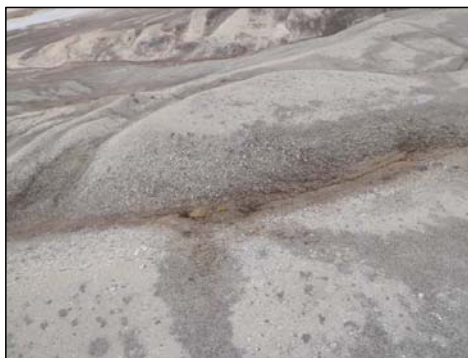
This crossing was steep (~15°). There is never fish habitat at this rail crossing.

Figure 1. Views of CV-60-6 at the rail crossing during summer (A) and fall (B).

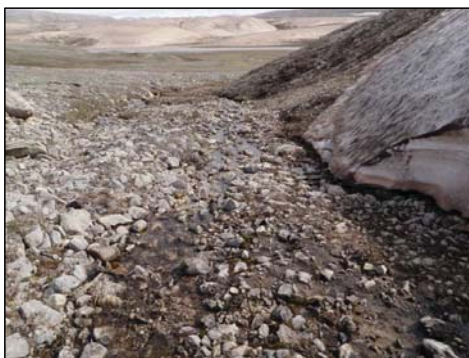
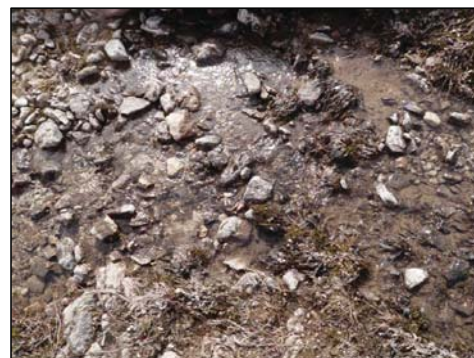
This crossing was shallow and steep (~15°) and the gradient continued to increase upstream. The nearest any char were captured or observed was 200 m downstream of the rail crossing. Starting approximately 125 m downstream the channel widens considerably and maximum depth is 1 cm. This likely represents a barrier to fish movements under most, if not all, flow conditions. Habitat downstream of the soft barrier is good quality for char. Fish use of habitat at or near the crossing is unlikely.

Figure 1. Views of CV-61-1 at the rail crossing during summer, looking upstream (A), downstream (B), and across (C).

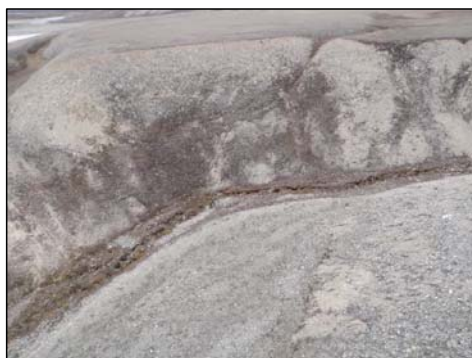
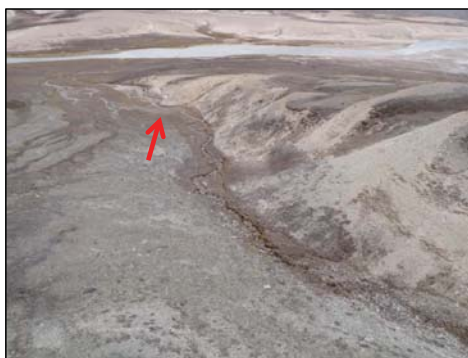
Figure 2. Aerial views of CV-61-1 during fall of the crossing (A) and downstream (B) showing the barrier (arrow).

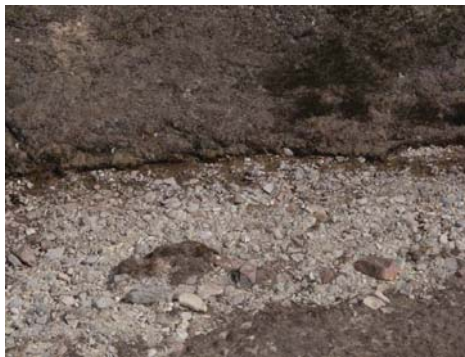
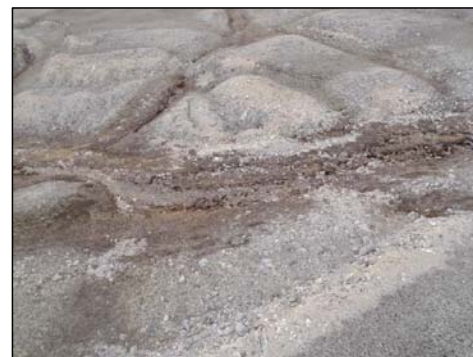
This crossing was very shallow and steep (~15°) and the gradient continued to increase upstream. Starting approximately 200 m downstream, the channel widens and flows become subsurface. This likely represents a barrier to fish movements under most, if not all, flow conditions. Fish use of habitat at or near the crossing is unlikely.

Figure 1. Views of CV-61-2 at the rail crossing during summer (A), the downstream flow barrier (B), and the crossing during fall (C).

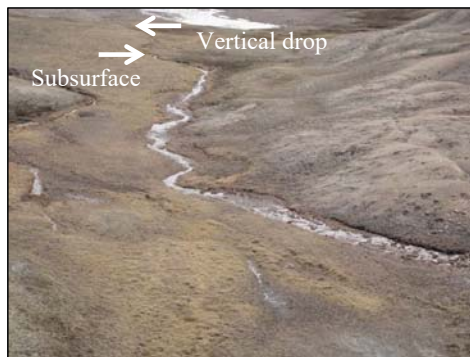
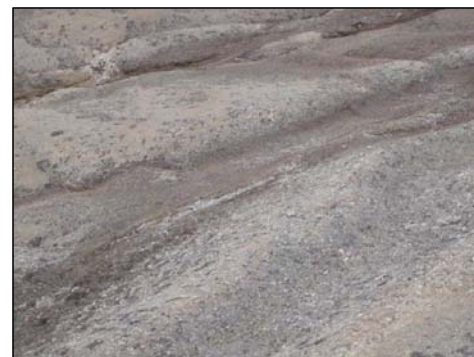
This crossing was very shallow in 2018 and steep (~15°). There are multiple gradient and subsurface flow barriers to movement downstream that likely prevent fish movements under most, if not all, flow conditions. Fish use of habitat at or near the crossing is unlikely.

Figure 1. Views of CV-61-3 at the rail crossing during summer (A), downstream barriers (B), and the crossing during fall (C).
