## Phase 2 Milne Rail Corridor Aquatic Habitat Assessment

**Crossing ID:** CV-89-1

**Baffinland Iron Mines  
Mary River Project**

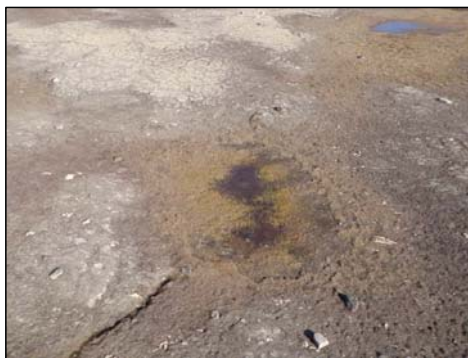
**Figure 1.** Views of CV-90-2 at the crossing during summer (A) and fall (B).

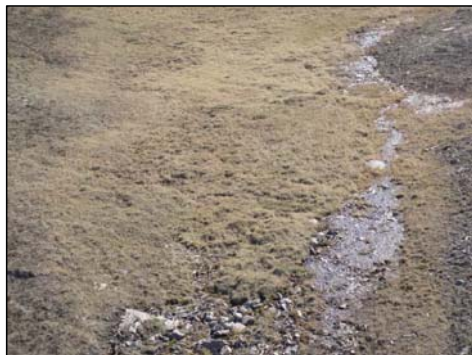
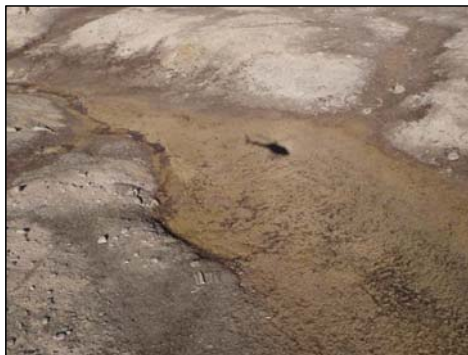
The crossing area is mostly dry or nearly so with a few short reaches of shallow surface flow and no connections to other waterbodies. There is no fish use of habitat at this crossing.

**Figure 1.** Views of CV-90-3 at the crossing during summer (A) and fall (B).

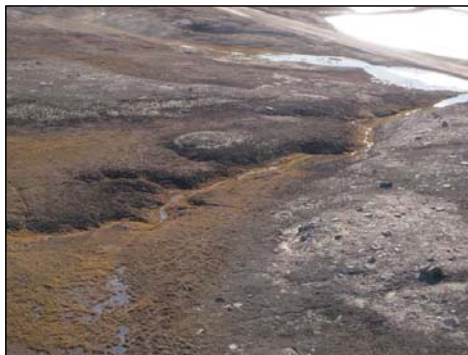
The crossing stream is small and flows into a fish-bearing lake downstream of the Tote Road. However, only about the lowermost 20 m downstream of the road culverts is usable by fish. A very steep gradient upstream of the road prevents fish use as noted during Tote Road surveys. There is no fish use of habitat at this crossing.

**Figure 1.** Views of CV-90-4 at the crossing during summer (A) and fall (B).

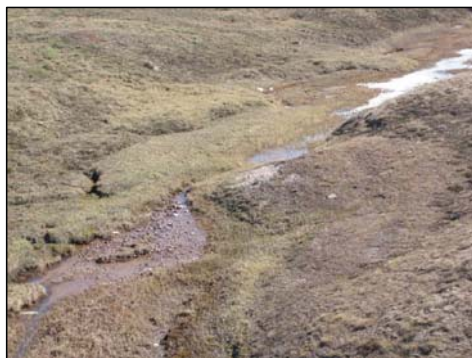
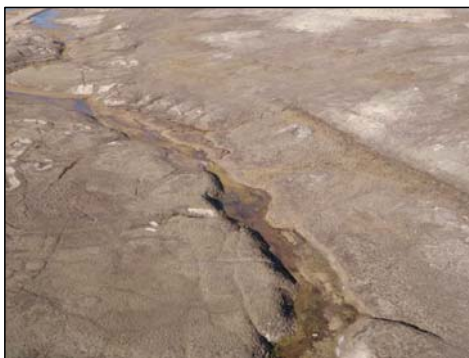
The crossing is shallow, steep and there is intermittent surface water downstream with no connections to other waterbodies. There is no fish use of habitat at this crossing.

**Figure 1.** Views of CV-91-0 at the crossing during summer (A) and fall (B).

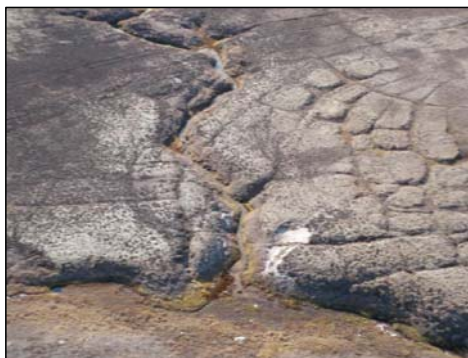
The crossing was nearly dry, was very steep and there is no access under all flow conditions. There is no fish use of habitat at this crossing.

**Figure 1.** Views of CV-91-1 at the crossing during summer (A) and fall (B).

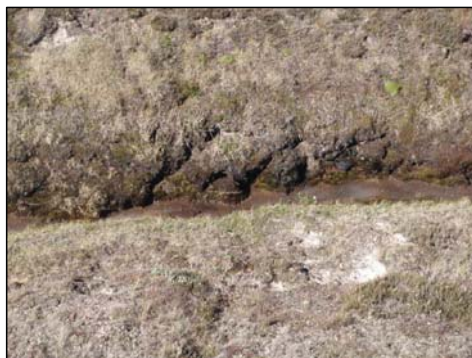
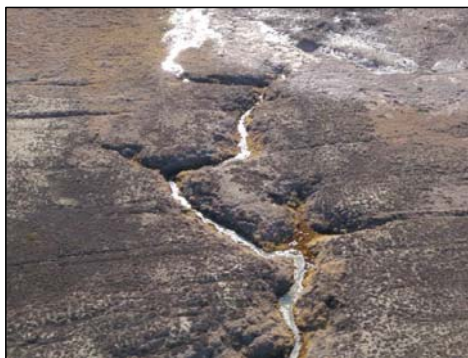
The crossing is a tributary of CV-91-0 and shares the same downstream barriers and lack of connection to overwintering habitat. There is no fish use of habitat at this crossing.

**Figure 1.** Views of CV-91-2 at the crossing during summer (A) and fall (B).

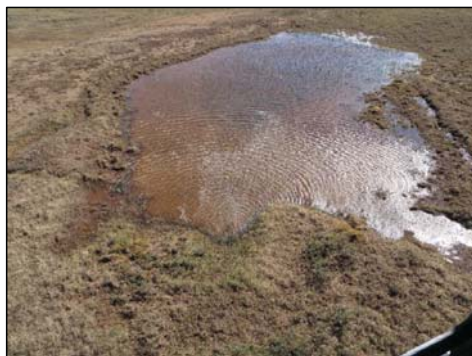
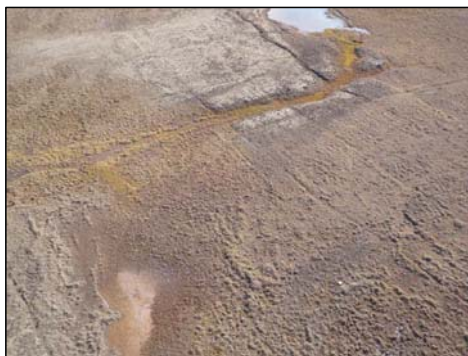
The crossing is a very shallow (< 0.5 m), isolated pond and adjacent dry stream. There is no fish use of habitat at this crossing.

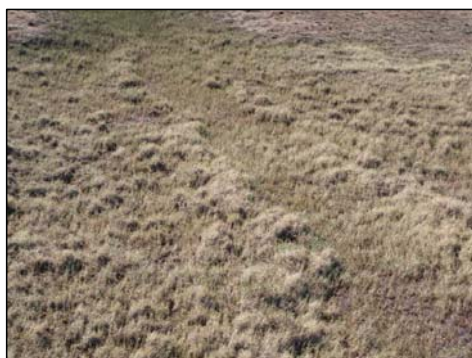
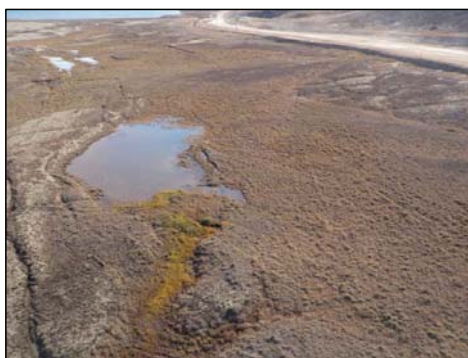
The crossing is a dry spot with no connections to overwintering habitat. There is no fish use of habitat at this crossing.

**Figure 1.** Views of CV-92-1b at the crossing during summer (A) and fall (B).

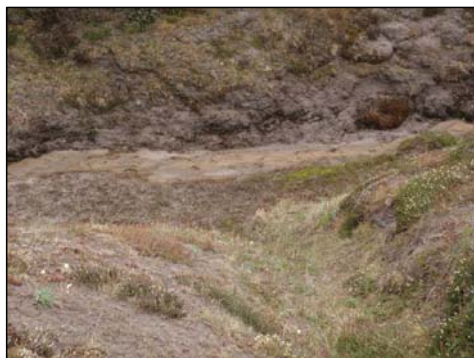
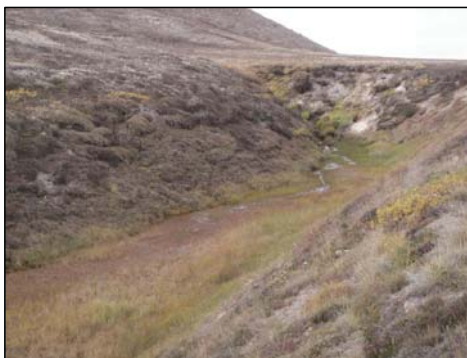
The crossing is nearly dry with frequent loss of surface flow and no connections to overwintering habitat. There is no fish use of habitat at this crossing.

**Figure 1.** Views of CV-92-2 at the crossing during summer (A) and fall (B).

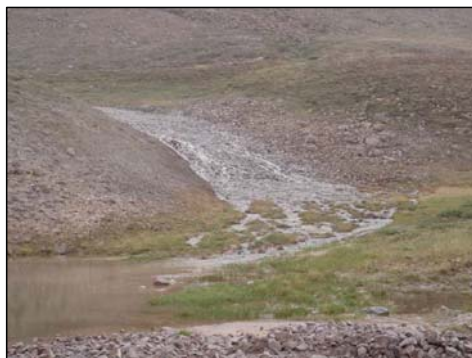
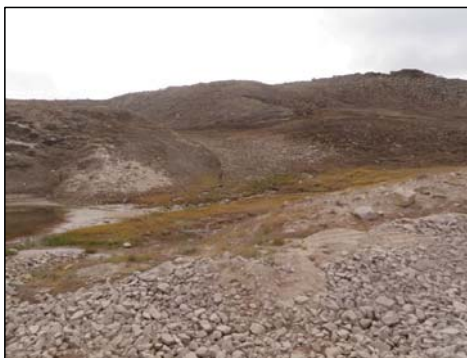
The crossing was low in summer and nearly dry in fall and connected only to a shallow downstream pond. There is no fish use of habitat at this crossing.

**Figure 1.** Views of CV-92-3 at the crossing during summer (A) and fall (B).

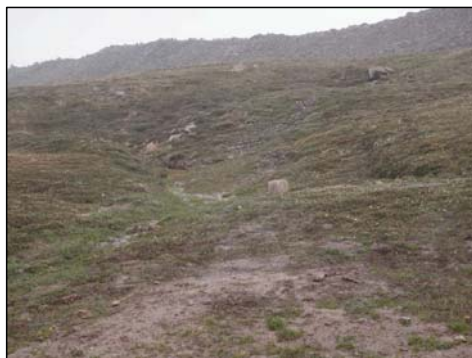
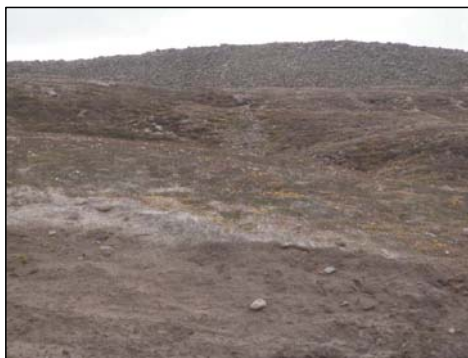
The crossing was a dry hillside. There is no fish use of habitat at this crossing.

**Figure 1.** Views of CV-92-4 at the crossing during summer (A) and fall (B).

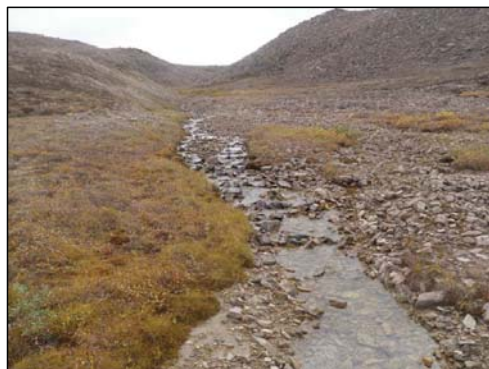
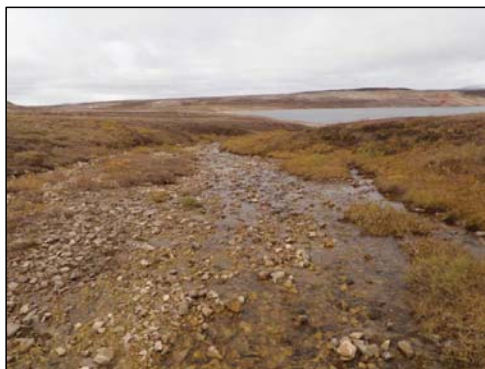
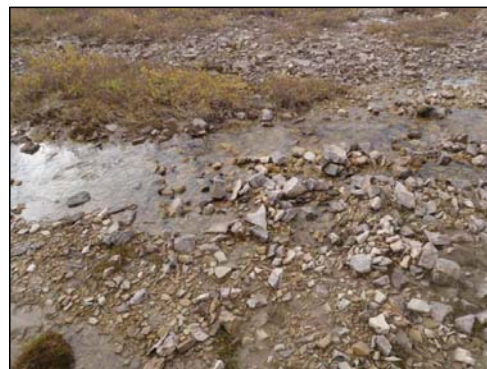
**Figure 7.** Summer (top) and fall (bottom) views of CV-92-5 at the 20 m upstream cross-section; (A) looking upstream; (B) looking downstream; and (C) looking across.

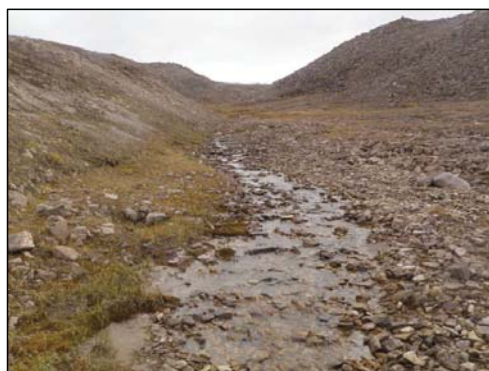
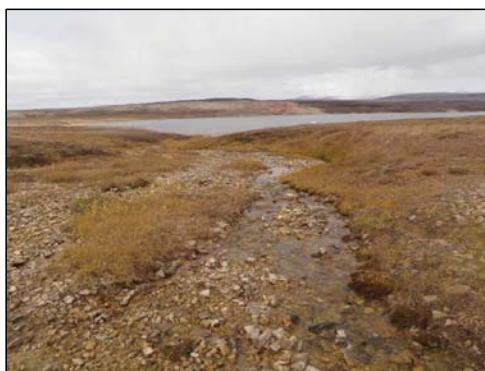
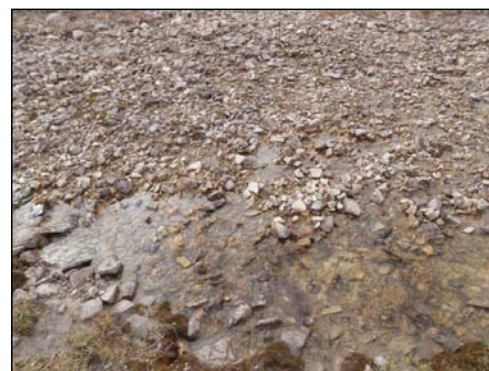
**Figure 8.** Summer (top) and fall (bottom) views of CV-92-5 at the 40 m upstream cross-section; (A) looking upstream; (B) looking downstream; and (C) looking across.

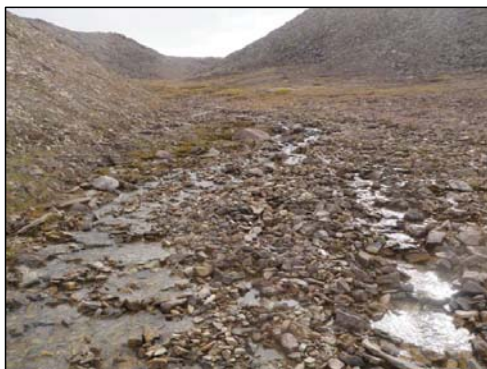
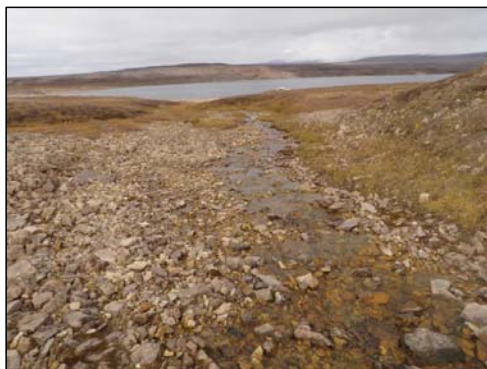
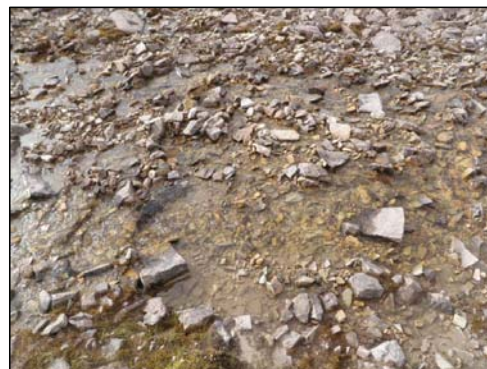
**Figure 10.** Summer (top) and fall (bottom) views of CV-92-5 at the 60 m upstream cross-section; (A) looking upstream; (B) looking downstream; and (C) looking across.

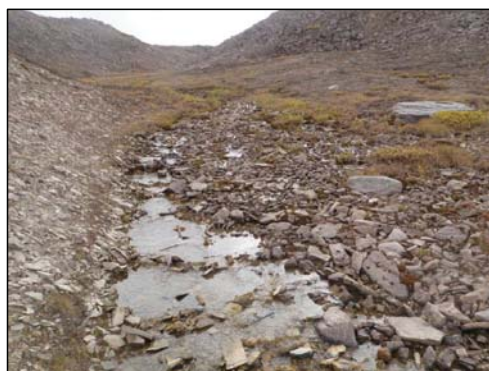
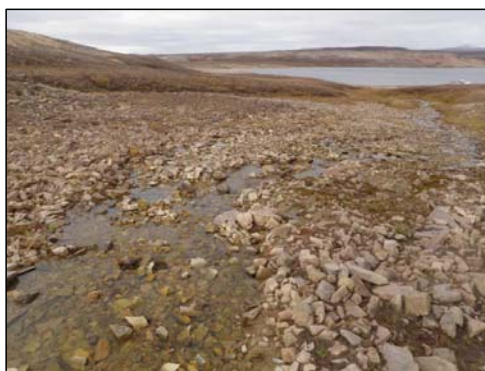
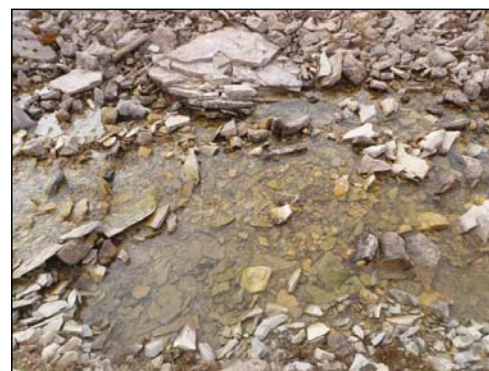
**Figure 11.** Summer (top) and fall (bottom) views of CV-92-5 at the 80 m upstream cross-section; (A) looking upstream; (B) looking downstream; and (C) looking across.

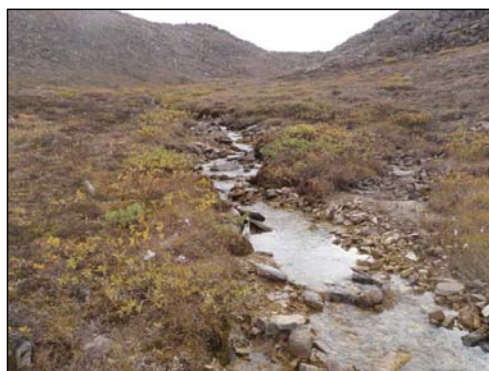
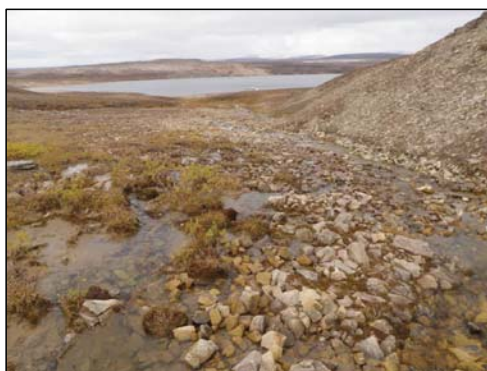
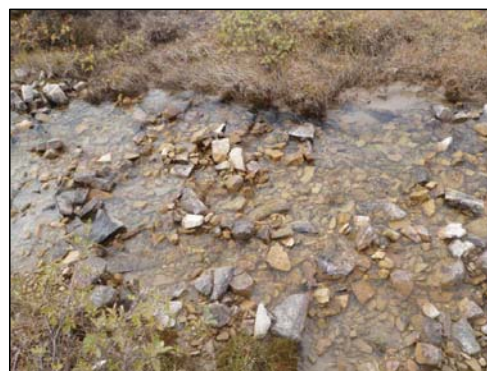
**Figure 12.** Summer (top) and fall (bottom) views of CV-92-5 at the 100 m upstream cross-section; (A) looking upstream; (B) looking downstream; and (C) looking across.

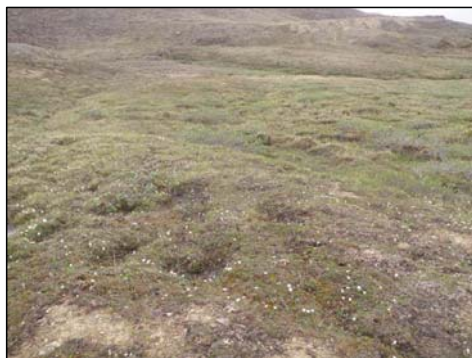
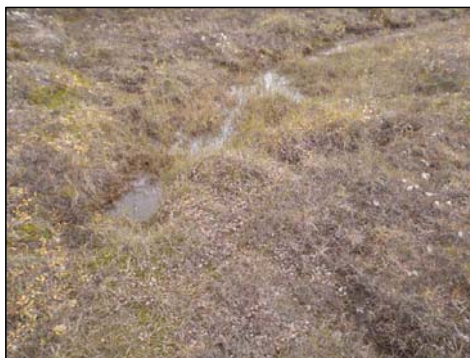
The crossing was a nearly dry low point. There is no fish use of habitat at this crossing.

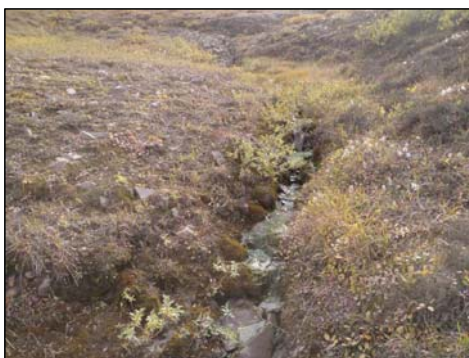
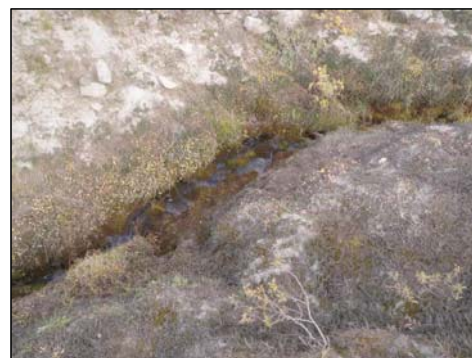
The crossings were nearly dry, very small, steep trickles on a hillside upstream of the Tote Road. There is no access under all flow conditions. There is no fish use of habitat at this crossing.

**Figure 1.** Views of CV-92-7 & 92-8 at the crossing during summer (A) and fall (B) and (C).

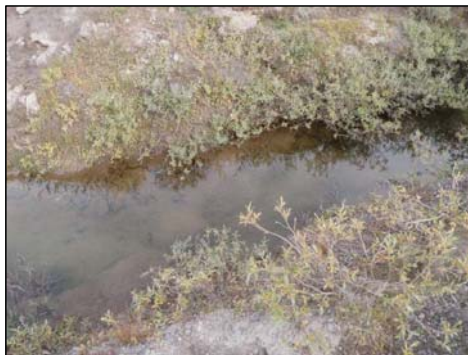
The crossing was a nearly dry, very small, steep trickle on a hillside upstream of the Tote Road. There is no access under all flow conditions. There is no fish use of habitat at this crossing.

**Figure 1.** Views of CV-92-9 at the crossing during summer (A) and fall (B).

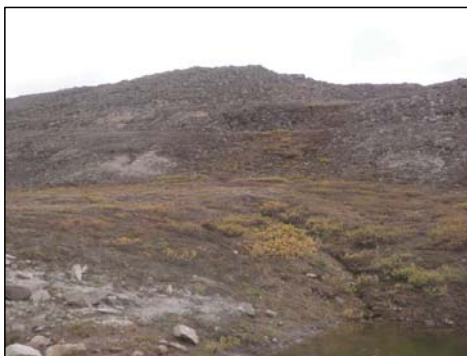
The crossing was a nearly dry, very small, steep trickle flowing into a fishless pond. There is no access under all flow conditions. There is no fish use of habitat at this crossing.

**Figure 1.** Views of CV-93-1 at the crossing during summer (A) and fall (B).

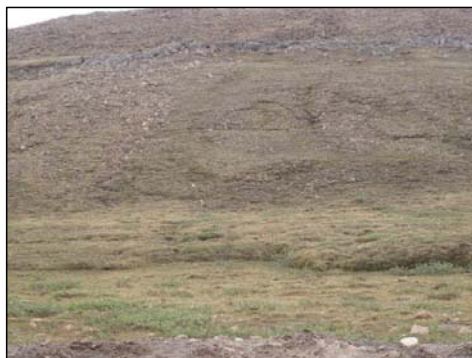
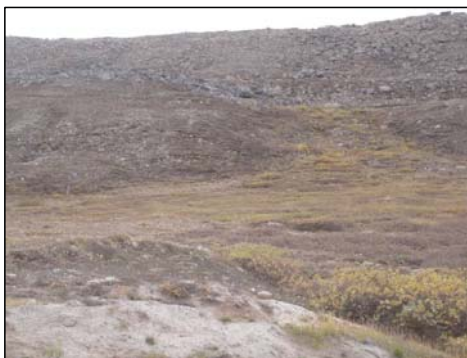
The crossing was a dry hillside. There is no fish use of habitat at this crossing.

**Figure 1.** Views of CV-93-2 at the crossing during summer (A) and fall (B).

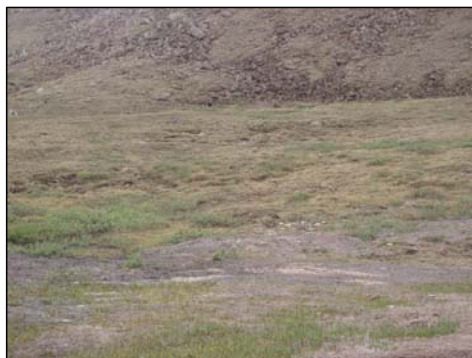
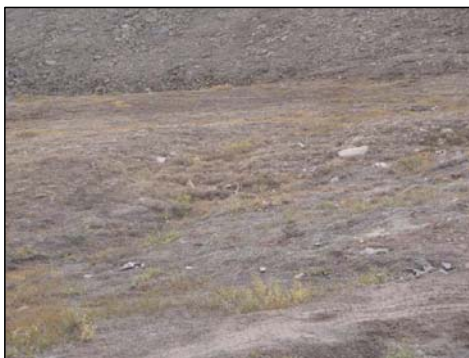
The crossing was a dry hillside. There is no fish use of habitat at this crossing.

**Figure 1.** Views of CV-93-3 at the crossing during summer (A) and fall (B).

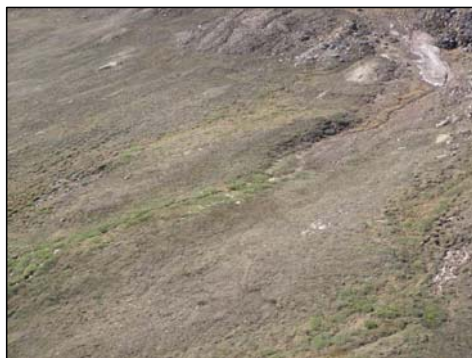
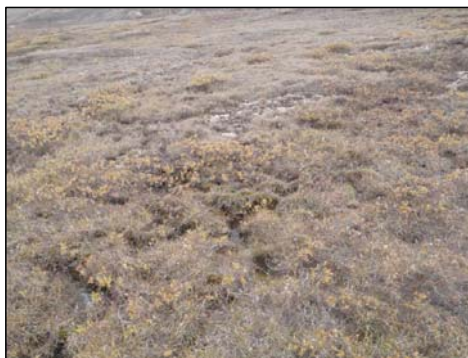
The crossing was a very small trickle on a hillside. There is no fish use of habitat at this crossing.

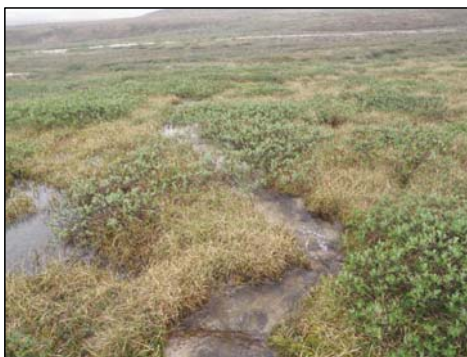
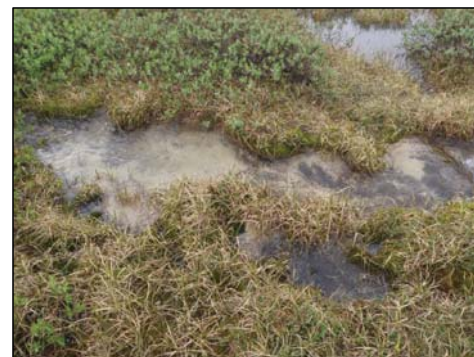
**Figure 1.** Views of CV-93-4b at the crossing during summer, looking upstream (A) downstream (B) and across (C).

The crossing stream is a tributary of CV-93-4, which is known to be fish-bearing; however there is a vertical drop barrier at the confluence. The barrier prevents access under all flow conditions. There is no fish use of habitat at this crossing.

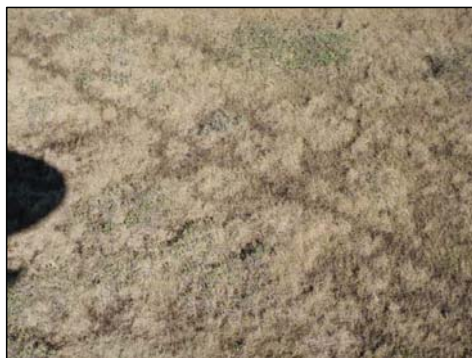
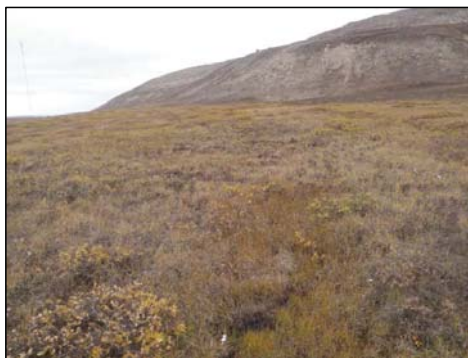
**Figure 1.** Views of CV-94-1 at the crossing during summer (A) and fall (B).

The crossing was a dry hillside. There is no fish use of habitat at this crossing.

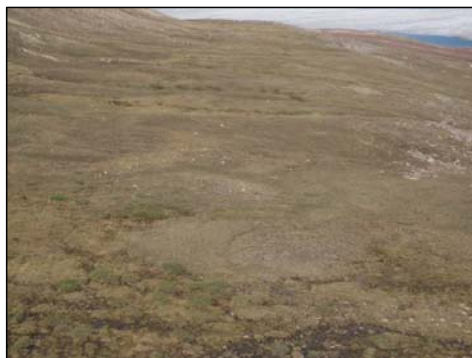
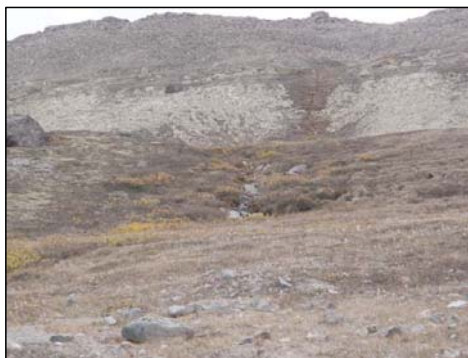
**Figure 1.** Views of CV-94-2 at the crossing during summer (A) and fall (B).

The crossing was nearly dry in summer and dry in fall 2018. There is never a connection with overwintering habitat. There is no fish use of habitat at this crossing.

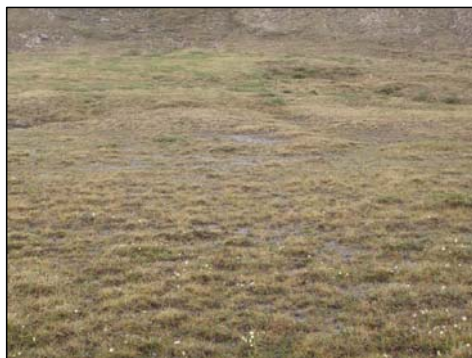
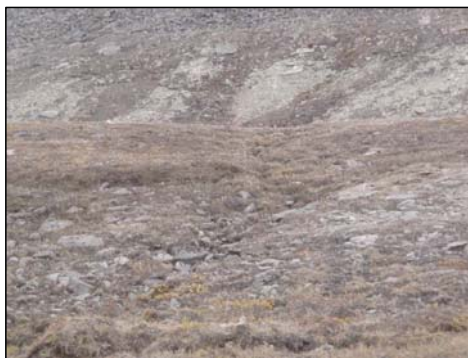
**Figure 1.** Views of CV-95-1 at the crossing during summer (A) and fall (B).

The crossing was a dry low point. There is no fish use of habitat at this crossing.

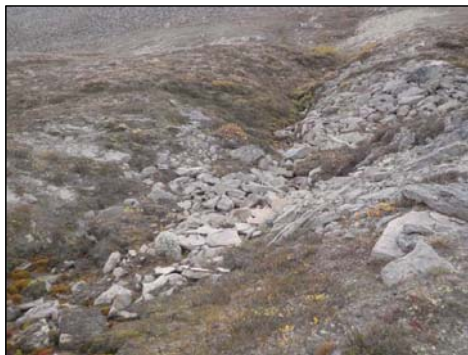
**Figure 1.** Views of CV-95-2 at the crossing during summer (A) and fall (B).

The crossing was nearly dry in summer and dry in fall 2018. The limited amount of water flowed under rocks at the crossing and dispersed over terrestrial vegetation downstream. There would be no access under any flow conditions. There is no fish use of habitat at this crossing.

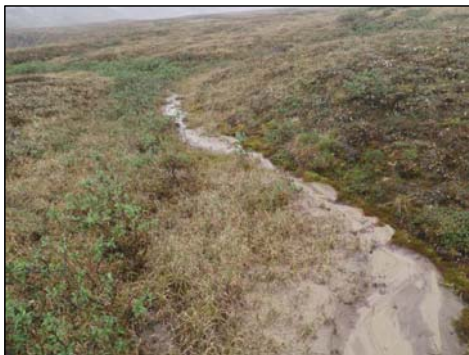
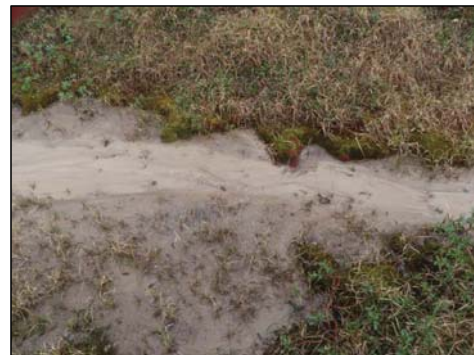
**Figure 1.** Views of CV-95-3 at the crossing during summer, looking upstream (A) downstream (B) and across (C).

The crossing was a small trickle flowing from the hills into a small, isolated lake. There is a large, vertical drop at the confluence with the lake that is impassable under all flow conditions. There is no fish use of habitat at this crossing.

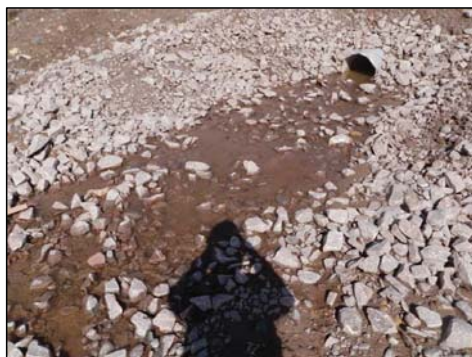
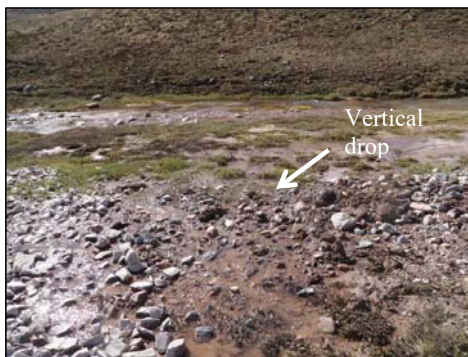
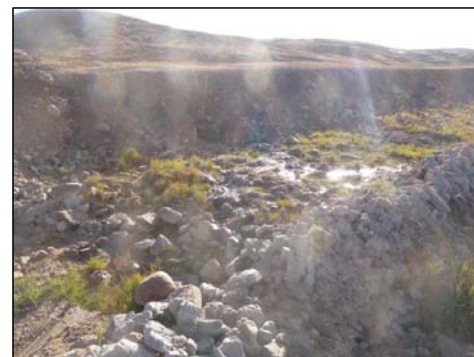
The crossing was immediately downstream of the Tote Road, flowing into CV-96-1. There is a vertical drop preventing any access to the rail crossing or upstream of the road. There is no fish use of habitat at this crossing.

**Figure 1.** Views of CV-96-2 at the crossing (A) and downstream towards CV-96-1 (B) during summer, and the crossing during fall (C).

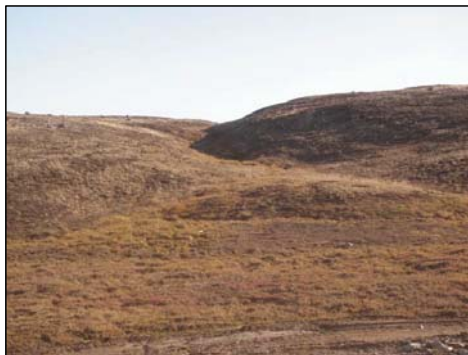
**B**

The crossing was dry in 2018. The steep gradient and consistently low flows have prevented access upstream of the Tote Road as observed during road monitoring. There is no fish use of habitat at this crossing.

**Figure 1.** Views of CV-96-3 at the crossing during summer (A) and during fall (B).

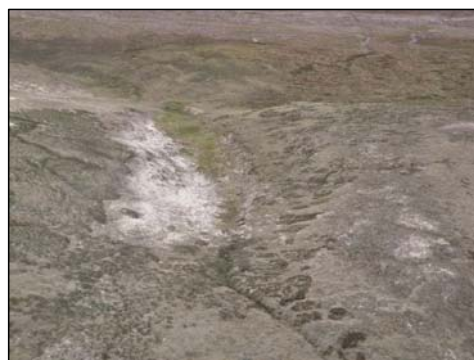
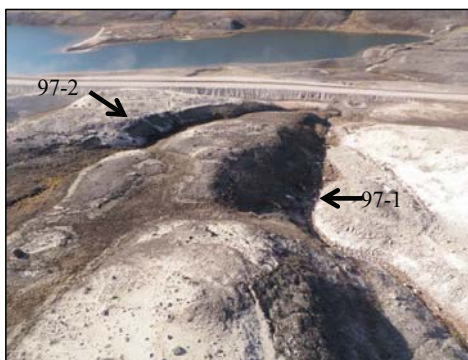
The crossing was dry in 2018. The steep gradient and consistently low flows have prevented access upstream of the Tote Road. There is no fish use of habitat at this crossing.

**Figure 1.** Views of CV-97-1 at the crossing during summer (A) and during fall, with nearby 97-2 (B).

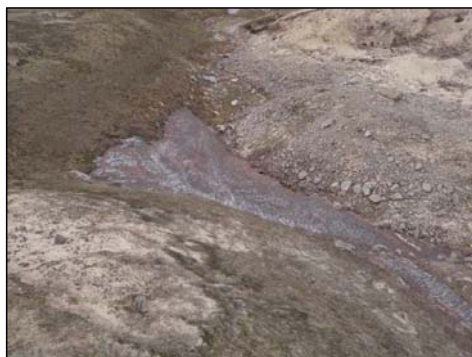
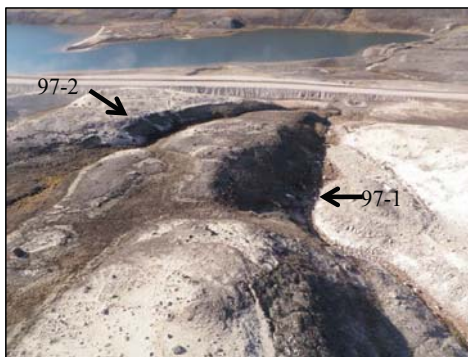
The crossing had low water in summer and dried up by fall 2018. In addition, there is a very steep gradient and never access from downstream habitat. There is no fish use of habitat at this crossing.

**Figure 1.** Views of CV-97-2 at the crossing during summer (A) and during fall, with nearby 97-1 (B).

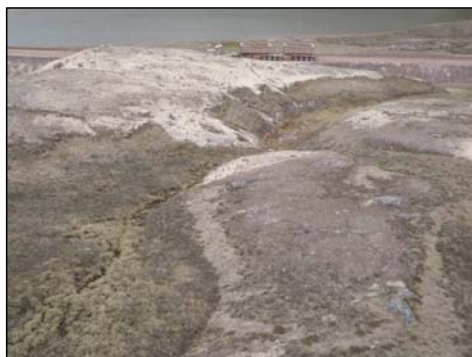
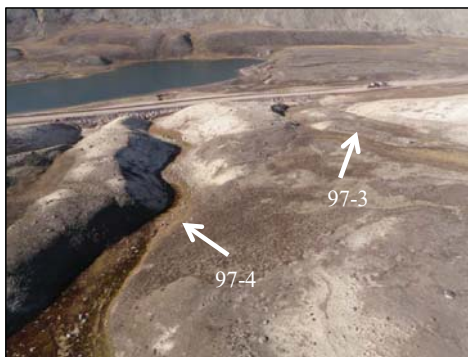
The crossing had low water in summer and dried up by fall 2018. In addition, there is a very steep gradient and never access from downstream habitat. There is no fish use of habitat at this crossing.

**Figure 1.** Views of CV-97-3 at the crossing during summer (A) and during fall, with nearby 97-4 (B).

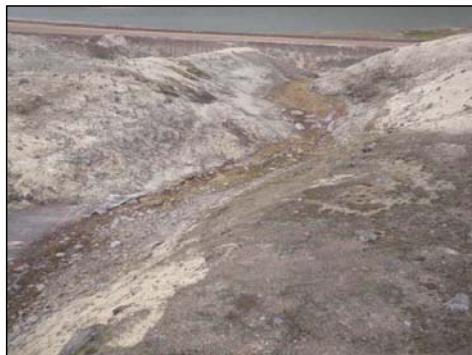
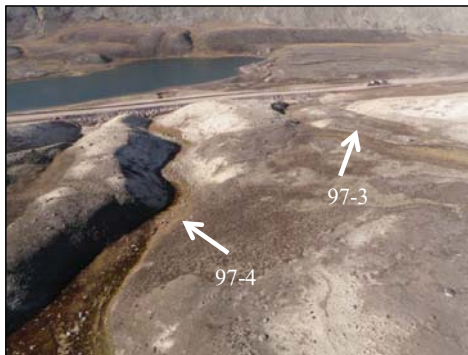
The crossing had low water in summer and dried up by fall 2018. In addition, there is a very steep gradient and never access from downstream habitat. There is no fish use of habitat at this crossing.

**Figure 1.** Views of CV-97-4 at the crossing during summer (A) and during fall, with nearby 97-3 (B).

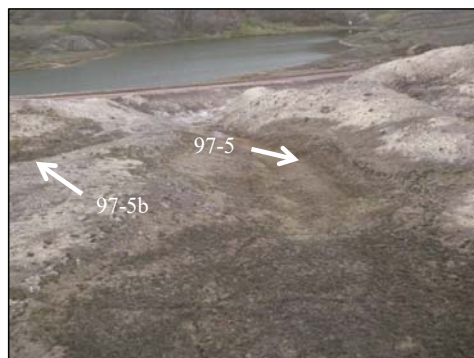
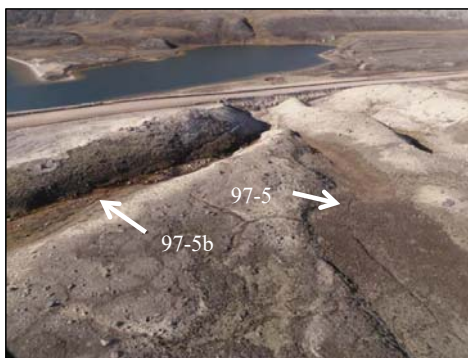
The 97-5 crossing was dry all year while 97-5b maintained a very small flow during the open-water period. Both streams had a very steep gradient and there was never access from downstream habitat near the road. There is no fish use of habitat at this crossing.

**Figure 1.** Views of CV-97-5 and 97-5b at the crossing during summer (A) and during fall (B).

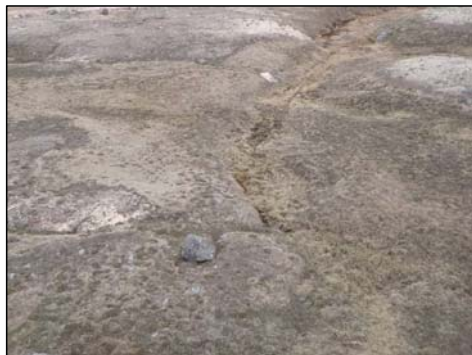
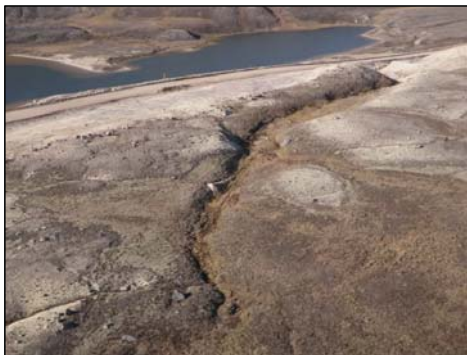
The crossing had very little water in summer and dried up by fall 2018. In addition, there is a very steep gradient and never access from downstream habitat. There is no fish use of habitat at this crossing.

**Figure 1.** Views of CV-97-6 at the crossing during summer (A) and during fall (B).

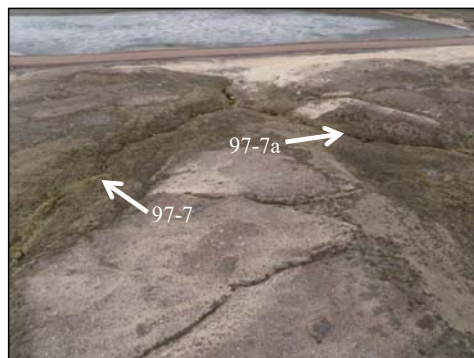
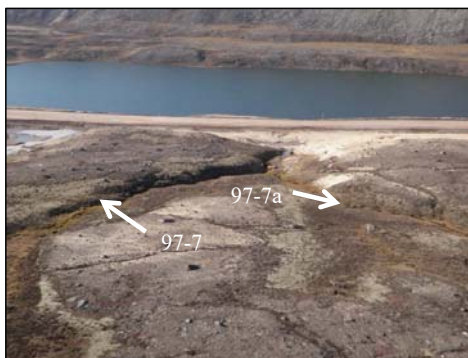
These crossings had very low water throughout the open-water period in 2018. Both also had very steep gradients, loss of surface flow, and there was never access from downstream habitat near the road. There is no fish use of habitat at this crossing.

**Figure 1.** Views of CV-97-7 and 97-7a at the crossing during summer (A) and during fall (B).

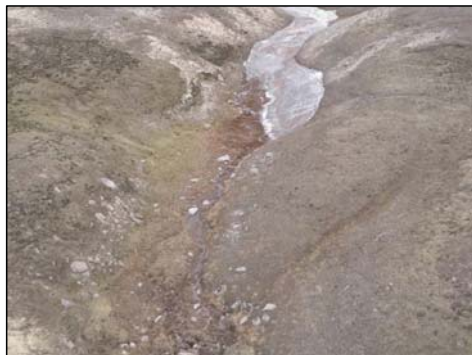
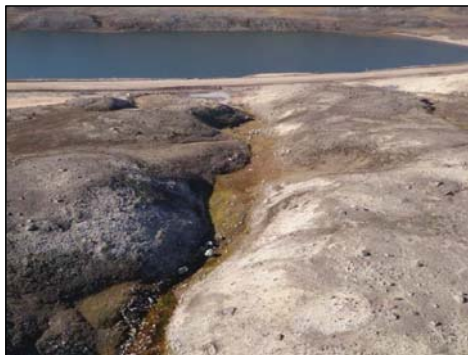
The crossing had very little water during the open-water period in 2018. In addition, there is a very steep gradient and never access from downstream habitat. There is no fish use of habitat at this crossing.

**Figure 1.** Views of CV-97-9 at the crossing during summer (A) and during fall (B).

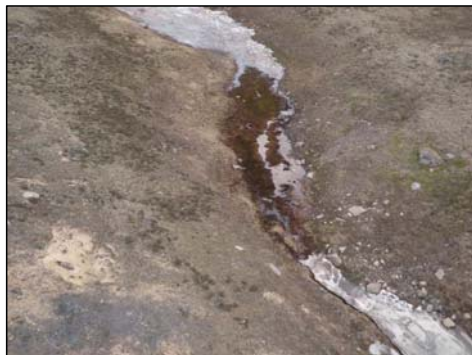
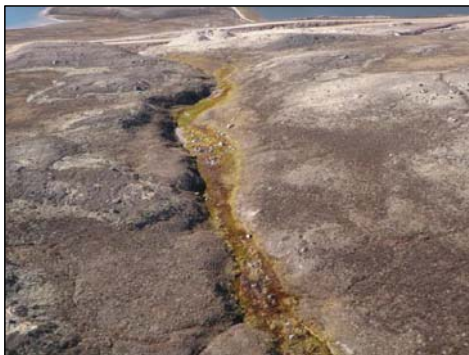
The crossing had very little water during the open-water period in 2018. In addition, there is a very steep gradient and never access from downstream habitat. There is no fish use of habitat at this crossing.

**Figure 1.** Views of CV-97-10 at the crossing during summer (A) and during fall (B).

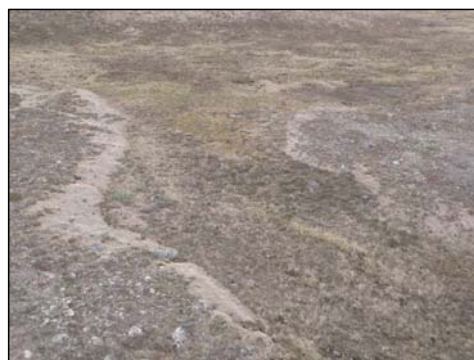
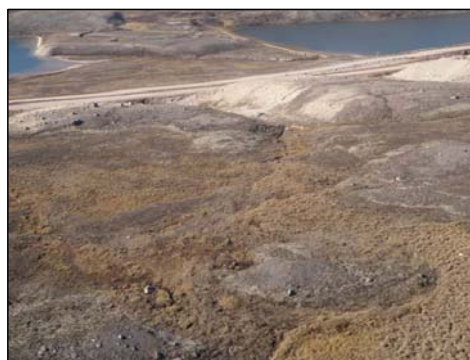
The crossing was a dry low point on a plateau. There is no fish use of habitat at this crossing.

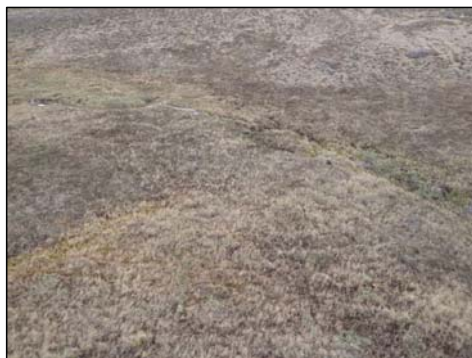
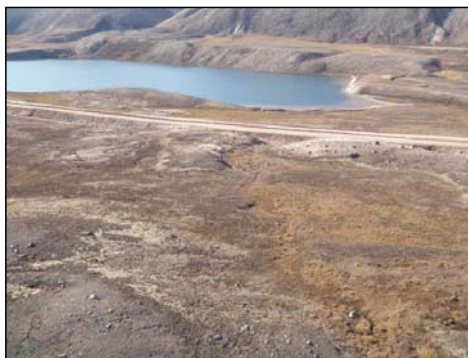
The crossing was a dry low point on a plateau. There is no fish use of habitat at this crossing.

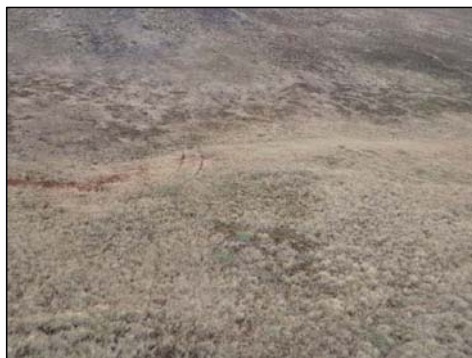
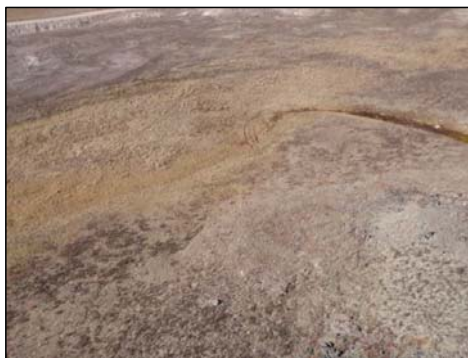
The crossing was a dry low point on a plateau. There is no fish use of habitat at this crossing.

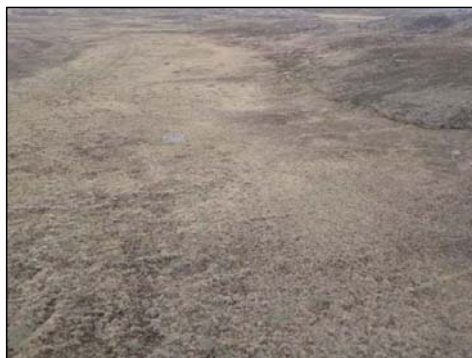
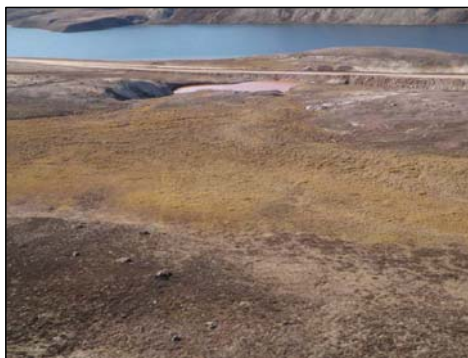
The crossing was a dry low point on a plateau. There is no fish use of habitat at this crossing.

**Figure 1.** Views of CV-98-1 at the crossing during summer (A) and during fall (B).

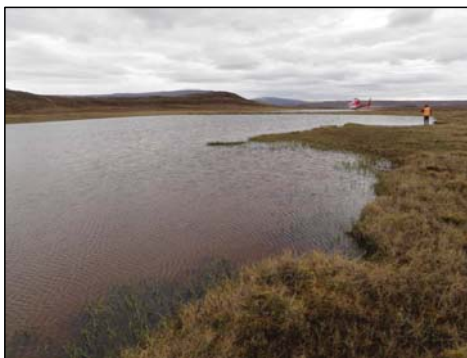
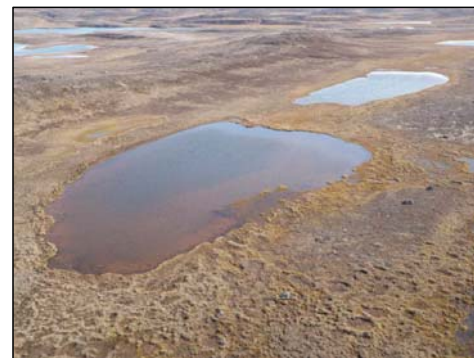
The crossing was a small, shallow pond with a maximum depth of approximately 2 m. No fish were captured or observed during an electrofishing survey of approximately half the shoreline and there was no evidence of their presence. There is no fish use of habitat at this crossing.

**Figure 1.** Views of CV-99-1 at the crossing during summer (A) and (B), and during fall (C).

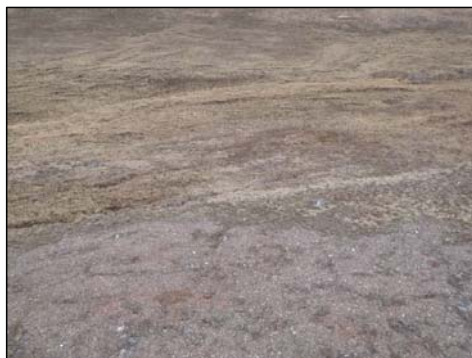
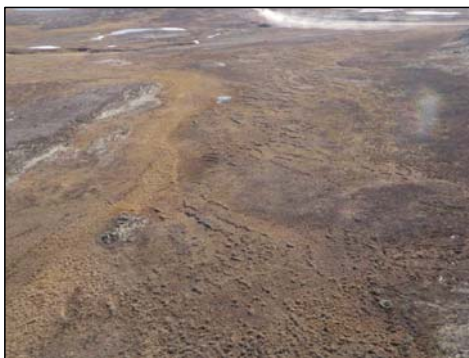
The crossing was dry in 2018 and there was no channel and no connection possible even during high water events. There is no fish use of habitat at this crossing.

**Figure 1.** Views of CV-99-2 at the crossing during summer (A) and fall (B).

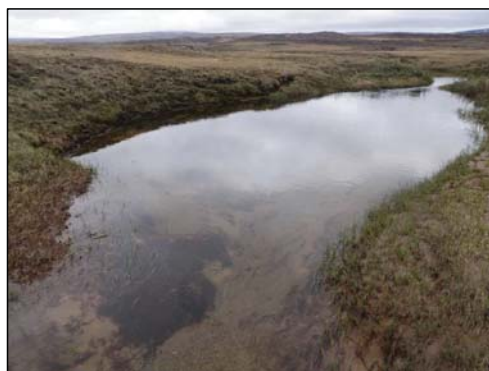
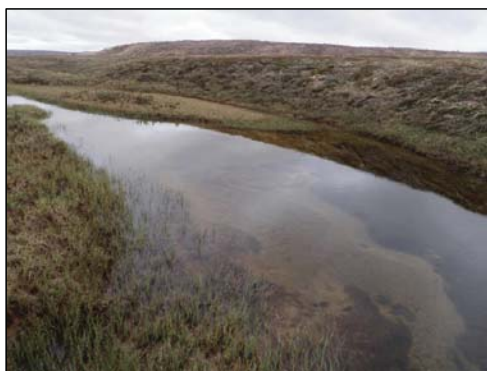
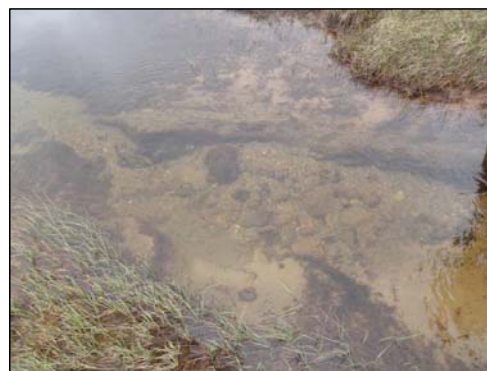
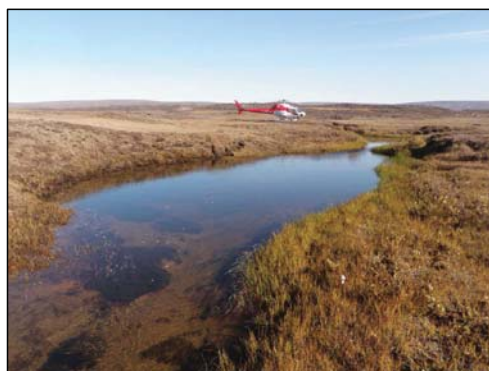
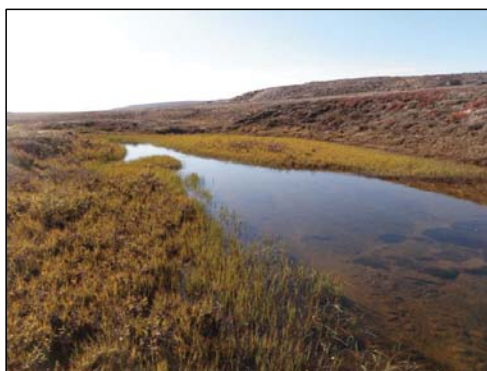
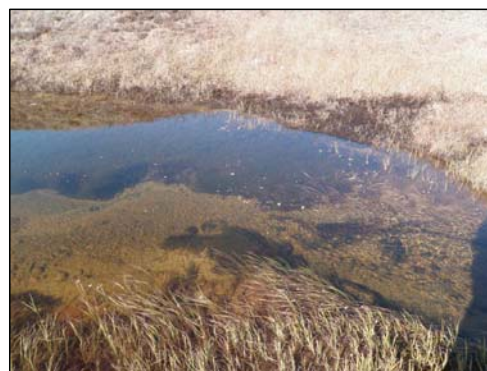
This rail crossing is a short distance upstream from Tote Road crossing BG-04, which has consistently provided important fish habitat for both species throughout the open-water period. Abundant, deep pools with plenty of cover are ideal habitat for both species. Fishing was not conducted during fall, but many fish were observed.

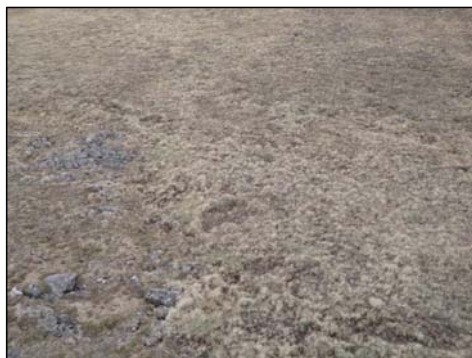
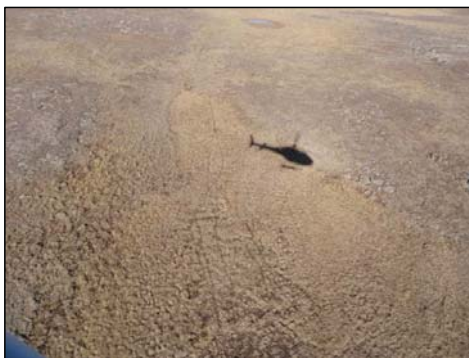
The crossing was a dry low point. There is no fish use of habitat at this crossing.

**Figure 1.** Views of CV-100-1 at the crossing during summer (A) and fall (B).

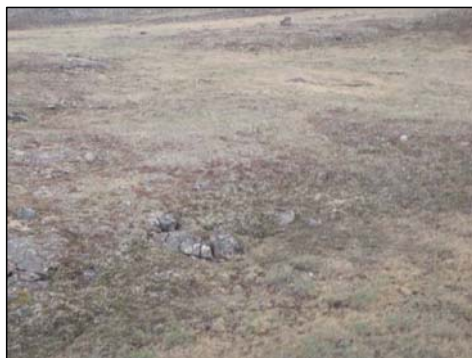
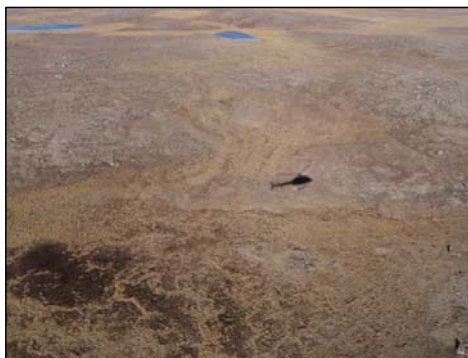
The crossing was a dry low point. There is no fish use of habitat at this crossing.

**Figure 1.** Views of CV-100-2 at the crossing during summer (A) and fall (B).

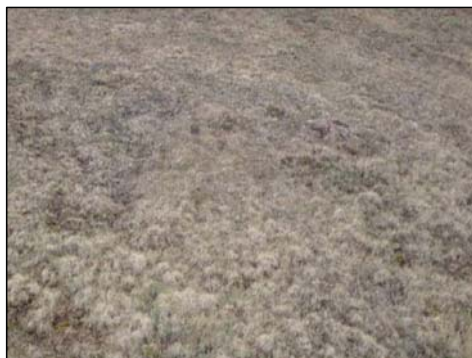
The crossing was a dry low point. There is no fish use of habitat at this crossing.

**Figure 1.** Views of CV-100-3 at the crossing during summer (A).

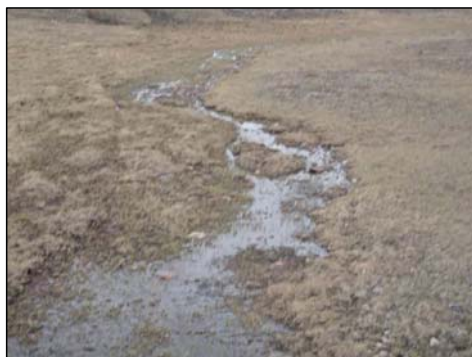
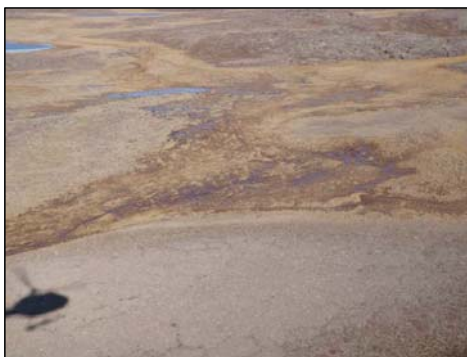
The crossing was shallow, broad, and often lacked a defined channel. In addition, surface flow periodically disappeared. There was no access from overwintering waterbodies, though there may be fish use of the pond downstream of the rail. There is no fish use of habitat at this crossing.

**Figure 1.** Views of CV-100-4 at the crossing during summer (A) and fall (B).
