APPENDIX K

Regulator Inspections and Baffinland's Responses

2023 and 2024 CIRNAC Inspections and Baffinland's Responses

**WATER LICENCE INSPECTION FORM**☒ Original
☐ Follow-Up Report

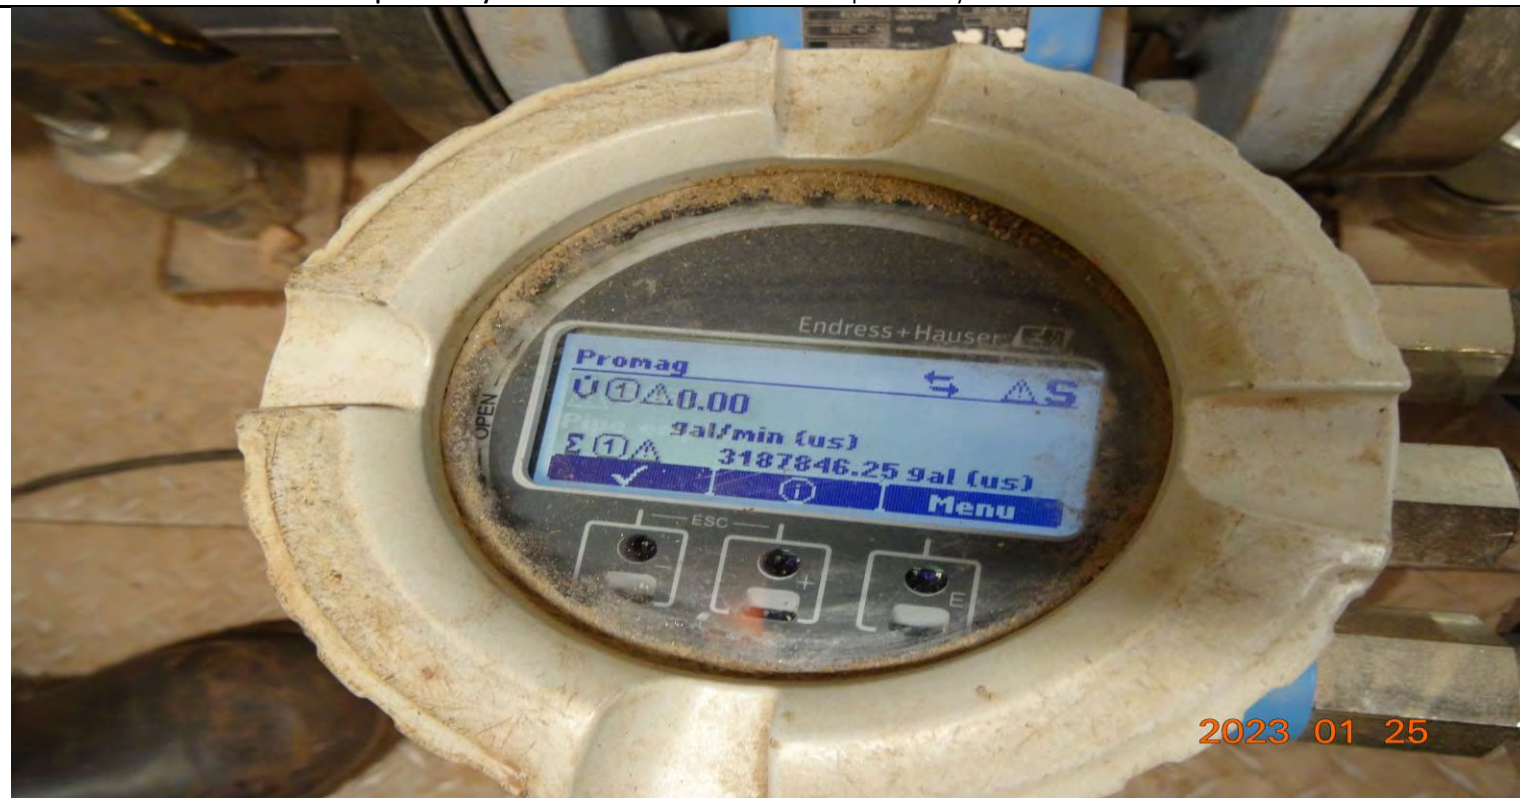
Camp Lake Jetty

Description: 3187846.25 US Gal = 12067.310 Cubic Metres on January 25th, 2023

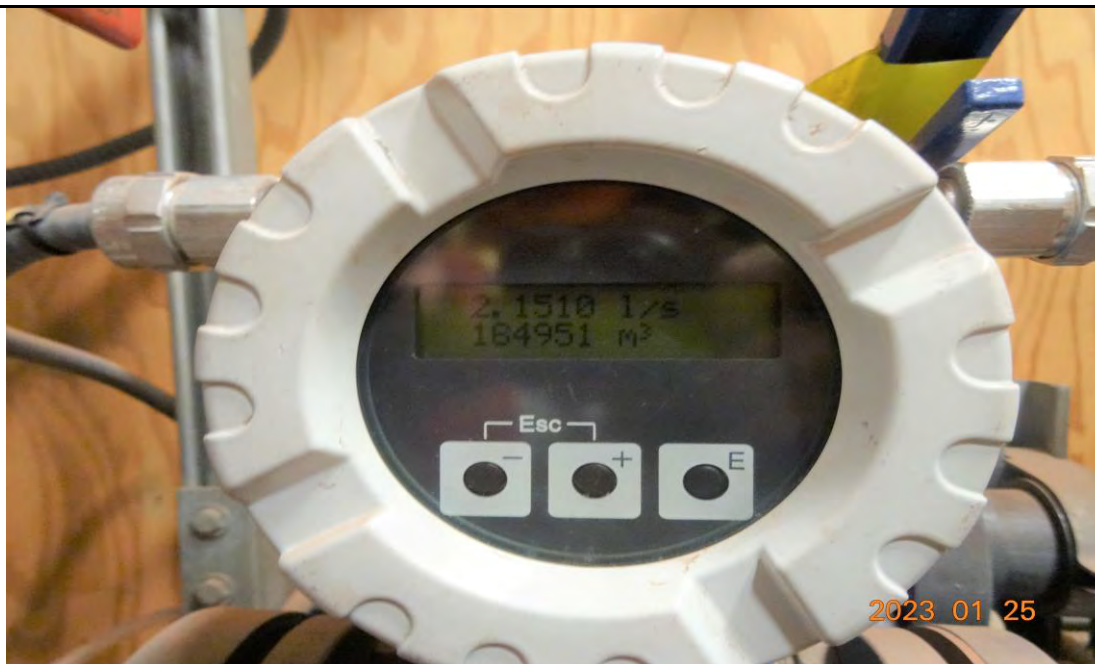
Saillivik Wastewater treatment Plant

Description: 164951 M³ Photo Inside Wastewater Treatment plant on January 25, 2023

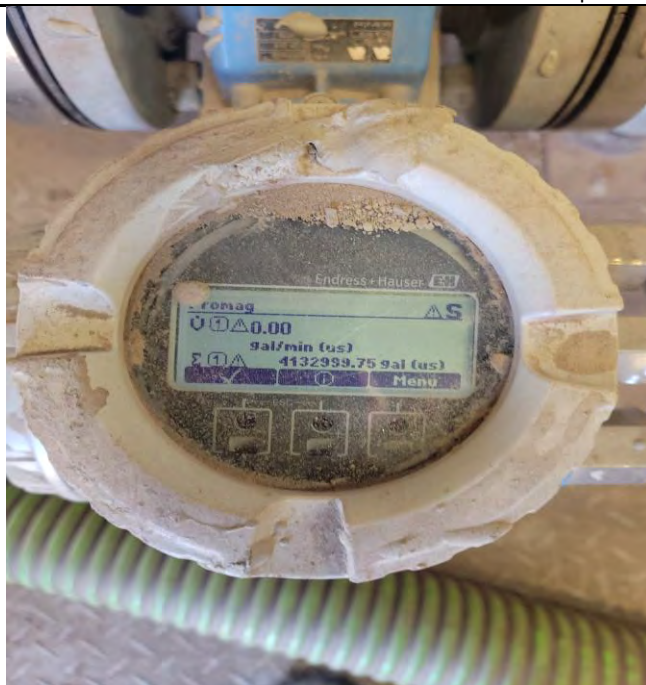
Flow meter at the Camp Lake water intake.

Description: Flow meter at the Camp Lake water intake pumphouse.

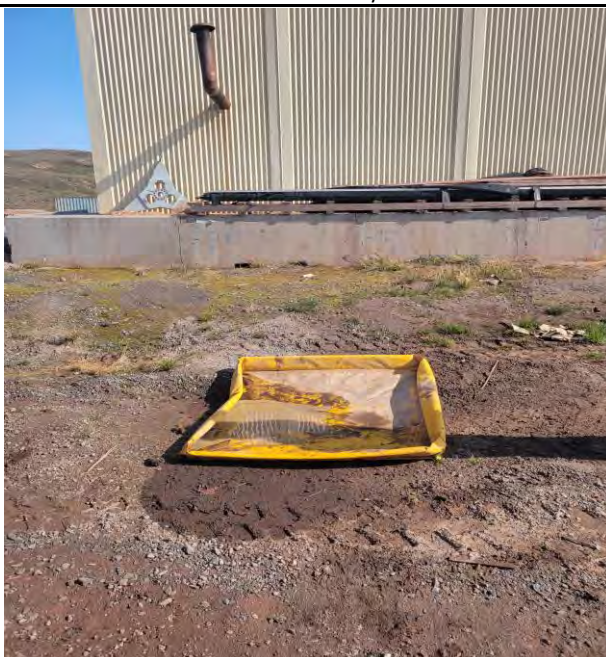
Photo #7

Description: Evidence of a spill outside the incinerator building. Crews stated remediation would start immediately.

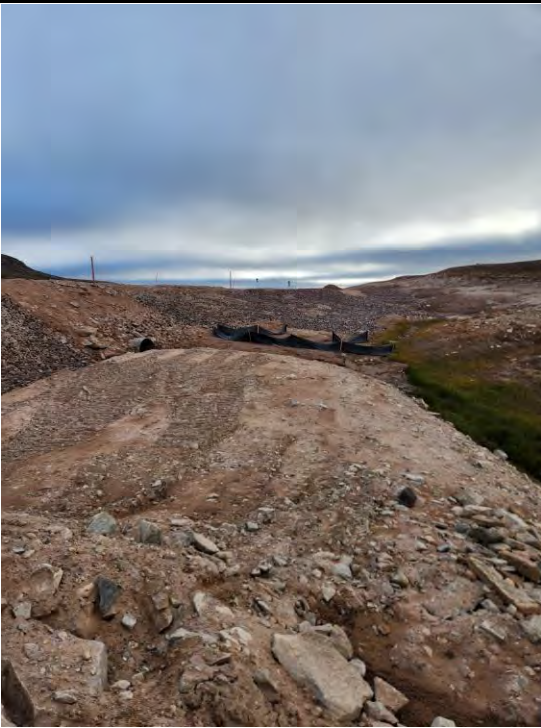
Photo Log		Location
Photo #2		Tote Road – Between KM 73-74

Description: Full site picture of erosion between KM 73-74.

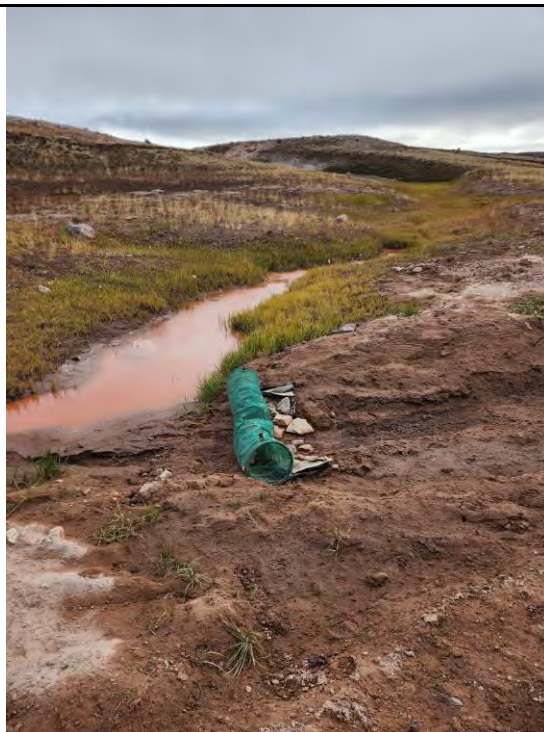
Photo #11

Description: Sediment-laden water coming from upstream towards the hill.

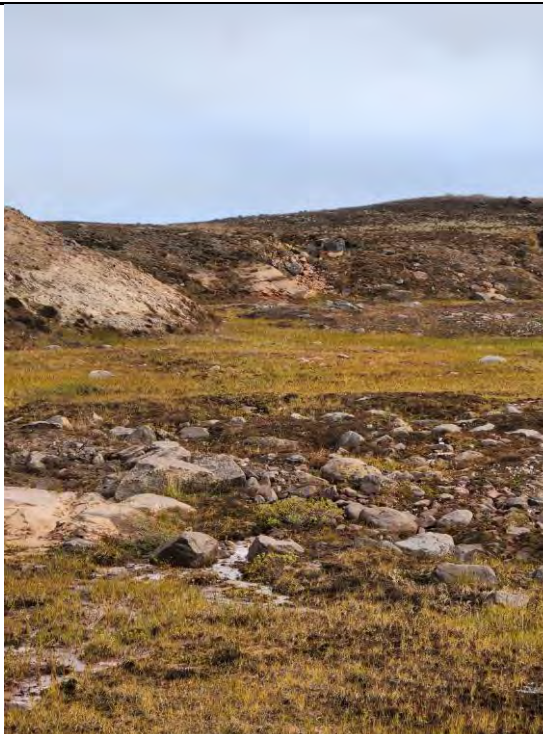
Photo #12

Description: Sediment-laden water appears to be flowing from under the hill. Source of water is unknown.

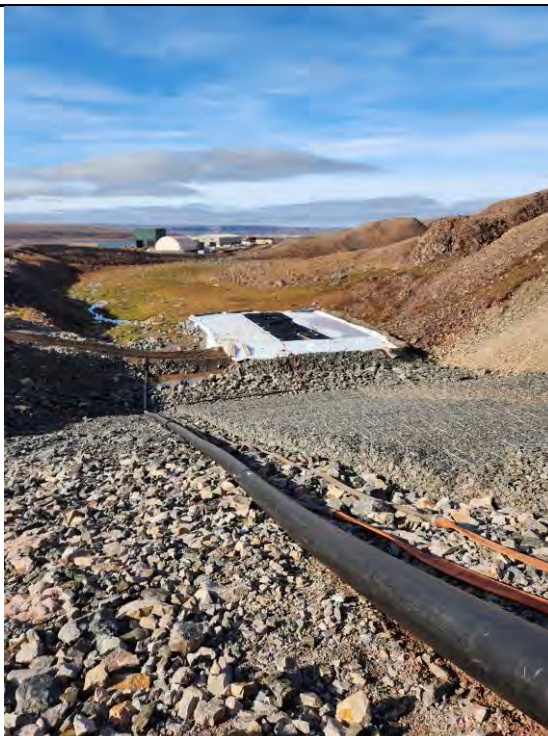
Photo #16

Description: A liner was installed at the bottom of the dam to collect sediments before entering the waterway.

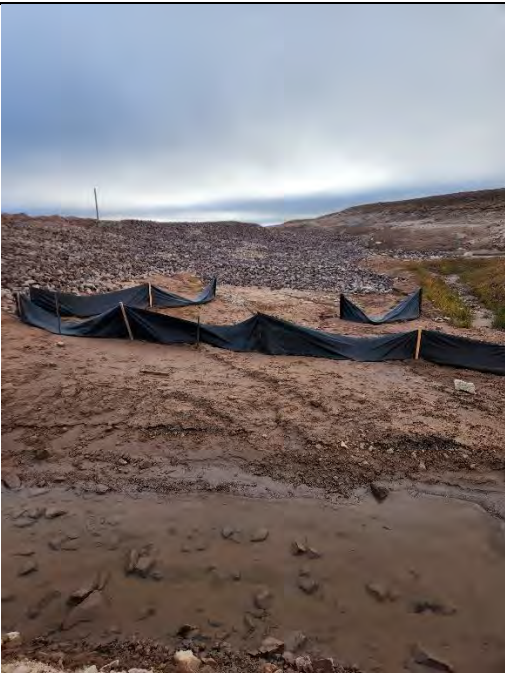
Photo Log	Location
Photo #1	Tote Road – Between KM 73-74

Description: Evidence of erosion which was contained with a silt fence.

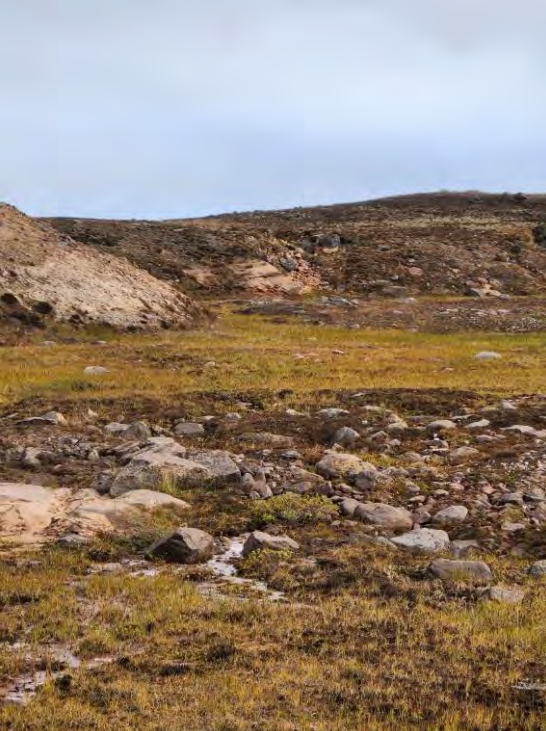
Photo Log	Location
Photo #12	Tote Road – KM 92

Description: Sediment-laden water appears to be flowing from under the hill. Source of water is unknown.

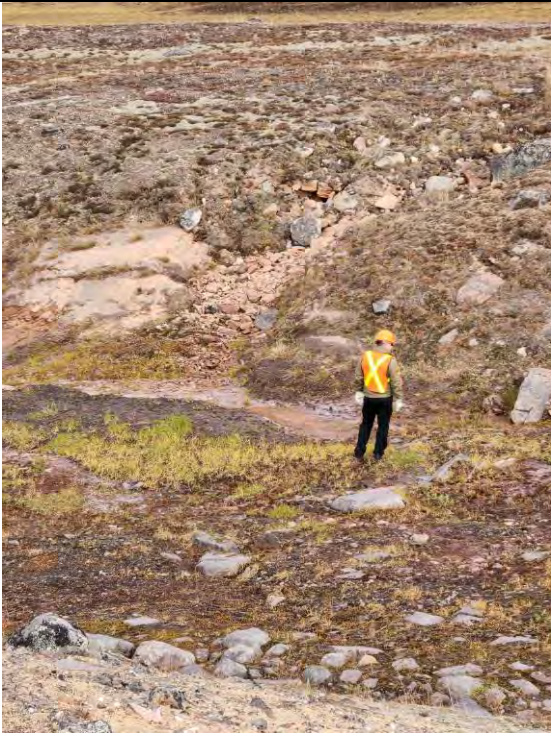
Photo Log	Location
Photo #13	Tote Road – KM 92

Description: Inspector Pasalic observing the site. Sediment-laden water is coming from under the tundra and may be occurring naturally.

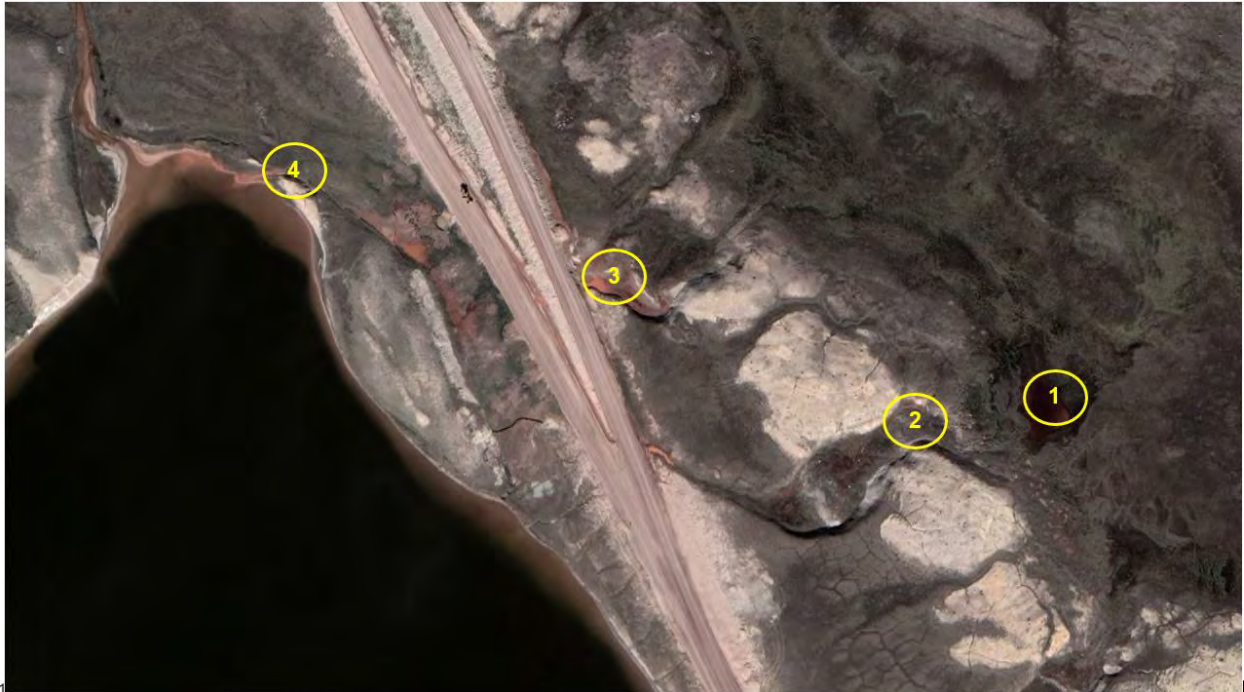
Summary of KM 92 Discoloured Water Investigation

On September 9, 2023, Baffinland field staff performed an investigation into the source of red coloured water seen at KM 92 during the CIRNAC Inspection, September 7, 2023.

Observations were made from four different locations. A full walk of the area was completed from location 1 to location 4. Baffinland conducted similar investigations in the past, as this phenomenon has been noticed before the inspection with CIRNAC. In 2019, similar conditions were observed and investigated.

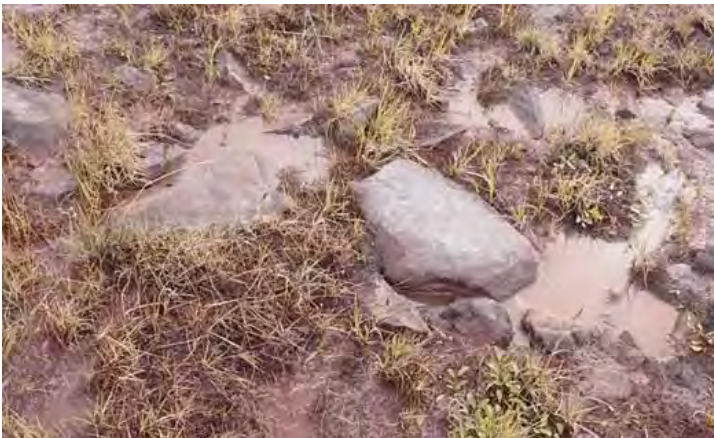
Photo 2 – Saturated ground, water not able to be absorbed.

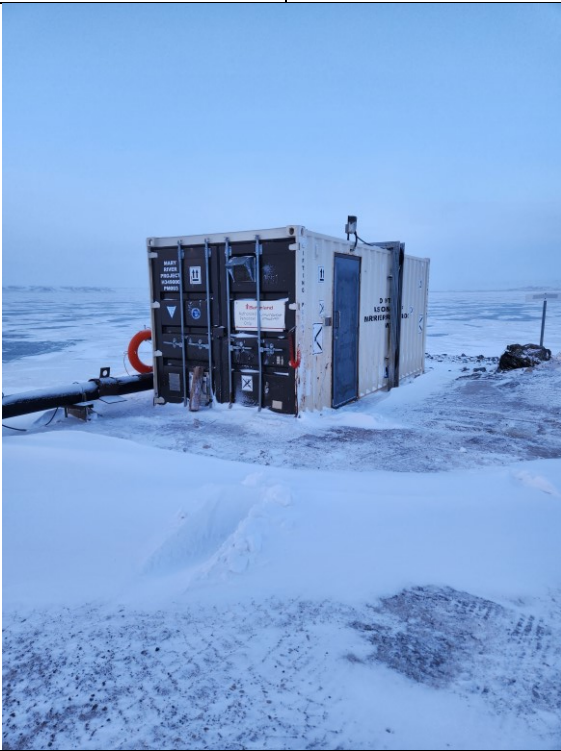
Photo No. 4	Lat/Long (DD.MM.SS.SS, NAD83)
Photo	71.19.666'N, 79.22.962'W

Description: Water Intake Station (Jetty). All systems observed were in proper working condition.

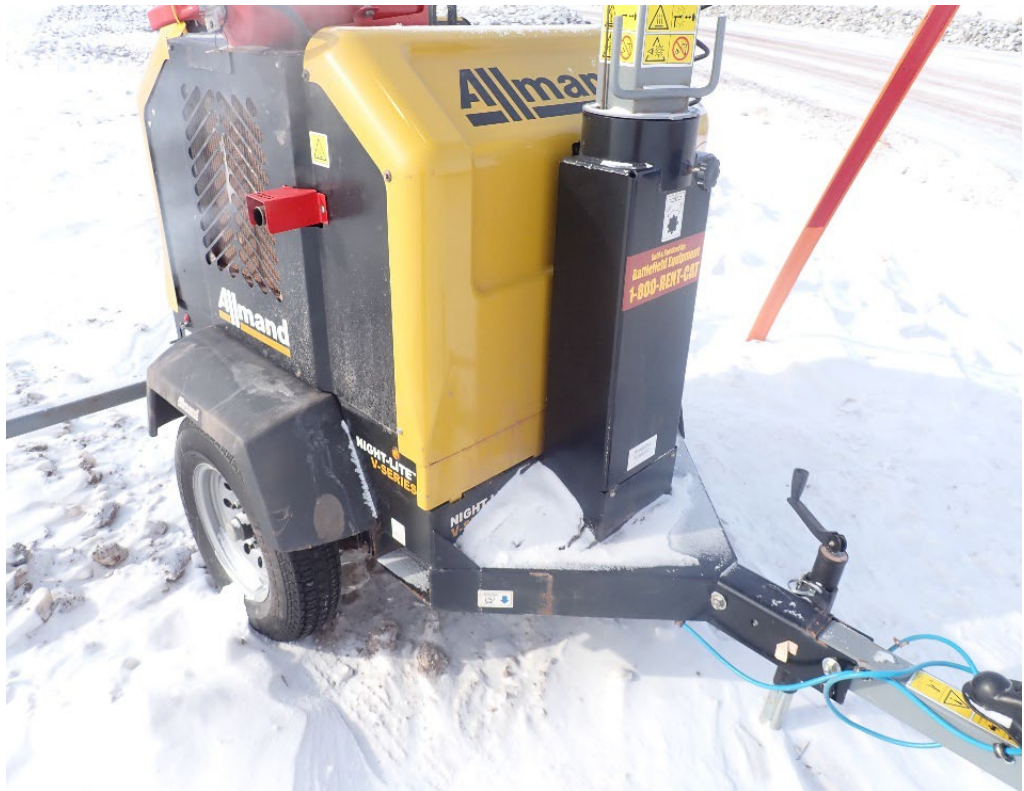
Photo 2: Generator/Light Plant at KM 97 indicating the make and model, April 20, 2024
