APPENDIX K2

2023 QIA Inspections and Baffinland's Responses

**Re: Baffinland Iron Mines Corporation's Mary River Project – Qikiqtani Inuit Association
June 2023 General Site Inspection Findings and Recommendations**

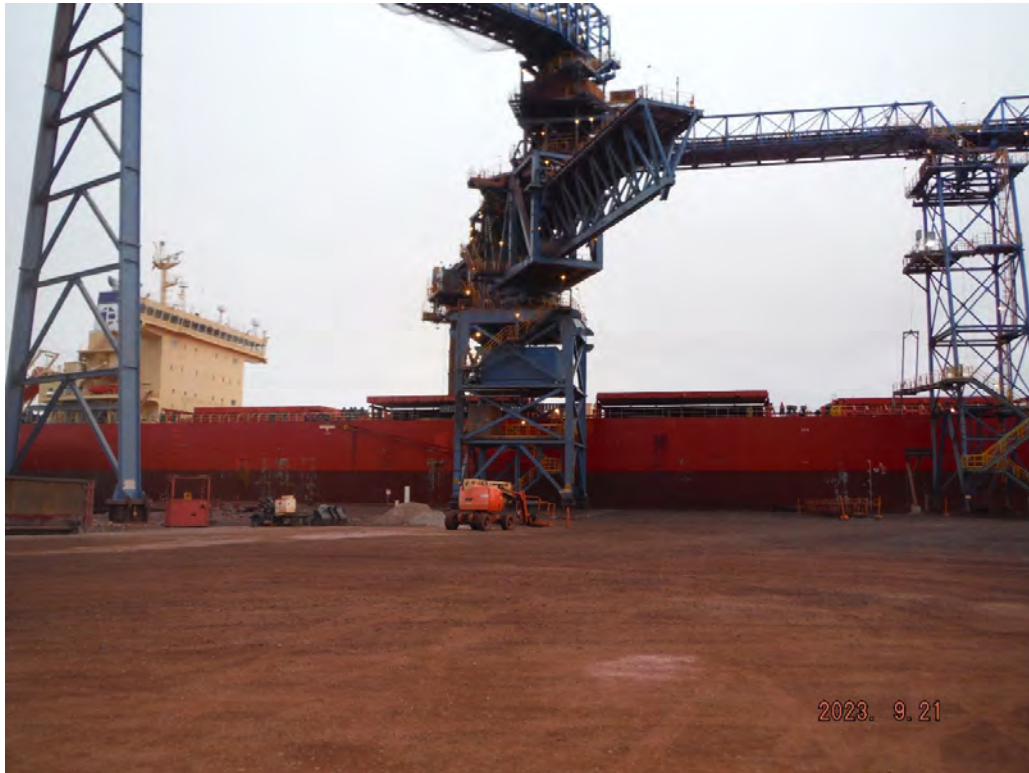
Photo 11 – Milne Port active loading of ship (Sep 2023).

10	Milne Port Loading Area	Loading of ship was occurring at time of observation (Appendix A Photo 11).	<ul style="list-style-type: none"> Although not observed at time of inspection, the dust levels should be minimized on the loading infrastructure (conveyors, chutes, etc.), stockpiles and in other areas 	No action required
