MINING IMPACT SPECIALISTS LTD. <small>ENABLING CHANGE TO SERVE FUTURE GENERATIONS.</small>	  <small>EST. 1971 LIMITED environmental research associates</small>	2023 Mary River Project Site Visit #2		
		Key Photos from September 2023 Inspection		
Mining Impact Specialists Ltd.	LGL Limited	Date: 05 Dec 2023	Approved: LEB	Page: 17

KM105 SEDIMENTATION POND ---- GROUT CURTAIN PROJECT

955-221 Mary River Mine 2023 Environmental Audit

955-221-R-001

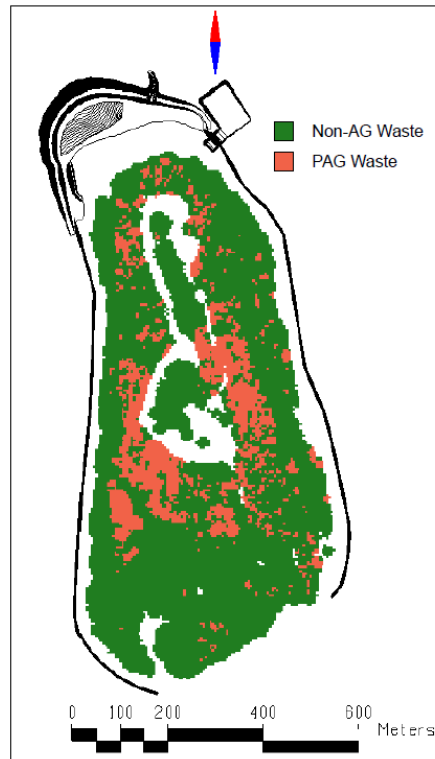
Figure 4.1: PAG and NAG Waste Locations within the WRF

The waste rock management plan was in large part followed in 2021 and 2022 with the two exceptions, as noted in BIM, 2022a, that are unlikely to have any long term environmental impact. However, BIM does not consider the criteria to only place PAG within 50 m of the outer face of the stockpile shell applicable at this point, as the current stockpile faces will continue to move outward as the stockpile increases (BIM, 2022a). Operationally, this is a reasonable statement, however it has lead to several instances where PAG rock was placed near, or at, the perimeter of the WRF (Figure 4.1) which in the event of an unplanned closure of the Mary River Mine would need to be encapsulated in NAG material.
