## Nunavut Impact Review Board (August 2019)

**Report title:** 2019 Winter Site Visit Report for the Nunavut Impact Review Board's Monitoring of Baffinland Iron Mines Corp.'s Mary River Project (NIRB File No. 08MN053)

**Project:** Mary River Project

**Site visit dates:** March 26-28, 2019

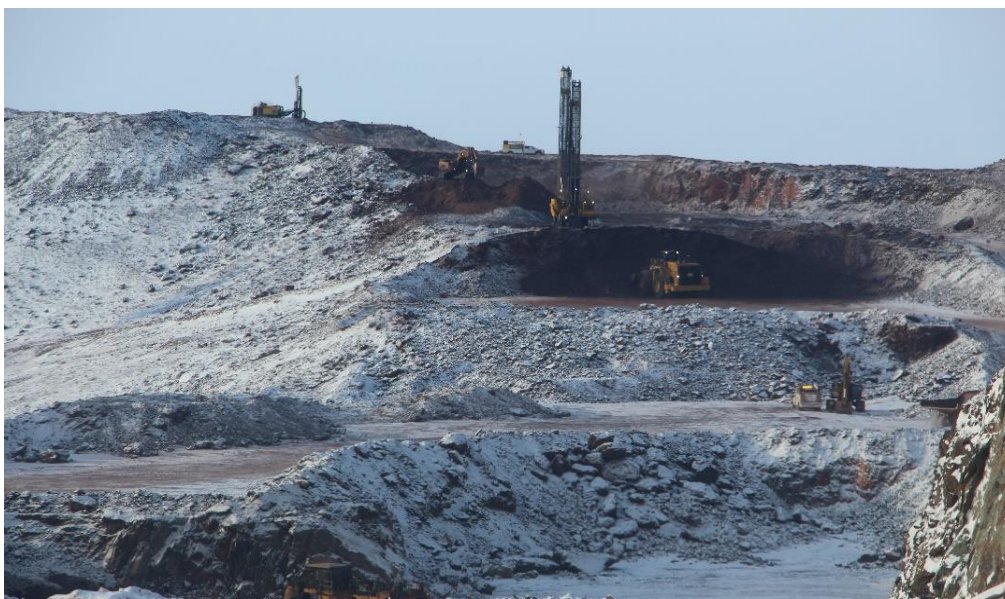
**Photo 1: Deposit No.1 at Mary River**

Upon completion of the site visit, NIRB staff met with Baffinland staff to discuss all the observations noted during the site visit. This meeting allowed for NIRB staff to discuss specific areas of the Project site needing improvement or changes with regards to environmental impacts and mitigation measures. [Photo 1](#) below is an observation image of the Deposit No. 1 Mine pit.

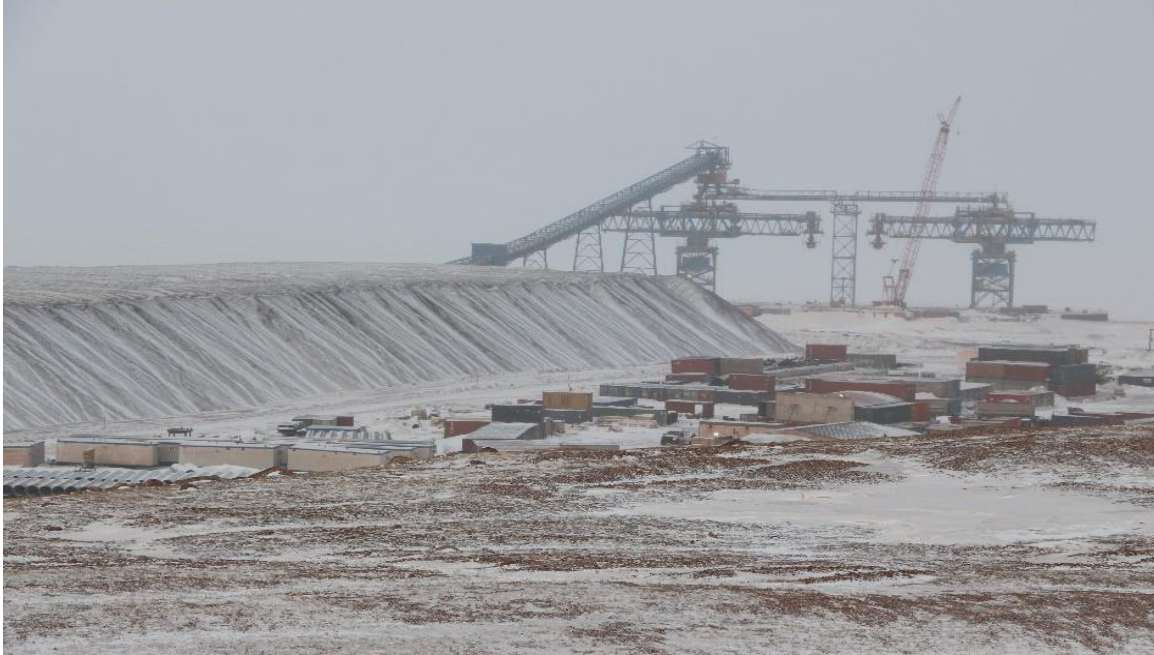
**Photo 2: Milne Inlet ore stockpile and port site**

The following sections briefly describe the major facilities visited during the tour around the project development area (PDA), as well as observations of the overall progress of the site compared to the previous site visit(s). Where applicable, the Monitoring Officer noted compliance with specific terms and conditions of the Project Certificate and followed up on items where Baffinland made commitment to mitigate the potential ecosystemic impacts of the Mary River Project. [Photo 2](#) is the observation image of the ore stock pile area and port site at Milne Inlet.

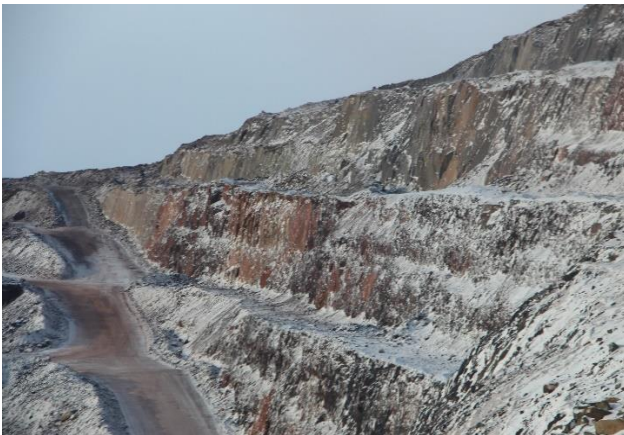
**Photo 5: Deposit No.1 Pit Benches**

After leaving the waste rock facility, NIRB staff visited Deposit No.1 mine pit and noted that ore extraction and mining activities were taking place there. Heavy trucks, loaders, and drill equipment were also observed within the mine pit area as consistent with other site visit observations ([Photo 5](#) and [Photo 6](#)). A few haul trucks were observed travelling to and from the pit area towards the crusher facility. No blasting activities occurred at the time of the site visit.

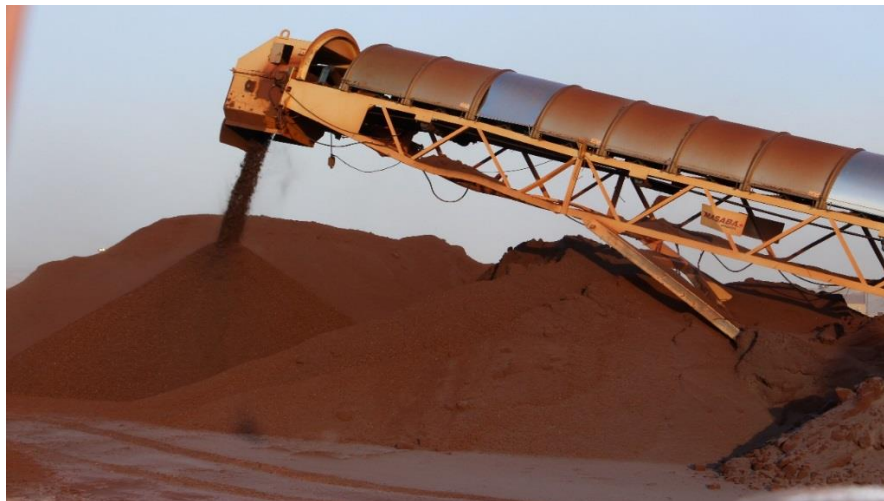
NIRB staff also took a tour around the crusher facility ([Photo 7](#) and [Photo 8](#)) to follow-up on the Board's 2018 recommendation #21 pertaining to the implementation of proper engineering designs and controls to address the increased dust emissions from the crusher plant. The following were observed during the tours of the crusher facility:

- Hoods/shrouds were still in place on the crusher equipment similar to the observations in 2017 and 2018, which resulted in decreased emission of dust from the facility compared to previous years. Further, the use of dust control technology especially near the transfer point and the belts appear to have been effective to a certain degree in reducing and controlling dust emission from the crusher; however, in certain areas of crusher facility visible dust plumes continue to be observed. NIRB staff noted that in general dust emissions from the crusher plant appear to have improved.

- During the last winter site visit, NIRB staff noted that the trenches/ditches around the crusher pad were filled with ore lumps, and the Monitoring Officer recommended that Baffinland address this issue immediately. During the current site visit, NIRB staff followed up with this observation and noted that the trenches/ditches around the crusher pad showed no signs of blocked drainage/channel.

- NIRB staff also noted progress around the crusher facility in relation to the clean-up of the piles of waste materials that had accumulated in the area for many years.

**Photo 7: Crushed Iron being piled for transport**

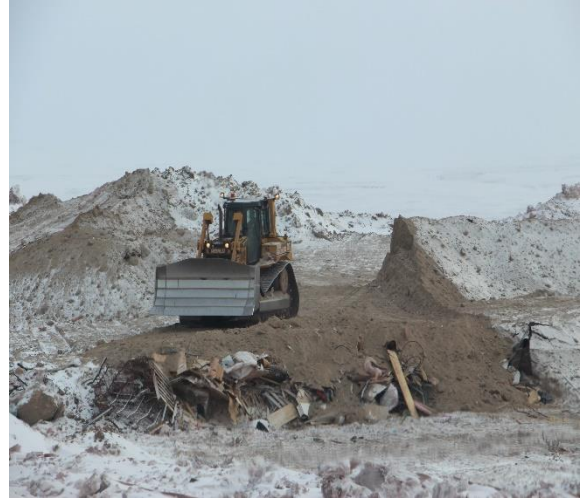
NIRB staff also visited the landfill site to follow-up on the Board's 2018 recommendation #20 pertaining to the need for Baffinland to address the recurring fencing issue around the landfill footprint. At the time of the site visit, NIRB staff noted that the landfill was still not fully enclosed with proper fencing thereby increasing the risk for offsite waste dispersion ([Photo 9](#)). NIRB staff also observed that one of the temporary laydown areas adjacent to landfill area continued to accumulate increased amount of unused materials and there are concerns that this laydown area may eventually become a permanent laydown area if these items are not properly cleaned out or relocated to an appropriate location for disposal. NIRB staff also observed a scrap vehicle ([Photo 10](#)) in the landfill site and this was brought to the attention of Baffinland site staff for immediate action. In addition, a bulldozer was also observed clearing wastes within the facility ([Photo 11](#)). The Monitoring Officer remains unsatisfied with the level of progress made by Baffinland since 2014 to address the fencing issue at the landfill site.

**Photo 11: Ongoing activities at the landfill**

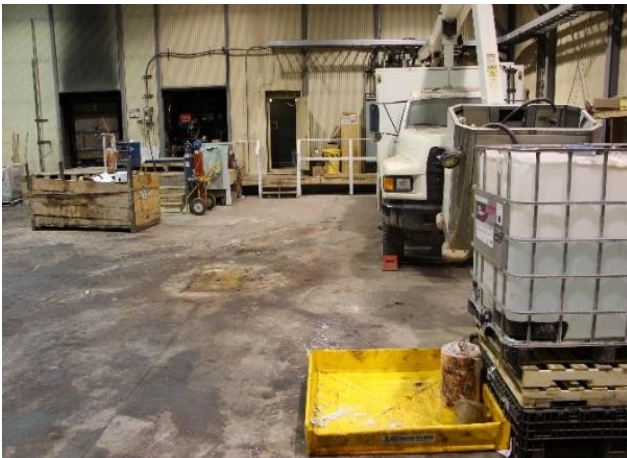
The incinerator at the Mary River mine site remain well maintained ([Photo 12](#)) and waste materials were observed to be segregated into labelled bins for incineration (i.e., food and paper waste) or disposal off site (i.e., batteries, paint, oily rags, kitchen grease etc.) ([Photo 13](#)). Waste sorting has improved as we didn't observe any recyclable waste materials such as cans for incineration unlike in 2018. During the current site visit, NIRB staff noted that the huge piles of tires and unused materials stored outside and in the vicinity of the incinerator facility have been removed.

**Photo 12: Inside of the Incinerator Building**

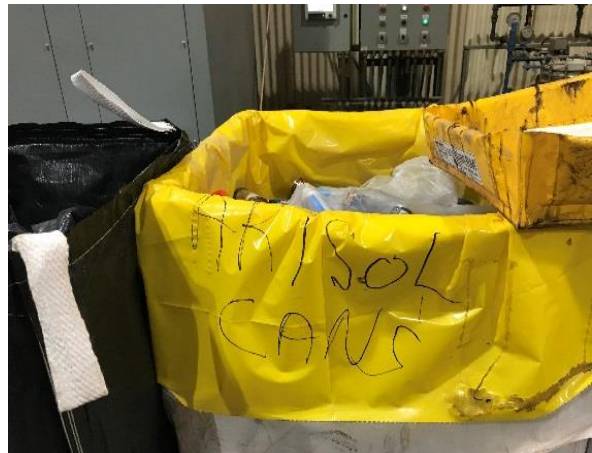
**Photo 13: Waste segregation in the facility**

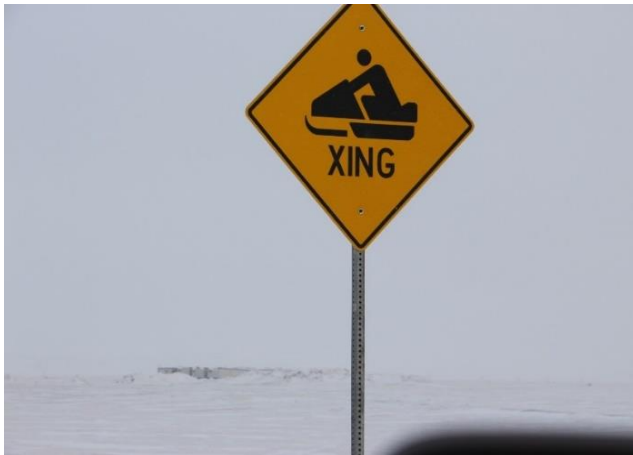
During the drive along the Tote Road, NIRB staff did not observe any major environmental issues along the Tote Road as the road was well maintained. However, at some locations, dust plumes were observed during the drive to Milne Inlet. In addition, snowmobile signages and bridge crossings were also observed along the Tote road ([Photo 16](#) and [Photo 17](#)).

**Photo 16: New road signage along the Tote Road**

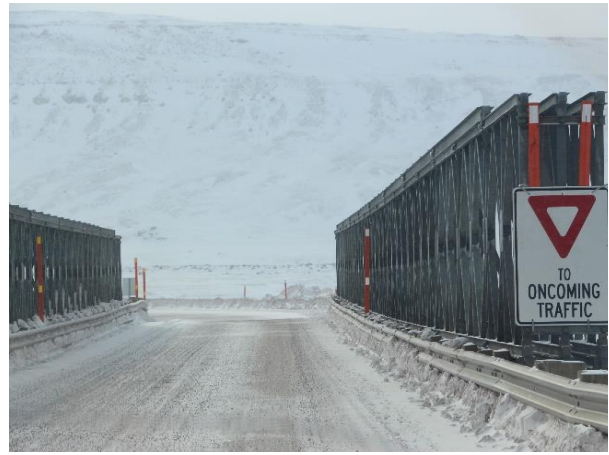
**Photo 17: Bridge crossing along the Tote Road**

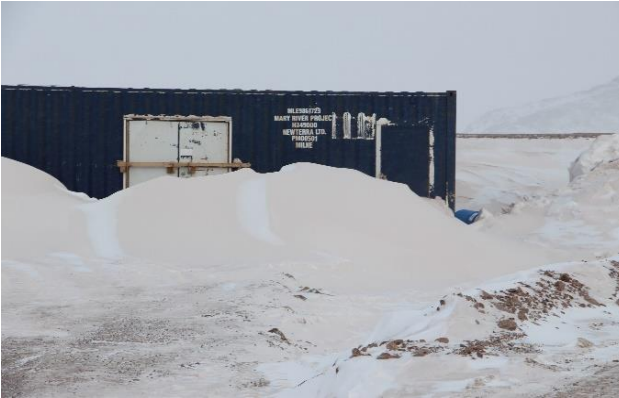
**Photo 18: Landfarm area**

NIRB staff visited the landfarm facility in order to follow-up with progress made to the facility in accordance with best practices. While some improvements have been made to the general operations of the facility, the entrenchment of synthetic liner materials within the facility continues to be an issue at the facility ([Photo 18](#) and [Photo 19](#)). NIRB staff also observed that salt bags had continued to be stored in a temporary laydown area near the landfarm and the Proponent was unable to outline what long-term storage options are being considered to ensure that salt bags in the area are not permanently stored in that location or damaged.

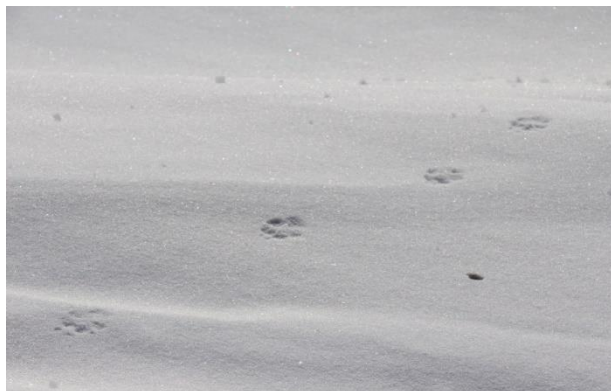
**Photo 26: Fox Tracks**

Pursuant to condition 53 and 61 of the Project Certificate Baffinland is required to demonstrate steps taken to prevent caribou mortality and wildlife safety measures on site. During the site visit, NIRB staff did not observe caribou around the Project area; however, many foxes were witnessed around the project site ([Photo 26](#)). Metallic skirtings were observed around the base of all accommodations buildings to deter foxes and other carnivores from entry into the buildings pursuant to the requirement of term and condition 64 of the Project Certificate. In addition, NIRB staff noted that wildlife logs were posted at the main camp buildings for staff to report on wildlife encounters or observations around Mary River, Milne Port, and along the Tote Road.
