Nunavut Impact Review Board

August 2019 Site Visit Report

The Mary River project

Baffinland Iron Mines Corporation

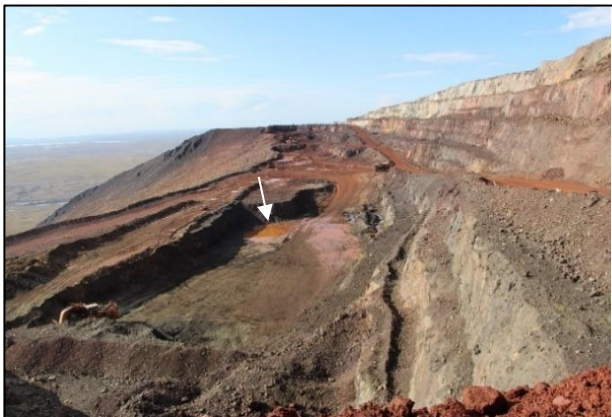
Photo 8: Mary River Mine Pit

NIRB staff visited the Deposit No.1 pit ([Photo 8](#)) and noted that ore extraction and mining activities were underway ([Photo 9](#)). Heavy trucks, loaders, and drill equipment were observed within the mine pit area as consistent with other site visits. NIRB staff noted that water was pooling within the mine pit ([Photo 8](#) see arrow); Baffinland staff indicated that the water present within the mine pit was acidic and that it was being pumped to the storage pond at the treatment facility. It was observed that while haul trucks were travelling to and from the pit area towards the crusher facility, a large amount of dust was produced by the trucks causing low visibility along the Haul road ([Photo 10](#)).

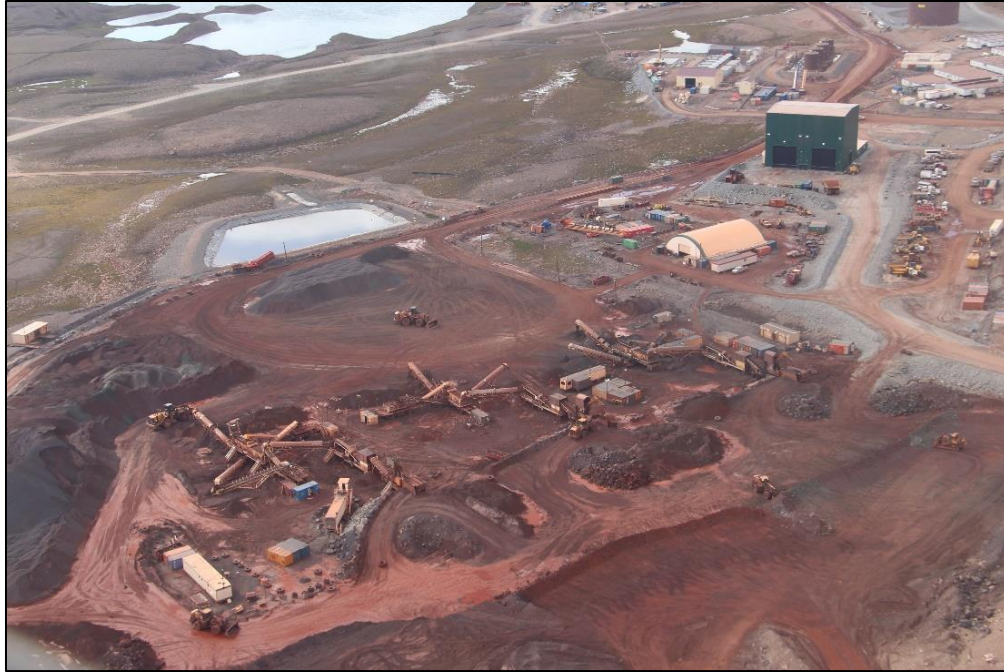
Photo 11: Aerial View of the Crusher Facility at the Mine Site

NIRB staff were also toured around the crusher facility ([Photo 11](#)) to follow-up on the Board's 2018 recommendation #21 pertaining to the implementation of proper engineering designs and controls to address the increased dust emissions from the crusher plant. The following were observed during the tours of the crusher facility:

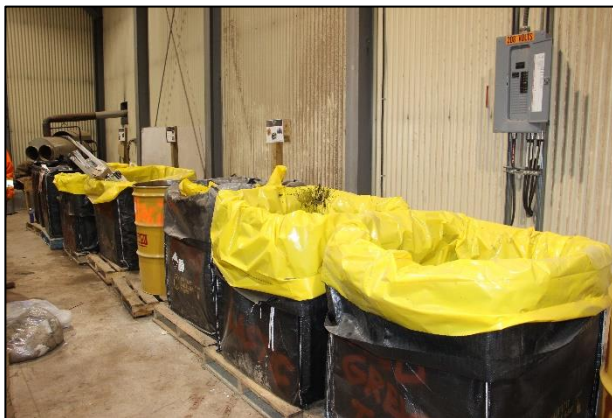
Photo 20: Waste Sorting

The incinerator facility at the Mary River mine site remains well maintained and most waste materials were observed to be segregated into labelled bins ([Photo 20](#)) for incineration (e.g., food and paper waste) or disposal off site (e.g., batteries, paint, oily rags, kitchen grease). However, the larger waste bins inside the incinerator facility were found to be overflowing ([Photo 21](#)) as the

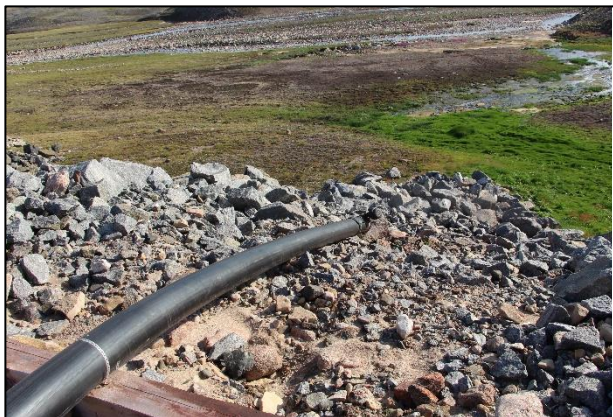
Photo 24: Stable

During the site visit, NIRB staff noted that the terrain around one of the discharge pipes was rip-rapped and stable ([Photo 24](#)), while there remained some erosion issues around the second pipe; possibly caused by permafrost decay around the sewage discharge pipe ([Photo 25](#)).

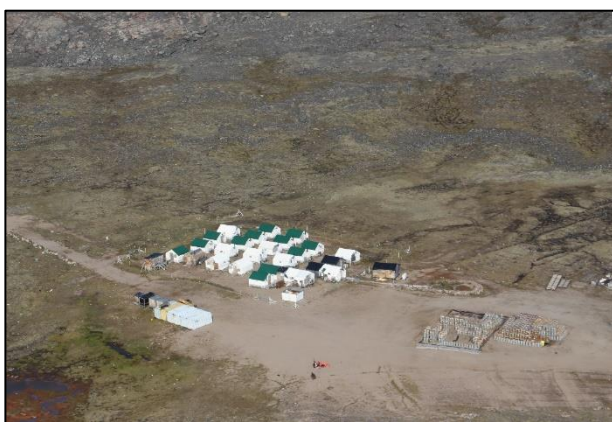
Photo 26: Steensby Inlet Mine Camp, August 2019

While on site, NIRB staff visited Steensby Inlet Camp ([Photo 26](#)) to observe any changes that have occurred since the last visit there in 2016. The camp located at Steensby Inlet is largely decommissioned and is solely being used as a fuel cache for the current monitoring programs and Ege Bay exploration activities by Baffinland (NIRB File No.18EN026). During the current site visit NIRB staff observed that several seacans had been removed since the last visit ([Photo 27](#)); however, the buildings on site were heavily deteriorating causing debris to be blown across the tundra ([Photo 28](#) and [Photo 29](#)). There also appeared to be chemicals and garbage bags left in Weatherhavens and/or seacans which can pose a risk to wildlife.

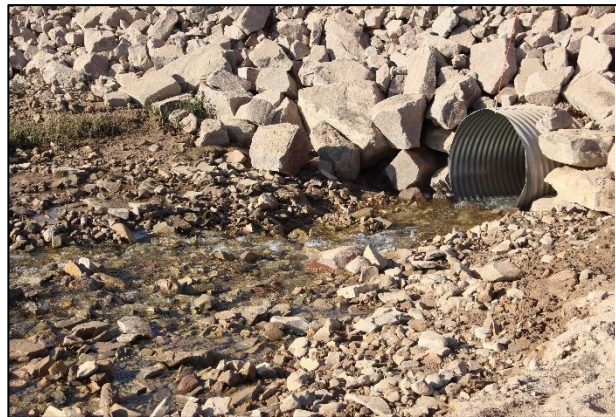
Photo 32: Culvert Along the Tote Road

Culverts along the Tote Road were also observed and noted to be in good condition ([Photo 32](#)). Along the drive of the Tote Road, NIRB staff also noted the presence of the emergency shelter. In general, the Tote Road is well maintained and there were no major environmental issues observed.

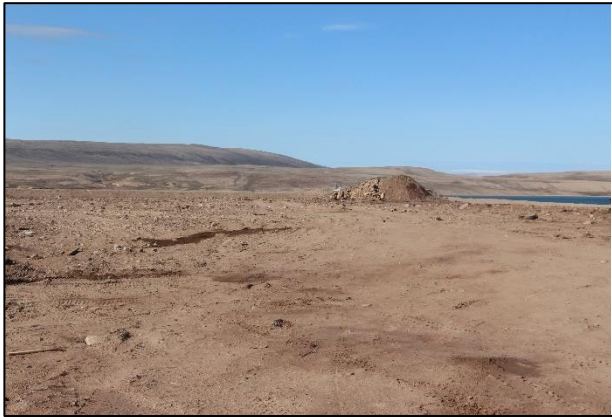
Photo 33: Cleaned Landfarm at Milne Port

NIRB staff visited the landfarm facility in order to follow-up with progress made to the facility in accordance with best practices and past Board Recommendations. Baffinland has made significant improvements at the landfarm facility. Tilling has begun in the 2019 season and most synthetic liners have been removed ([Photo 33](#)); however, there is still progress to be made towards completing the cleanup of smaller pieces of entrenched liners ([Photo 34](#)).

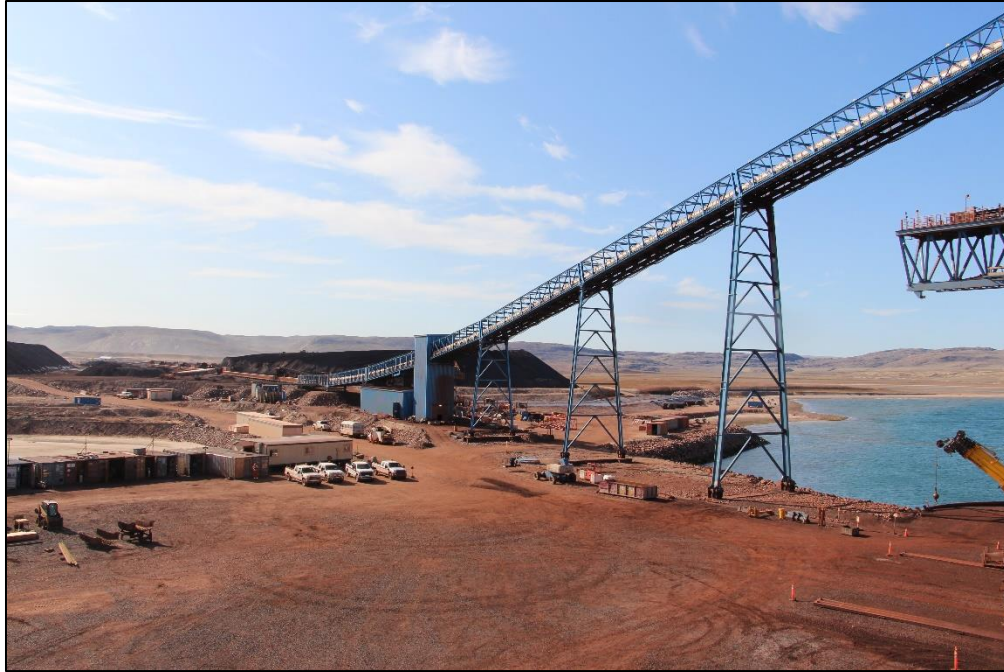
Photo 35: Ore Dock and Ship Loading Conveyor Belt

NIRB staff also took a tour around the ore dock area, ship loader and the ore stockpile. Generally, the ore dock and ship loader were very clean and organized ([Photo 35](#)). There was very little noticeable dust being dispersed as the ships were being loaded due to the shoots extending directly into the ship's ore storage compartment ([Photo 36](#)). NIRB staff observed the ore stockpile being leveled, shaped and separated for ship loading ([Photo 37](#)). Further, NIRB staff noted that the ore stockpile seen in both the August (summer) and March (winter) 2019 site visits was noticeably larger than in the past, a result of the Production Increase Proposal approved in 2018. While NIRB staff were on site, there were several ore carriers, tug boats as well as the *MSV Botnika* located at various anchoring locations in Milne Inlet waiting to facilitate ship loading activities ([Photo 38](#)).

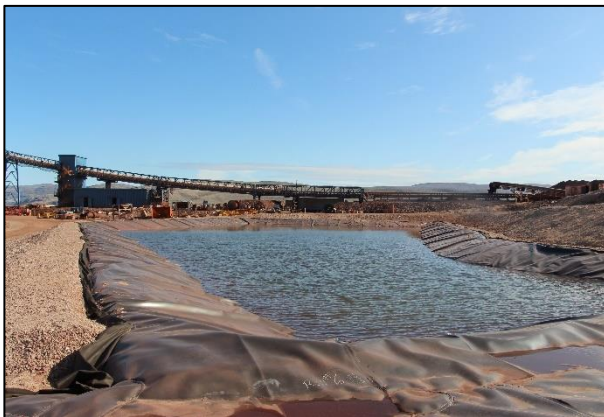
Photo 39: East Settling Pond at Milne Port

NIRB staff visited both settling ponds at Milne Port and noted that the ponds and adjacent water treatment facility seem to be in working condition and well maintained. The scrap materials located within the vicinity of the settling pond during the 2019 winter (March) site visit had been removed and the area was clear of obstruction ([Photo 39](#) and [Photo 40](#)).

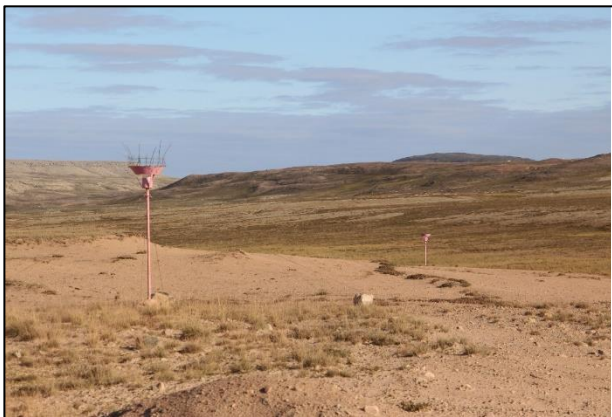
Photo 44: Dust Fall Stations at various distances leading away from the Tote Road

Dust management and monitoring plans were followed up on during the site visit pursuant to Terms and Conditions 10 and 58 pursuant to the NIRB’s Project Certificate No. 005. During the drive along the Tote Road, NIRB staff observed several dust-fall stations ([Photo 44](#)). NIRB staff also noted that traffic (both haul and pick-up trucks) caused significant dust generation both along the Tote Road and the Haul road towards Deposit No.1. At the time of visit, and throughout the Baffinland road network, NIRB staff did not observe the application of dust suppressants on the roads.

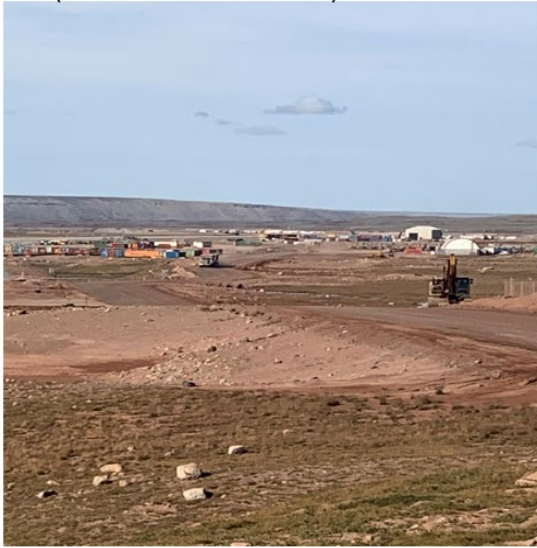
Long range visual-TREATED- Minimal dust off OHT (24 hours after treatment)

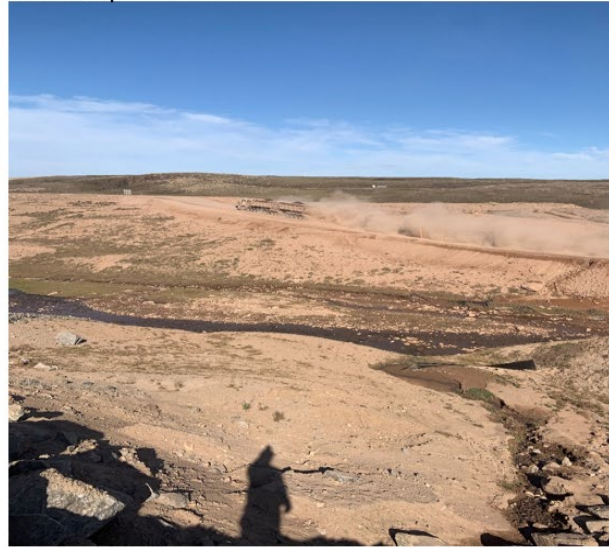
Long range Visual- UNTREATED- Visual dust off OHT at KM100 dip northbound

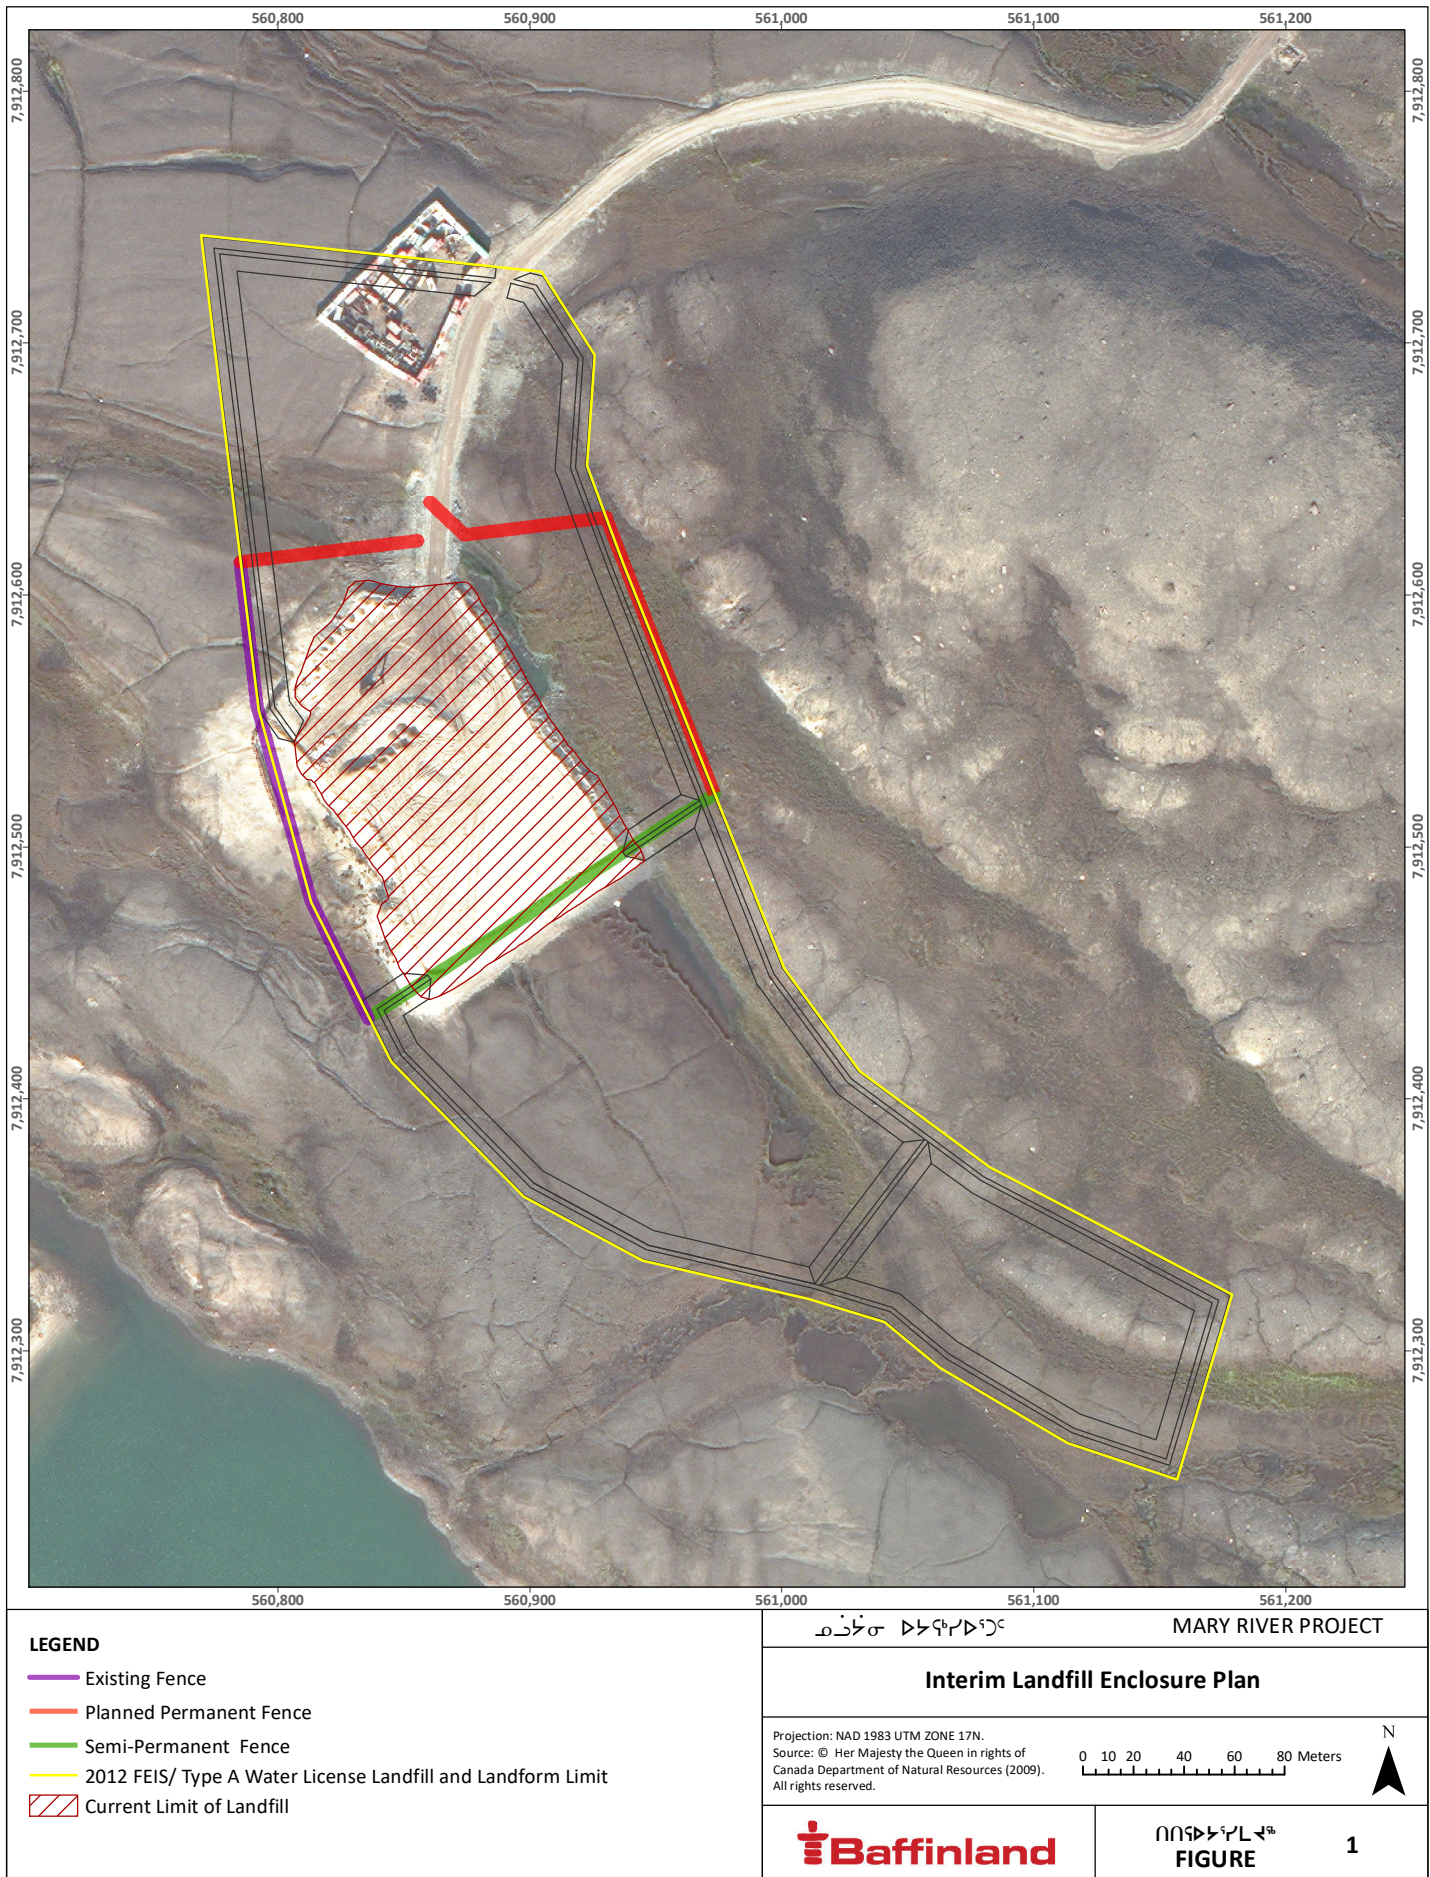
Figure 1 – Interim Landfill Enclosure Plan

#	Project Location	Description of Concern or Finding	Recommended Action	Response
3	Mine Site / Landfill	Landfill fence does not completely surround active landfill areas. More cover material required on top of current layer and west side.	Develop detailed action plan for landfill fence construction that surrounds entire action landfill area.	<p>Baffinland is committed to managing the Mine Site Landfill as per the approved Waste Management Plan. After discussions with NIRB, a fence was installed on the west side of Cell 1 to address concerns of potential wind-blown debris sourcing from the landfill to the Tundra. Baffinland erected a fence in the fall of 2018. This included approximately 275 metres of fence on the downwind side of the landfill. The fence also repurposed over 800 used tires as part of Baffinland's used tire disposal and recycling initiative. The fence currently captures windblown debris from the landfill effectively. (Refer to photos in Attachment 2).</p> <p>An additional 405 metres of Landfill fence was ordered by Baffinland for delivery on the 2019 sealift (mid to late September arrival). The fence will be erected to further mitigate the potential for wind-blown debris impacting the tundra that the prevailing wind fence was not already capturing. Figure 1 (Attachment 3) outlines the plan to enclose the current working space of the landfill by the end of Q4 2019.</p>
