2016-2017 Annual Monitoring Report for Baffinland Iron Mines Corp.'s Mary River Project

Report title: The Nunavut Impact Review Board's 2016-2017 Annual Monitoring Report for the Mary River Project (NIRB File No. 08MN053)

Project: Mary River Project

Monitoring Period: September 2016 – September 2017

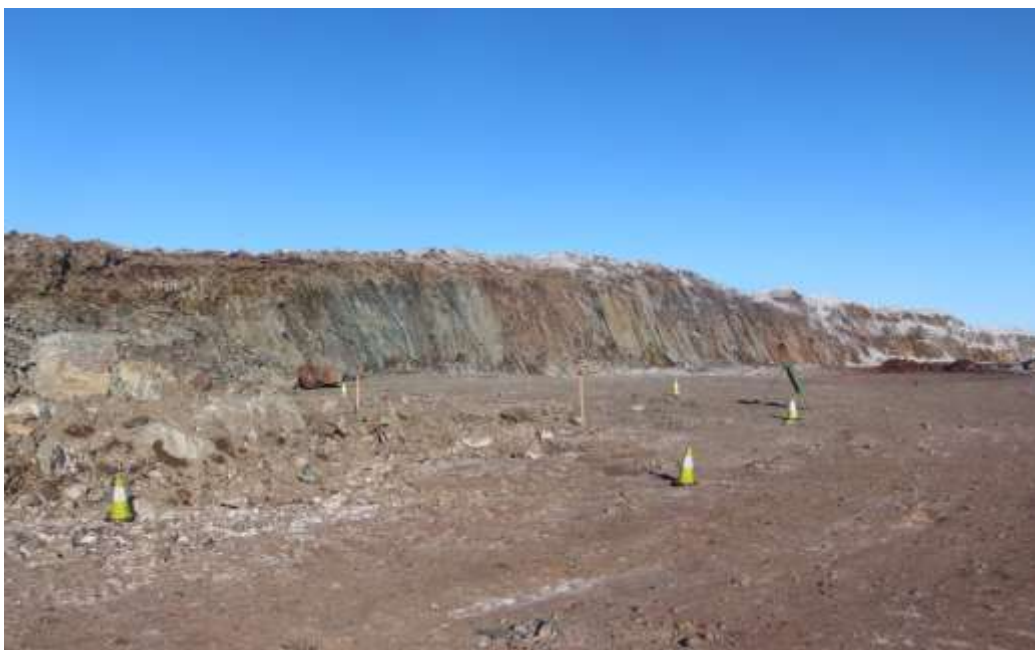
Picture 7: Mine pit at Deposit No. 1

During the 2016 site visit, the Monitoring Officer observed that the waste rock storage area lacked appropriate water management structures to properly divert or intercept overland runoff from the waste rock dump to the nearby sediment pond, and as a result the NIRB’s 2016 Recommendation 16 specifically requested that Baffinland clarify why the mitigation measures for managing site contact water, as committed to within the FEIS of the Mary River Project and Addendum to the FEIS for the ERP, were not in place at the time of the NIRB’s site visit. In responding to the Board’s recommendation, Baffinland reported that it subsequently completed the construction of a waste rock settling pond and a ditching system adjacent to the waste rock storage area immediately after the 2016 site visit, and that new structures were onsite to direct most of the runoff from the waste rock stockpile to the sedimentation pond.

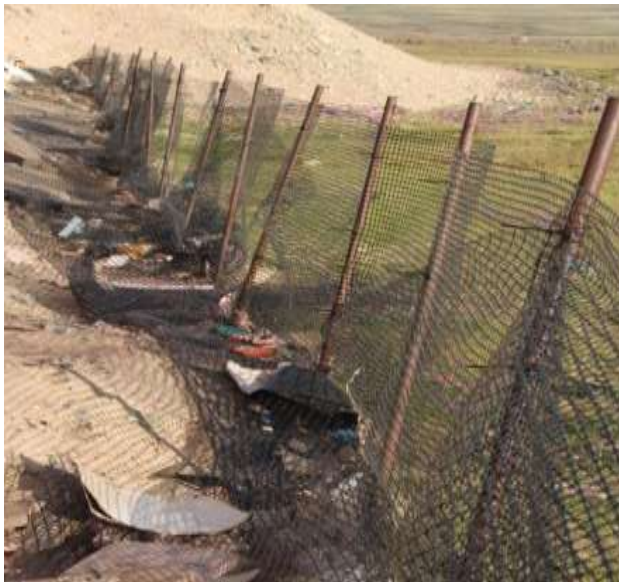
Picture 14: Litter fence (2016 observation)

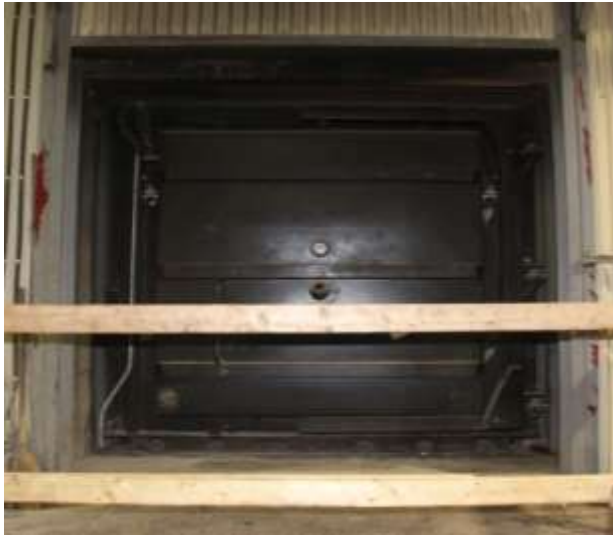
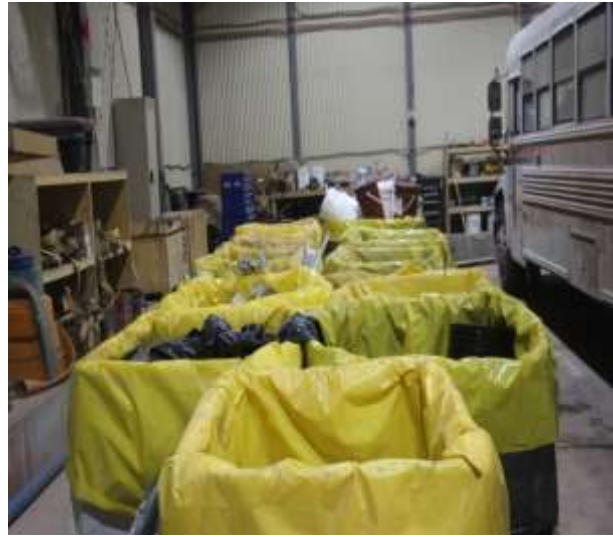
Based on the 2016 site observations and the 2017 March site visit, the Monitoring Officer noted that the incinerator in use at the Mine site continue to remain well maintained except for the minor pooling of drainage water within the incinerator facility ([Pictures 16 and 17](#)). The NIRB's 2016 Recommendation 21 specifically requested that Baffinland take immediate steps to remove unused scrap materials, tires and synthetic materials currently stored temporarily at various Project locations, including around the immediate vicinity of the incinerator facility in order to improve the visual quality of the site. During this site visit, the Monitoring Officer observed the ongoing effort of Baffinland staff in relocating most of the historical tires into seacans for offsite disposal ([Picture 18](#)).

Picture 16: Incinerator

Picture 17: Waste storage within incinerator facility

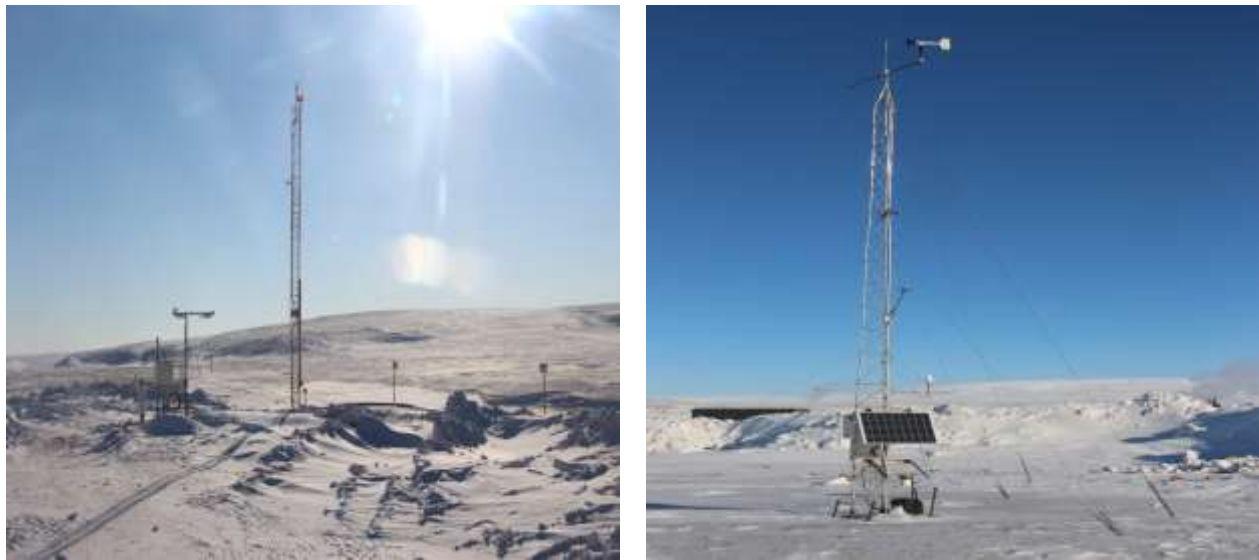
During the tour of the Mine area, the Monitoring Officer was directed to observe a fully operational weather system. The Monitoring Officer also observed that current weather-related information is displayed on the monitors located within the main accommodation building ([Picture 29](#)).

Picture 29: Weather monitoring systems in Mary River site

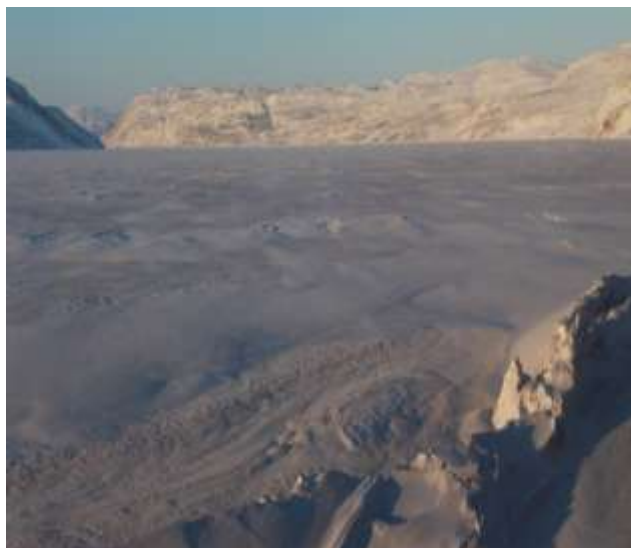
Picture 31: No dust deposition on sea ice (2017)

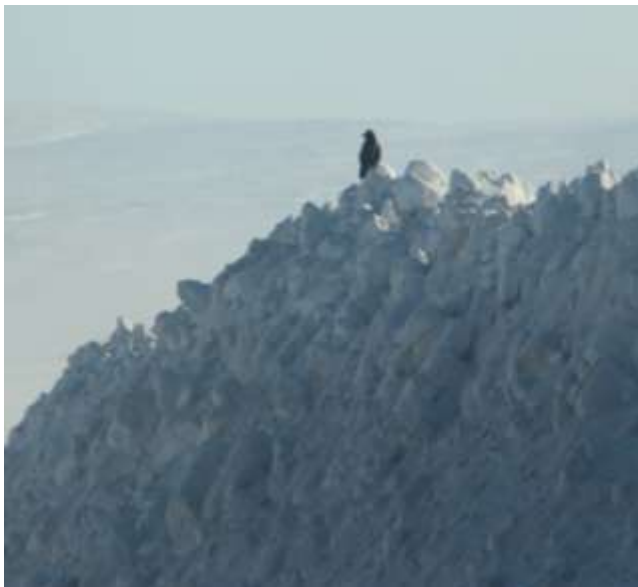
Ravens were observed along the Tote Road as well as around the landfill area ([Picture 35](#)) which would be expected during this site visit due to its timing. Past issues raised by Baffinland regarding the installation of communication towers onsite were concerns that lights were shown to be an attractant to birds, and that in the study area birds are active during the 24-hour daylight season. At the time of the site visit, no bird deterrent strobe or flashing lights was observed on the communicator tower ([Picture 36](#)); but the Monitoring Officer would be verifying the status of the lights during the summer Mary River site visit.

Picture 35: A raven was spotted along the Tote Road

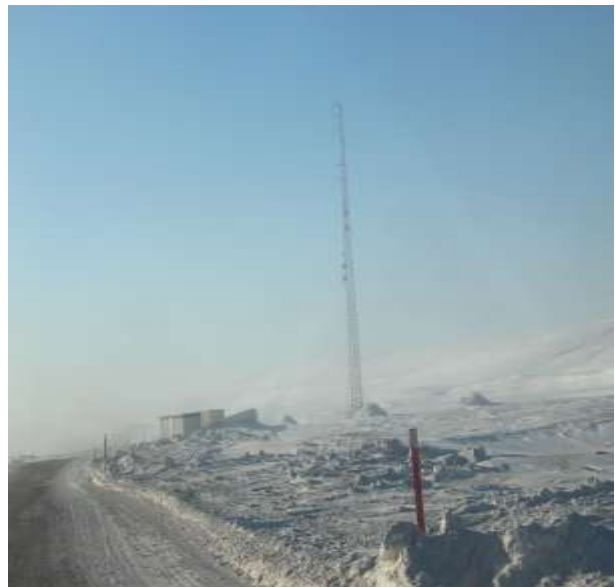
Picture 36: Communication tower along Tote Road

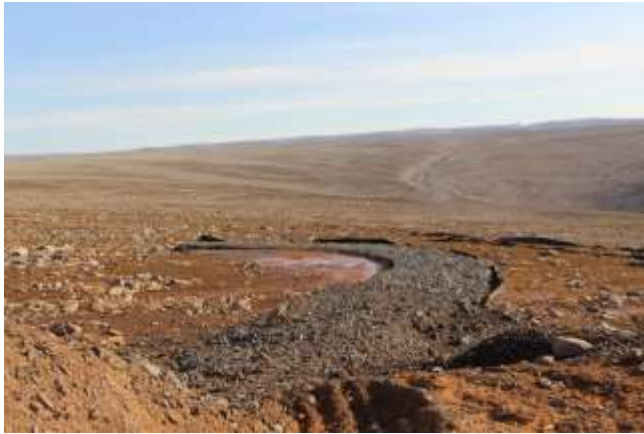
During previous site visits in 2015 and 2016 respectively, the Monitoring Officer noted the emplacement of several check dams along the Haul Road for controlling the flow of site contact water into the adjacent tundra, and were noted again during this current visit after being hidden by snow in March 2017 ([Picture 4](#)). At the Mine pit area, the Monitoring Officer noted three (3) drilling rigs (not in operation during the visit) and a mining bench with holes preparing for blasting ([Picture 6](#)).

Picture 4: Check dam and silt fences beside Haul Road

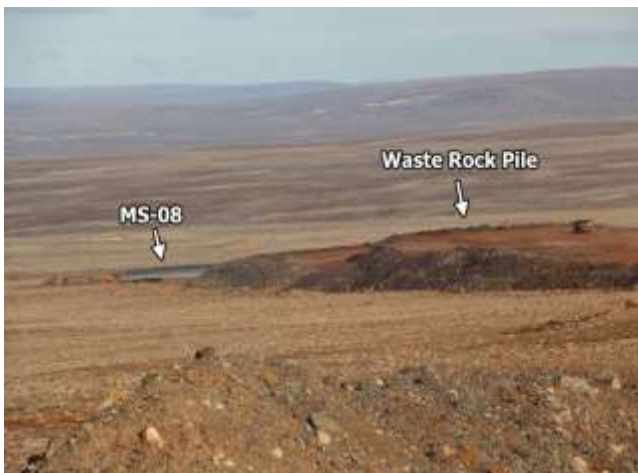
Picture 8: Waste Rock Pile

After leaving the Mine pit area ([Picture 7](#)), the NIRB staff observed the adjacent waste rock site, an area designated for the disposal of potentially acid generating (PAG) rocks ([Picture 8](#)). During the 2016 site visit, the Monitoring Officer observed that the waste rock storage area lacked appropriate water management structures to properly divert or intercept overland runoff from the waste rock dump, and as a result the NIRB's 2016 Recommendation 16 specifically requested that Baffinland clarify why the mitigation measures for managing site contact water, as committed to within the FEIS of the Mary River Project and Addendum to the FEIS for the ERP, were not in place. In responding to the Board's recommendation, Baffinland reported that it subsequently completed the construction of a waste rock sedimentation pond ([Picture 9](#)) and a ditching system ([Picture 10](#)) adjacent to the waste rock storage area immediately after the 2016 site visit, and that new structures were onsite to direct most of the runoff from the waste rock stockpile to the sedimentation pond.

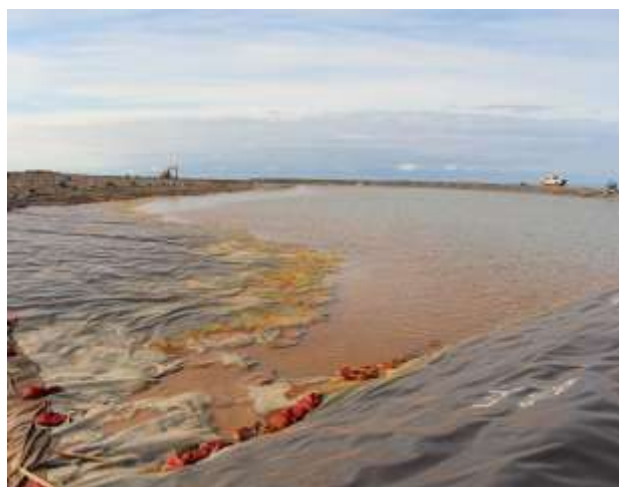
Picture 9: MS-08 Sedimentation Pond

In the March 2017 site visit, the area of the ditch and sedimentation pond (MS-08) was covered in snow preventing close examination. Prior to the August 2017 site visit, MS-08 had been the subject of concern as per the Qikiqtani Inuit Association and Environment and Climate Change Canada inspections as not being adequate to contain contact water. Therefore, Baffinland had constructed emergency ditches to contain the seepage/overflow and intercept water not being diverted into MS-08 ([Picture 11](#)). In the August 2017 site visit it was noted that there were structural deficiencies in the pond design which would cause the pond to overflow, and that two (2) pumps were in place (but not operational) to pump excess water out of the pond. ([Picture 12](#)).

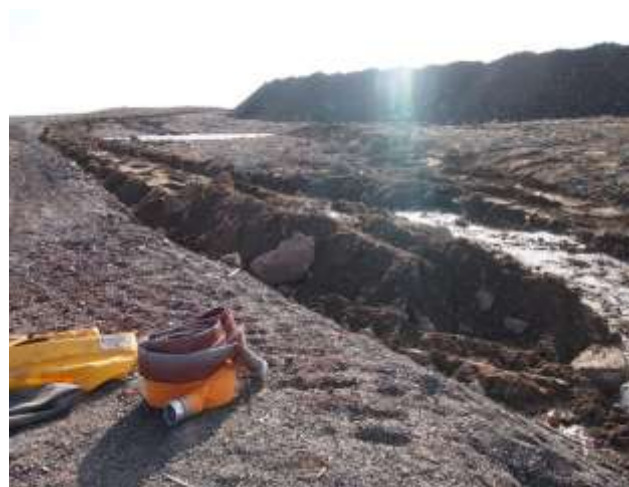
Picture 10: MS-08 Ditching

Baffinland staff indicated that it was making effort to redevelop the ditches in the western portion of the facility in order to more efficiently intercept seepage and prevent further flow of untreated contact water onto the tundra. Also observed at MS-08 were scarecrows ([Picture 13](#)) intended to discourage birds from using the sedimentation pond. Baffinland staff reported that they had proven successful in keeping birds away from the pond.

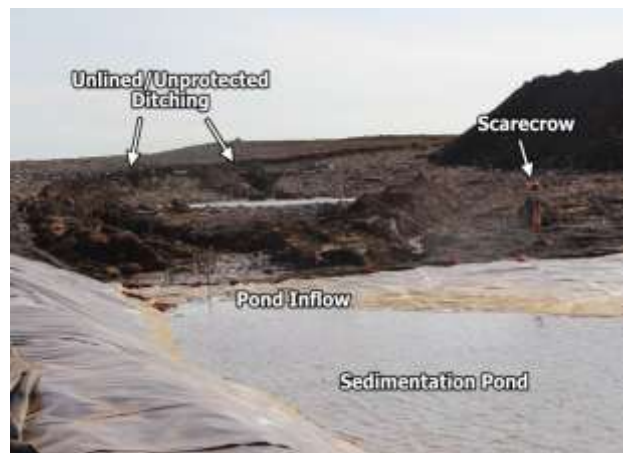
Picture 13: MS-08 Pond inflow and scarecrow

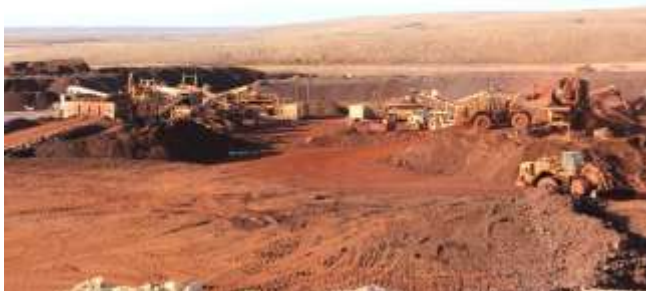
Picture 15: Crusher Plant

The dust emission observed from the crusher plant ([Picture 14](#)) during the August site visit appear to have improved compared to previous site observations in 2015, 2016, and March 2017 ([Picture 15](#)). As discussed in the March 2017 site visit, between NIRB site visits Baffinland installed the shrouds at the crusher plant's transfer points ([Picture 16](#)), hoods over the crusher jaws, and lowered the height of drop for trucks dumping ore to reduce the generation of dust plumes (see Pictures 5 and 6 of the Winter 2017 Site Visit Report). Baffinland staff indicated a dustfall measuring station had been installed to monitor dust generated at the crusher pad. During the August 2017 visit, trucks were observed delivering ore, and ore being processed through the facility. A water truck used for dust control was also observed.

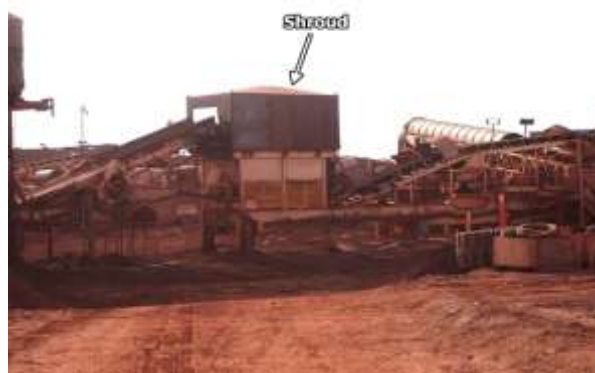
Picture 16: Transfer point shroud

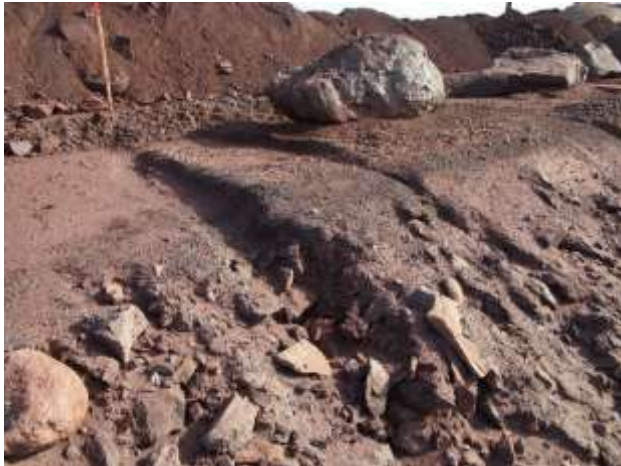
Observation of the MS-06 sedimentation pond indicated the pond had been filled to capacity, as had been reported by Baffinland, and was of insufficient size to contain the amount of runoff required ([Picture 19](#)). Further, it was observed that the ditch used to intercept runoff and direct it to the MS-06 sedimentation pond had no lining or other erosion control measures to maintain it, and that sections of the pad were eroding into the ditch ([Picture 20](#)). Some portions of the ditches were becoming blocked due to the expansion of the pad having pushed material into the ditch as well as the deposition of material carried off the pad due to erosion ([Picture 21](#)).

Picture 20: Erosion of Crusher Pad

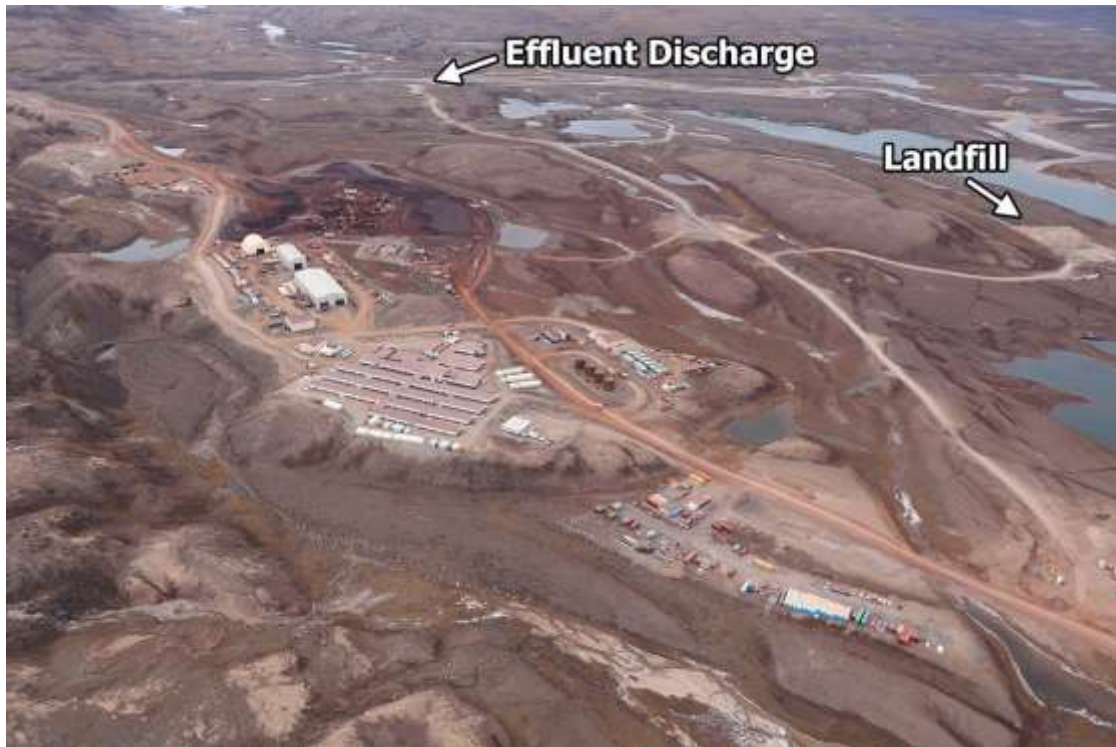
Picture 22: Landfill and Effluent Discharge Locations

NIRB staff also took a tour around the landfill site ([Picture 22](#)) in order to follow-up on the recurring issues noted during previous site observations pertaining to the deterioration of the landfill litter fences. In the 2016 and March 2017 site visits, it was noted that fencing mesh had been removed from the supporting poles, and that Baffinland had not implemented the recommendations of the NIRB made in 2014, 2015, and 2016 regarding the maintenance of fencing surrounding the landfill to retain wind-blown debris. As had been noted during the March 2017 visit, the landfill was lacking fencing with only a small section of wooden fencing providing any means of containing wind-blown debris ([Picture 24](#) and [26](#)). No improvement in the fencing in comparison to the March 2017 site visit was observed.

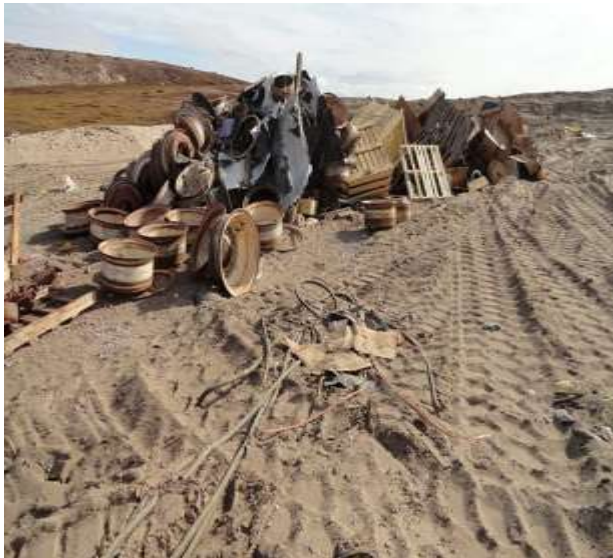
Baffinland indicated that the landfill had begun a second lift and noted its intent to request an expansion of the landfill site. As in previous site visits, the Monitoring Officer noted to Baffinland staff the continuing concern of the NIRB regarding the lack of appropriate fencing.

Picture 25: New garbage in landfill

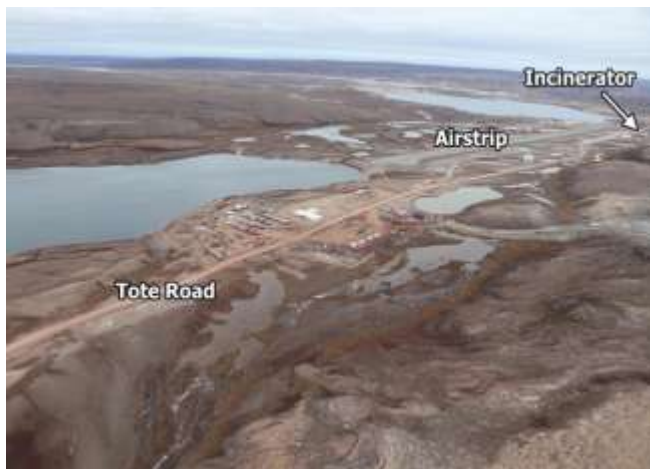
Picture 27: Location of Mary River Incinerator

Based on the previous 2016 site observations and the most recent 2017 site visit, the Monitoring Officer noted that the incinerator in use at the Mine site ([Picture 27](#)) continues to remain well maintained. The NIRB's 2016 Recommendation 21 specifically requested that Baffinland take immediate steps to remove unused scrap materials, tires and synthetic materials currently stored temporarily at various Project locations, including around the immediate vicinity of the incinerator facility, in order to improve the visual quality of the site. During the August 2017 visit, it was noted that while the area around the incinerator showed improvement in the cleanup of scrap and synthetic materials, the large pile of scrap tires remained adjacent to the incinerator. ([Picture 29](#)). It was noted that aside from the visual issue, a single large mass of tires represented the potential for causing serious and difficult to control fire should the tires to ignite. Baffinland staff stated the same concern had been raised by the Mine Rescue Team who would be responsible to responding to such an incident.

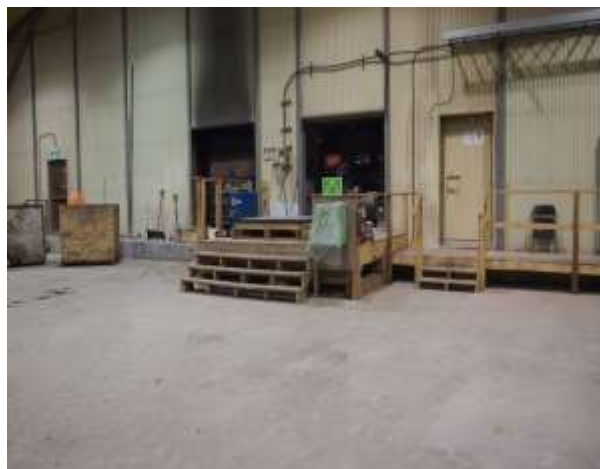
Picture 28: Mary River incinerator Interior

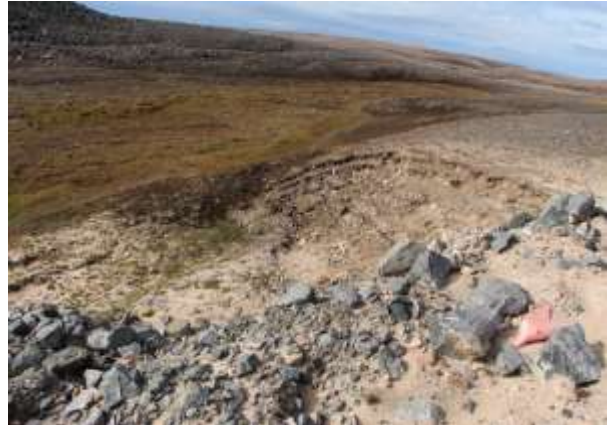
While the measures in place to reduce erosion at the effluent discharge appeared to be functioning as intended ([Picture 30](#)), it was noted in the 2016 site visit that the ground to the side of one (1) of the sewage lines was in the process of slumping due to erosion and lack of riprapping. ([Picture 31](#)). This issue remained apparent in the August 2017 site visit and had not been addressed. Visual investigation indicated that the slumping appeared to be natural and not associated with Baffinland's operations. It was suggested that Baffinland monitor the progress of the slump, if it was not already doing so, in able to monitor the progression and respond appropriately if issues should arise.

Picture 31: Slumping adjacent to discharge

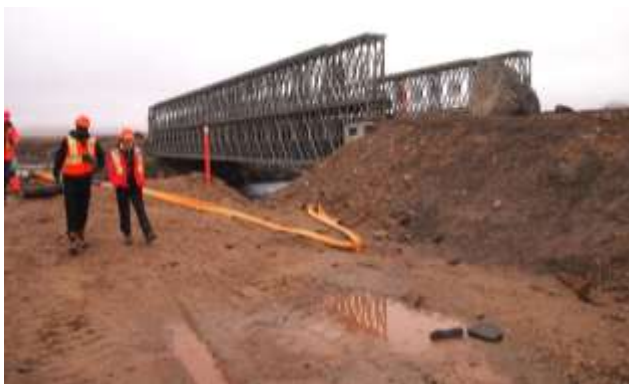
Picture 32: KM 80 Bridge

During 2017 summer site visit, the Monitoring Officer did not observe any major environmental issues along the Tote Road. Due to wet conditions at the time of the visit, dust plumes due to vehicle traffic were minimal. The Monitoring Officer also followed-up with Baffinland in regards to the removal of a CAT excavator, which had broken through the river ice in December 2016 near the km 80 bridge ([Picture 32](#)) and had not yet been removed at the time of the March 2017 visit. Baffinland confirmed the excavator had been successfully recovered. NIRB staff noted at the km 80 bridge that the seacans which had formerly made up the bridge had yet to be removed. ([Picture 33](#)) It was also observed that scrap metal from culverts that had been replaced at various locations along the Tote Road had not yet been removed and Baffinland indicated the intent to do so.

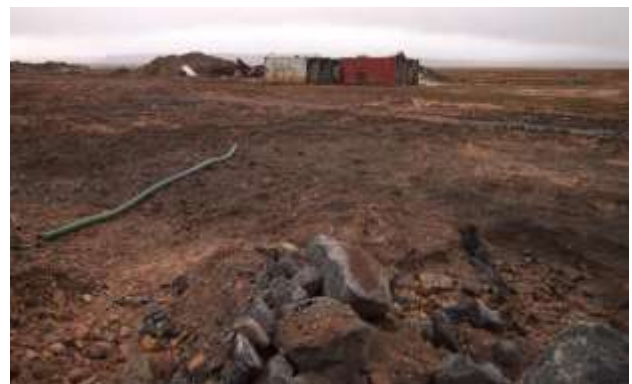
Picture 33: KM 80 Bridge seacans

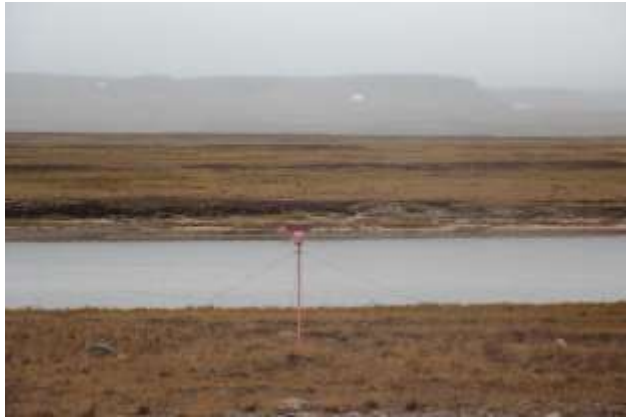
Picture 34: Dust Measuring Station, Tote Road

The unusually high levels of moisture due at the time of the visit limited the amount of dust generated by vehicles, therefore the amount of dust which would normally be generated by traffic could not be judged visually during this visit.

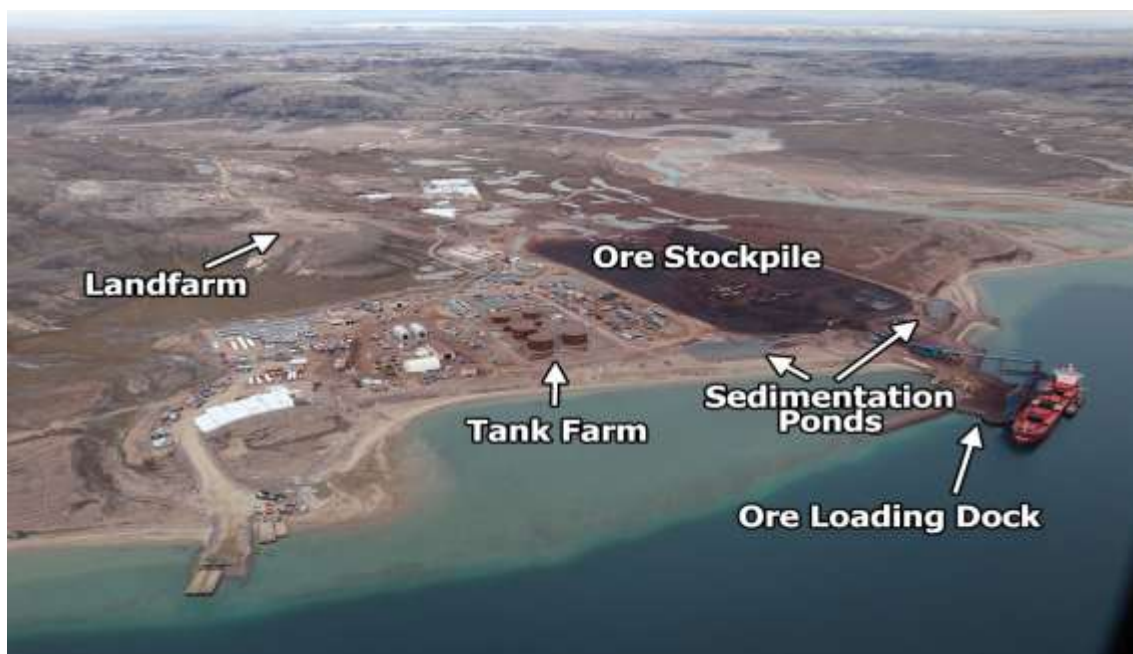
Picture 36: Milne Port

Mr. Knight led the tour of Milne Inlet ([Picture 36](#)). During the August 2017 site visit, the loading of an ore ship was in progress ([Picture 37](#)).

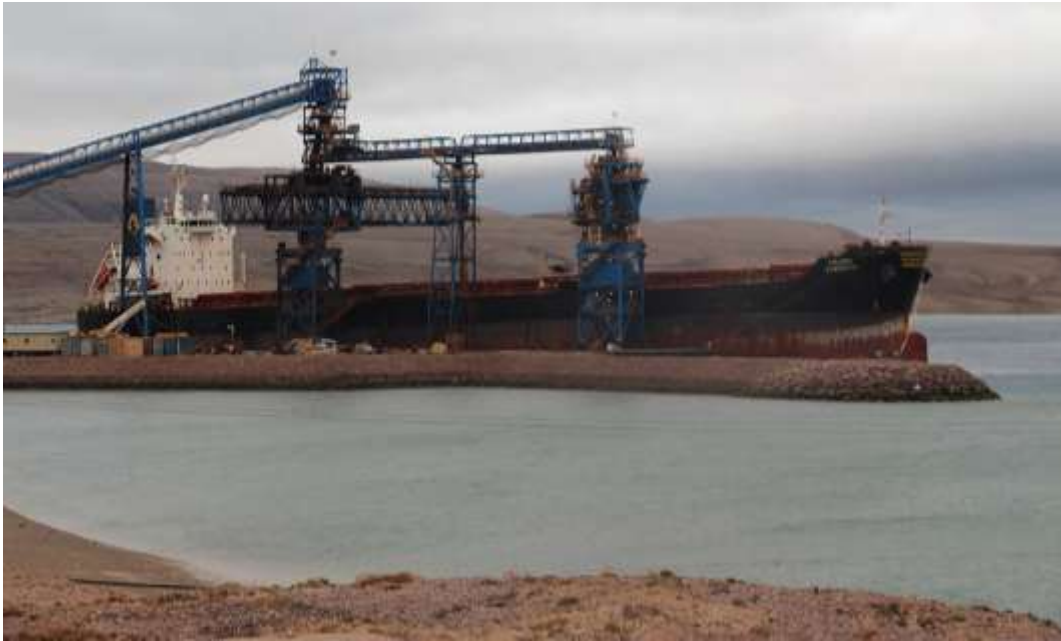
Picture 37: Ship Loading at Milne Port Ore Dock

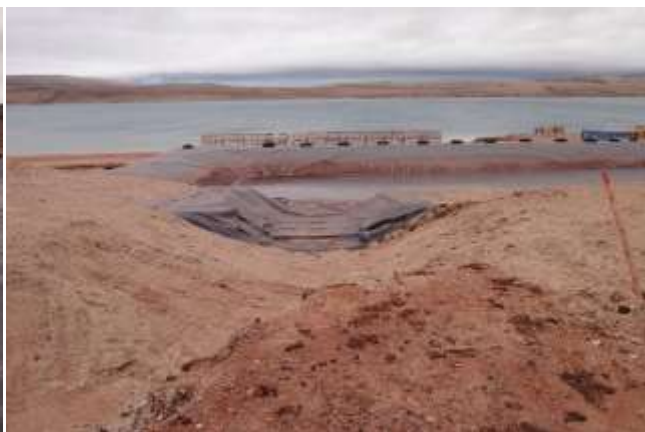
The sedimentation ponds located on the east ([Picture 38](#)) and west sides ([Picture 39](#)) of the ore stockpile pads were noted as having deposited sediment below the level of the surroundings berms indicating that they were of sufficient size to deal with the amount of runoff water currently present; however, the east pond was near capacity indicating it would be insufficient to deal with the quantities of water present during freshet. The ditch feeding the western pond showed a lack of protection against erosion ([Picture 40](#)) and observation of the ditch seemed to indicate that study of the grade of the ditch should be assessed in order to allow for water flow into the pond ([Picture 41](#)). It was suggested that Baffinland confirm that the ditch had a proper grade and consider some form of protection be applied to the sides of the ditch to prevent erosion which could dam water flow.

Picture 39: Stockpile West Pond

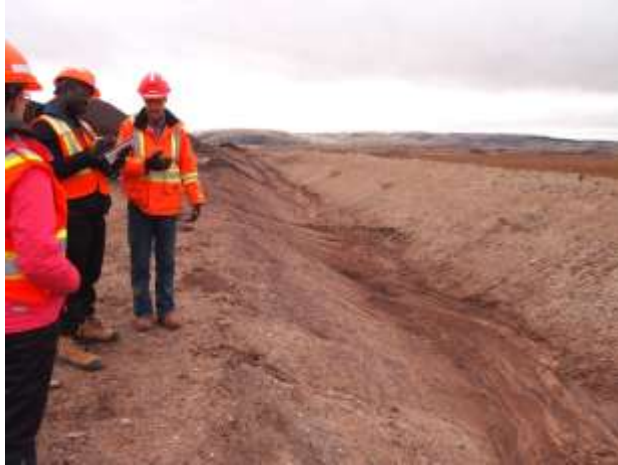
Picture 40: Ditch with no erosion protection

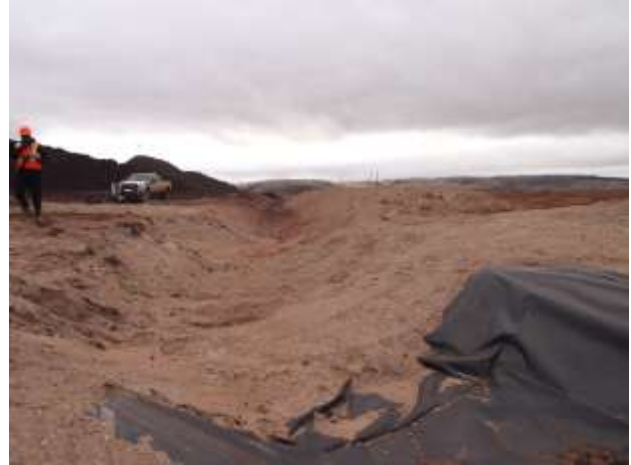
Picture 41: Looking up ditch

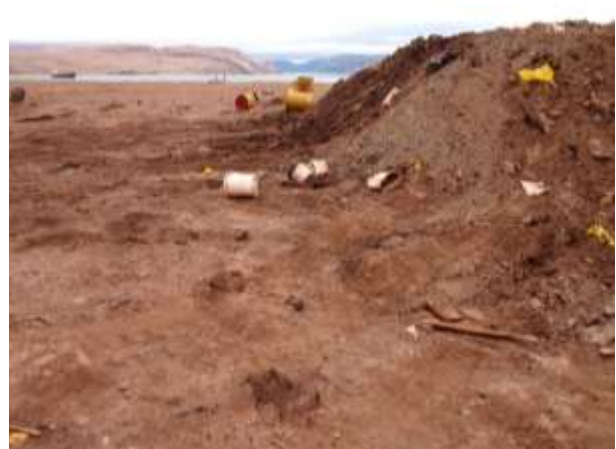
Since 2014, the Monitoring Officer consistently reported on the deteriorating condition of the landfarm facility, and has raised concerns that the disposal synthetic liners, contaminated snow and soils have not been properly managed in accordance with industry best practices. The NIRB's 2016 Recommendation 20 specifically requested that Baffinland implement best practices for landfarm operations, including for management of contaminated snow, waste synthetic liners, including used tires. At the time of this visit the landfarm showed some minor improvement compared to the March 2017 visit and significant improvement to that of the 2016 site visit; however, liner material continued to be observed to remain in the landfarm, as well as refuse such as plastic buckets and barrels ([Pictures 42, 43, and 44](#)). The waste water holding pond within the landfarm similarly had garbage and debris in it such as used petroleum containment booms and a portable spill berm ([Picture 45](#)).

Picture 43: Landfarm debris

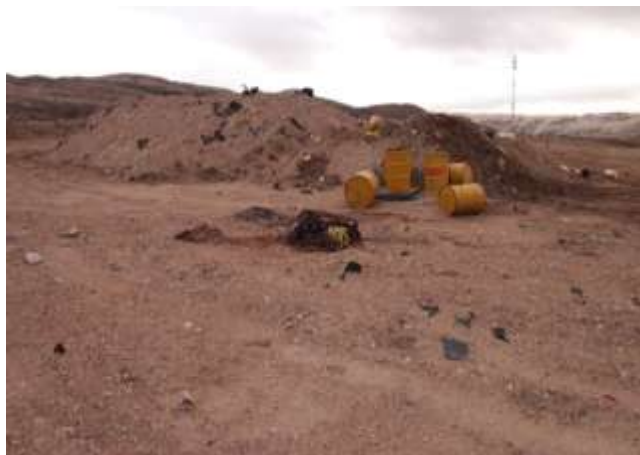
Picture 44: Barrels in landfarm

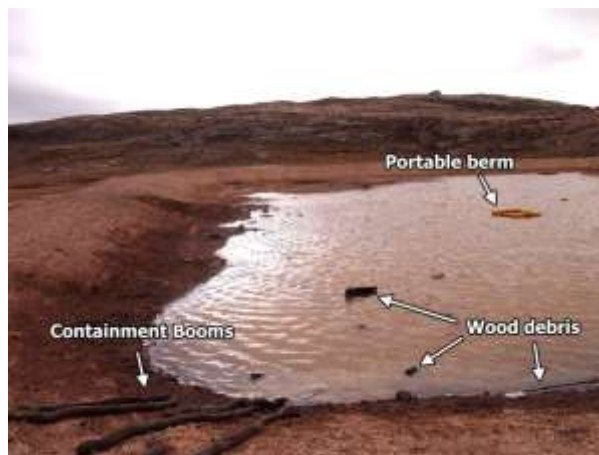
Picture 45: Debris in landfarm pond
