ROAD CV-0-0A

LOCATION AND CROSSING DESCRIPTION

**BAFFINLAND IRON MINES
MARY RIVER PROJECT**

North/South Consultants Inc.
Aquatic Environment Specialists

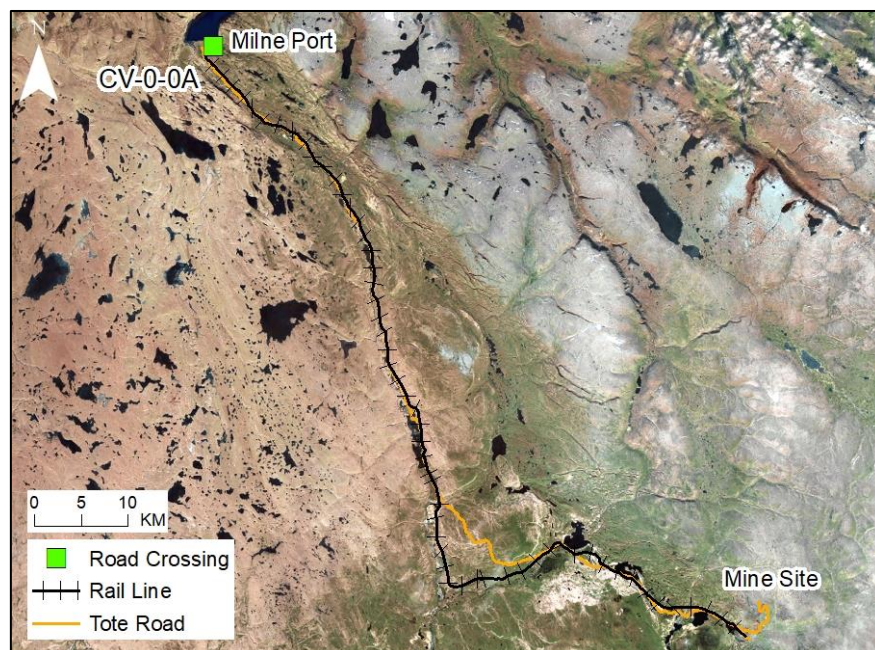
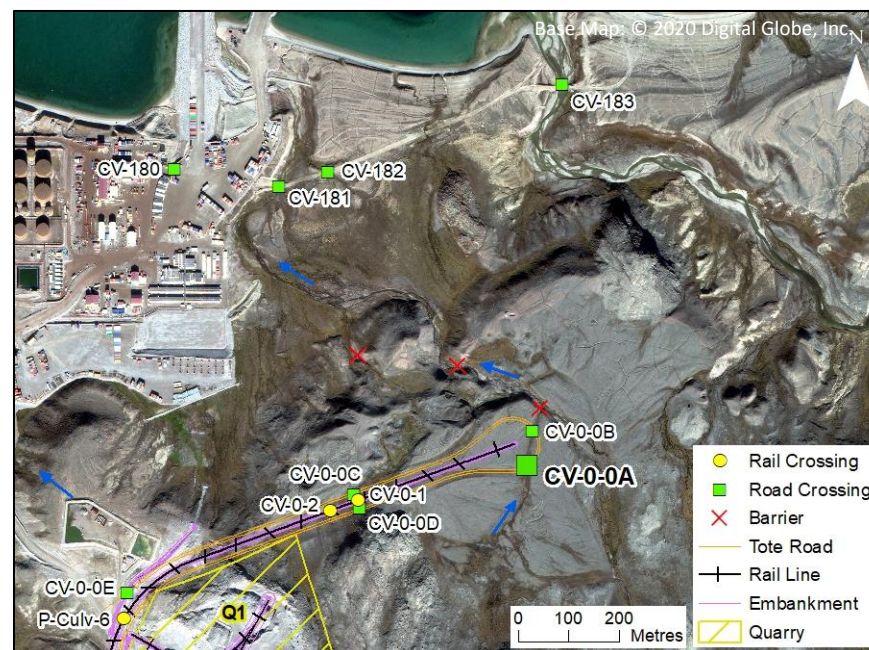
The access road loop at the northern terminus of the North Rail crosses a headwater stream at two locations. The crossing at CV-0-0A is located 60 m upstream of crossing CV-0-0B. This stream flows north into Milne Inlet approximately 1.4 km downstream. At the crossing location, the stream is only a small meltwater channel at the top of a plateau, which was dry at the time of the spring 2019 survey.

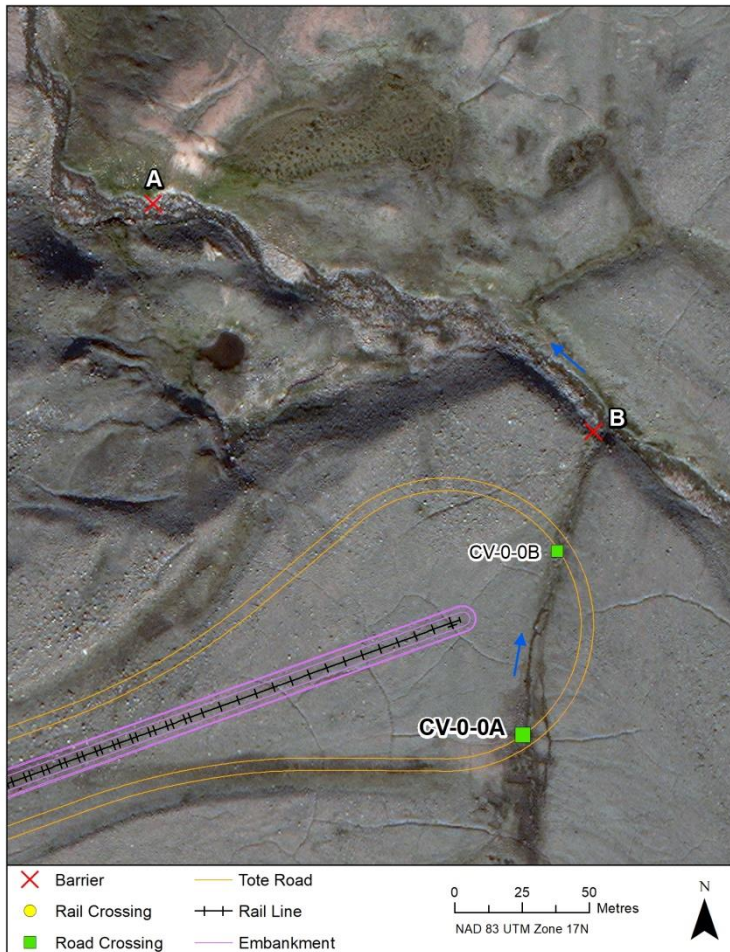
Upstream/ Downstream	UTM		Barrier Type			Height (m)	Gradient (°)	Description	Site Label
	Easting	Northing	1	2	3				
Downstream	504487	7975861	HG				10	Permanent Barrier: gradient increases from 10-20 degrees moving upstream from this location	A
Downstream	504651	7975776	VD	HG		2.0	20	Permanent Barrier: high gradient (dry at time of assessment)	B
