# PORT SITE P-CULV-5

**BAFFINLAND IRON MINES  
MARY RIVER PROJECT**

**North/South Consultants Inc.**  
Aquatic Environment Specialists

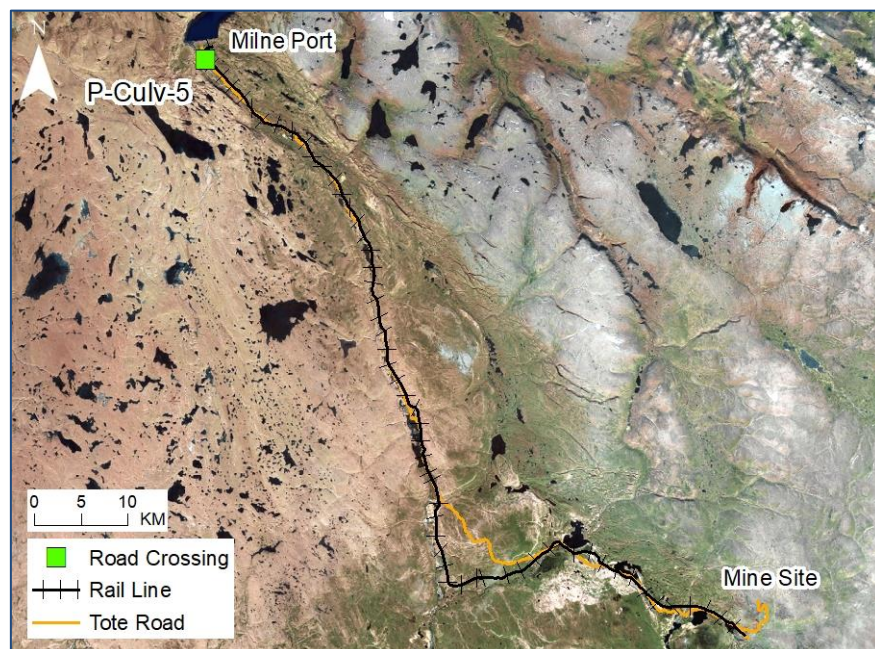
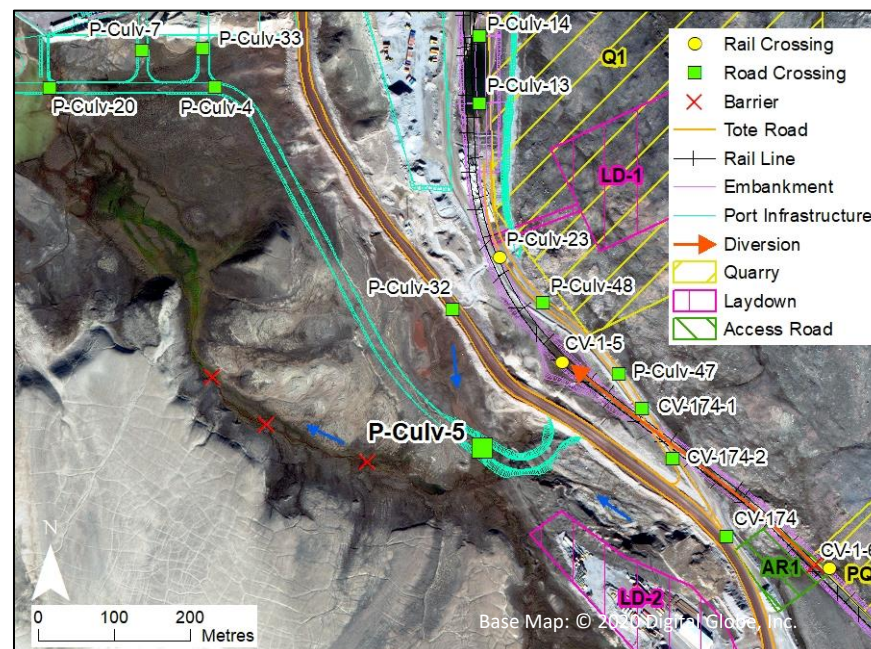
Site P-Culv-5 is a culvert installation and partial pond infill on a proposed access road at the port site. The site receives water from two branches; the north where it is crossed by P-Culv-32 and the southeast where it is crossed by the Tote Road at CV-174 and the rail at CV-1-6 with a proposed access road corridor (AR1) between the two that includes a portion of this branch. The pond infill is on the north branch at its confluence with the southeast branch. This stream is the inflow to the pond at P-Culv-20, approximately 1 km to the northwest. The stream channel is relatively poorly defined with flows often diffuse over terrestrial vegetation. The pond infill area is shallow (<0.20 m), with fine substrate with occasional small cobble.

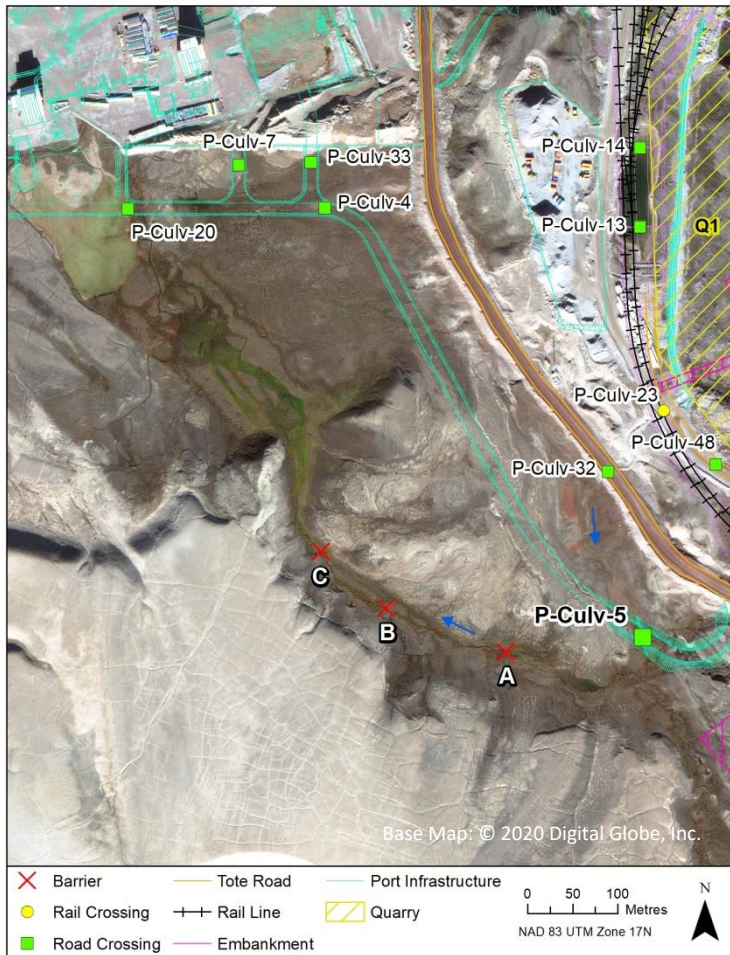
There are several small vertical drops downstream that combine with shallow water to act at least as seasonal barriers to fish movement in the stream. In addition, there is no surface water outflow of the downstream pond at P-Culv 20 and no connectivity with Phillips Creek/Milne Inlet. Barriers downstream and lack of connectivity to overwintering habitat prevent fish use of habitat at P-Culv-5.

Upstream/ Downstream	UTM		Barrier Type			Height (m)	Gradient (°)	Description	Site Label
	Easting	Northing	1	2	3				
Downstream	503680	7974206	VD	SHALL		0.2		Potential permanent barrier: Small vertical drop with shallow water	A
Downstream	503547	7974255	VD	SHALL		0.2		Potential permanent barrier: Small vertical drop with shallow water	B
Downstream	503475	7974318	VD	SHALL		0.45		Potential permanent barrier: Moderate vertical drop with shallow water	C

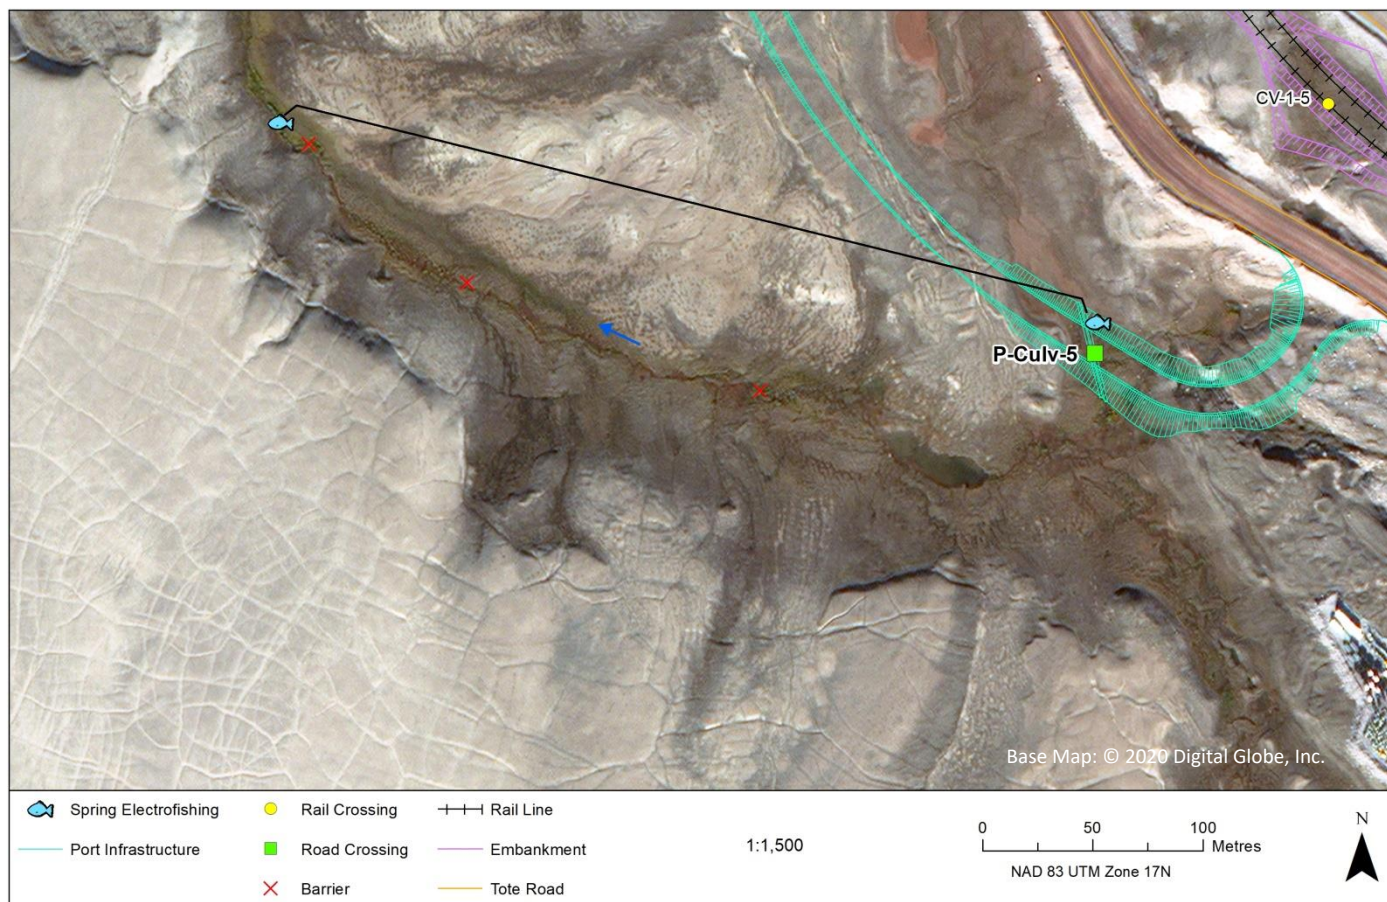
## FISHING SITES

Most of this stream had insufficient depths for electrofishing in spring 2019. Deeper pools among the terrestrial vegetation were fished. No fish were observed or captured. There is no connectivity to overwintering habitat and the site is not fish-bearing.
