RAIL CV-107-3

LOCATION AND CROSSING DESCRIPTION

BAFFINLAND IRON MINES
MARY RIVER PROJECT

**North/South Consultants Inc.**
Aquatic Environment Specialists

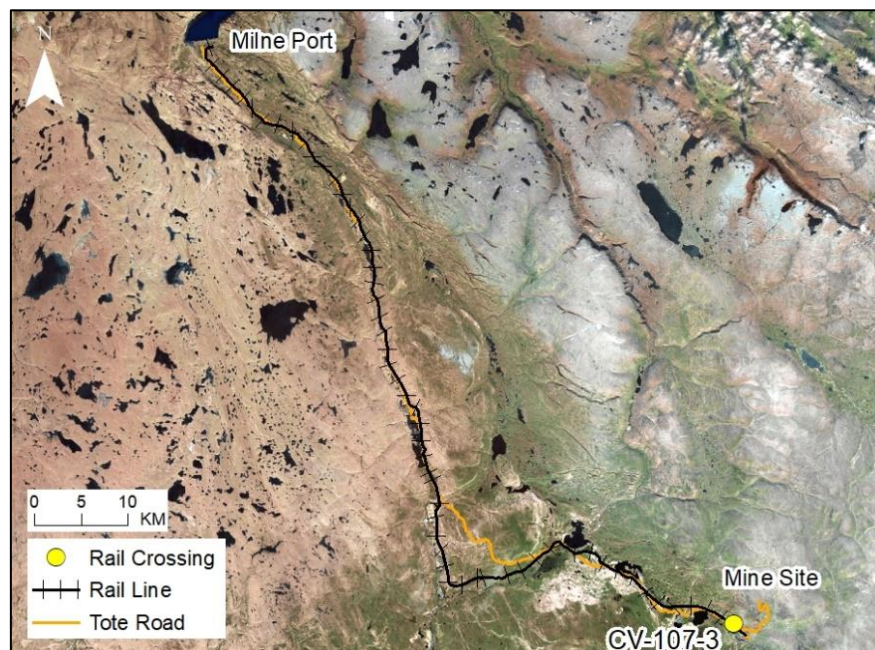
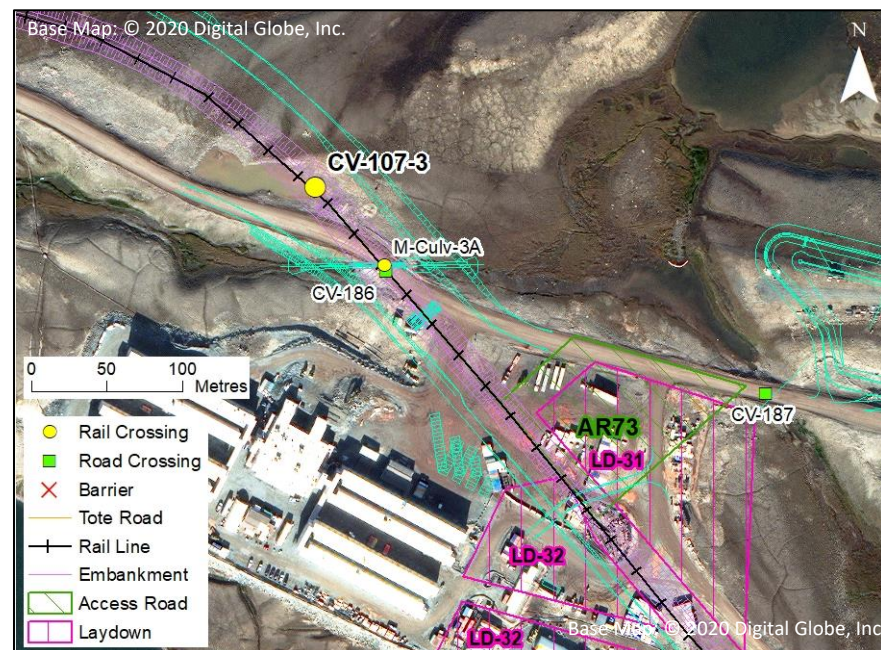
The rail crosses and infills a portion of a shallow (approximate maximum depth 0.5 m), turbid, isolated roadside pond that was a former borrow pit at site CV-107-3. The pond lacks an inflow and outflow and does not provide fish habitat.
