RAIL CV-108-3

LOCATION AND CROSSING DESCRIPTION

**BAFFINLAND IRON MINES
MARY RIVER PROJECT**

North/South Consultants Inc.
Aquatic Environment Specialists

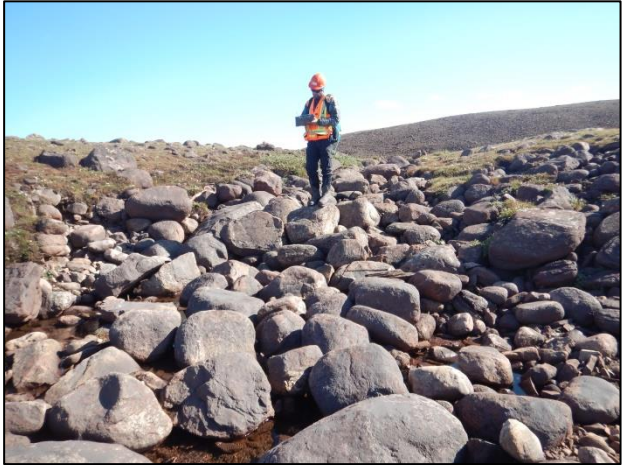
| Upstream/ Downstream | UTM | | Barrier Type | | | Height (m) | Gradient (°) | Description | Site Label |
|---|---|---|---|---|---|---|---|--|---|
| Downstream | 561093 | 7912895 | VD | HG | B | 0.55 | 15 | Permanent Barrier: Upper end of long barrier | A |

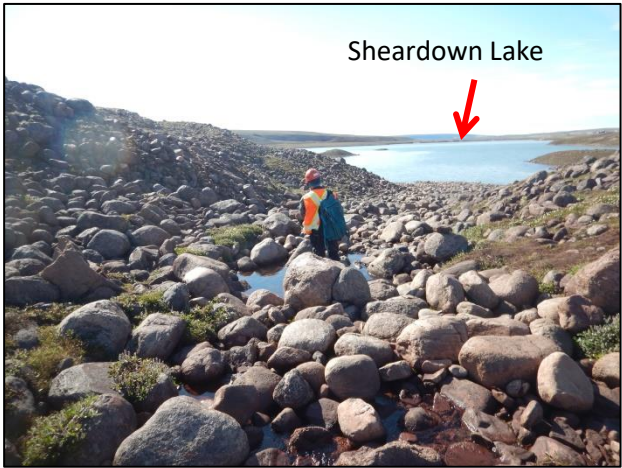
| Upstream/ Downstream | UTM | | Barrier Type | | | Height (m) | Gradient (°) | Description | Site Label |
|---|---|---|---|---|---|---|---|--|---|
| Downstream | 561025 | 7912966 | B | | | | | Permanent Barrier: Lower end of long barrier | B |
