RAIL CV-109-1

**BAFFINLAND IRON MINES
MARY RIVER PROJECT**

**North/South Consultants Inc.**
Aquatic Environment Specialists

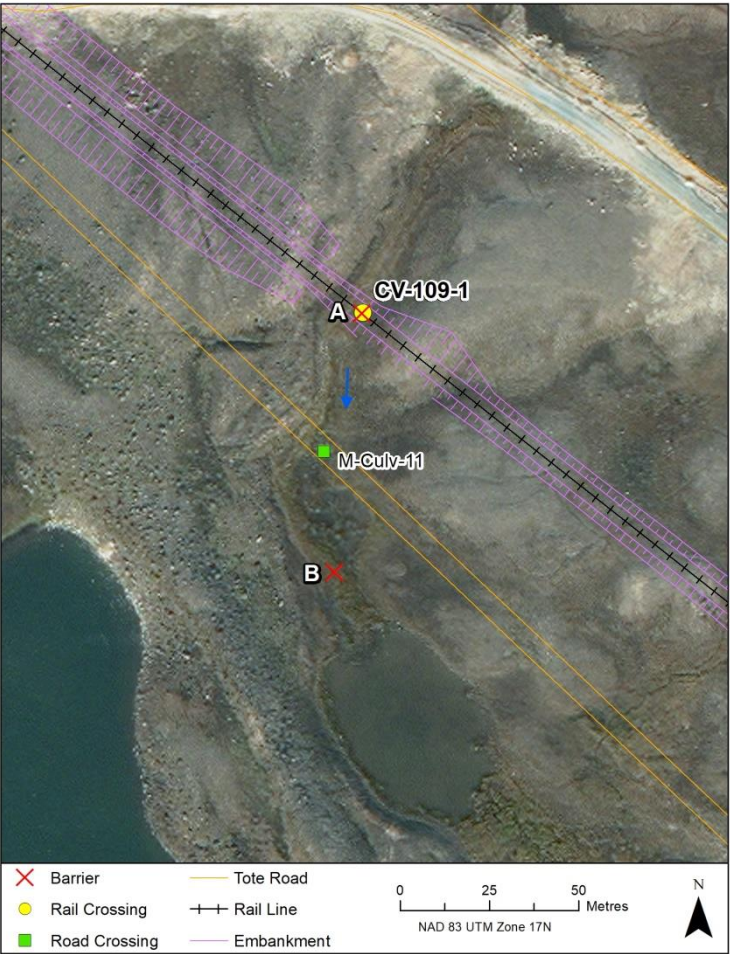
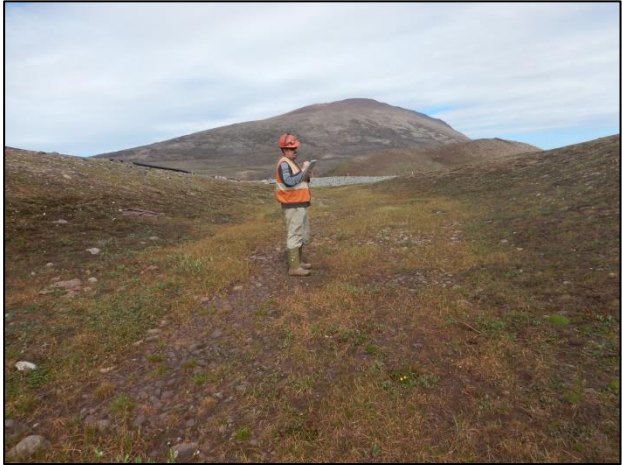
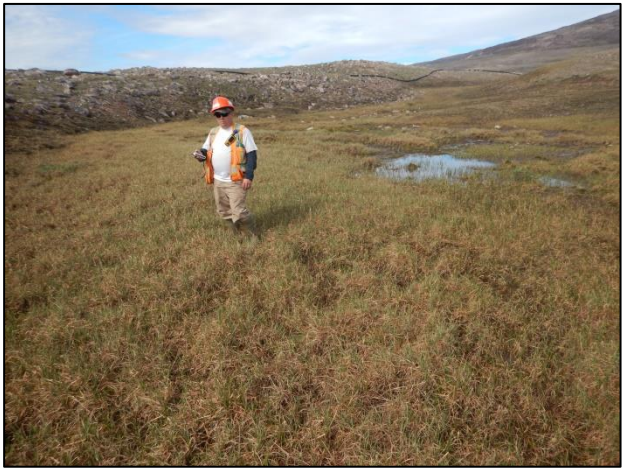
BARRIERS

Upstream/ Downstream	UTM		Barrier Type			Height (m)	Gradient (°)	Description	Site Label
	Easting	Northing	1	2	3				
Downstream	561860	7912344	SSF					Permanent Barrier: No surface water or channel at crossing and downstream	A
Downstream	561852	7912271	SSF					Permanent Barrier: Berm of terrestrial material obstructing surface flow	B
