# ROAD M-CULV-2A

**BAFFINLAND IRON MINES  
MARY RIVER PROJECT**

**North/South Consultants Inc.**  
Aquatic Environment Specialists

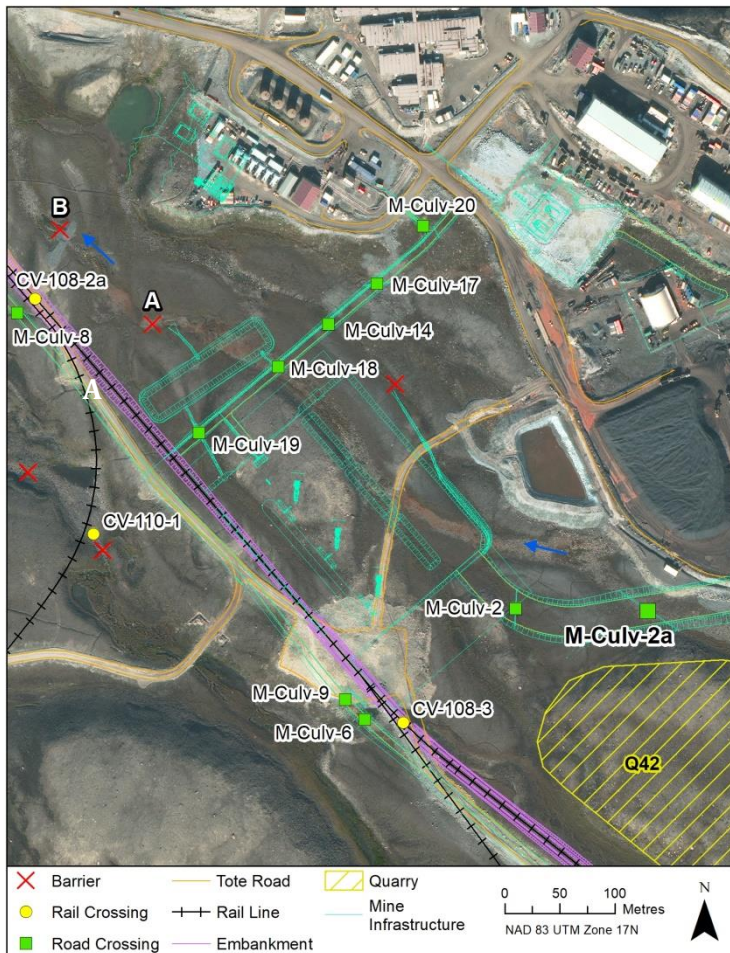
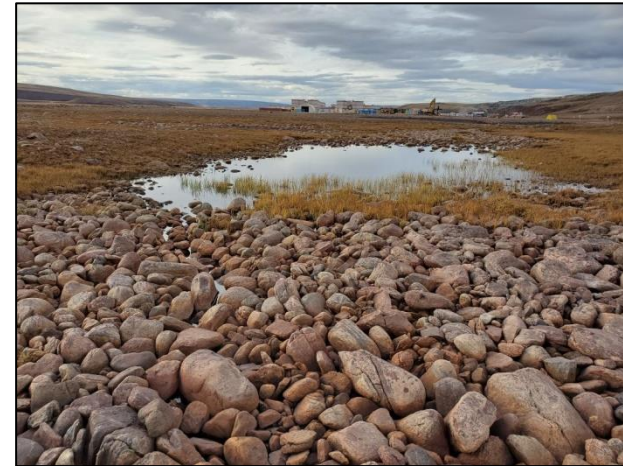
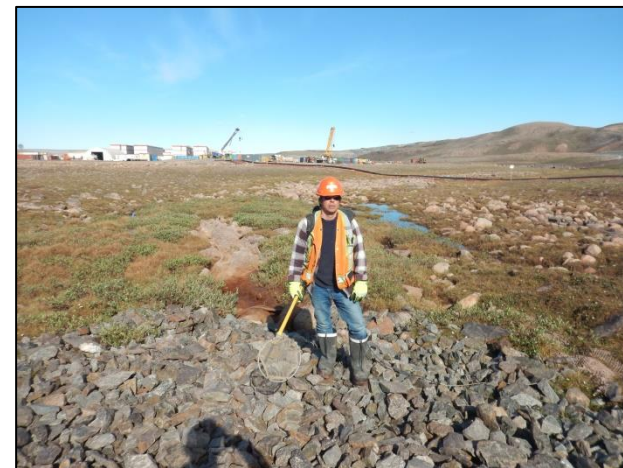
Upstream/ Downstream	UTM		Barrier Type			Height (m)	Gradient (°)	Description	Site Label
	Easting	Northing	1	2	3				
Downstream	561138	7913101	SSF					Permanent Barrier: Water flows under boulder field	A
Downstream	561054	7913187	SSF					Permanent Barrier: Existing construction footprint, no culvert, subsurface flow	B
