ROAD M-CULV-6

LOCATION AND CROSSING DESCRIPTION

**BAFFINLAND IRON MINES
MARY RIVER PROJECT**

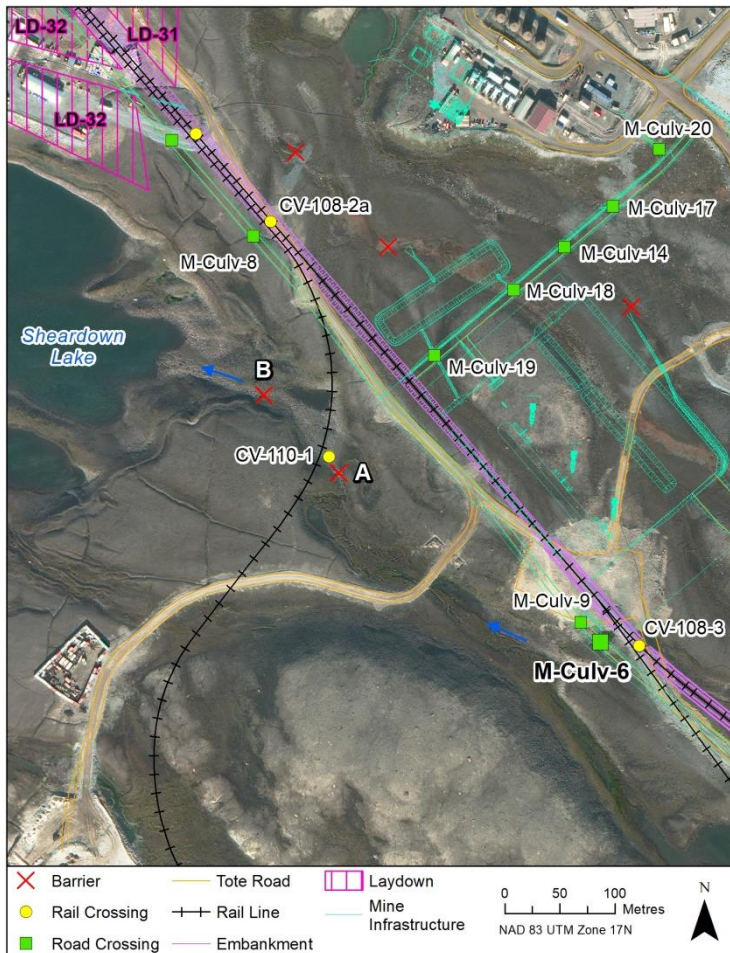
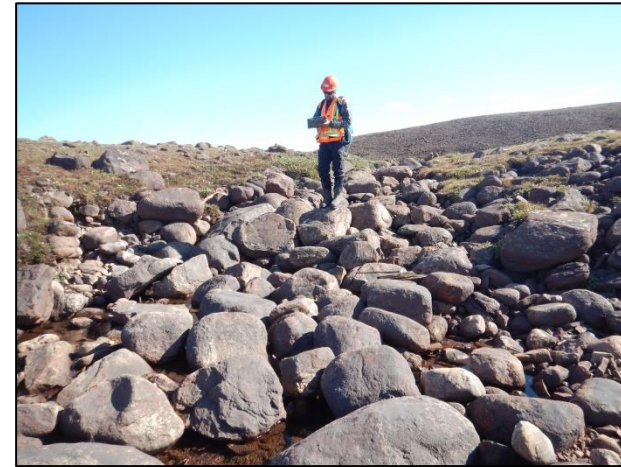
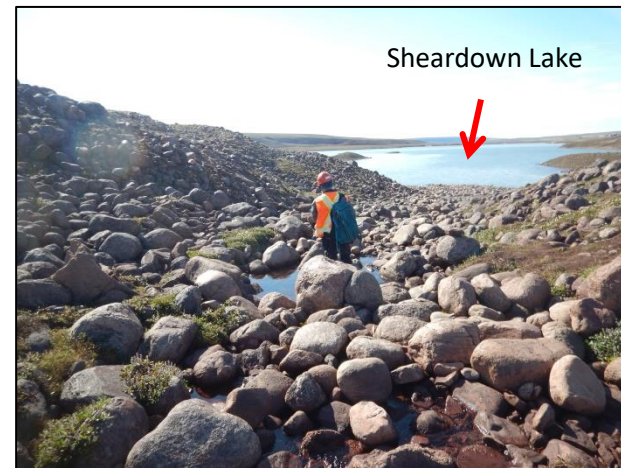
BARRIERS

Upstream/ Downstream	UTM		Barrier Type			Height (m)	Gradient (°)	Description	Site Label
	Easting	Northing	1	2	3				
Downstream	561093	7912895	VD	HG	B	0.55	15	Permanent Barrier: Upper end of long barrier	A
Downstream	561025	7912966	B					Permanent Barrier: Lower end of long barrier	B
