LOCATION AND CROSSING DESCRIPTION

27-Jun-19 Site ID: M-Culv-13 **Dates Surveyed:** Waterbody Type: Stream **Project Interaction:** Road Culvert **Centreline UTM Coordinates:** 17W 562044 E 7912124 N Culvert Length (m): 13.7 Number of Barrels: Culvert Diameter/Span (mm): 600 Slope (%): 6.3

BAFFINLAND IRON MINES MARY RIVER PROJECT

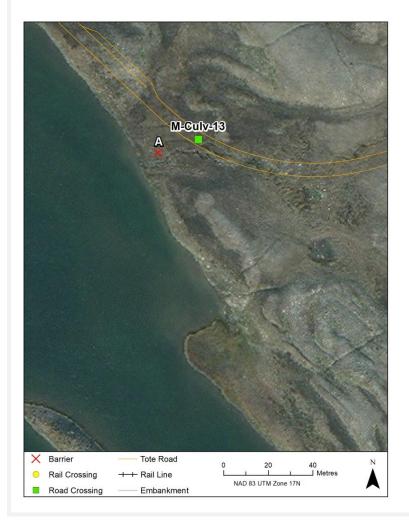
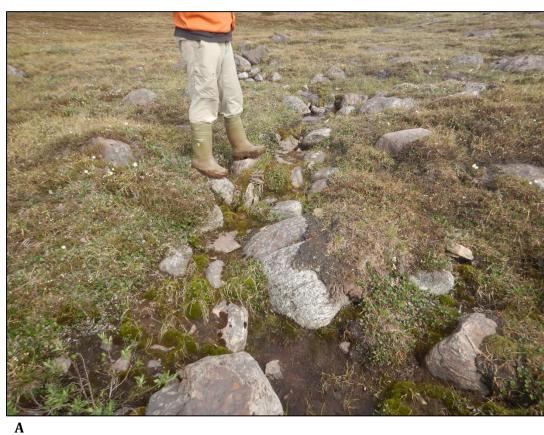
Upstream/	UTM		Barrier Type			Height	Gradient	Description	Site
Downstream	Easting	Northing	1	2	3	(m)	(°)	Description	Label
Downstream	562026	7912118	SSF					Permanent Barrier: Flow becomes subsurface at steeper point on hill.	Α

The downstream lake may have sufficient depths to support overwintering, but a downstream subsurface flow barrier prevents fish access to the M-Culv-13 site.
