LOCATION AND CROSSING DESCRIPTION

Site ID:	CV-4-3	Dates Surveyed:	15-Jun-19	Waterbody Type:	Stream
Project Interaction:	Rail Daylight + Culvert	Centreline UTM Coordinates:	17W 505842 E 7972438 N	Culvert Length (m):	12
Number of Barrels:	1	Culvert Diameter/Span (mm):	900	Slope (%):	1

BAFFINLAND IRON MINES MARY RIVER PROJECT

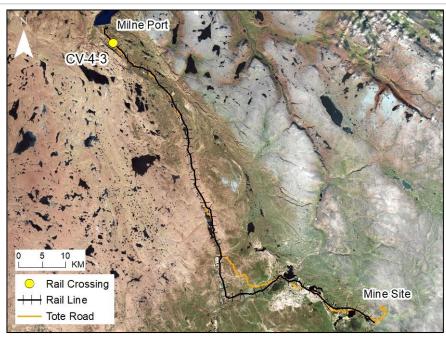
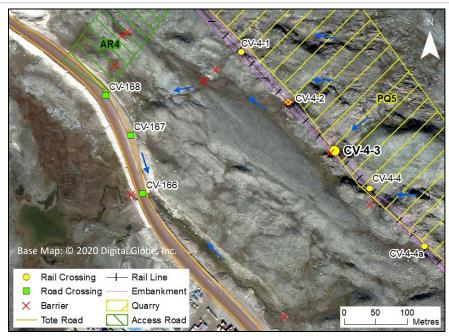
Several permanent barriers to upstream fish passage are present downstream from the centreline, including high gradient and sub-surface flow. One of these subsurface flow barriers is shared by all crossings on this drainage.

Due to the presence of permanent barriers, there is no fish habitat at site CV-4-3.
