RAIL CV-4-5

**BAFFINLAND IRON MINES
MARY RIVER PROJECT**

North/South Consultants Inc.
Aquatic Environment Specialists

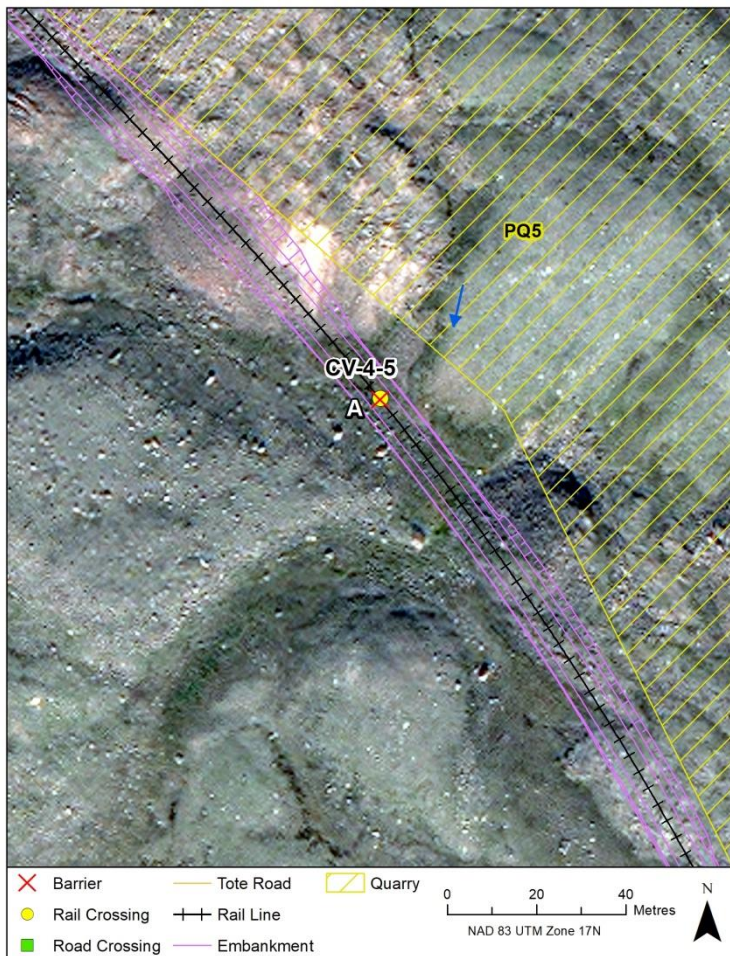
Upstream/ Downstream	UTM		Barrier Type			Height (m)	Gradient (°)	Description	Site Label
	Easting	Northing	1	2	3				
Upstream, at, and downstream	506066	7972198	SSF	HG			>10	Permanent Barrier: Subsurface flow from upstream to downstream of the crossing, leaving only a small wetted area.	A
