LOCATION AND CROSSING DESCRIPTION

Site ID: CV-8-0 **Dates Surveyed:** 16-Jun-19 Waterbody Type: Stream **Centreline UTM Coordinates: Project Interaction:** Rail Culvert 17W 508289 E 7969746 N Culvert Length (m): 24 Number of Barrels: Culvert Diameter/Span (mm): 900 **Slope (%):** 5

BAFFINLAND IRON MINES MARY RIVER PROJECT

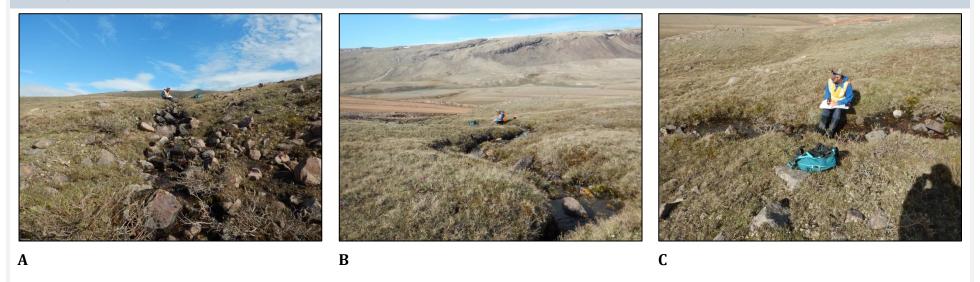
16-JUN-19

This stream does not connect to fish-bearing waters on its downstream end, and any upstream fish passage is blocked by a high gradient from the roadside ditch to the crossing. There is no fish habitat at this crossing.
