RAIL CV-8-2

LOCATION AND CROSSING DESCRIPTION

BAFFINLAND IRON MINES
MARY RIVER PROJECT

**North/South Consultants Inc.**
Aquatic Environment Specialists

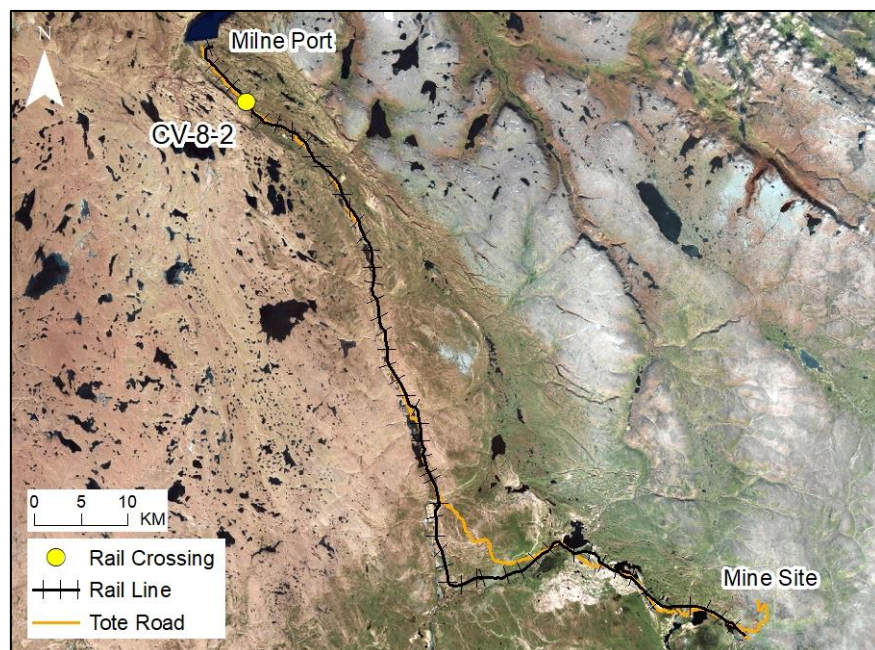
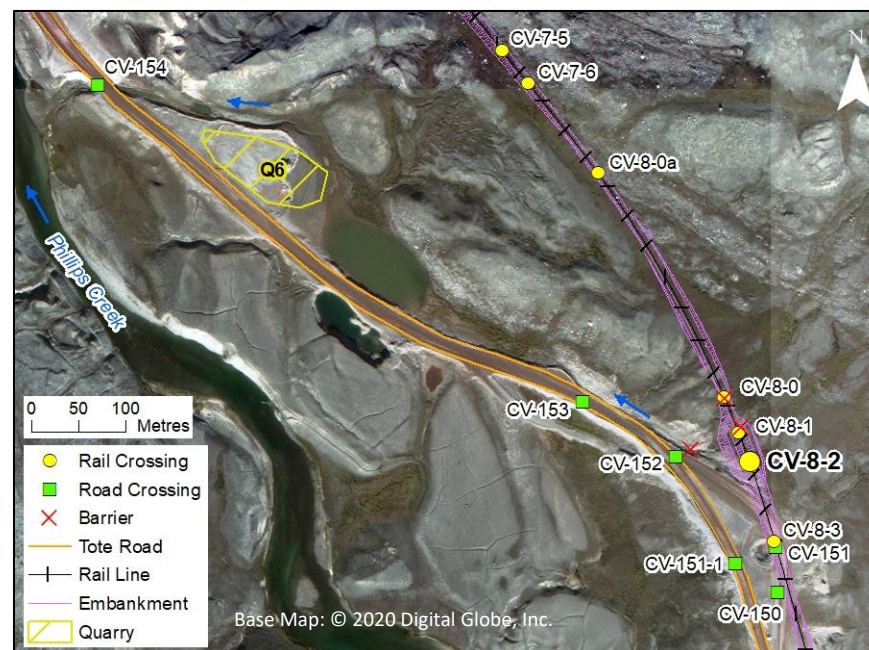
The rail crosses a drainage at site CV-8-2. The drainage consists of some permafrost slumping that created a flowpath for local snow melt on 16 June 2019, but which had completely dried up by 2 July 2019. This meltwater flows into a roadside ditch that collects surface water from the area and that diverts water towards a pond to the northwest and eventually a culvert crossings at CV-154. There are no existing culverts at CV-152 or CV-153. The drainage ditch is steep with some patches of subsurface flow under cobble creating a permanent barrier to fish passage.

There is no fish habitat at this crossing.
