RAIL CV-8-3

LOCATION AND CROSSING DESCRIPTION

BAFFINLAND IRON MINES
MARY RIVER PROJECT

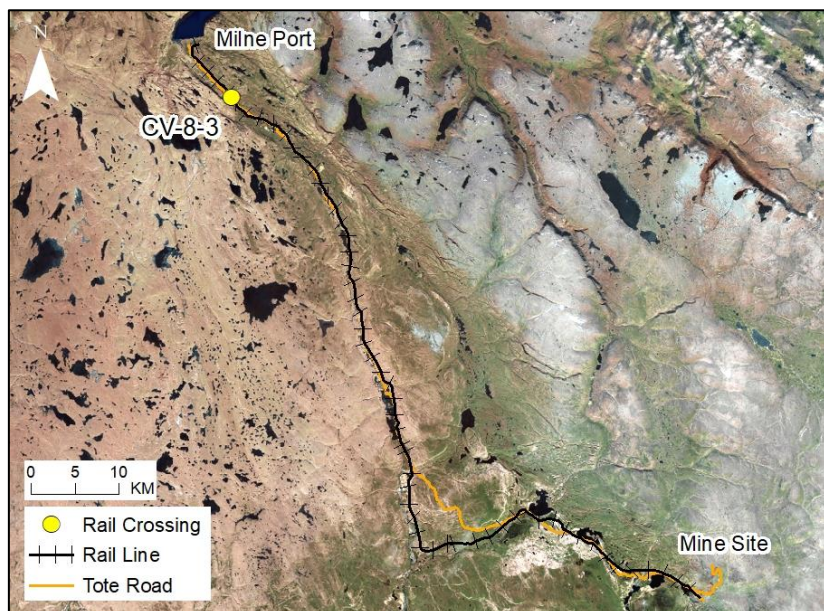
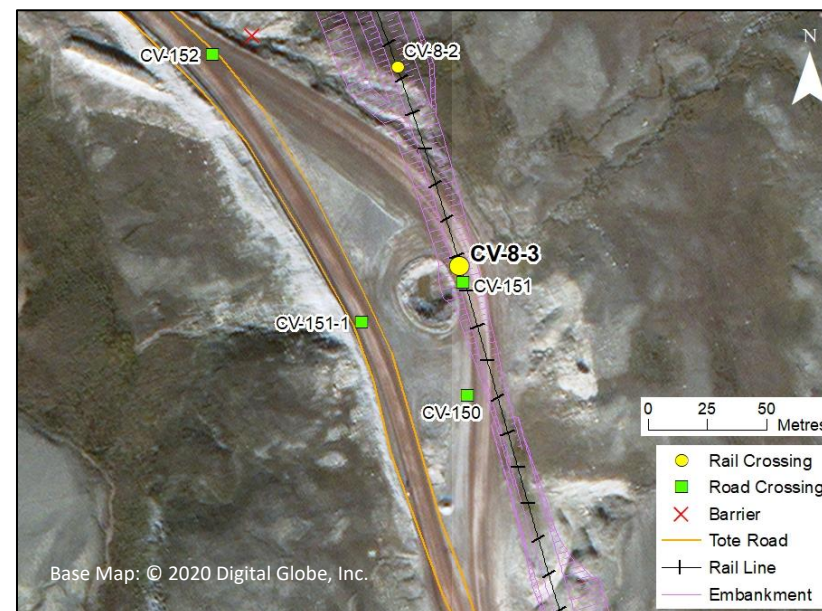
The rail overlaps with the existing Tote Road and a roadside ditch pond at CV-8-3. The pond is located between the northbound and southbound lanes of the Tote Road. The pond is a small depression in road aggregate that collects water during snow melt and precipitation. This pond had nearly dried up between 16 June and 2 July 2019. The pond is fully isolated, as there are no culverts on either section of the road.

The pond is not connected to any other waterbodies and is too shallow to support overwintering. There is no fish habitat at this site.
