RAIL CV-10-5

LOCATION AND CROSSING DESCRIPTION

Site ID:	CV-10-5	Dates Surveyed:	16-Jun-19 and 2-Jul-19	Waterbody Type:	Stream
Project Interaction:	Rail Culvert	Centreline UTM Coordinates:	17W 509853 E 7967818 N	Culvert Length (m):	30
Number of Barrels:	1	Culvert Diameter/Span (mm):	900	Slope (%):	5

**BAFFINLAND IRON MINES
MARY RIVER PROJECT**

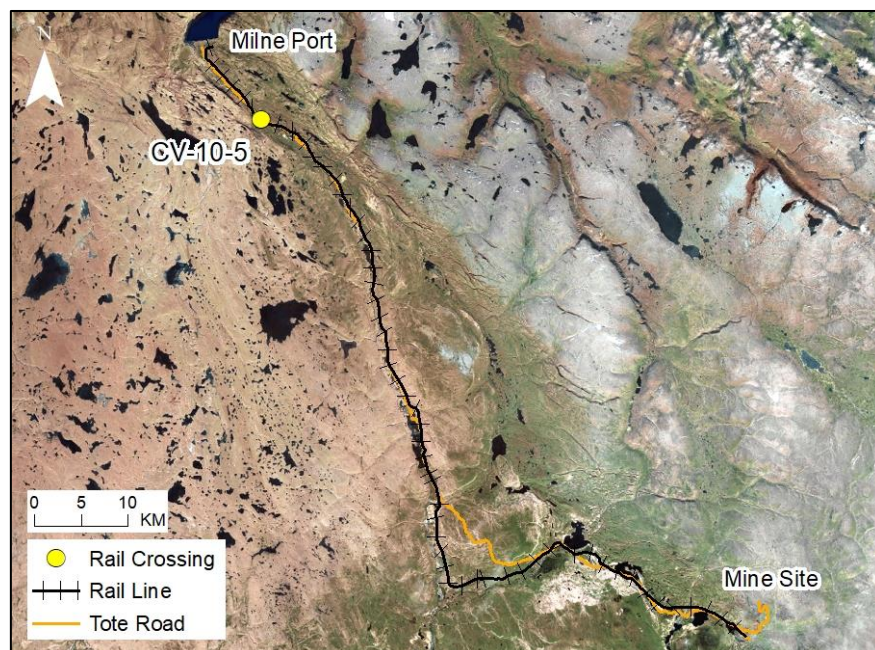
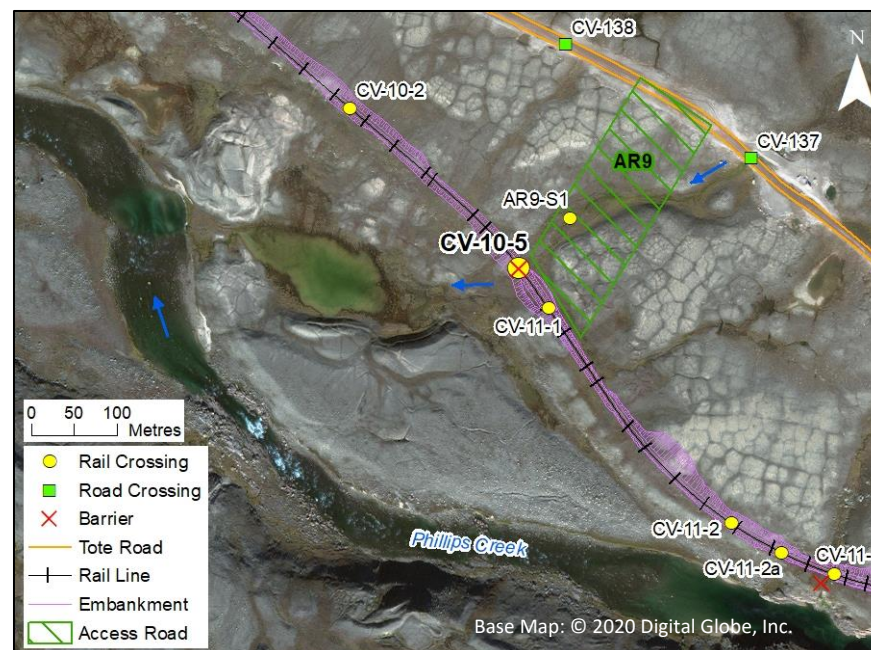
The North Rail crosses an unnamed ephemeral stream at CV-10-5 that is crossed by the Tote Road upstream at CV-137. The stream flows into a shallow pond and ultimately Phillips Creek. The channel at the crossing is very narrow (0.2 m) and was dry in spring 2019.

The rail crossing centerline is located on a steep hillside with a high gradient that acts as a permanent barrier to upstream fish passage. The steep gradient extends for at least 50 m downstream from the crossing centreline.

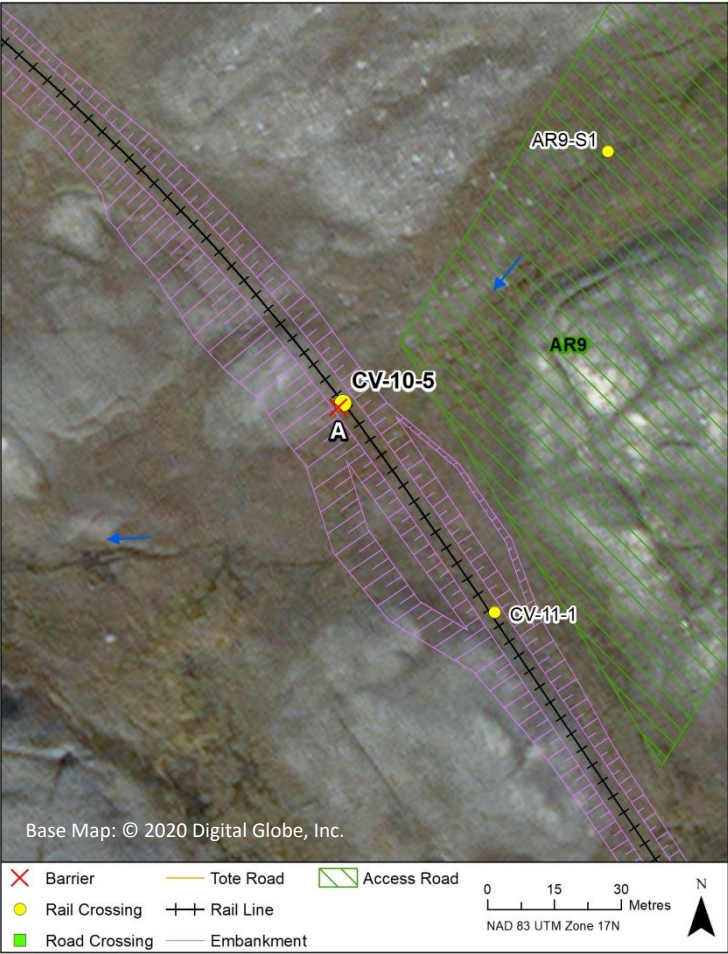
Upstream/ Downstream	UTM		Barrier Type			Height (m)	Gradient (°)	Description	Site Label
	Easting	Northing	1	2	3				
At crossing	509852	7967817	HG				13	Permanent Barrier: High gradient at and downstream of the crossing centreline extending for at least 50 m	A
