RAIL CV-15-3

LOCATION AND CROSSING DESCRIPTION

**BAFFINLAND IRON MINES
MARY RIVER PROJECT**

North/South Consultants Inc.
Aquatic Environment Specialists

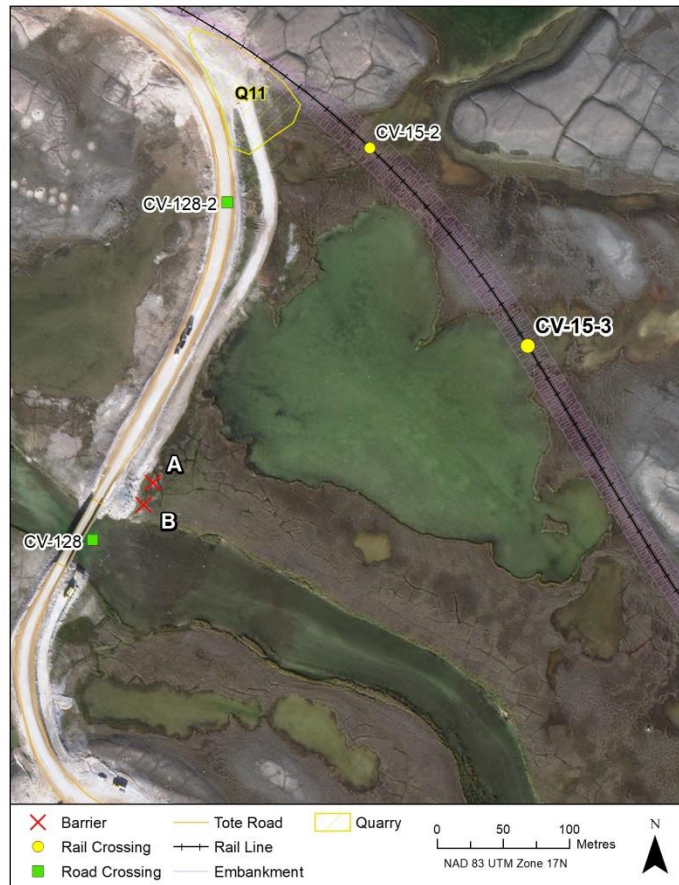
Upstream/ Downstream	UTM		Barrier Type			Height (m)	Gradient (°)	Description	Site Label
	Easting	Northing	1	2	3				
Inflowing Stream	All inflows appear to be diffuse over terrestrial habitat and not fish-bearing								
Outflowing Stream	513610	7965928	Other					Intermittent Barrier: Summer only – disconnected pools	A
Outflowing Stream	513603	7965911	B	SHALL				Intermittent Barrier: Summer only - Boulder garden and shallow depths at mouth	B

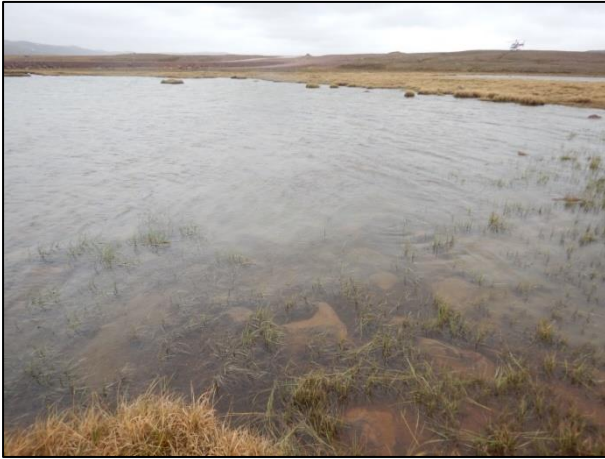
A

Photos 1. Photos of the pond CV-15-3: (A) at the encroachment location looking east; (B) at the encroachment site looking offshore to the southeast; (C) at the encroachment site looking south; (D) at the encroachment site looking southwest; and (E and F) pond showing connection to Unnamed downstream river at the Tote Road bridge CV-128 in spring.
