**Re: Follow up March 9-12, 2015 AANDC Water Licence Inspection**  
**Mary River Project – Water Licence No. 2AM-MRY1325**

WATER LICENCE INSPECTION FORM

**Table A.1 - Response to AANDC Water Licence Inspection - March 9 to 12, 2015**

**Re: Follow-up to Spill #15-089, Reported on March 12<sup>th</sup>, 2015**  
**Mary River Project - Water Licence No. 2AM-MRY1325**

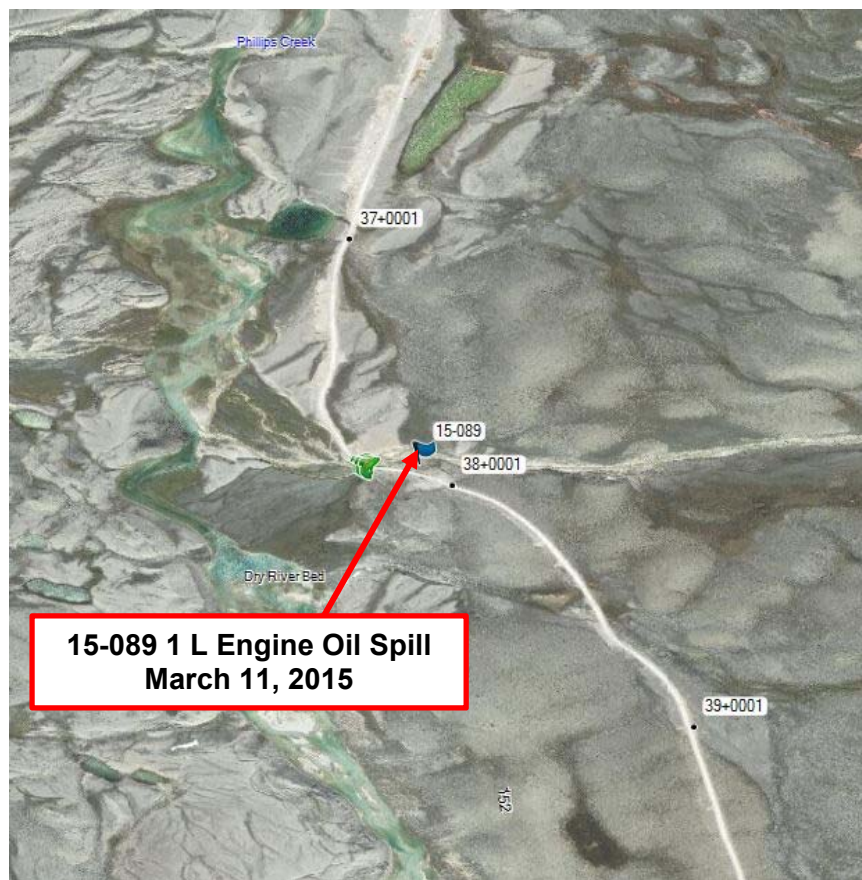
**Map of Spill Location**

On March 11, 2015 at 17:00, a leak was observed under a ground thawing unit located at Km 38 of the Tote Road. The unit was positioned on the frozen stream at crossing CV099. Approximately 1L of engine oil escaped from an improperly positioned dip stick and was released onto the frozen stream ice surface. There was no spill tray in place to prevent the oil from leaking directly onto the stream bed.

Upon discovery, a spill tray and absorbent material was put underneath the leak to prevent further release to the receiving environment. Repairs were then made to the unit to stop the leak. Approximately 0.2 m<sup>3</sup> of impacted snow and gravel was recovered and transported/disposed of in the landfarm facility at Milne Port. The ground thawing unit was subsequently inspected, found to be in good working order with no further leaks, and put back into service by the maintenance department. A large spill tray was installed to protect the ground / stream bed under the unit. The Operations Group, who are responsible for the operation of the ground thaw unit, were reminded that ongoing utilization of spill trays and monitoring of same are key requirements of our environmental permits.

The Ground Thaw Unit is back in service. Regular inspections are conducted on the ground thawing unit and other equipment to check for leakage and to ensure spill tray use.
