**RE: Water Licence 2AM-MRY1325 September 2019 Inspection**

**Attachment 1:  
2AM-MRY1325 September 2019 Inspection Report**

**Table 1 – Baffinland Responses to CIRNAC Water Licence Inspection – September 2019**

## Mine Operations 2020 Freshet and Mine Haul Road Water Management Improvements

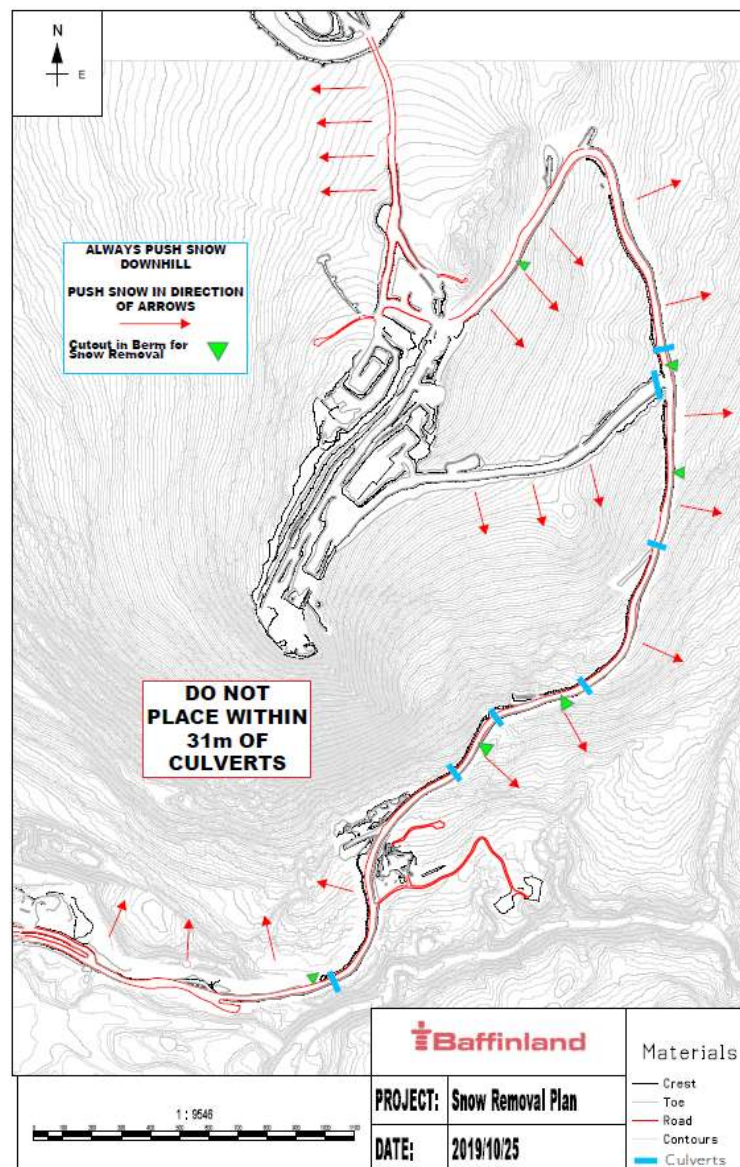
Figure 5: 2019 Snow Removal Plan

A snow removal plan has been developed for the mine haul road to limit the accumulation of snow in areas that might cause issues during freshet. Figure 5 illustrates the areas and directions in which snow can be dumped to limit melt water flowing into areas where it can gather sediments. Limits have been set around culverts to reduce the potential for blocking culverts and melt water that would report into the culverts.
