**APPENDIX E.8**  
**DECOMMISSIONING REPORTS**

## **APPENDIX E.8.1**

### **MINE SITE**

## **INSPECTION OF THE MILNE INLET TOTE ROAD AND ASSOCIATED BORROW SOURCES**

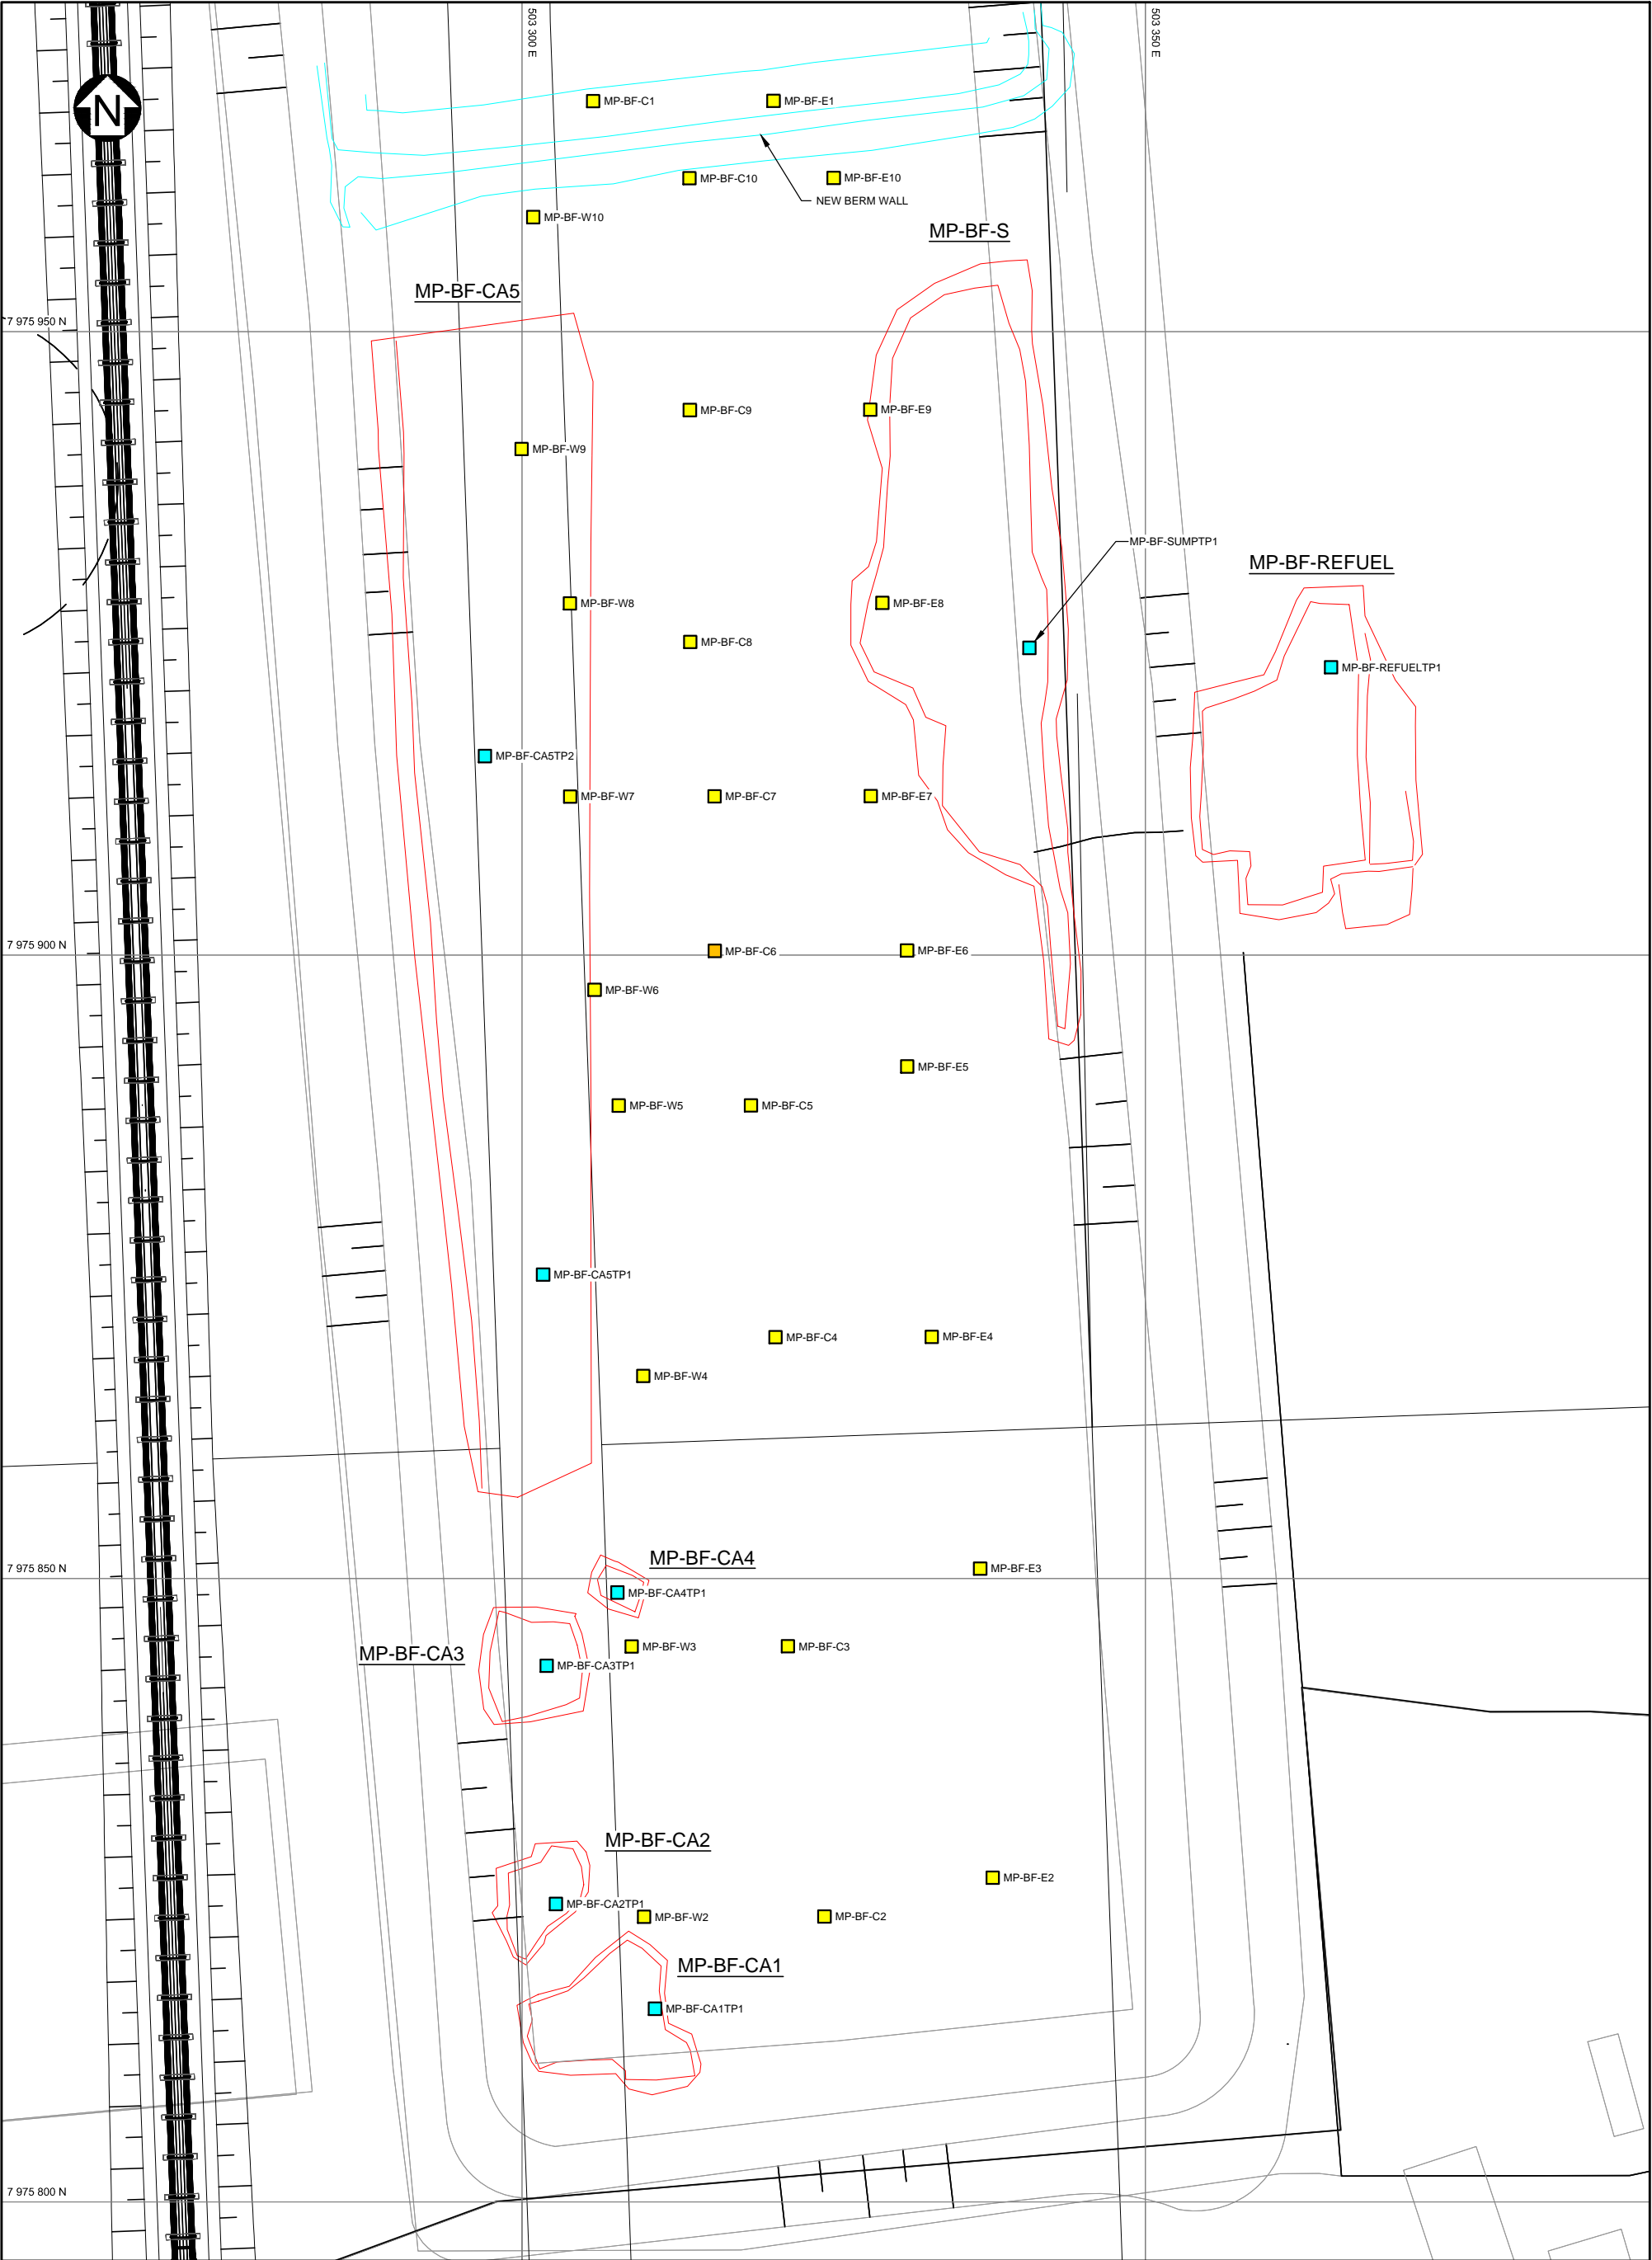
EXCAVATION LIMITS FOR  
CONTAMINATED AREAS  
NEW BERM WALL

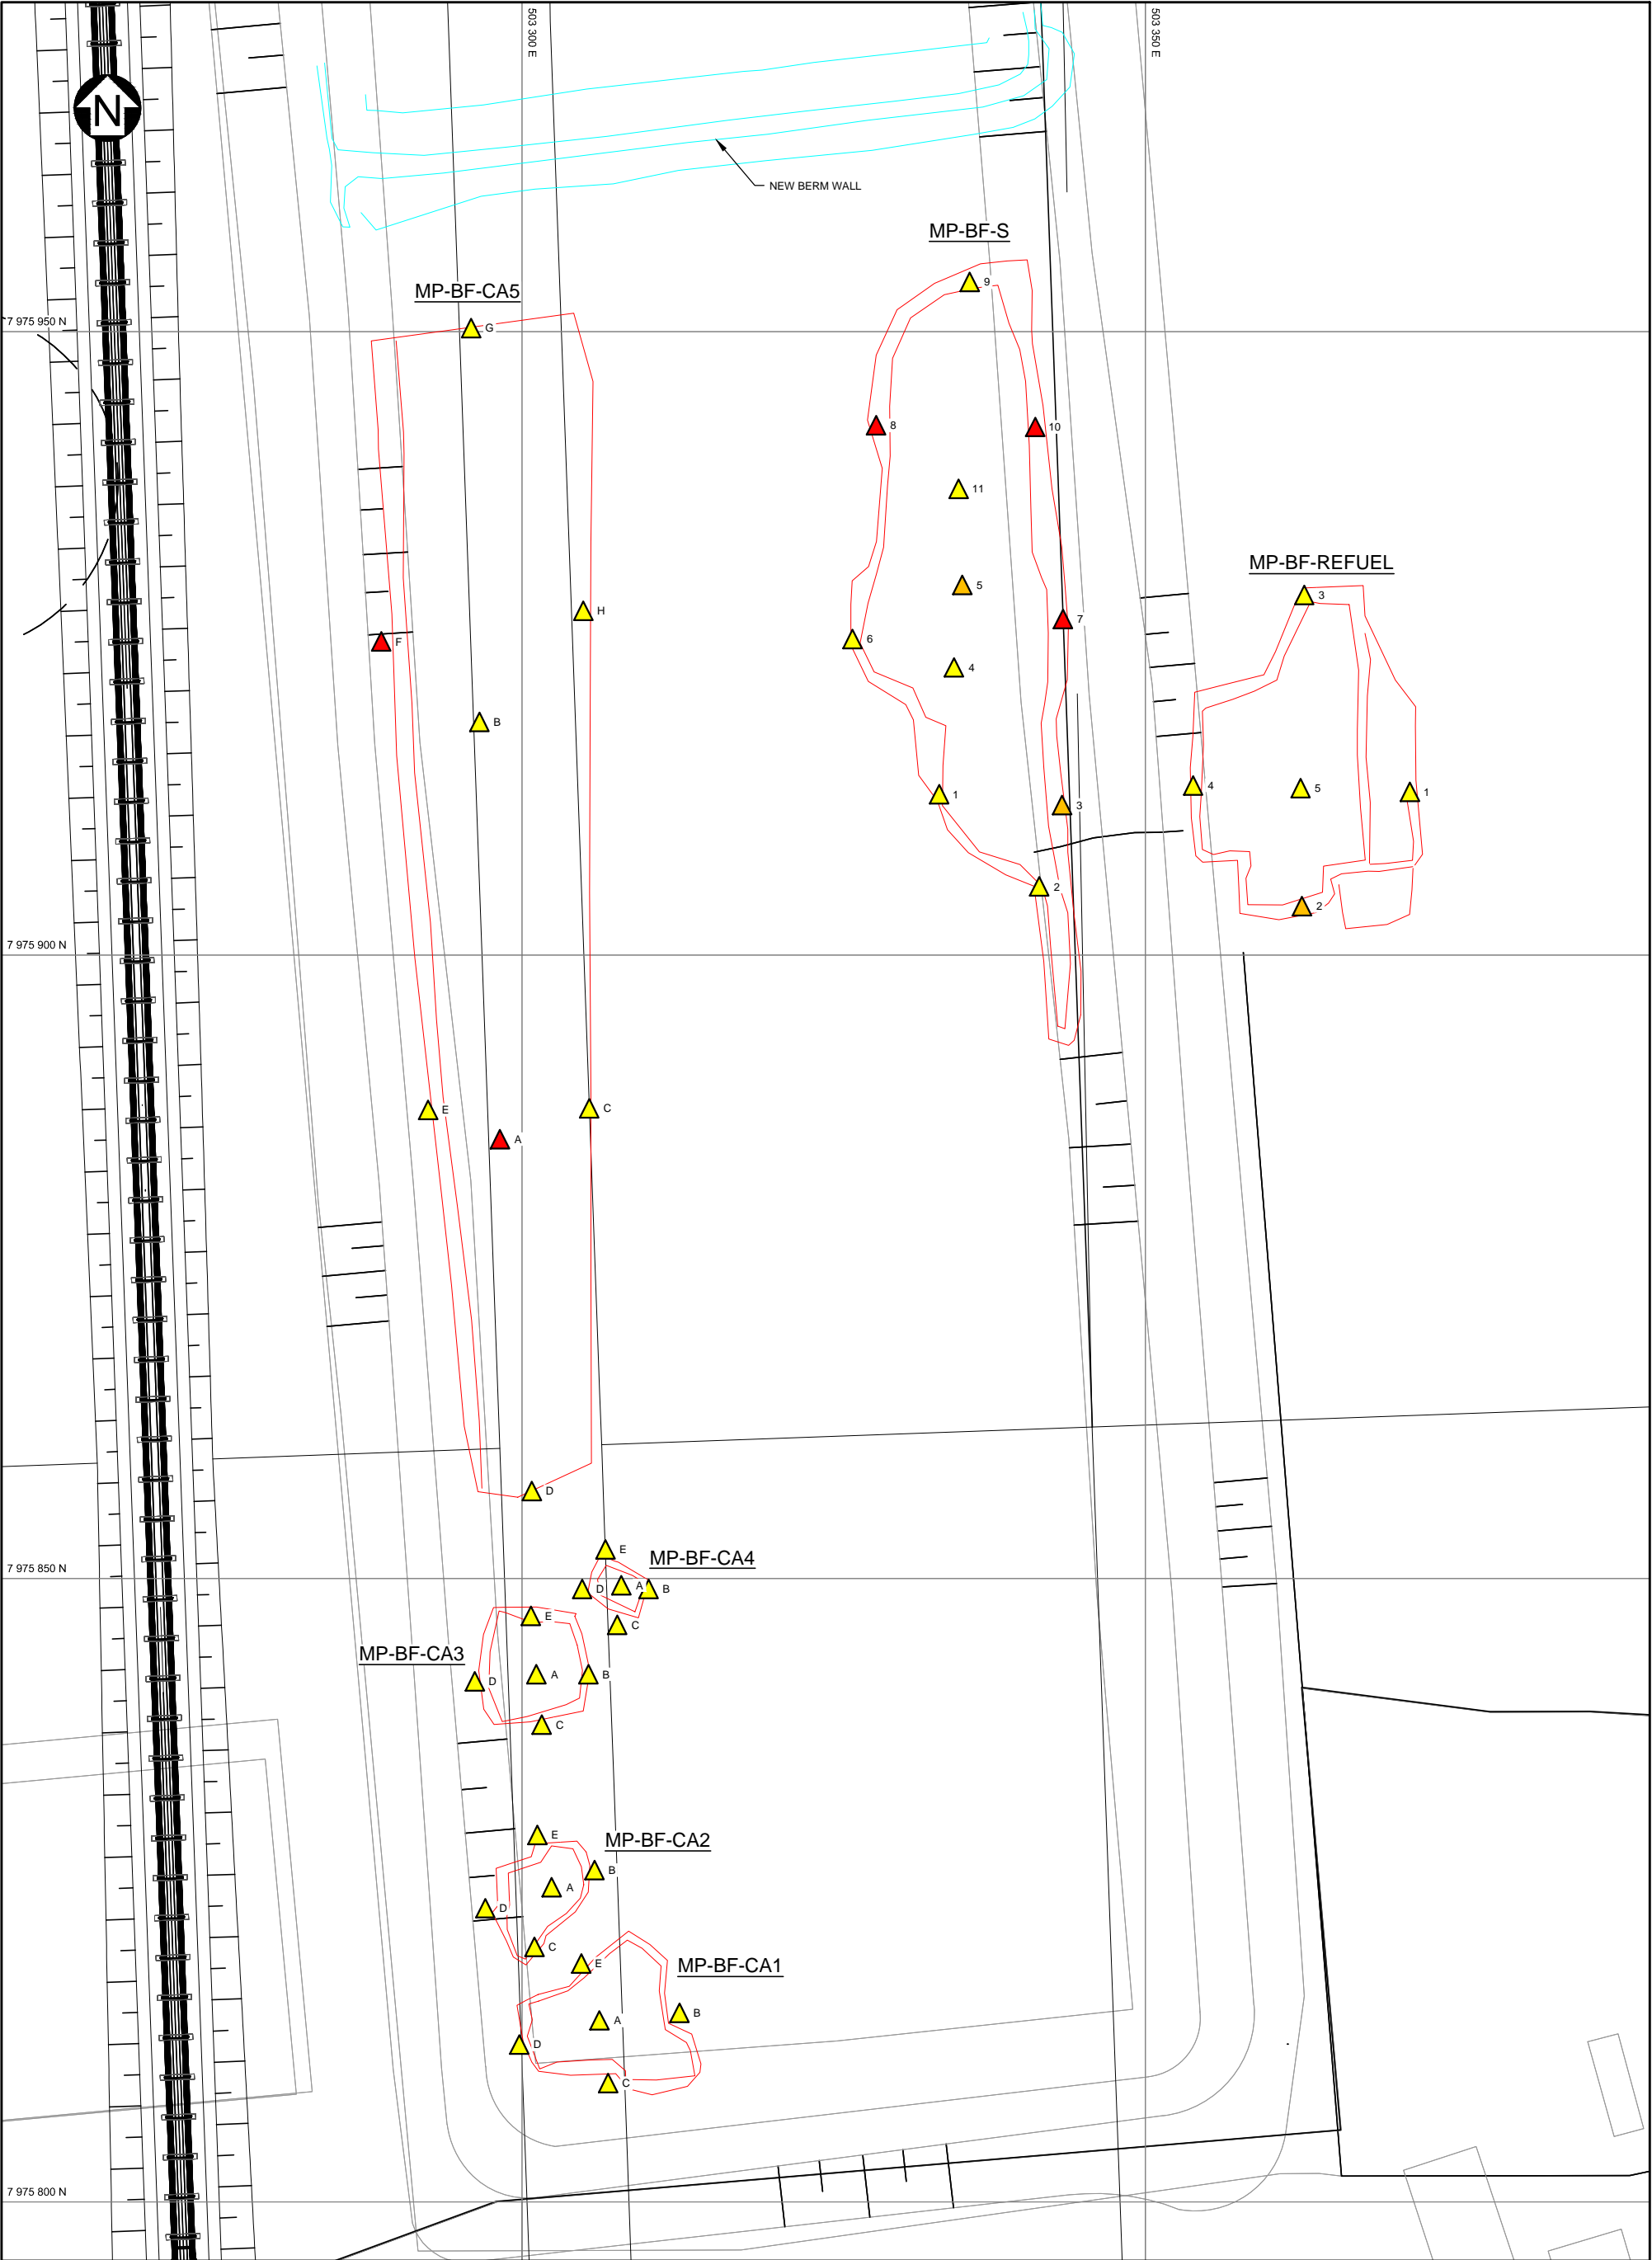
- LE EN
- EXCAVATION LIMITS FOR CONTAMINATED AREAS
  - NEW BERM WALL
  - SOIL SAMPLES WITH PH LEVELS BELOW TIER 1 GUIDELINES FOR ALL LAND USE TYPES
  - SOIL SAMPLES WITH PH LEVELS ABOVE TIER 1 GUIDELINES FOR COMMERCIAL/INDUSTRIAL LAND USE
  - SOIL SAMPLES WITH PH LEVELS ABOVE TIER 1 GUIDELINES FOR AGRICULTURE/PARKLAND LAND USE
