APPENDIX D.7.6
2016 WSCC INSPECTION REPORTS
AND BAFFINLAND RESPONSES

REPORT OF AN INSPECTOR OF MINES

Mine:	Mary River project	Location:	~950 km NW of Iqaluit	
Operator:	Baffinland Iron Mines Corp.	Lat.	71-19'N	Long. 79-24'W
Manager:	Bernard Laflamme	Inspection Date:	20160114 to 19	
Address	2275 Upper Middle Road East - Suite 300 Oakville ON L6H 0C3

Fred Bailey (chief inspector of mines) and Martin van Rooy (engineer/mine inspector) conducted a general safety inspection of Baffinland's Milne Inlet site, Tote Road and Mary River site. Baffinland's response to WSCC's safe advantage program was audited.

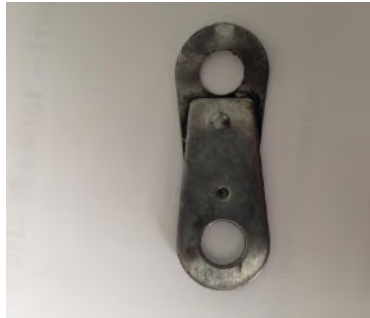
- 16. Noticed further to the 12 October 2015 inspection report, the lid on the Milne Inlet 40-gallon solvent cleaning tank, was repaired however, the Mary River 40-gallon solvent cleaning tank lid is not repaired.

Please install the solvent tank lid's restraining device as per the manufacturer's instructions, to ensure the lid will automatically fall closed, in case of a fire in the solvent tank.

Response: *Latch Installed on April 11, 2016*

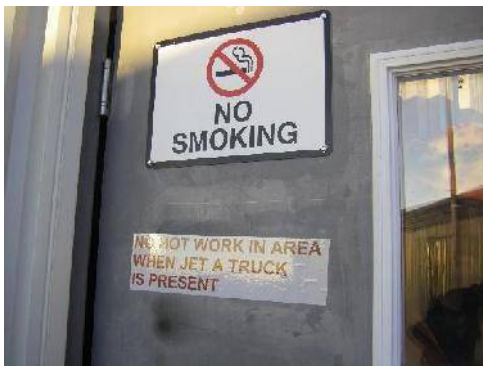
24. Noticed an 18,000 lt jet fuel tanker is parked with some other mobile equipment in Mary River's site service building.

Please review the procedure that must be followed for parking this fuel tanker inside this building and determine if the fire detection and protection is adequate when it is parked in this building.

Response: *Hot work activities will not be permitted in that building. Signage will be posted.*
Target Completion Date: *March 1, 2016. Completed February 13 2016*

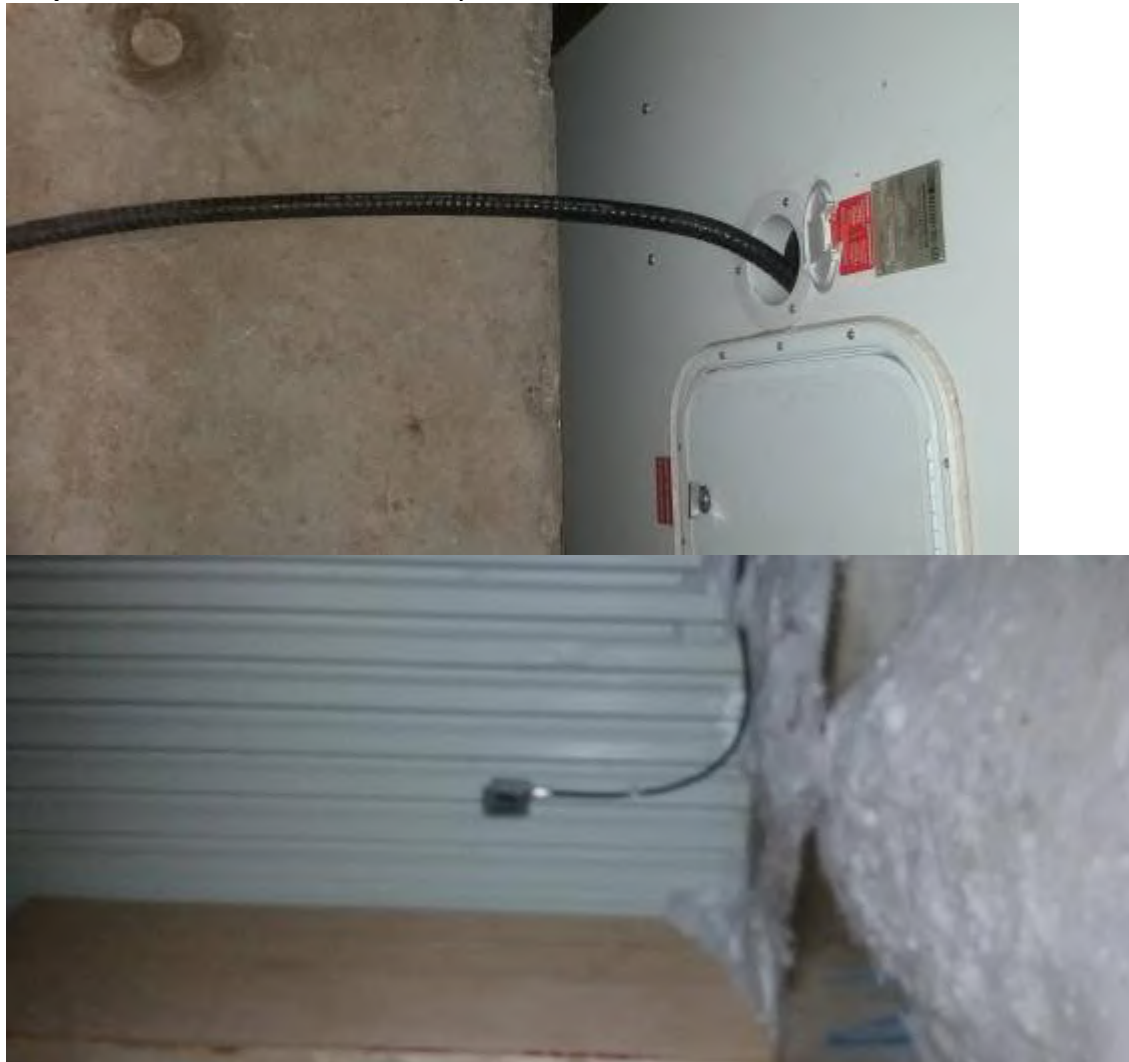
25. Noticed the long extension cords used for power to the toilets and frost fighters installed in Mary River's warehouse building.

Please install an electrical outlet at the equipment, plug the equipment directly into the outlet and remove the extension cord.

Response: *COMPLETED on February 18, 2016*

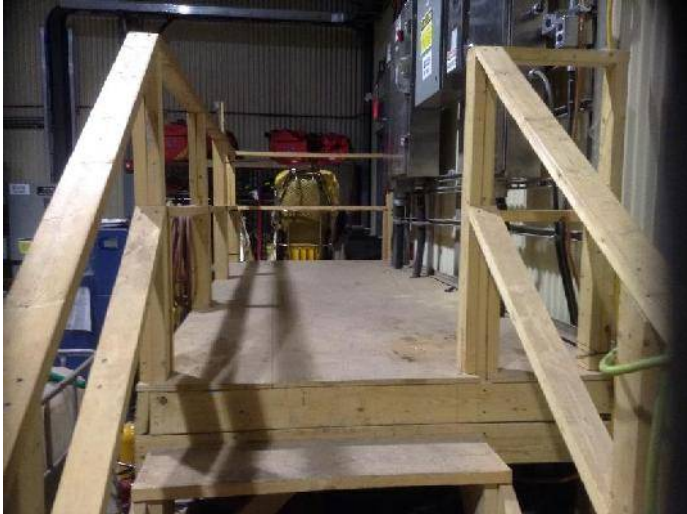
Above pic is the MRT – complete.

- 3 This is a repeat infraction see inspection report 21 March 2015... Please instruct all supervisors to check all electrical distribution panels in their area routinely, to ensure at least one meter clear working space, free of clutter is maintain around the electrical equipment.

The equipment stored in front of the electrical panel at the MRT garage has been removed. Completed July 27, 2016

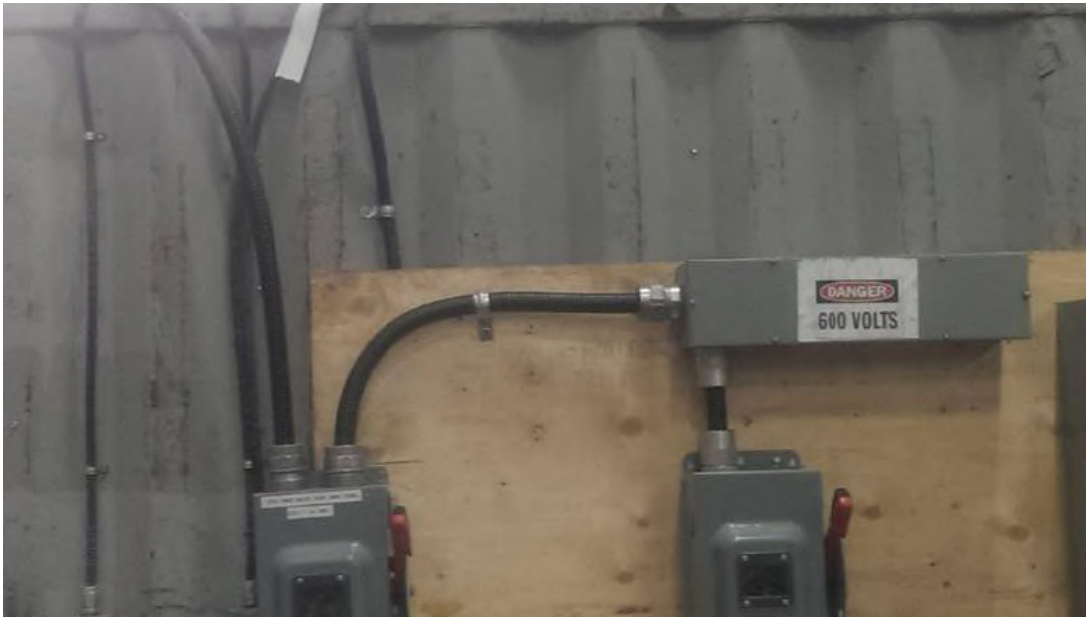
Noticed the Teck cable between the main 600V switch and the splitter at the Milne Toromont shop is bent well beyond acceptable minimum radius.

7 Please re-servise the Teck cable in accordance with the Canadian Electrical Code.

Picture above shows completion.

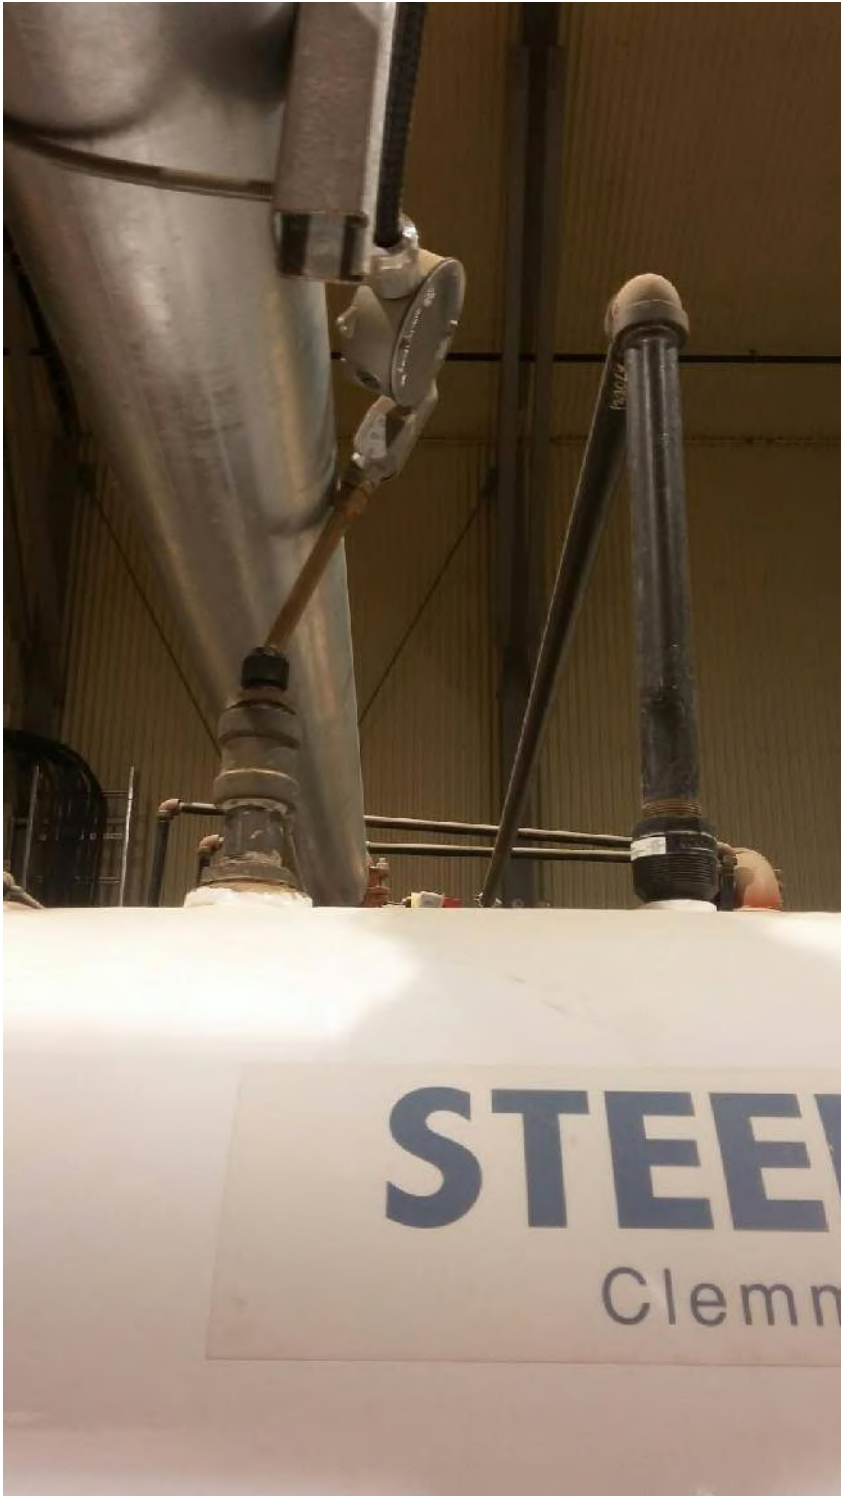
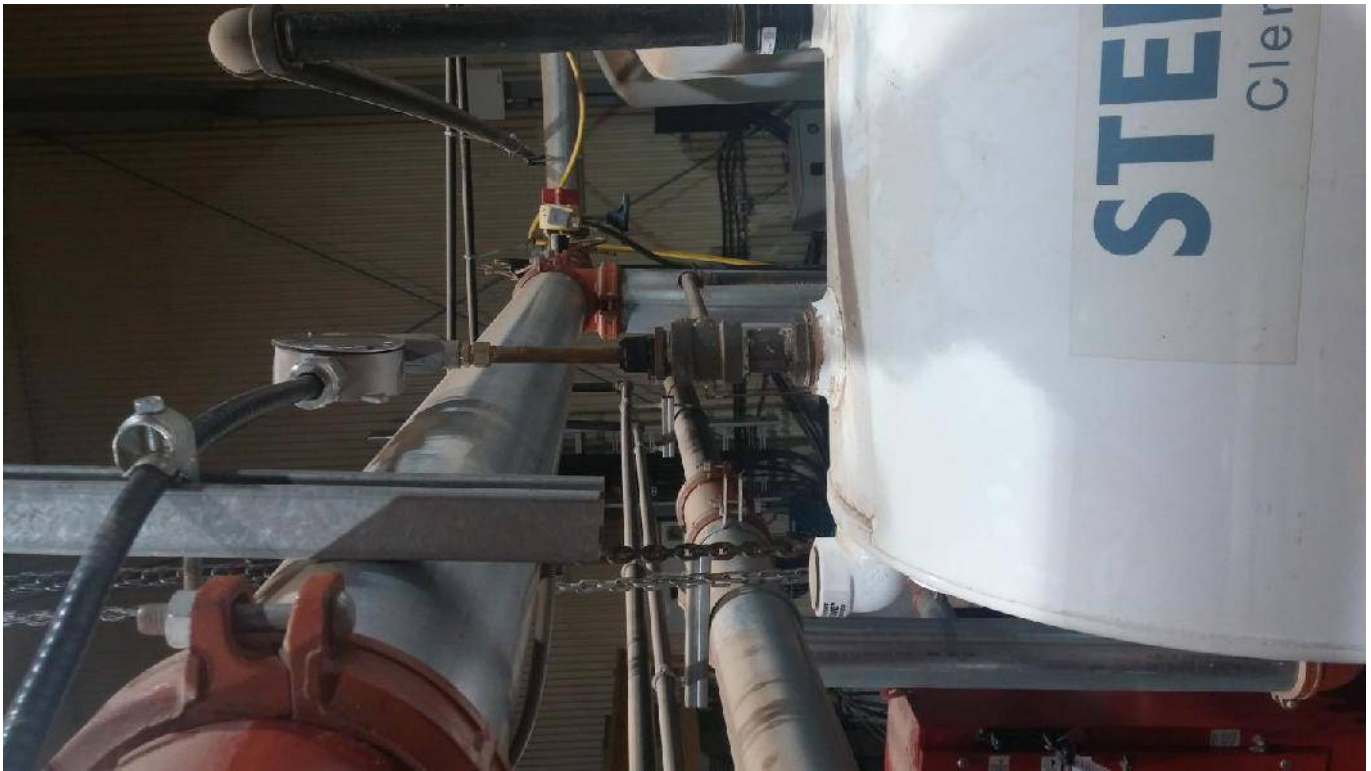
Noticed the sensor on top of the fire pump's diesel tank at the Milne Water Treatment Plant, is bent by a sagged water line because of the subsiding floor.

16 Please secure the water line and repair the sensor.

Completed – pic above is rotated 90degrees.

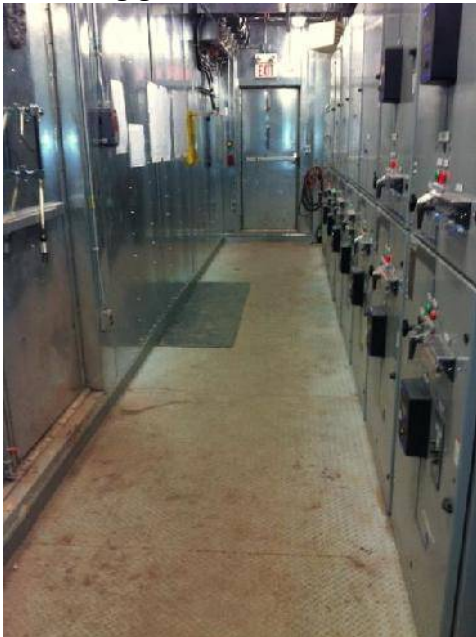
Noticed the insulating gloves stored in cardboard boxes at Mary River Power House 2.

Insulating gloves and material stored in switch room.

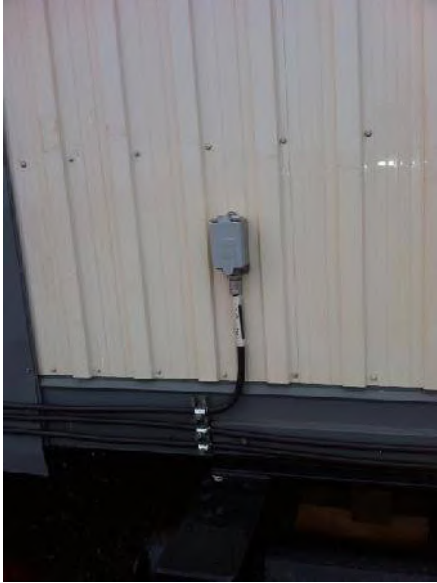
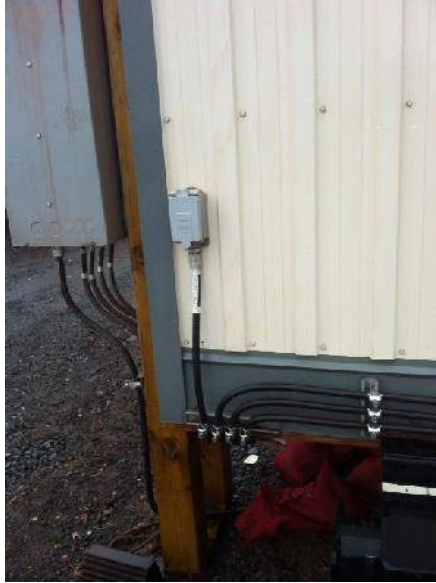
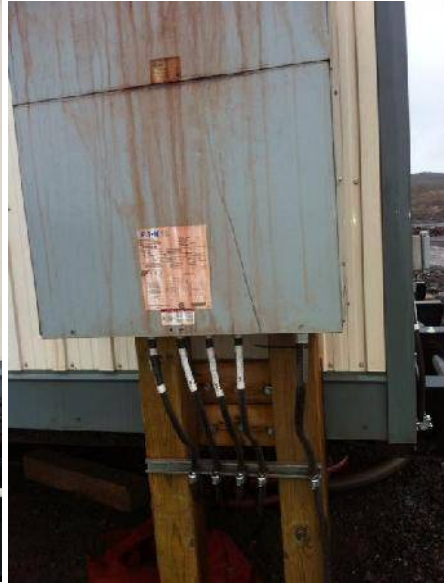
Noticed there is a receptacle outside the Pit Office, it is fed from a mini-distribution center via G-GC cable. The G-GC cable has been damaged and a splice has been made with electrical tape.

41 Please remake the splice with a shrink-on sleeve to provide the same protection, strength etc. as the original cable jacket or replace the G-GC cable. Provide GFI protection and ensure the receptacle is rated for this application.

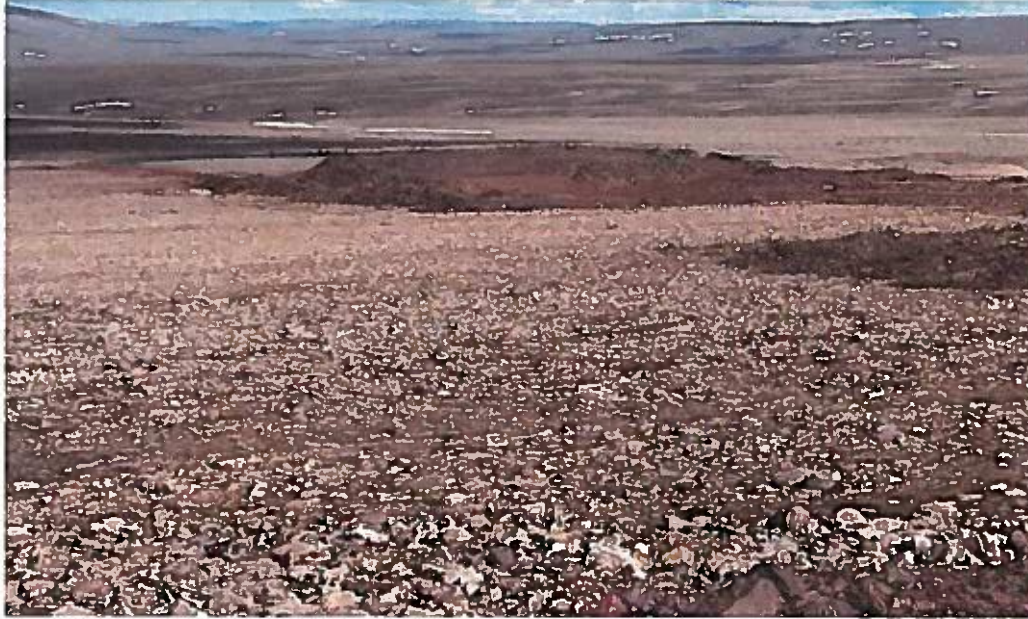
Photo 6: 18m high angle of repose stockpile with frost on surface

The temporary ore stockpiles are constructed using either a stacker or loader. The stockpiles will be up to 18m high with angle of repose slopes see Photo 6. The stockpiles are extracted by

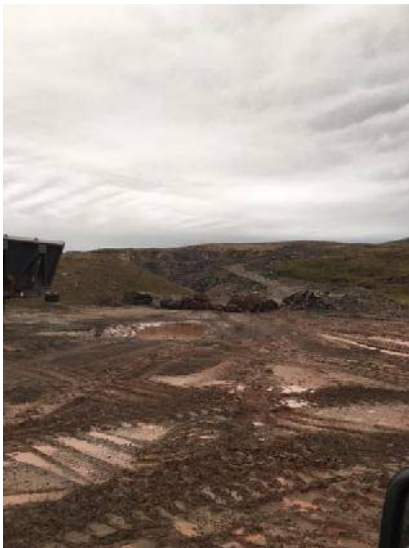
Noticed the following deficiencies noted for the QMR2 Quarry: - 1) loose across the bench faces, and 2) bench width is less than 8m.

Berm is installed at QMR2. Installed August 15, 2016

In progress. Expected completion date November 30, 2016.
