APPENDIX D.7.7

FOLLOW-UP SPILL REPORTS

Re: Follow-up to Spill #16-006, Reported on Jan 6th, 2016
Mary River Project - Water Licence No. 2AM-MRY1325

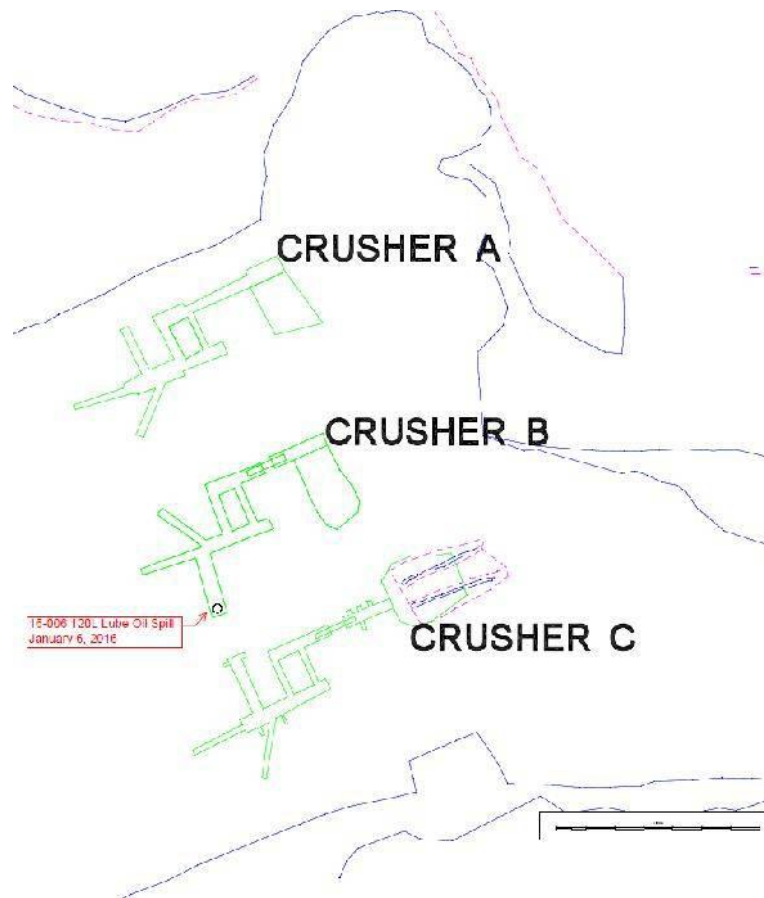
Figure 1 - Spill Location

At approximately 07:30 on January 06, 2016, the crusher operator was starting up the equipment on the B-Spread Crusher at the Mine Site Crusher Pad and the belt gave way and broke. This resulted in the belt coming in contact with the lube oil return line on the Tertiary cone, causing the line to release lube oil to the adjacent area. The volume of the spill was approximately 120L covering an approximate area of 4 m². The spill location is > 100 m from the nearest drainage (non-fisheries habitat) and all water bodies are currently frozen.

The Crusher Supervisor and Environment Department were notified immediately upon spill discovery. The lube oil was contained and cleaned up with spill pads and the contaminated material was placed in Quatrex bags. The contaminated material from the impacted area was removed for disposal in the Landfarm Facility at Milne Port.

The belt broke due to a catastrophic failure. Preventative maintenance and inspection programs for the various components of the crusher are in the process of being fully implemented.

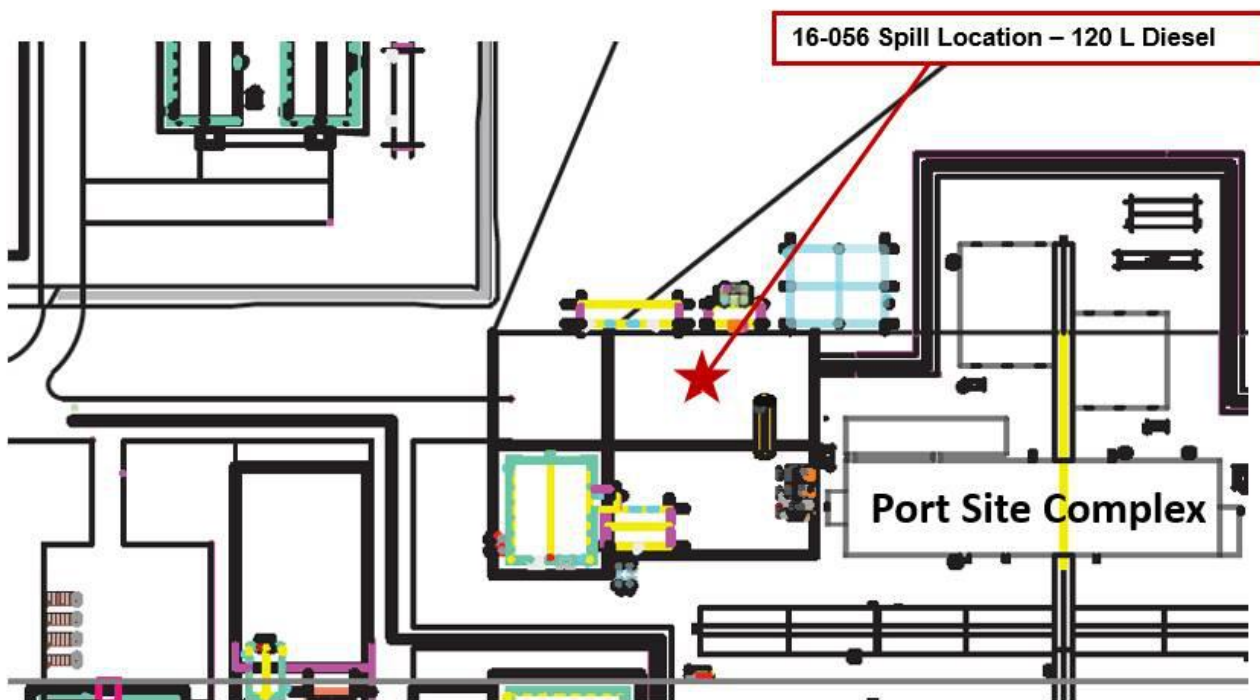
Figure 1 – Spill Location

On February 26, 2016 at 5:30 HRS, a worker discovered that the cube van (truck) had leaked approximately 120 litres of diesel onto the ground underneath the vehicle, affecting an area of approximately 10 m2. Upon further inspection, it was determined that the vehicle's fuel line had become damaged and had leaked the contents of the vehicle's fuel tank onto the ground. The location of the spill was greater than 200 meters away from the nearest water body, Milne Inlet, which is currently frozen.

The cube van (truck) fuel line has been repaired and is back in operation. The affected area has been cleaned up and the contaminated snow and soil have been taken to the Milne Port Landfarm Facility for treatment.

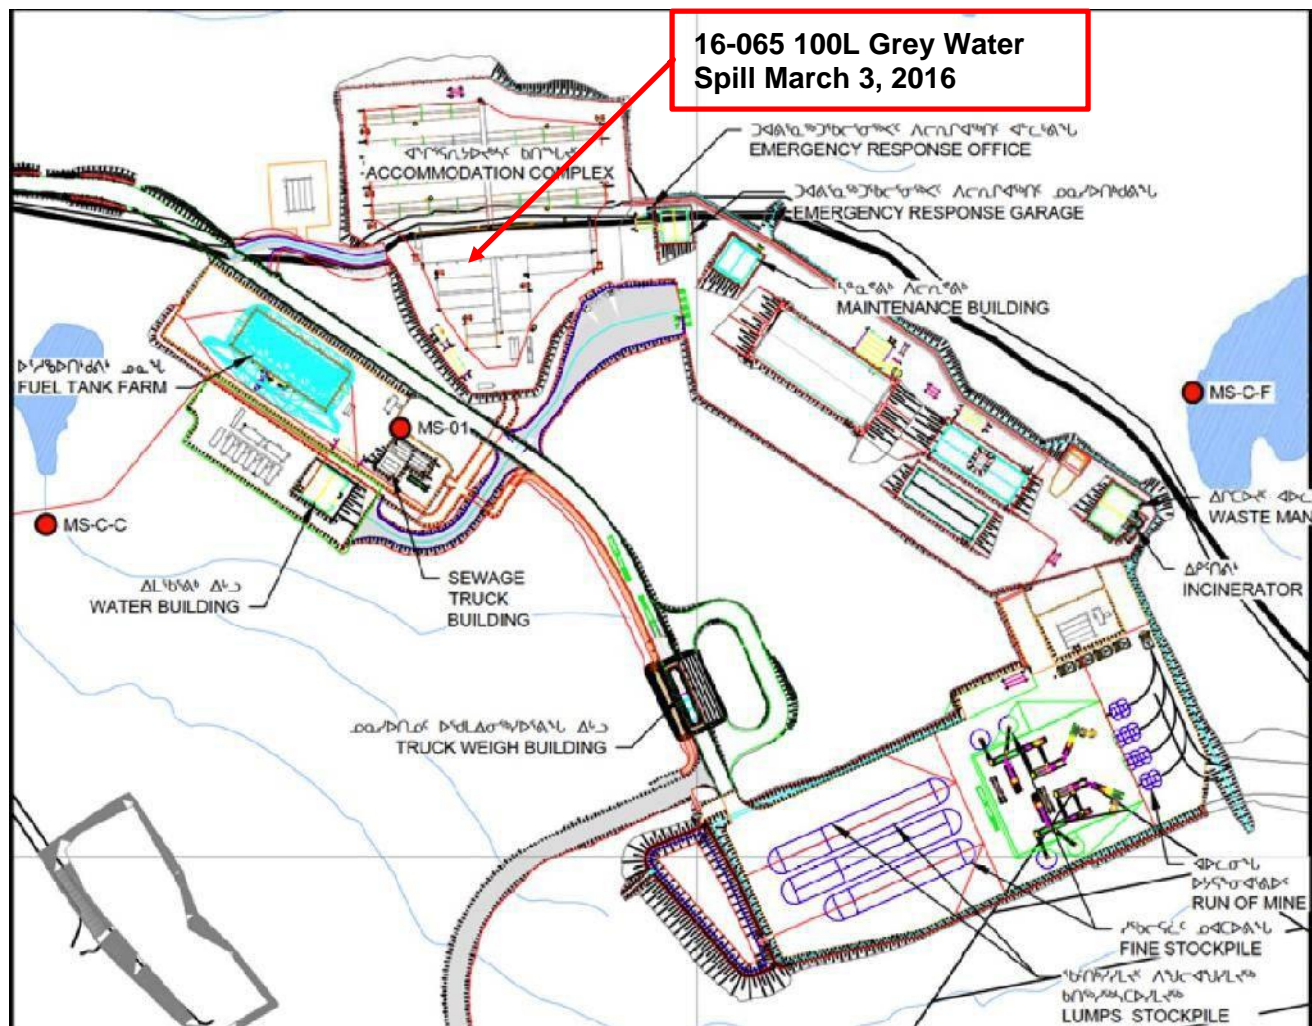
Figure 1 - Spill Location

On March 3, 2016 at approximately 13:00, while completing routine daily inspections of sewer lines and lift stations a release of grey water was discovered at lift station 19, located between the office and kitchen complexes of the Mine Site Complex. Upon further investigation, the lift station float switch had malfunctioned, causing an overflow which resulted in 100 Litres of grey water to slowly leak onto the adjacent ground surface. An area of approximately 10m² was impacted. The location of the spill was on the Mine Site camp pad, is greater than 100 meters from the nearest watercourse and all water bodies are currently frozen and ice covered.

Fixed Plant Maintenance and the Environment Department were immediately notified. The vacuum truck was used to empty the lift station and remove any pooling grey water. The pumps were shut off and the float was system was replaced.

The lift station float switch was replaced shortly after the spill was reported and the lift station is back in service and functioning properly.

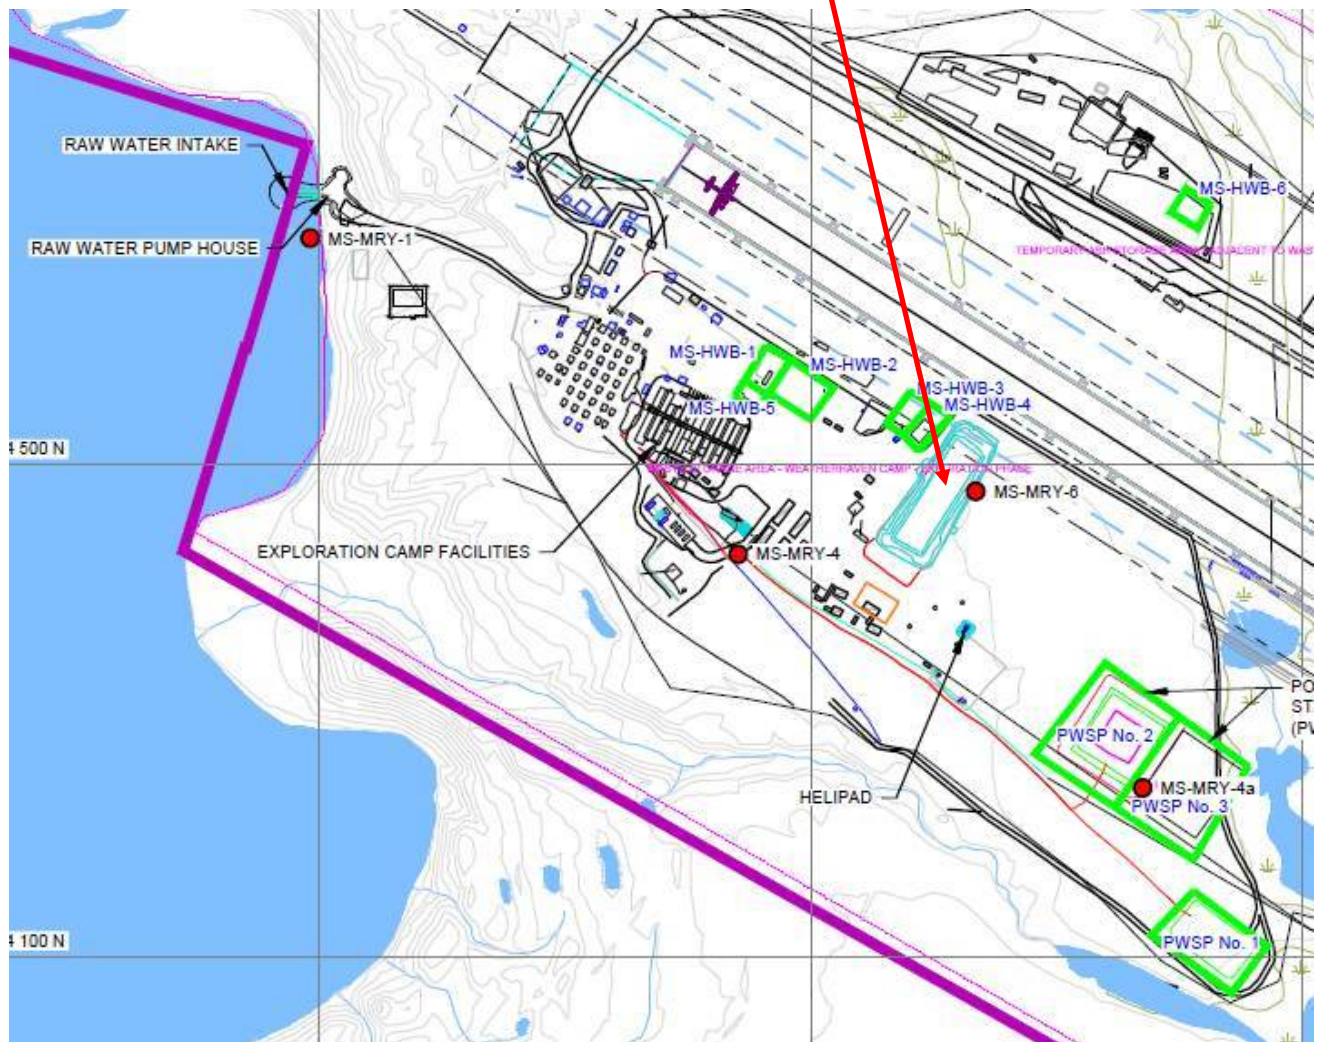
Figure 1: Map of Spill Location

**16-195 1000L Used Oil
Spill May 26, 2016**

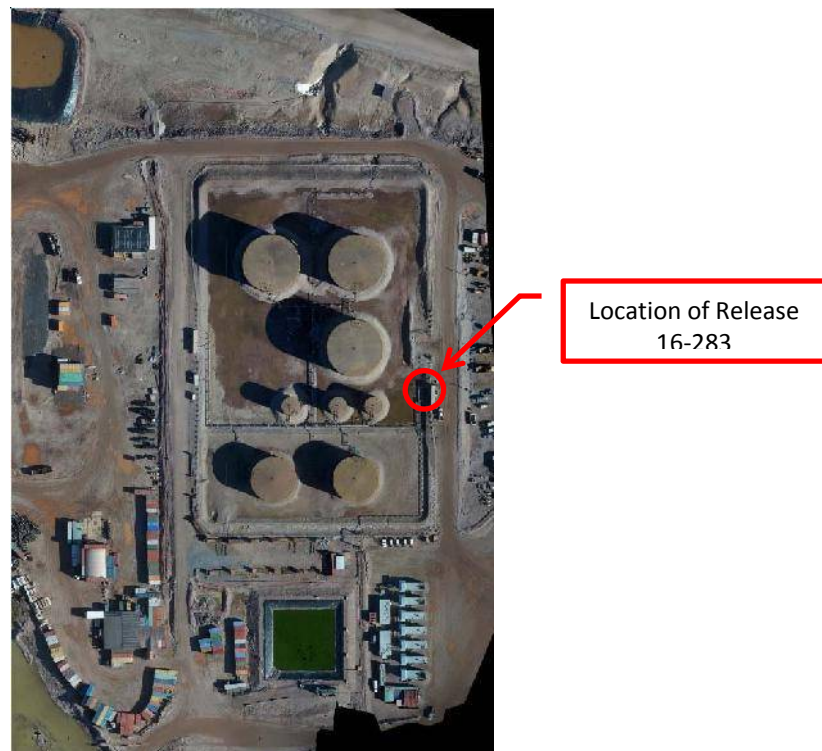
Figure 2: Aerial view of containment berm.
