Re: Follow-up to Spill #16-338, Reported on September 12, 2016
Mary River Project - Water Licence No. 2AM-MRY1325

**16-338 – 200 L Hydraulic Oil
Spill September 12, 2016**

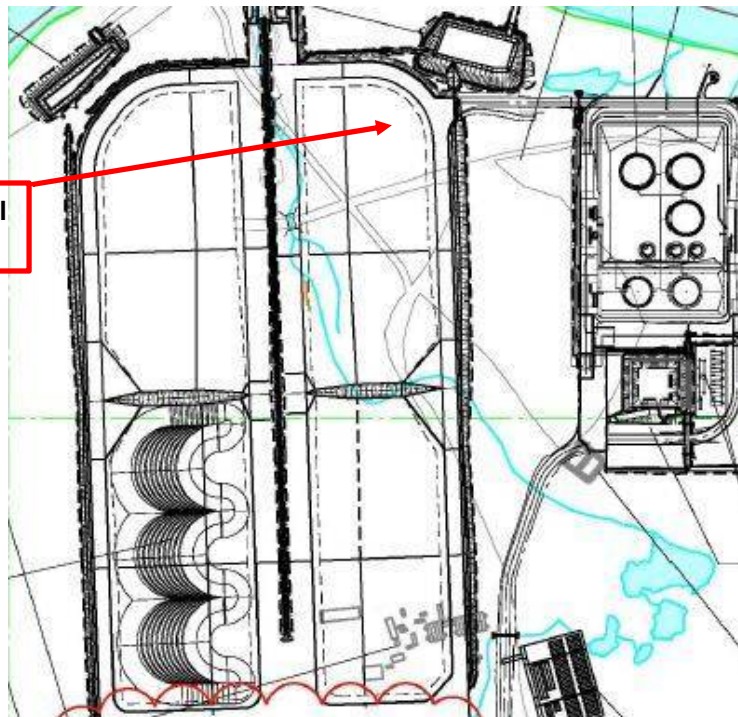
Figure 1 - Spill Location

On September 12, 2016 at 00:30 HRS, a loader operator discovered that the Sandvik Screen Plant, located within the Milne Port Ore Storage Pad, was leaking hydraulic oil. The operator immediately shut down the equipment and then called his supervisor to investigate. Approximately 200 litres of hydraulic oil was released to the adjacent ground surface on the Ore Storage Pad, an engineered contained area with ditches and a lined settling pond. Investigation determined the cause of the spill to be fitting failure, which was subsequently replaced prior to equipment start-up. The nearest natural water body is >100 m away from both the spill location and storage location and is currently frozen.

Ensure pre-op inspections are completed before use of the Sandvik Screen Plant.

The ditches and settling pond for the Milne Port Ore Storage Pad will be monitored for the presence of free phase product and sheen during the open water season.

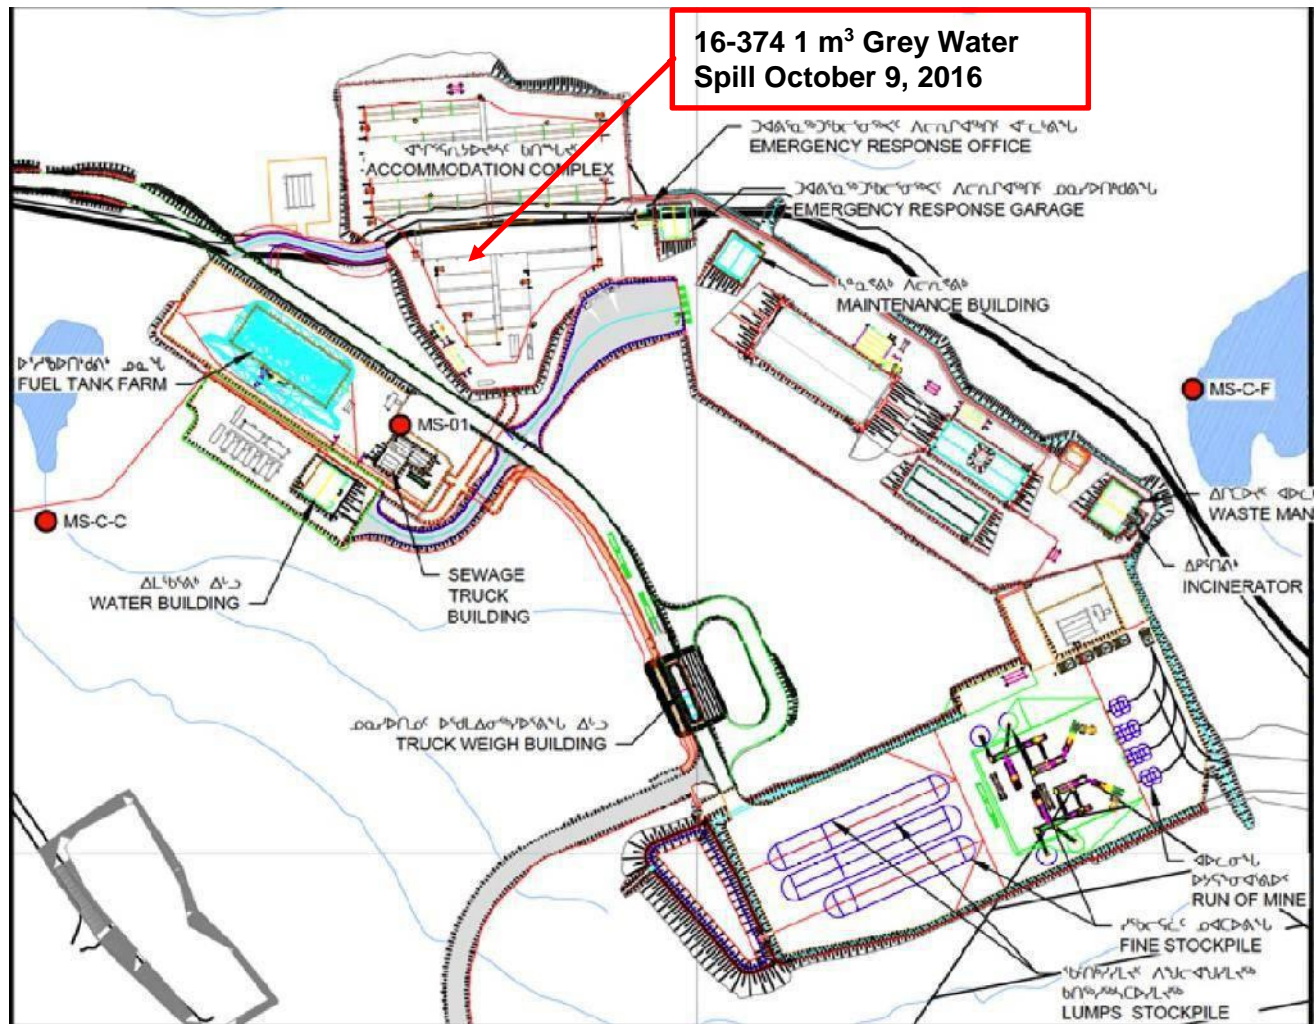
Figure 1 - Spill Location

At 08:00 HRS on October 9, 2016, Environment personnel, on a routine inspection, discovered an overflow originating from the Mine Site accommodation complex kitchen south lift station 19. This lift station only receives grey water from the kitchen. Recoverable released grey water was vacuumed and disposed of in containment. Upon the initial investigation it was determined the float from the lift station failed to actuate the pumps causing the lift station to overflow. Approximately 1 m³ of grey water was released onto the adjacent ground, affecting an area of approximately 75 m².

Baffinland Fixed Plant Maintenance was immediately notified of the release. The vacuum truck was used to draw down the grey water level in the lift station, preventing further overflow and collect recoverable greywater that was released. The pumps were shut-off and the float was replaced.

The lift station pump float was repaired shortly after the spill was reported and the lift station was placed back into service after it was determined that the float was functioning properly.

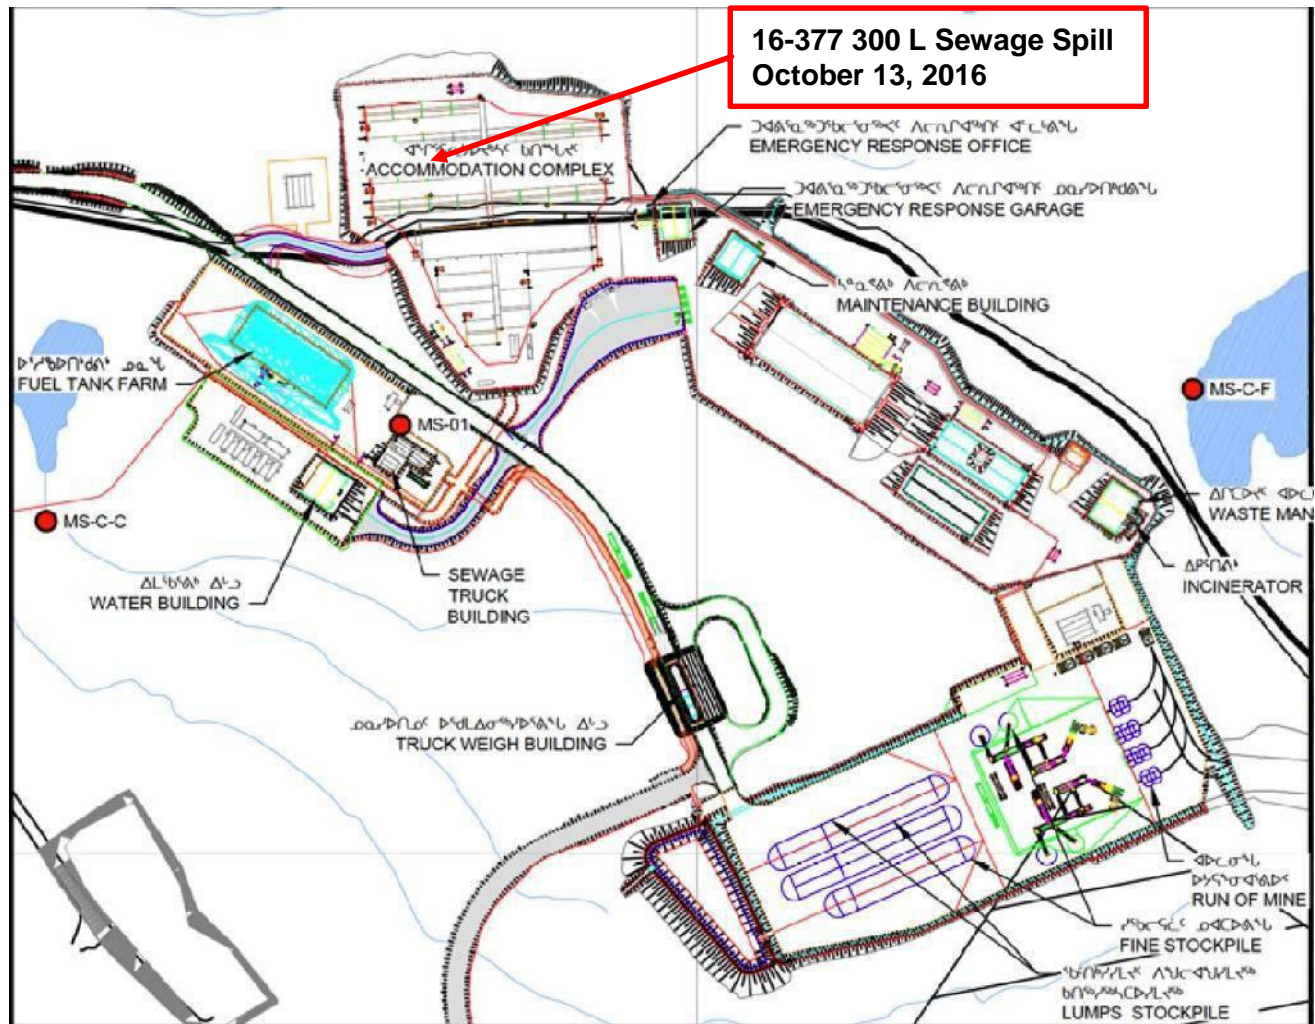
Figure 1 - Spill Location

At approximately 12:00 on October 12, 2016, Mine Site Services personnel discovered a tank overflow originating from the AD Wing of the Mine Site accommodations complex. This lift station is a temporary station/tank that is in use while the original lift station is undergoing repairs. There is no level alarm on this temporary tank and it requires manual pumping. It appeared as though the pumping of this tank was overlooked during shift change. Approximately 300 L was released onto the adjacent ground surface covering an area of snow-covered ground of approximately 20 m².

Until repairs to the permanent lift station are complete and placed back into commission, the temporary lift station will remain in use. As per the recommendation provided, monitoring of sewage levels and daily pumping will be completed.
