APPENDIX E.8.7.2
INITIAL AND FOLLOW UP SPILL REPORTS
OTHER
(Part 1)

Re: Follow-up to Spill #17-002, Reported on January 2nd, 2017
Mary River Project - Water Licence No. 2AM-MRY1325

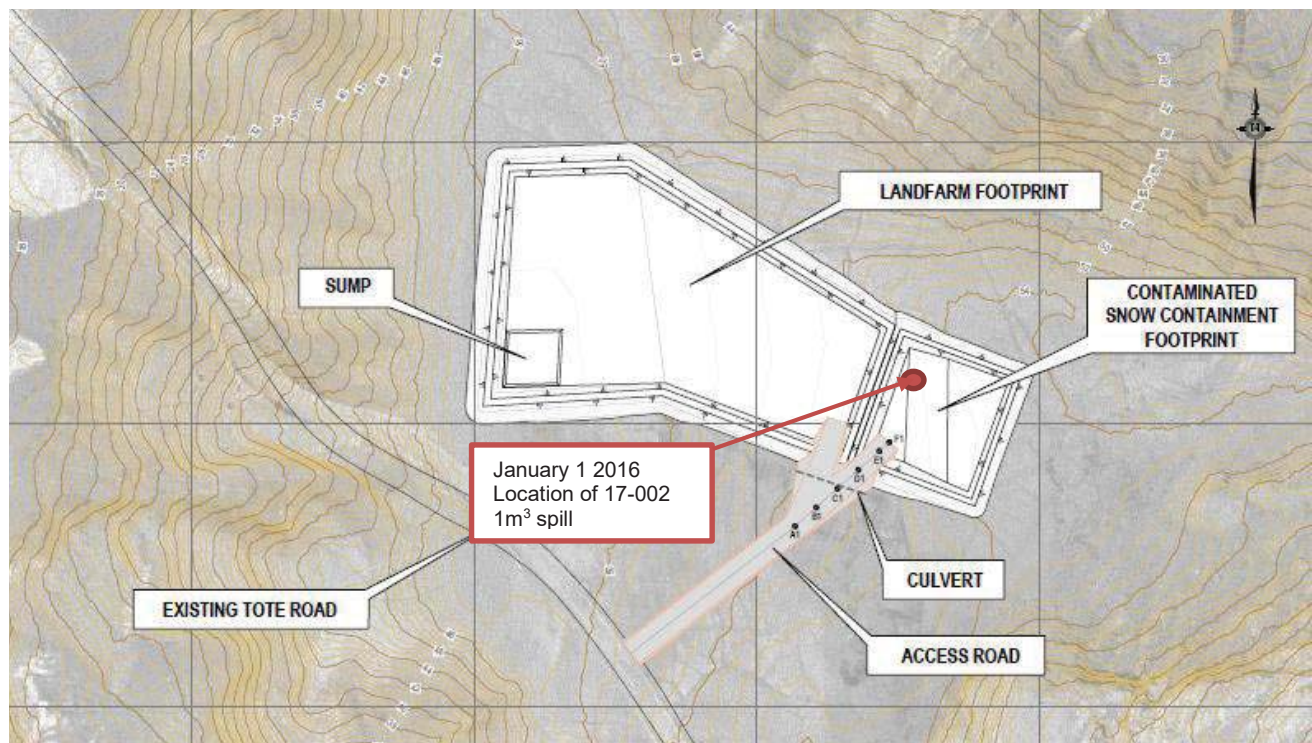
Figure 1: Spill Location

On January 1st, 2017 at 22:00 a Surface Works operator was asked to dispose of sump water totes. Sump water is stored in the contaminated snow dump, a lined engineered facility to be processed during the summer months. The operator took the tote to the snow dump and opened the valve to drain the tote. The operator picked up a second tote and returned to the snow dump. When he entered the snow dump with the second tote he noticed the initial tote had contained waste oil, which had emptied into the lined snow dump. Approximately 1m³ of waste oil was released. The closest water body is >100 m and is currently frozen; the spill is confined to the lined snow dump.

The Surface Works Supervisor was immediately notified. The waste oil and affected snow/ice was scraped up using an excavator and placed into over pack drums. The over pack drums were removed and placed into the Milne Port Hazardous Waste Berm 1 (HWB1) which is a lined containment facility. Visual observation indicates that the contaminated material was successfully removed.

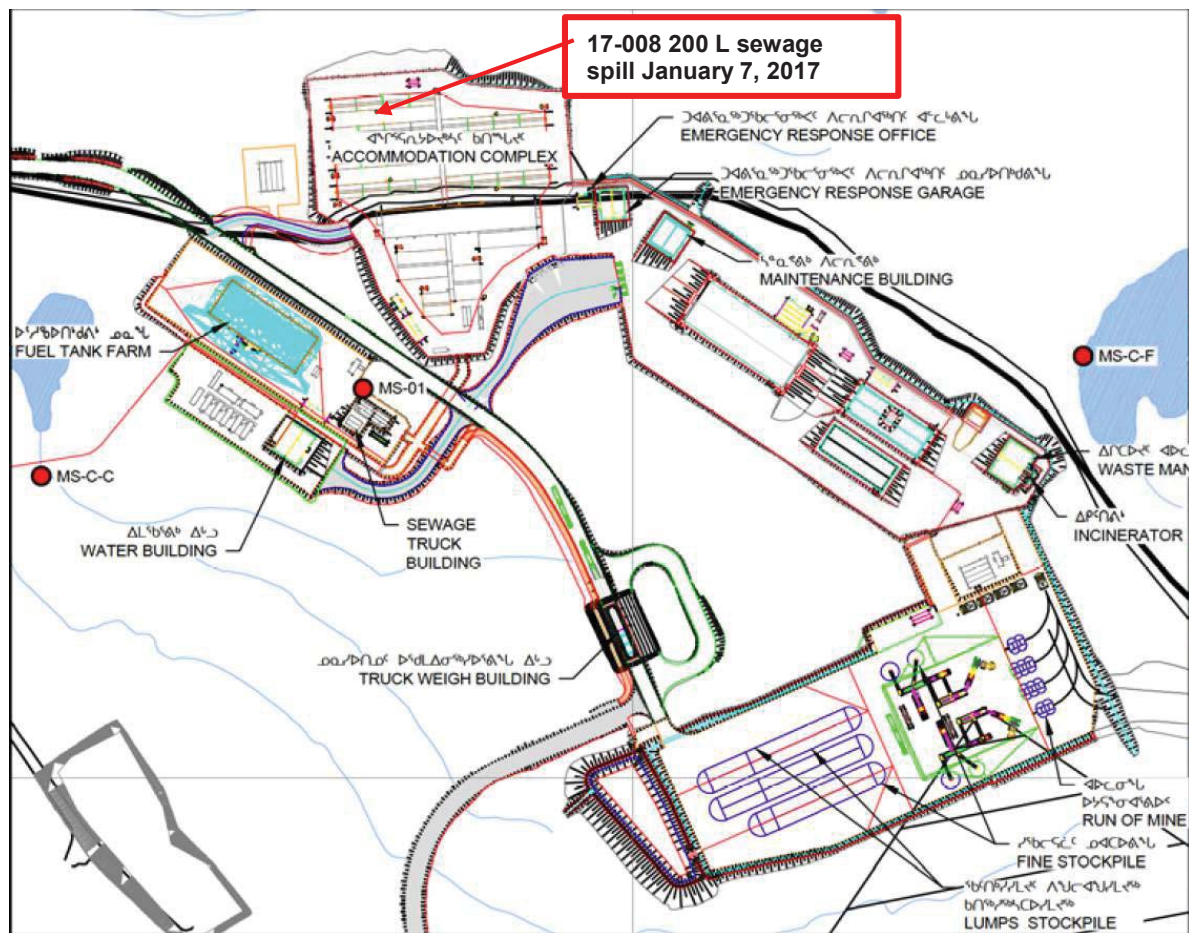
Figure 1 – Map of spill location

The pump was shut off and the vacuum truck was used to remove sewage from the lift station which was brought to sewage pond 1. The float switches were replaced on January 7 day shift with a new type of float switch that is reported to be more chemical resistant. The area is currently frozen but best efforts will be made to remove the contamination during the summer.

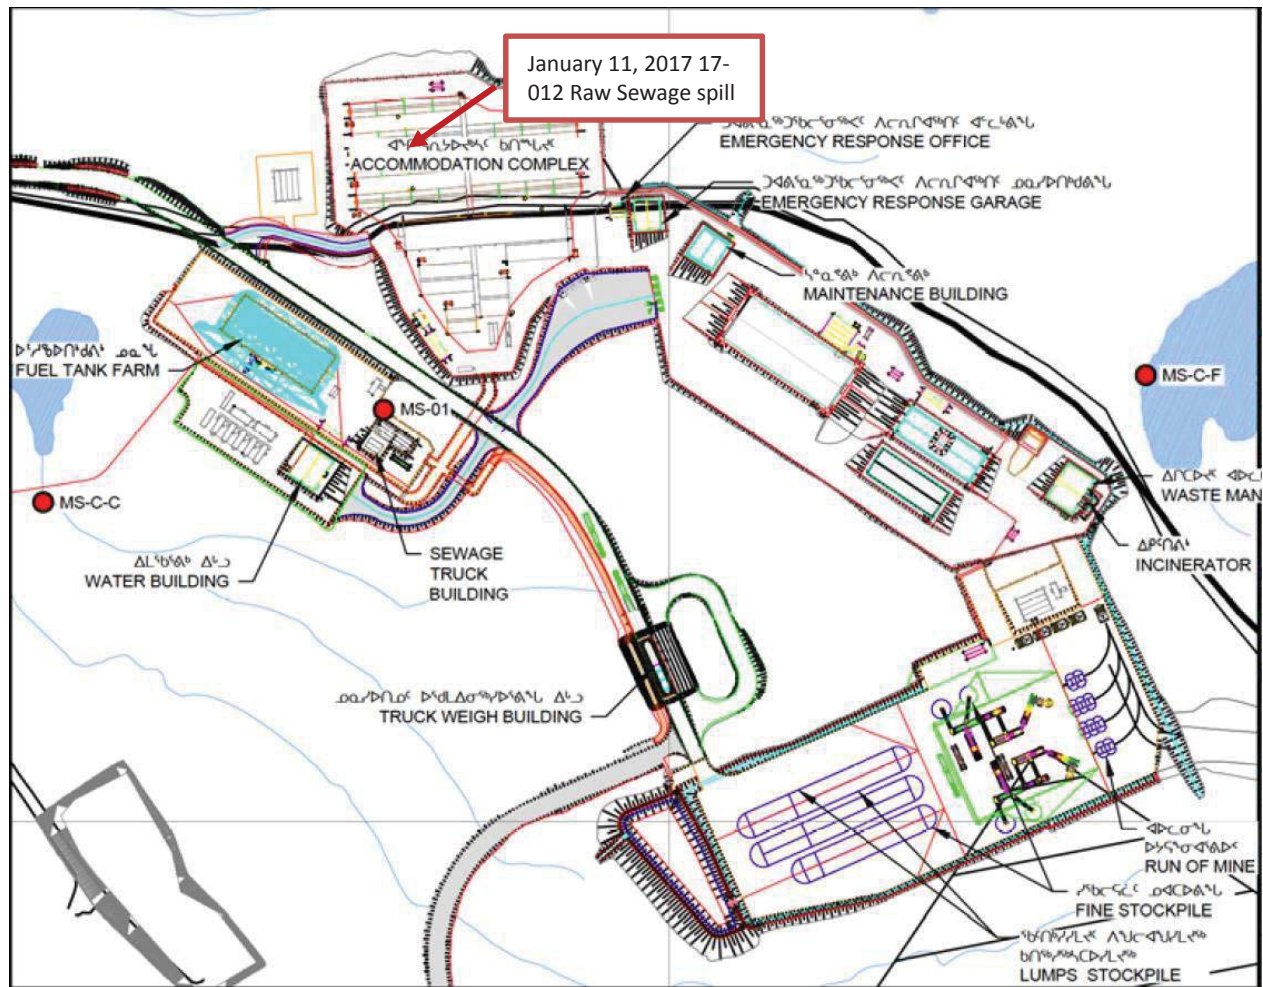
Figure 1: Spill Location AF West Wing

At 09:30 HRS on January 11th, during a daily routine inspection, a Site Service worker noticed and responded to sewage leaking from behind the West AF Wing lift station (LS 15) of the Mine Site Complex (MSC). Approximately 500 L of raw sewage was released to the adjacent camp pad ground surface, impacting approximately a 20 m² area. The leak occurred due to a disconnected coupling on the gravity line. The coupling was repaired within several hours of discovery. This location is greater than 100 m to the nearest water body, which is currently frozen.

The Employee immediately reported the leak to his Supervisor, and the Environment Department was notified. The coupling was repaired within hours of being reported. Visual observation of the affected area was impeded by surrounding structures and recent snow fall.

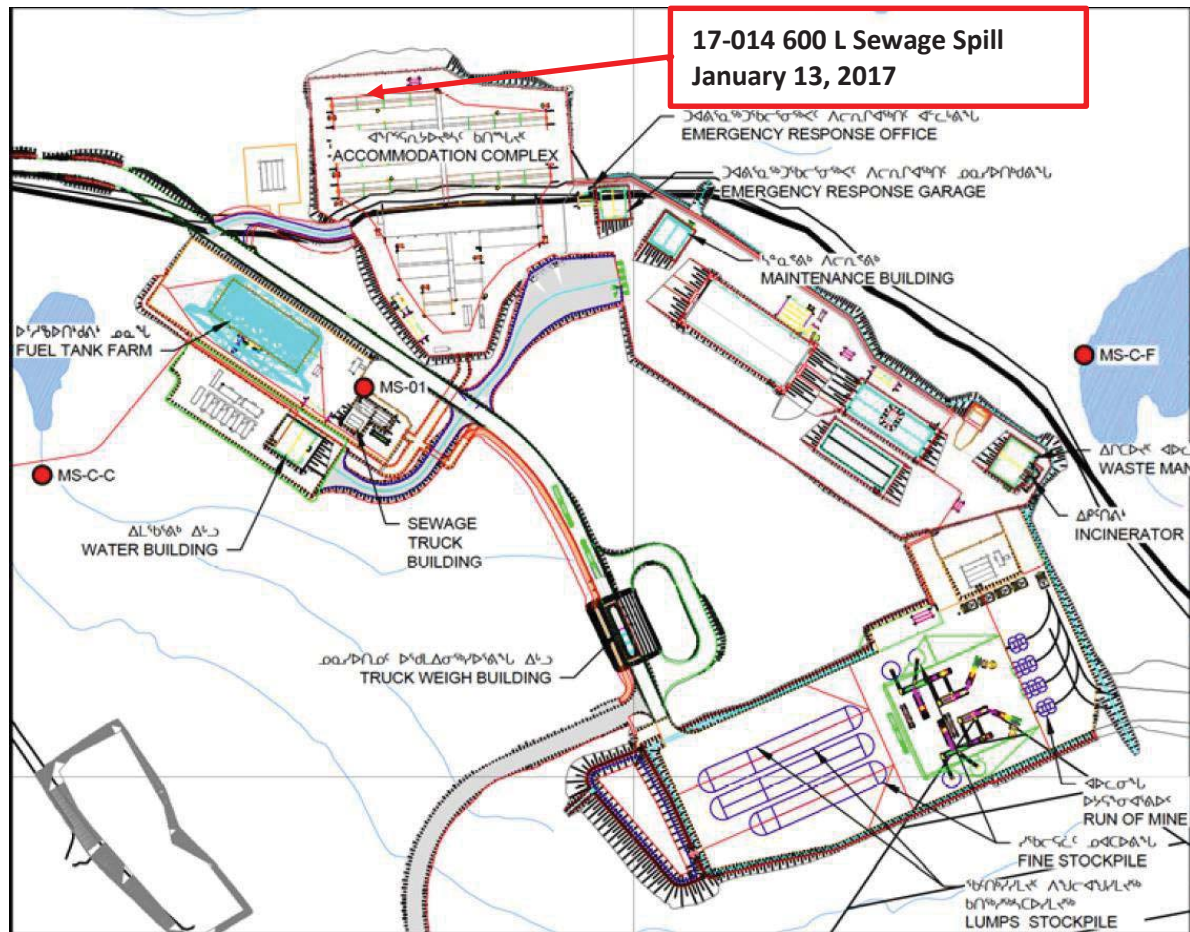
On January 13th 2017 at 9:00 HRS a Site Services Fixed Plant employee was completing the routine (daily) checks of the sewage lines and observed steam coming up through the snow behind the east lift station of the AB wing of the Mine Site Complex (LS 10). After removing snow, it was observed that the gravity line feeding the lift station had become separated by a 2 cm gap, allowing sewage to be released on the camp pad. Based on the daily inspection frequency, it is suspected that it had been leaking for less than 12hrs. It is estimated that an approximate volume of 600 L was discharged to the surrounding camp pad. This location is greater than 100 m to the nearest water course which is currently frozen.

The Environment department was notified and completed an inspection at 9:30HRS. Site Services Fixed Plant used a vacuum truck to remove 150L of pooling sewage which was deposited into sewage pond 1. The separated line was repaired and insulated.
