APPENDIX E.8.7.2
INITIAL AND FOLLOW UP SPILL REPORTS
OTHER
(Part 4)

Re: Follow-up to Spill #17-360 – Reported on September 22nd, Update No.1 on 25th, 2017
Mary River Project - Water Licence No. 2AM-MRY1325

Re: Follow-up to the #17-312 update reported on September 27th, 2017
Mary River Project - Water Licence No. 2AM-MRY1325

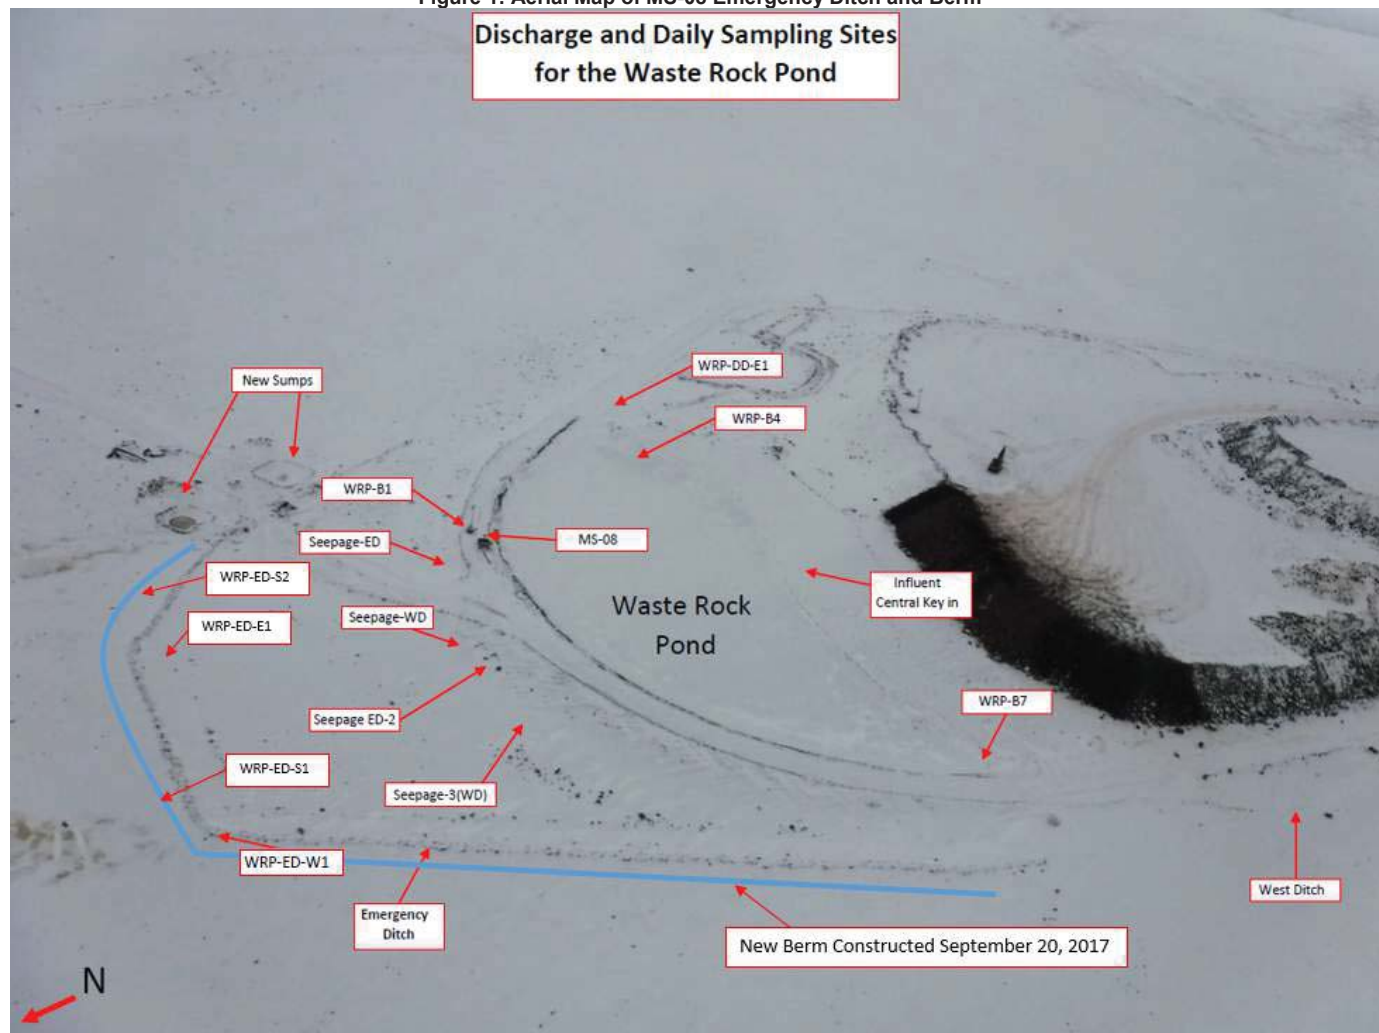
Figure 1: Aerial Map of MS-08 Emergency Ditch and Berm

On an inspection of the Waste Rock Pond and ditching, it was noticed that there was discolored water down gradient of the emergency containment ditch constructed below the toe of the waste rock sedimentation rock berm, which was reported on September 28th. The source of this discolored water/ice is undetermined. Further investigation will include water samples being taken, and utilizing Rhodamine dye in an attempt to determine the source of the discolored water/ice. The observed discolored water/ice outside the emergency containment ditch is located on a flat tundra plateau which would flow through the camp lake water shed to Camp Lake approximately 5.5 km away. This spill is being reported: 1) As required by the conditions of water license no. 2AM-MRY1325, Part H, item 9 (b) pursuant to subsection 12(3) of the Nunavut Waters and Nunavut Surface Rights Tribunal Act; 2) Under the Fisheries Act as required by section 31 of the Metal Mining Effluent regulations.
