### **GEOTECHNICAL INSPECTIONS**

**APPENDIX C.2.1**  
**GEOTECHNICAL INSPECTION**  
**JULY/AUGUST 2018**

**RE: Submission of 2018 Geotechnical Inspection Report No. 1 (Jul/Aug. 2018)**

FIRST INSPECTION OF TWO

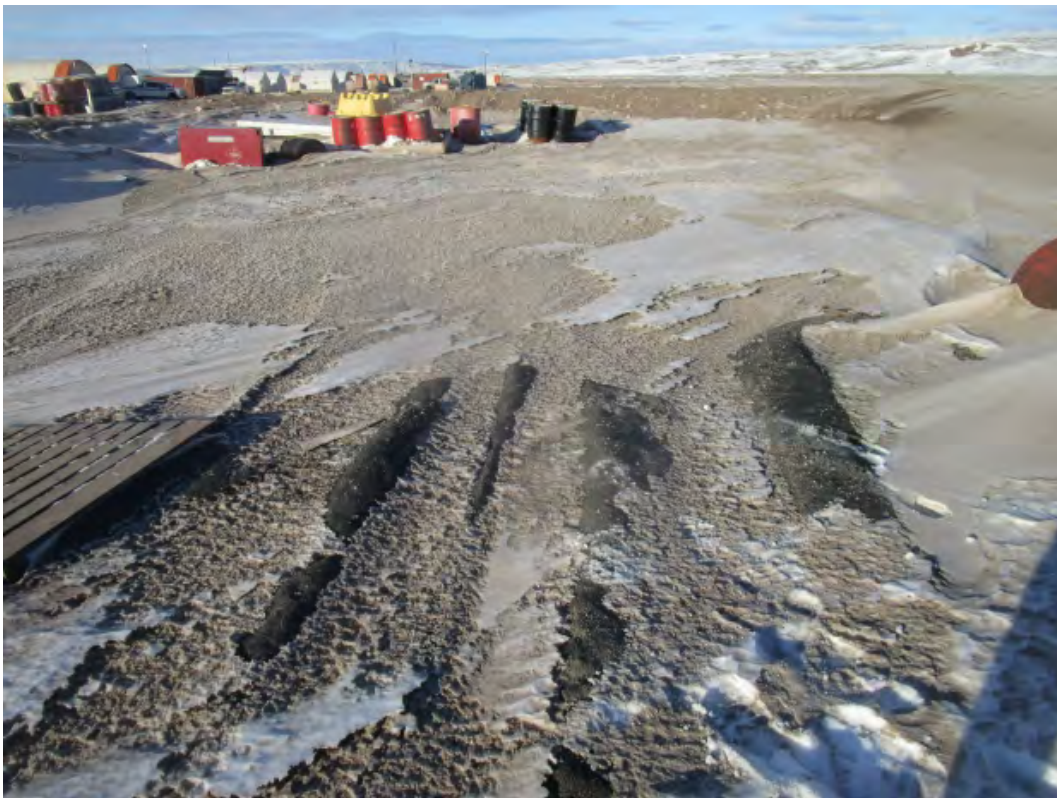
H. MS-HWB-2 – Hazardous Waste Storage – Exposed Liner

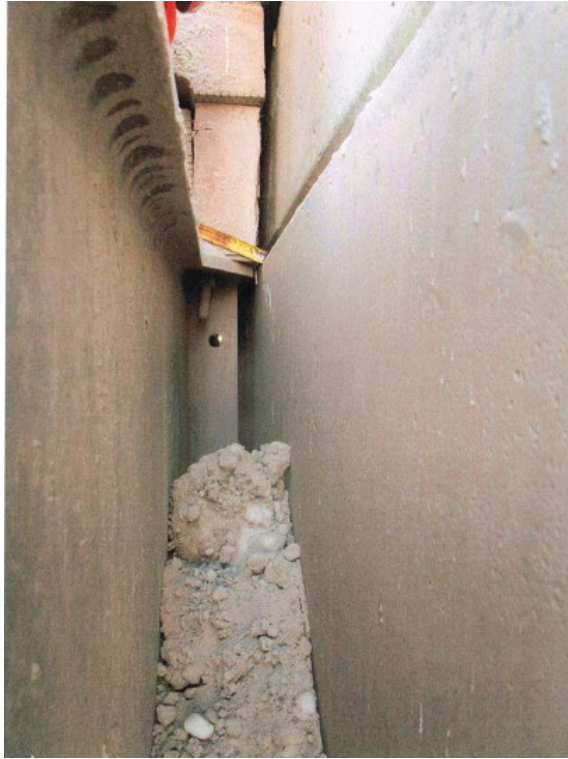
**Photo 1 - North Abutment - NE Corner**

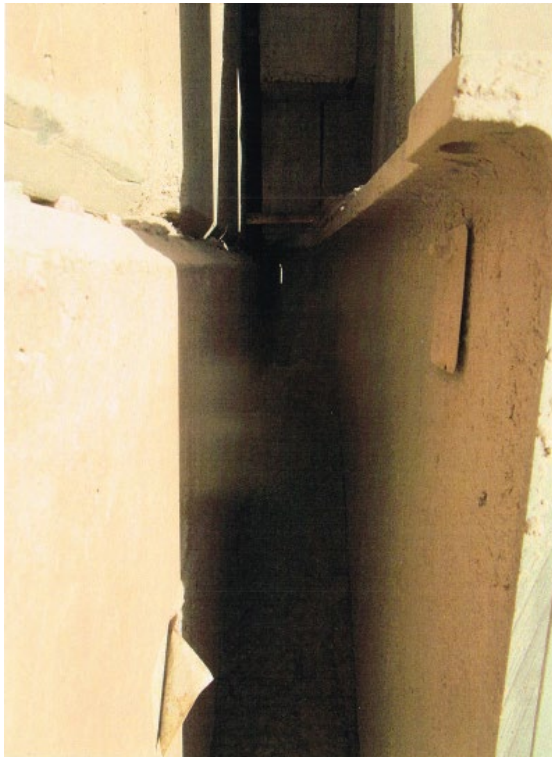
**Photo 2 - North Abutment - NW Corner**
