APPENDIX E.8.2

QIA INSPECTION REPORTS AND BAFFINLAND RESPONSES

Table 1. Summary of findings, recommendations, and action items from the June 2018 Site Inspection

RE: Response to QIA June 2018 Site Inspection, Findings and Recommendations

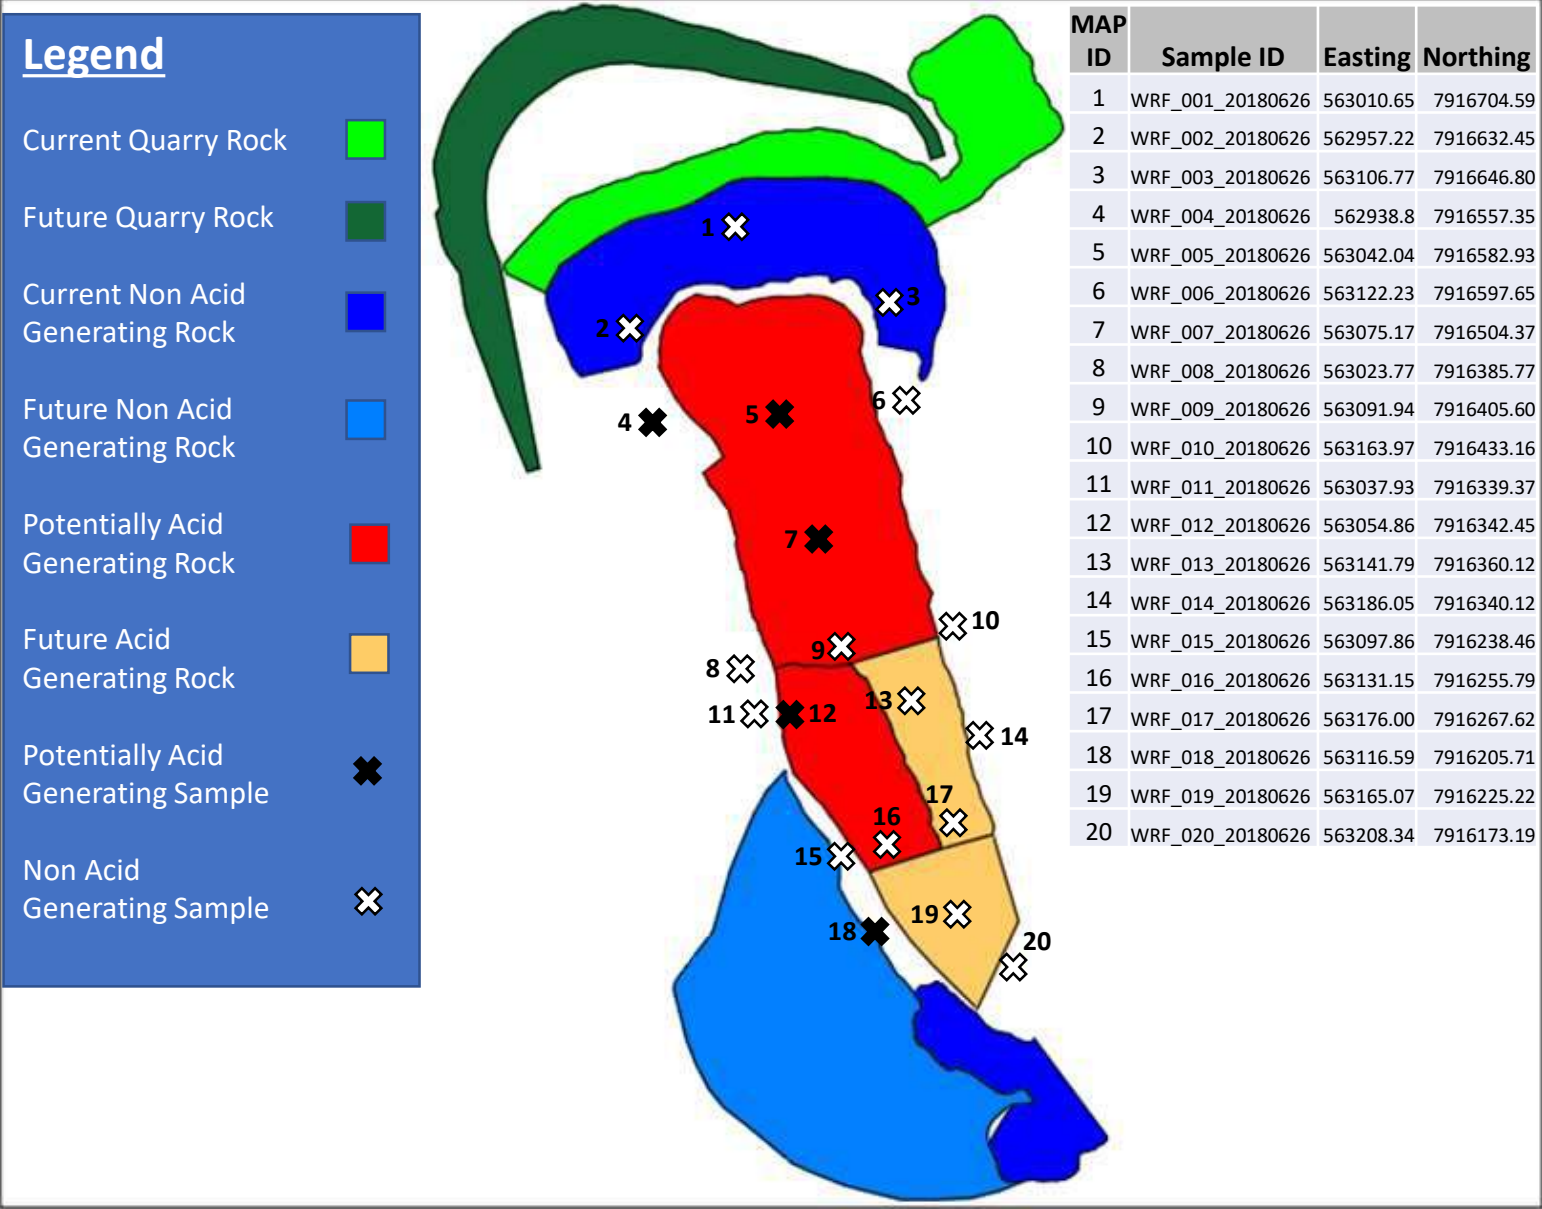
Figure 1: Waste Rock Facility Sample Location Plan

Sample WRF_018_20180626, classified as PAG, was sampled from a location where only NAG waste rock is expected to have been placed as indicated in Figure 1. The rock is supposed to be the base layer of NAG placed on the ground on which PAG material will eventually be placed. Sample WRF_004_20180626 obtained from a slope that appears to be located outside the identified PAG boundaries as sent by Baffinland on June 8, 2018. Baffinland is requested to explain why PAG material was placed in these locations, provide a plan and a schedule to address the situation on or before August 30, 2018.

Given the non-compliance observed from the Sample WRF_018_20180626 location, it is required that the sampling and verification program be performed on an annual basis at the minimum to verify the success of PAG rock segregation and placement. This program should be developed by Baffinland and submitted to QIA for approval.

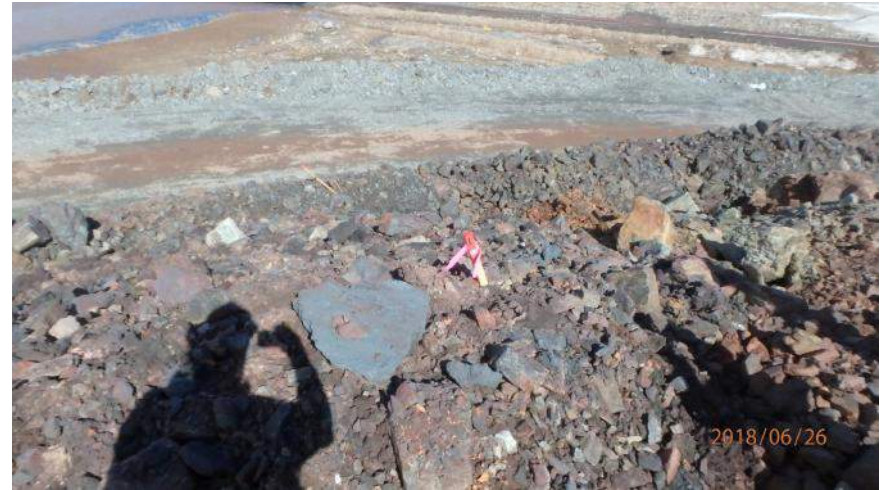
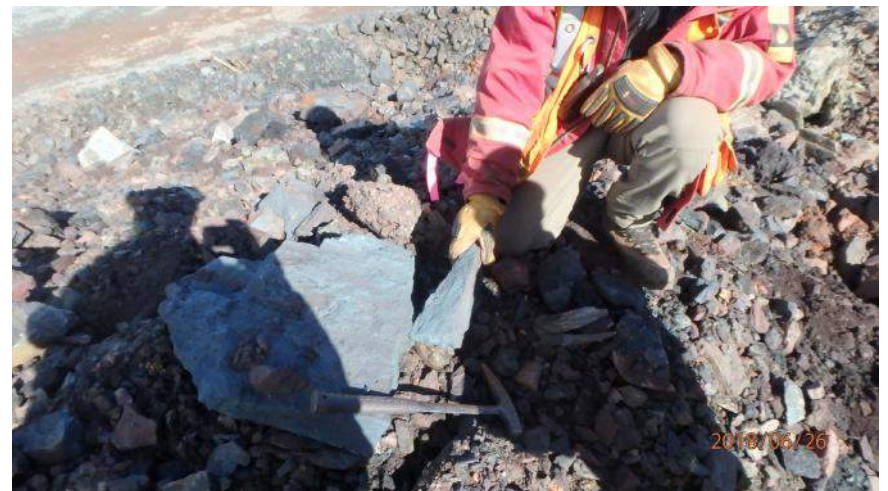
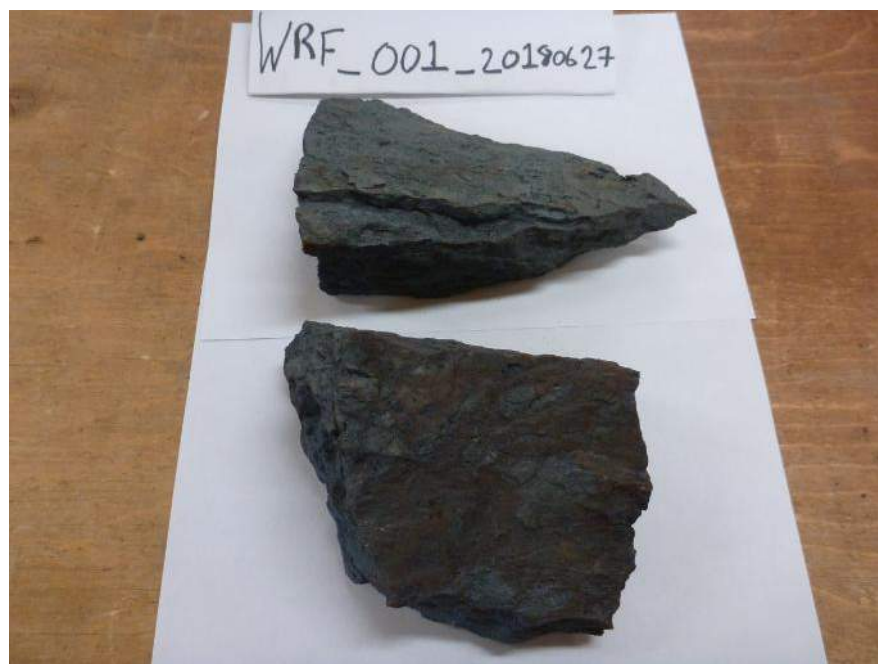
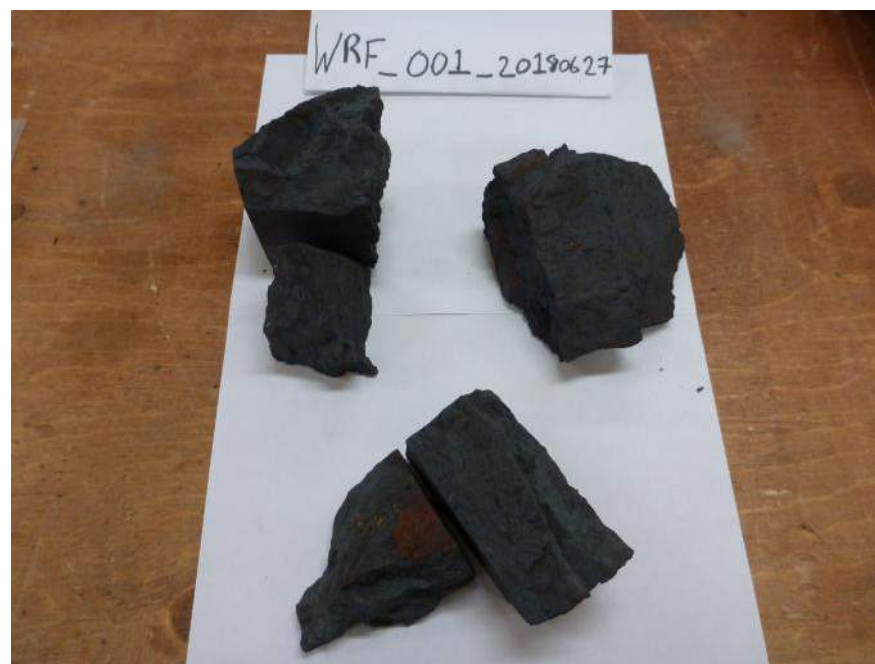
WRF_001_20180626

- Sample collected from northern facing slope of stockpile
- Area is predominantly iron ore
- Sample is high grade iron formation
- Weakly magnetic massive hematite with minor magnetite. Moderate porosity and no visible sulphides

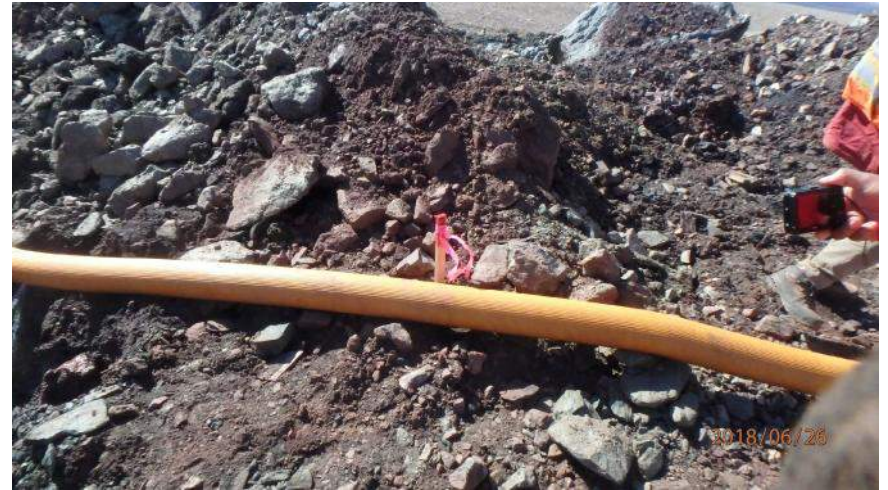
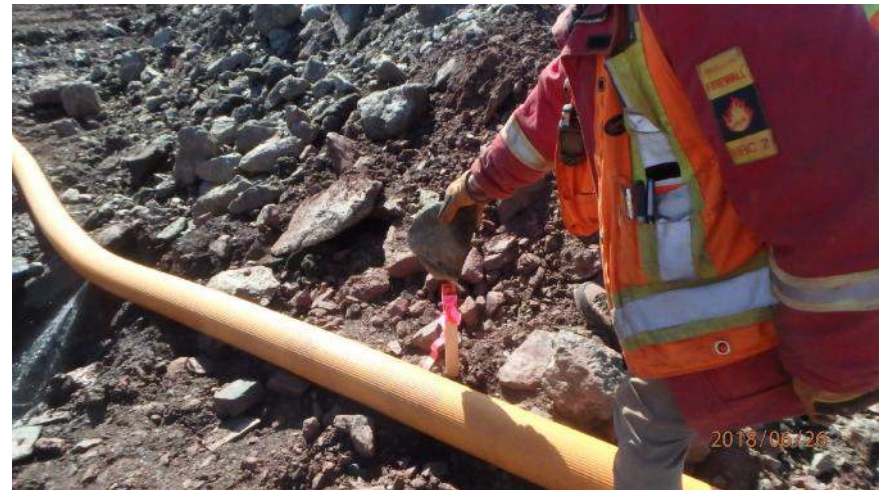
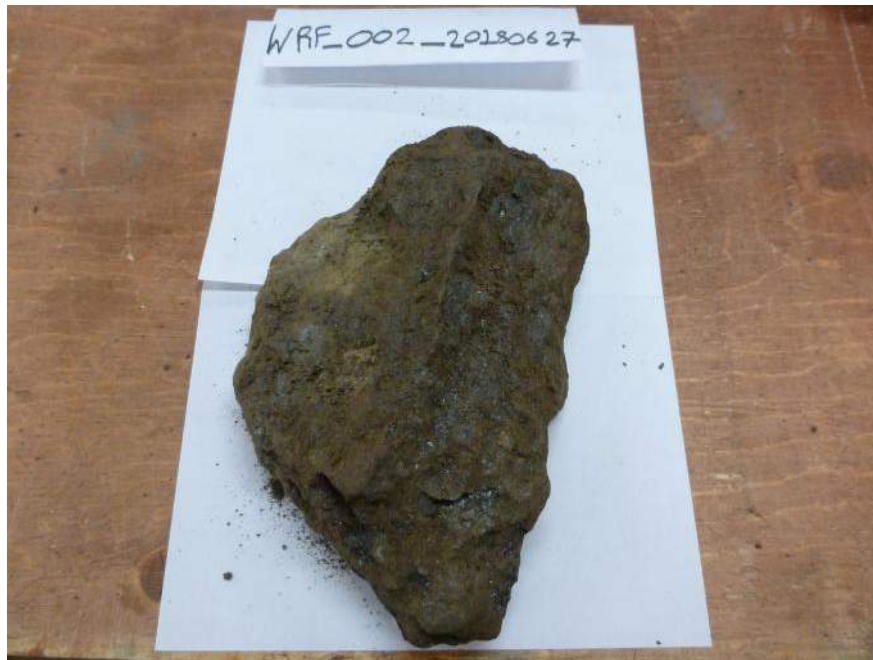
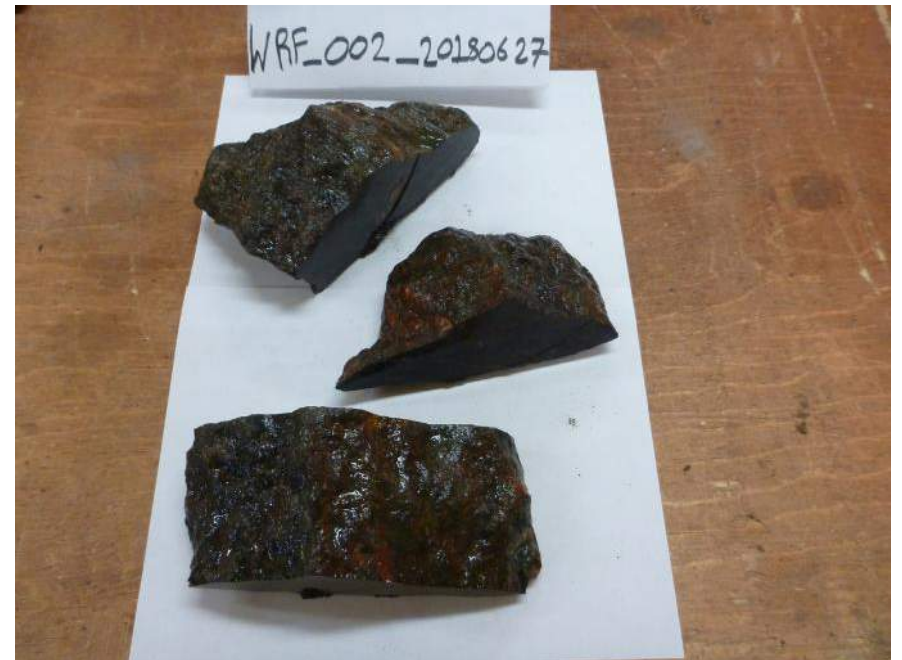
WRF_002_20180626

- Sample collected from north-western terrace of stockpile
- Area is a mix of iron ore and biotite chlorite schist
- Sample is biotite chlorite schist
- Dominantly biotite and mm scale garnets moderately chlorite and hematite altered. No visible sulphides.

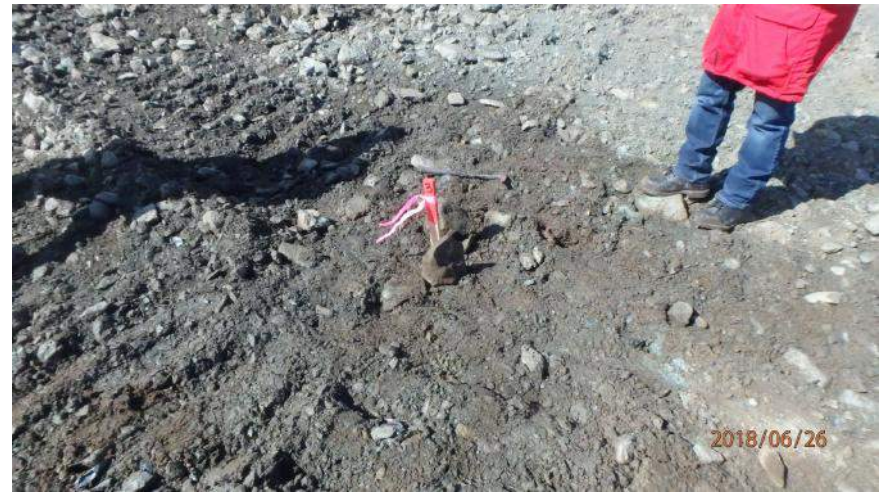
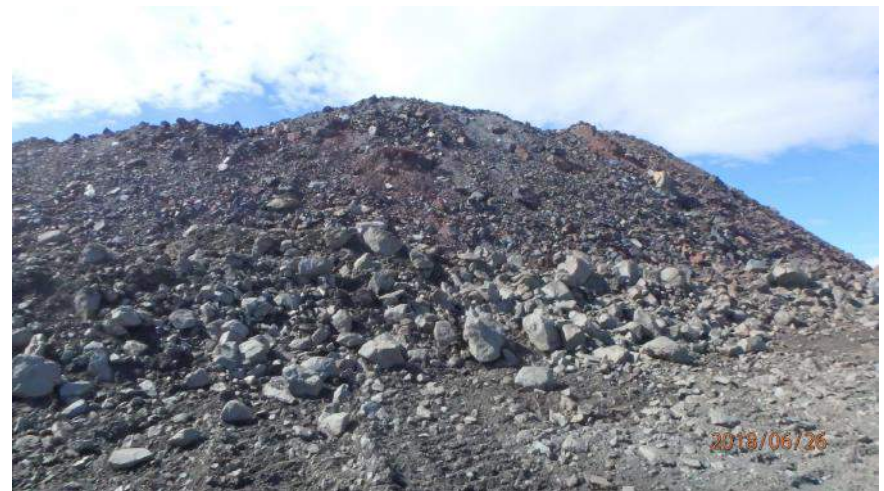
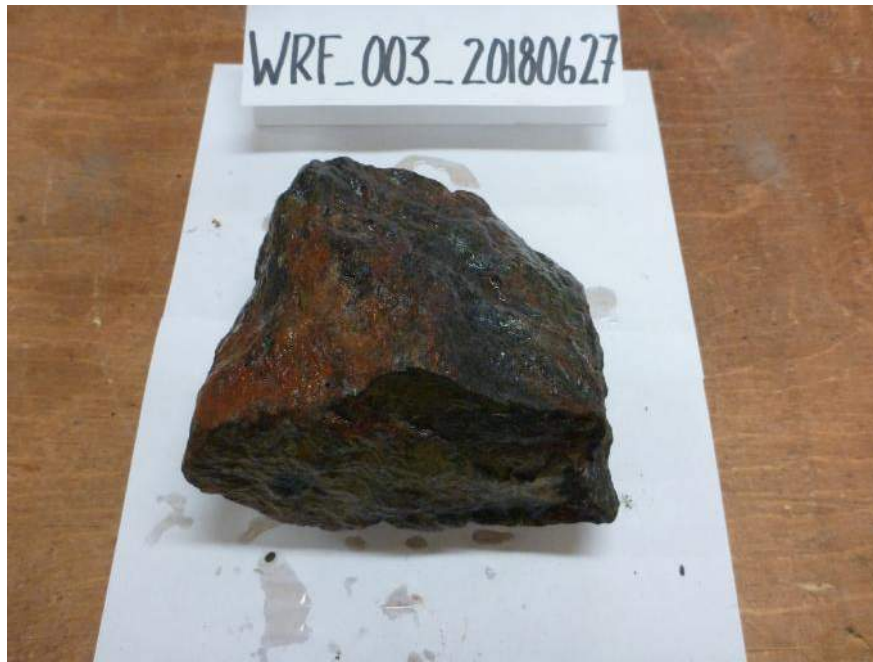
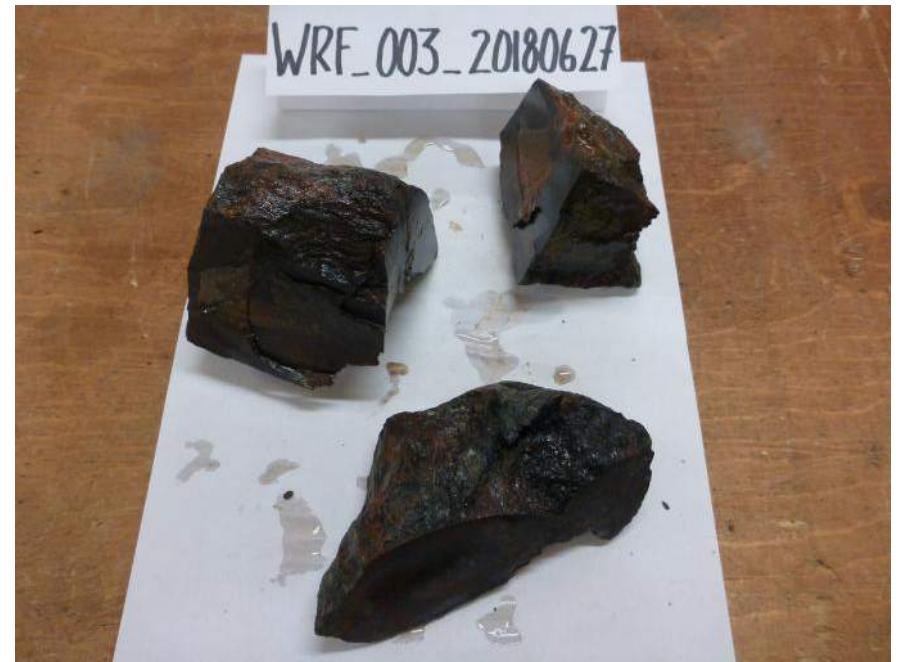
WRF_003_20180626

- Sample collected from north-eastern terrace of stockpile
- Area is mainly biotite chlorite schist
- Sample is biotite chlorite schist
- Matrix is dominantly diorite and chlorite with moderate hematite staining. Local quartz right veinlets cross cutting. No visible sulphides.

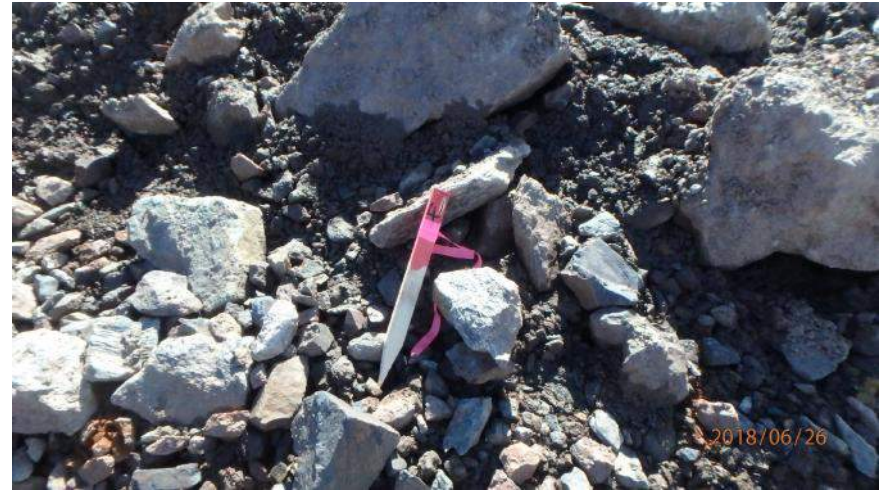
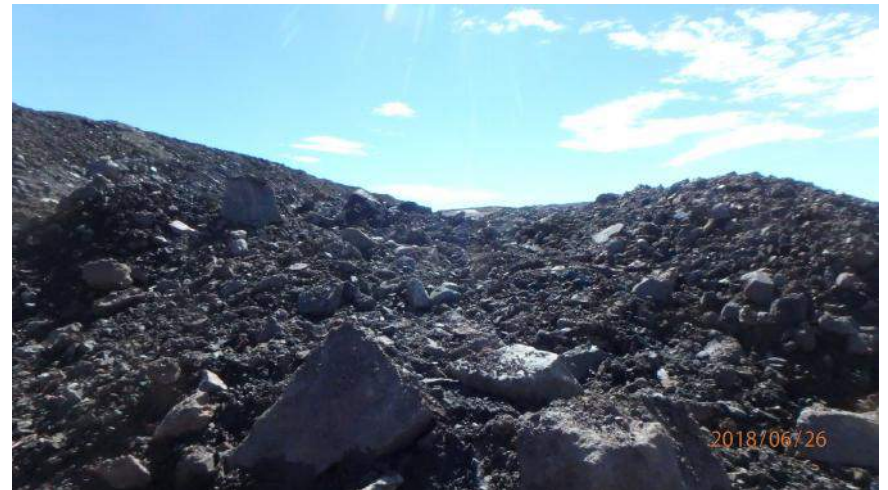
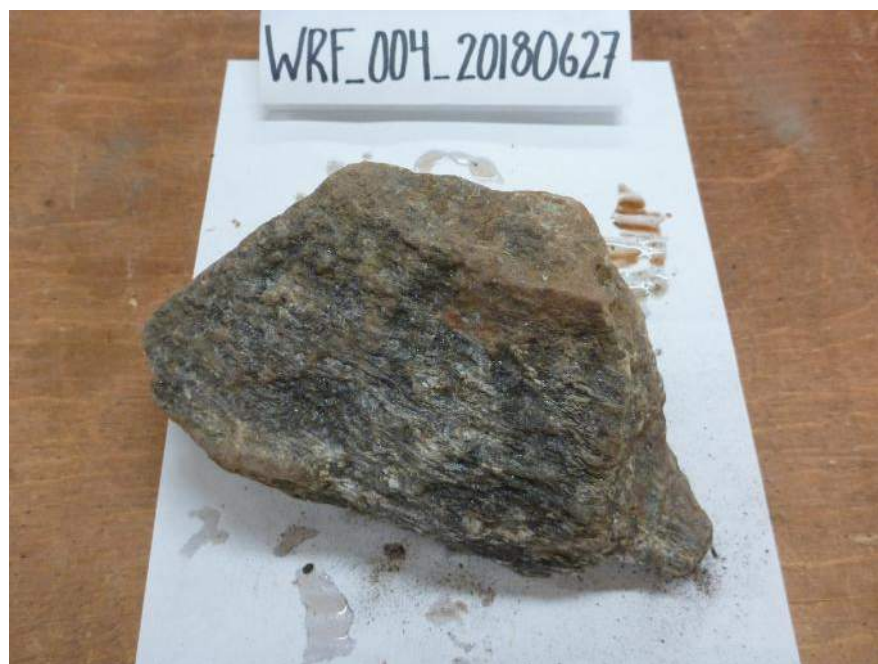
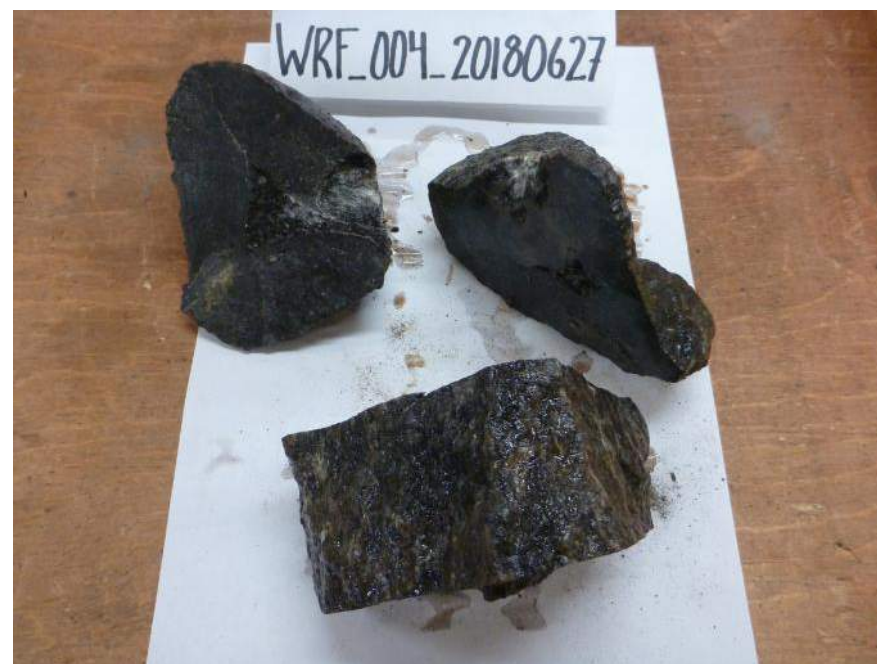
WRF_004_20180626

- Sample collected from western terrace of stockpile
- Area is a mix of different schist units
- Sample is Quartz-Feldspar-Biotite-Amphibole Gneiss
- Dominant mafic layers with strained quartz approaching augen texture. 1% disseminated pyrite in matrix.

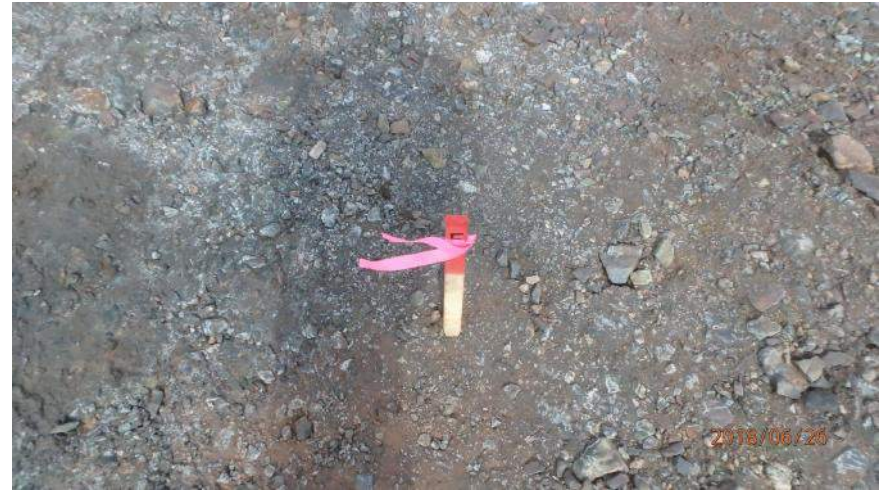
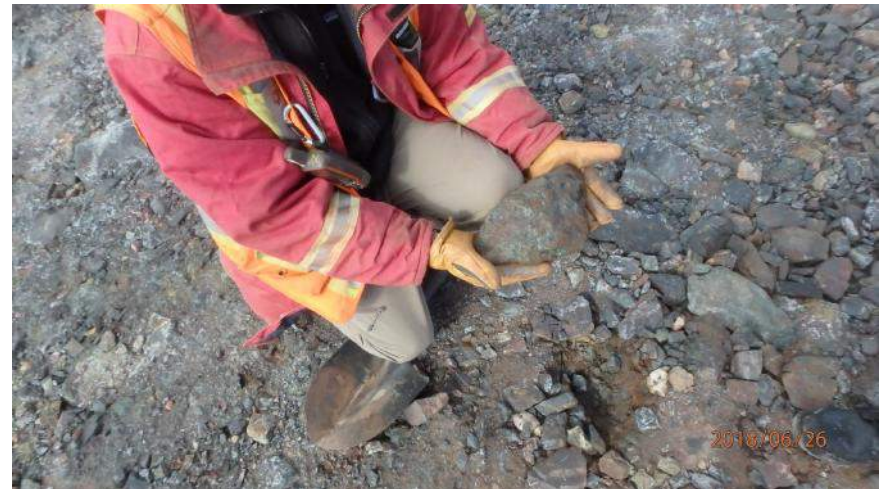
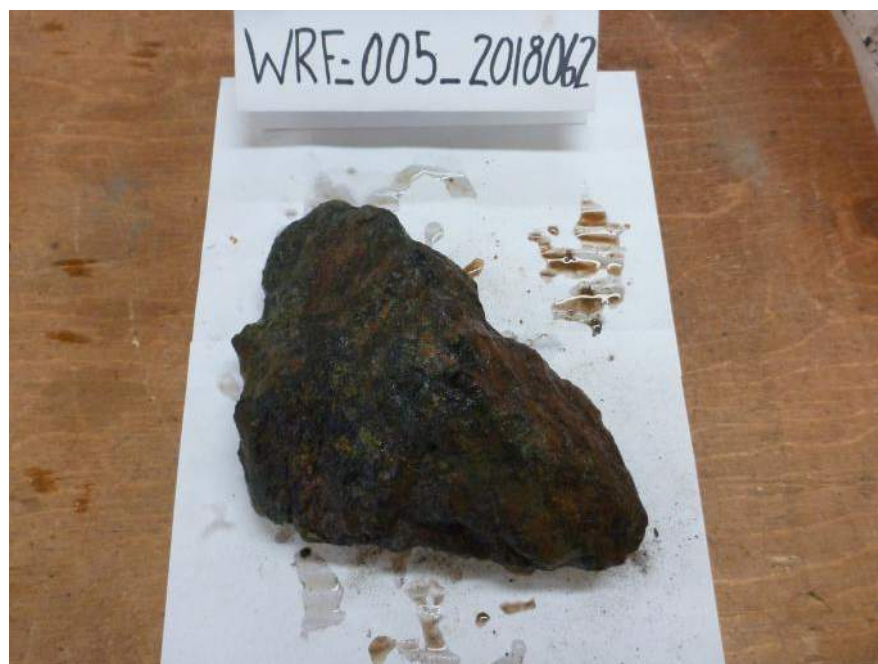
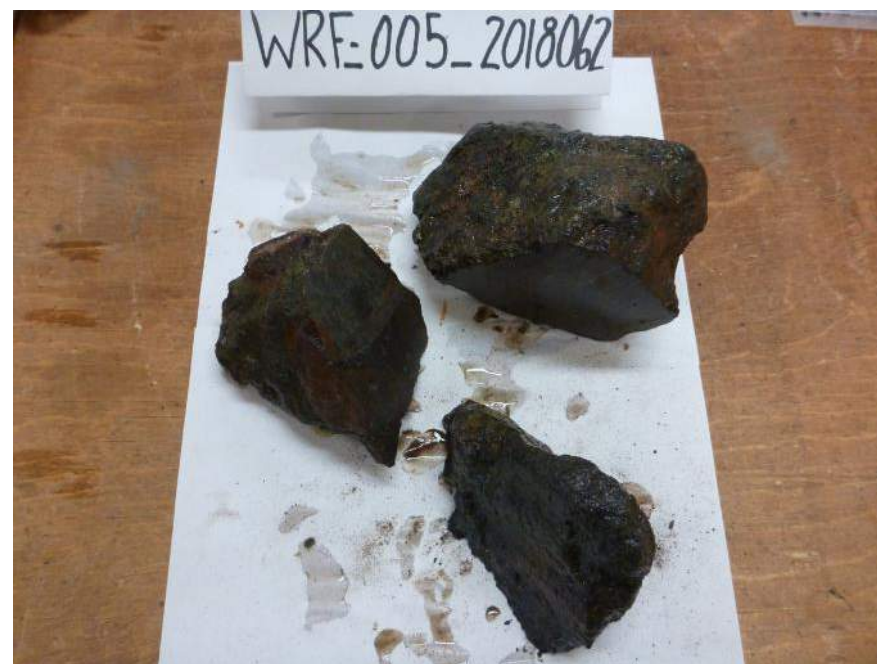
WRF_005_20180626

- Sample collected from top lift of stockpile
- Area is hard-packed. Mix of chlorite schist and some ore.
- Sample is Chlorite Schist
- Chlorite matrix with weak hematite alteration. 2% fine trained to medium trained blebby pyrite.

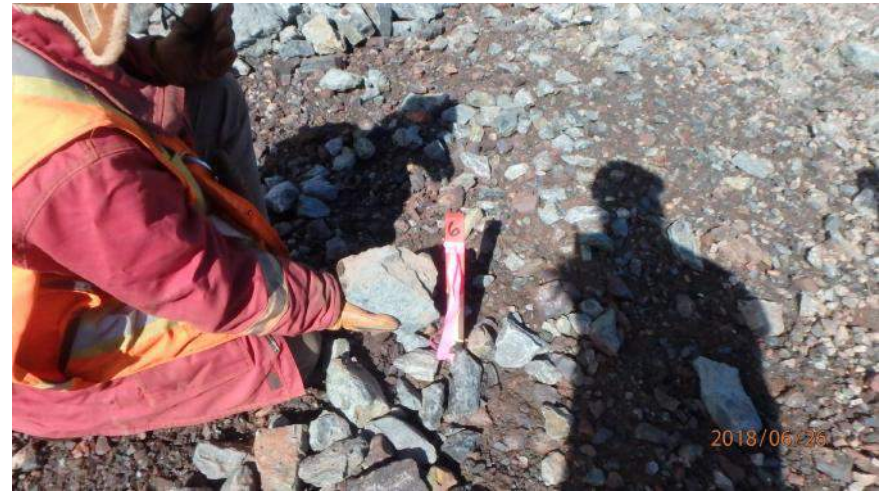
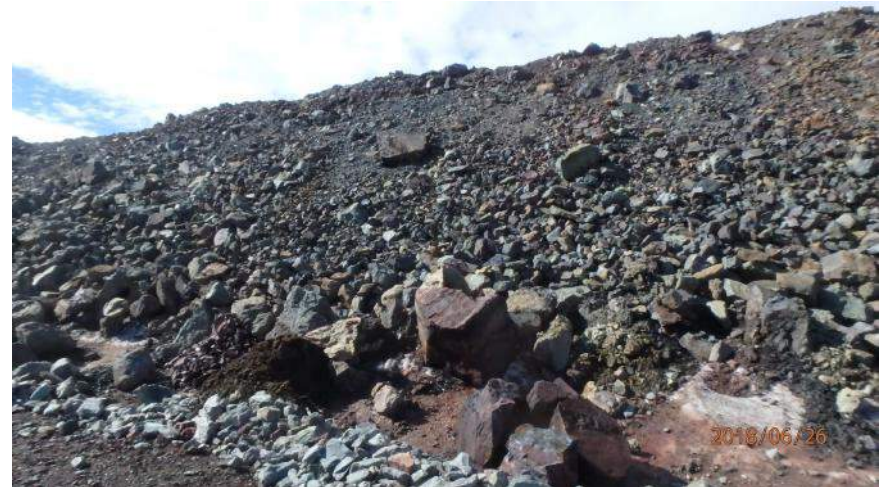
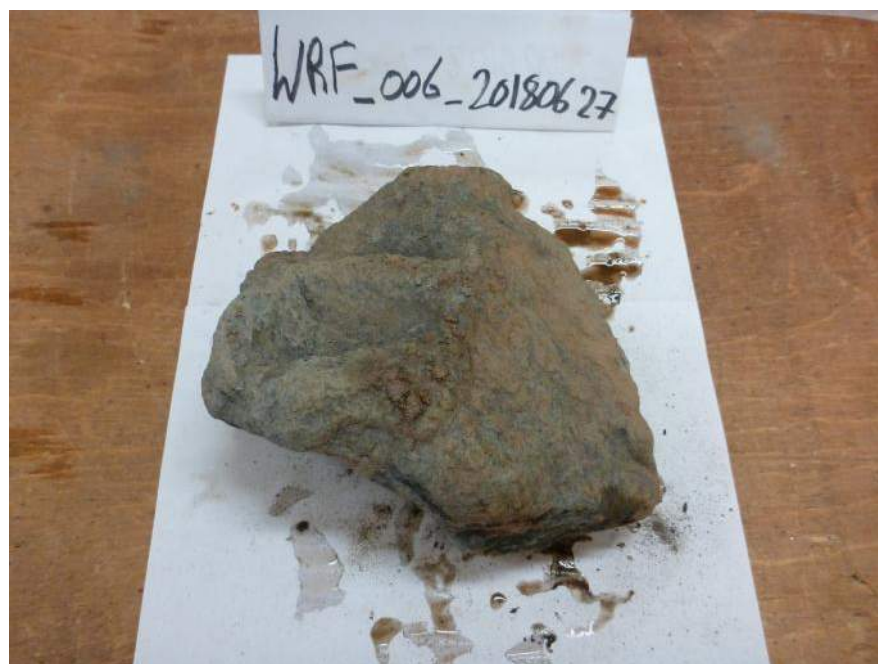
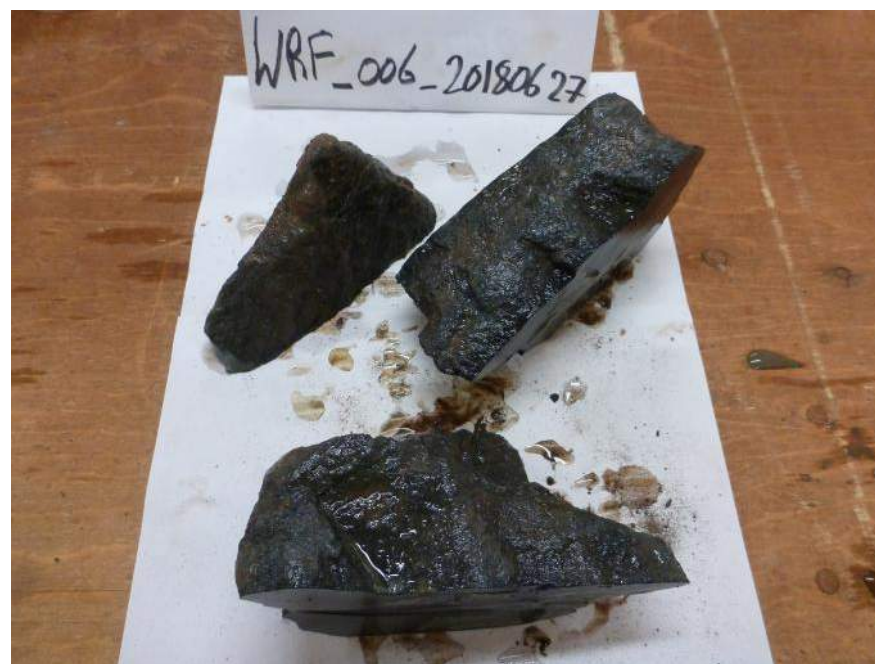
WRF_006_20180626

- Sample collected from eastern terrace of stockpile
- Area is a mix of chlorite schist and some ore.
- Sample is Chlorite Schist
- Chlorite dominant schist with 1% fine grained disseminated pyrite.

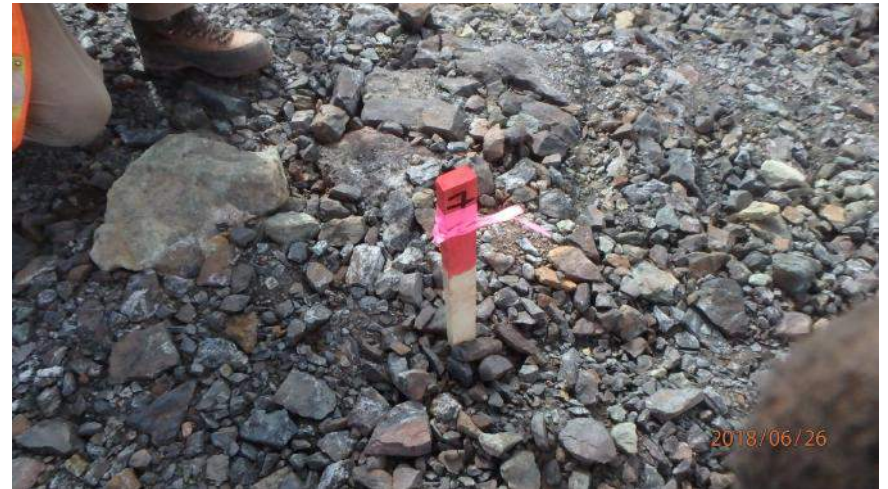
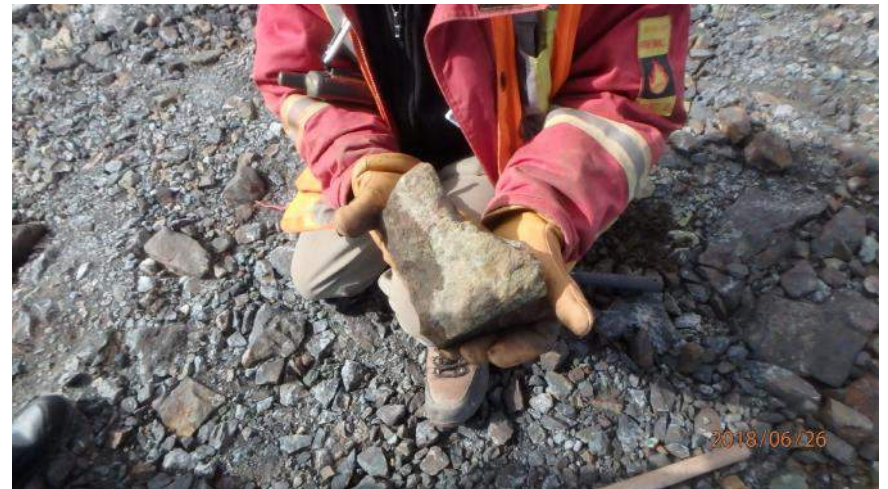
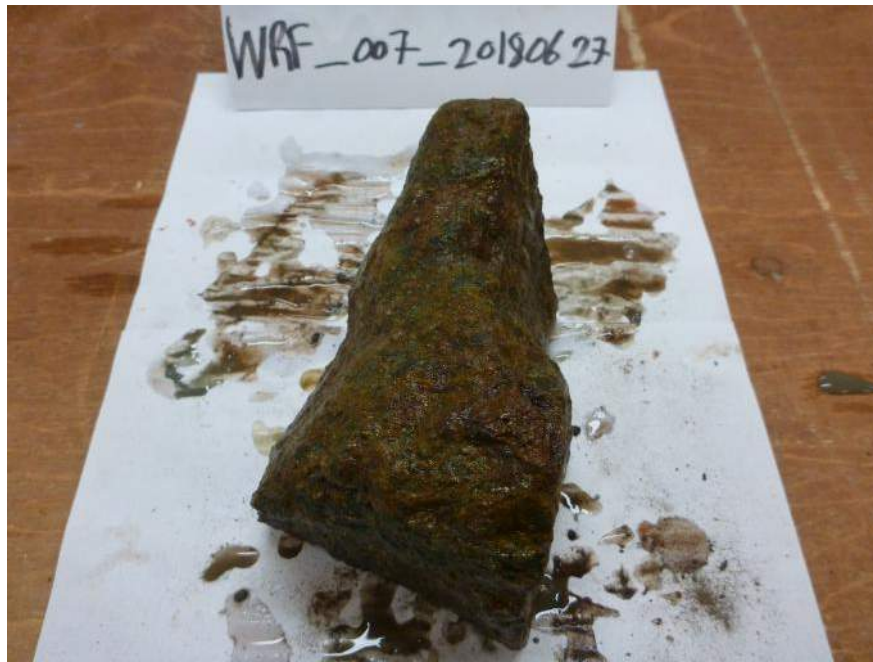
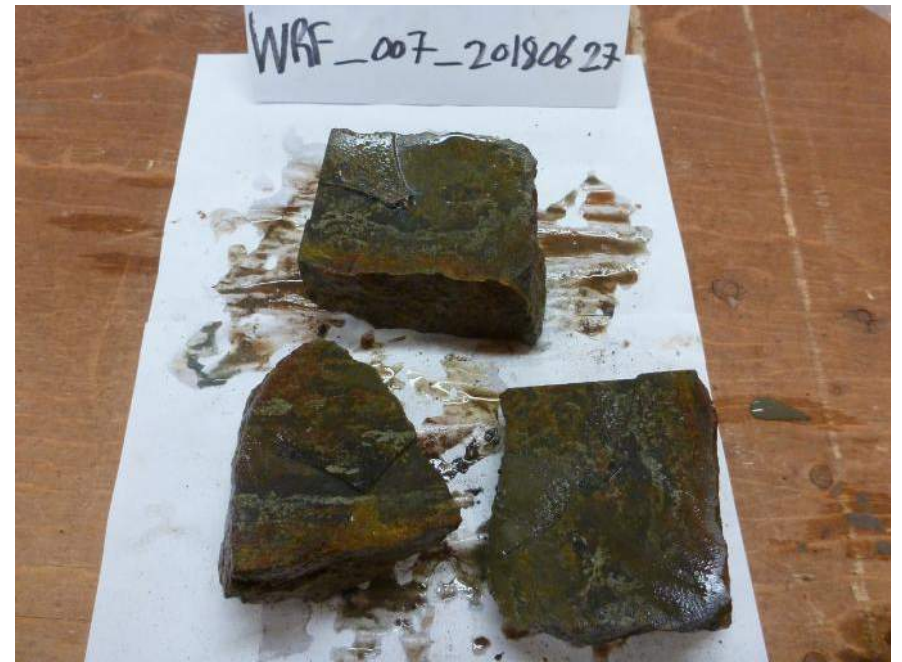
WRF_007_20180626

- Sample collected from top lift of stockpile
- Area is hard-packed. Mix of chlorite schist with minor ore.
- Sample is Chlorite-Biotite Schist
- Chlorite and biotite dominant matrix with 20% fine grained to coarse grained net textured and stringer pyrite.

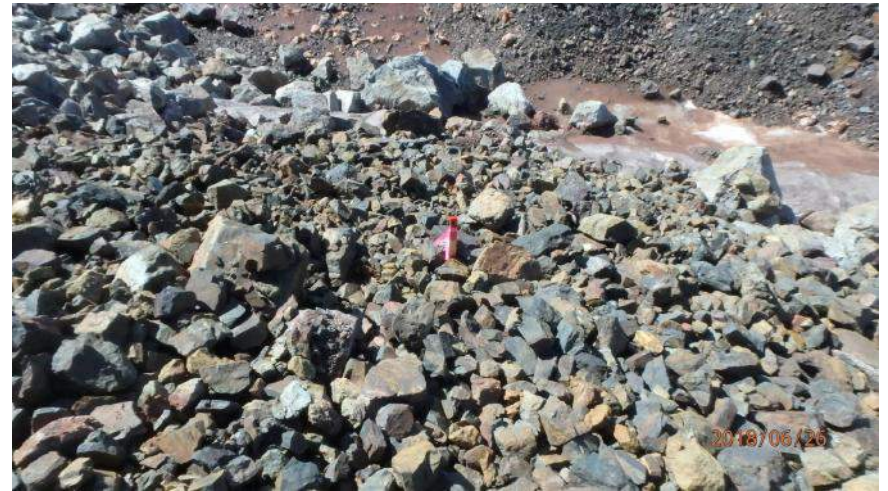
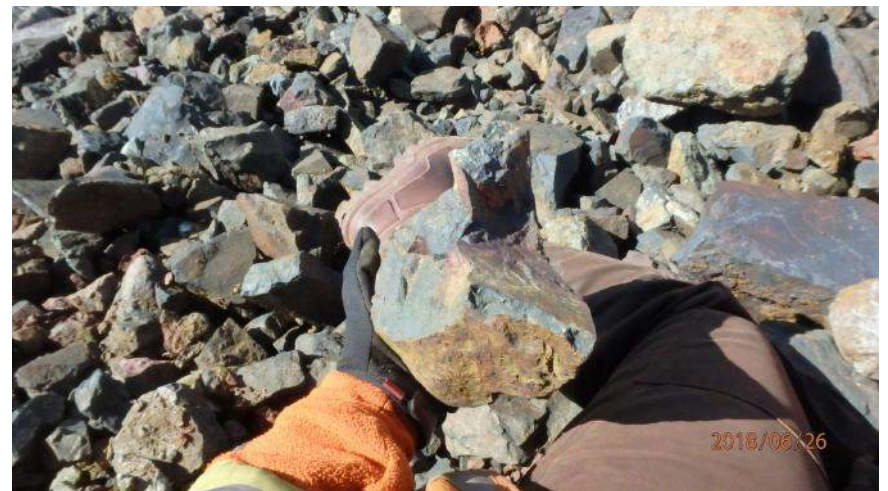
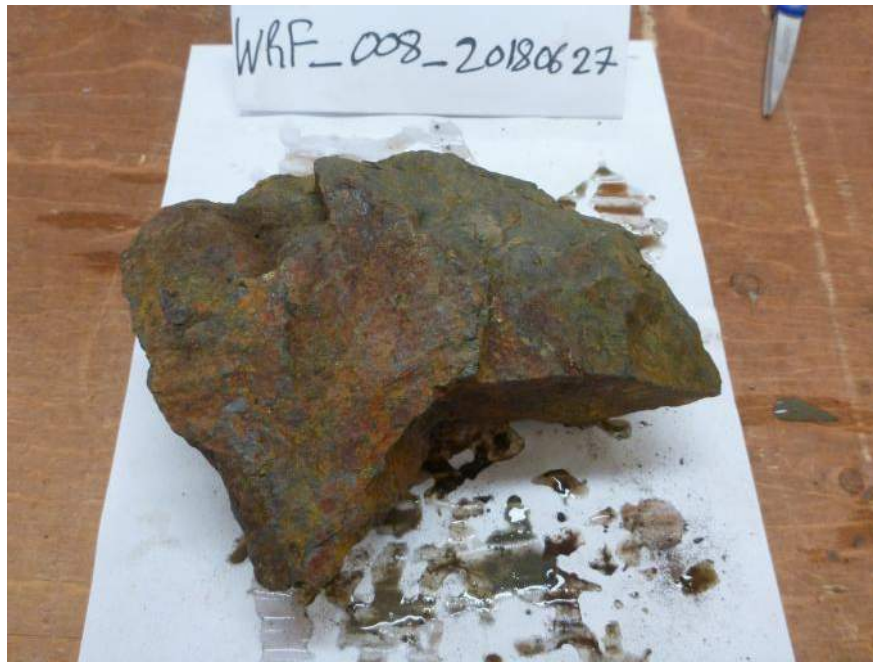
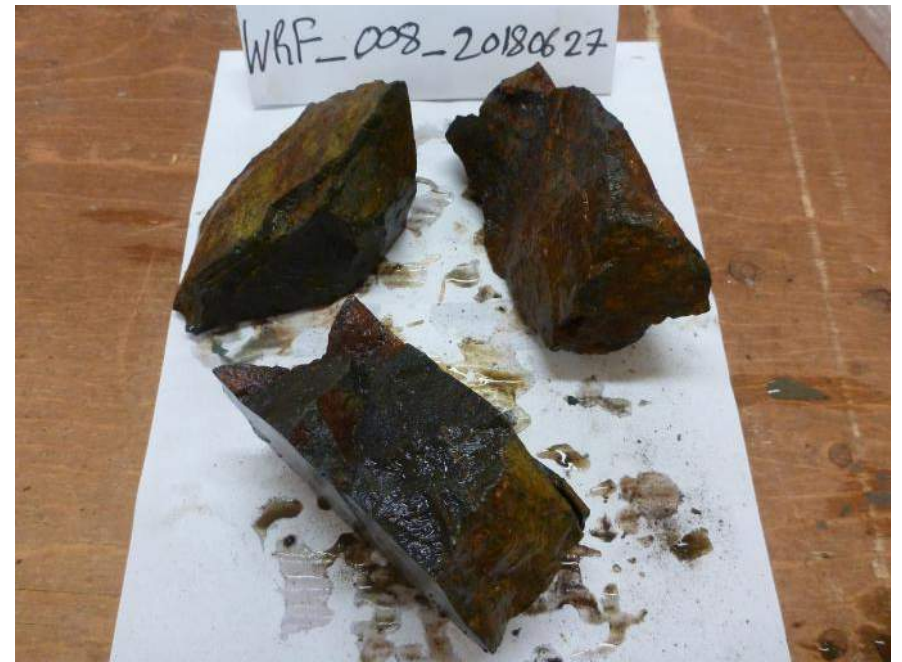
WRF_008_20180626

- Sample collected from western slope of stockpile.
- Area is a mix of high-grade iron ore and biotite-chlorite schist.
- Sample is High Grade Iron Formation.
- Massive magnetite with clay filled voids.
No sulphides visible.

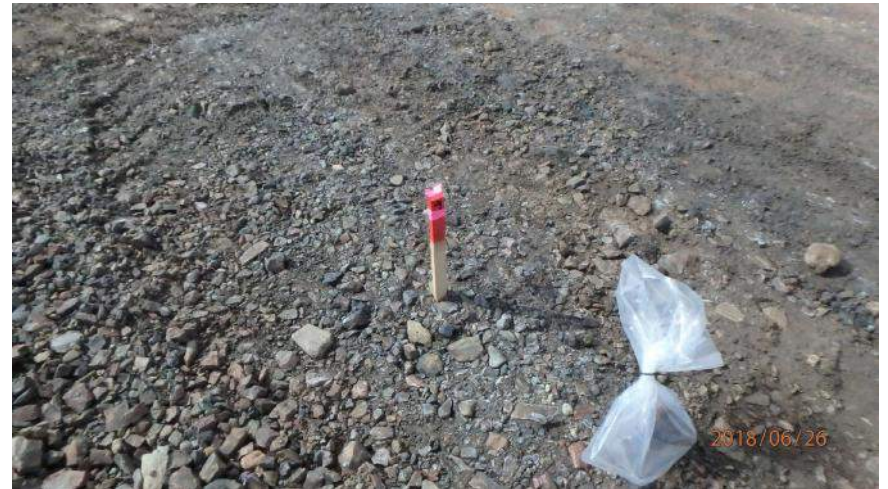
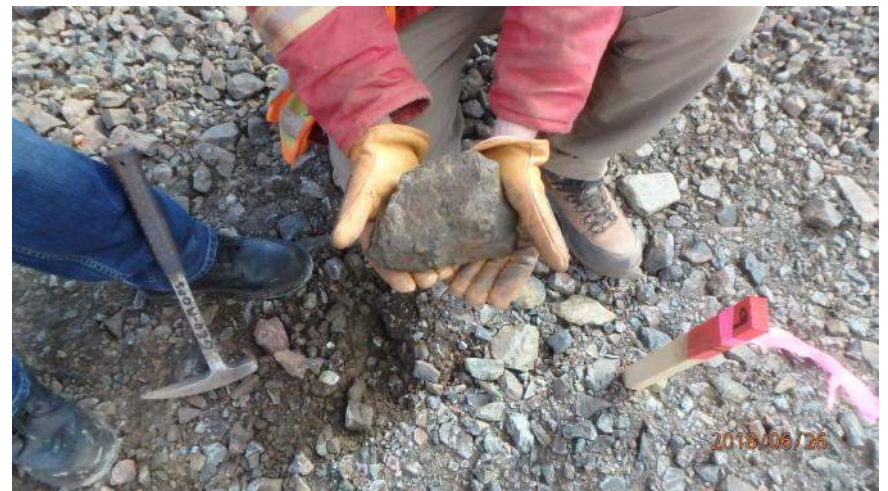
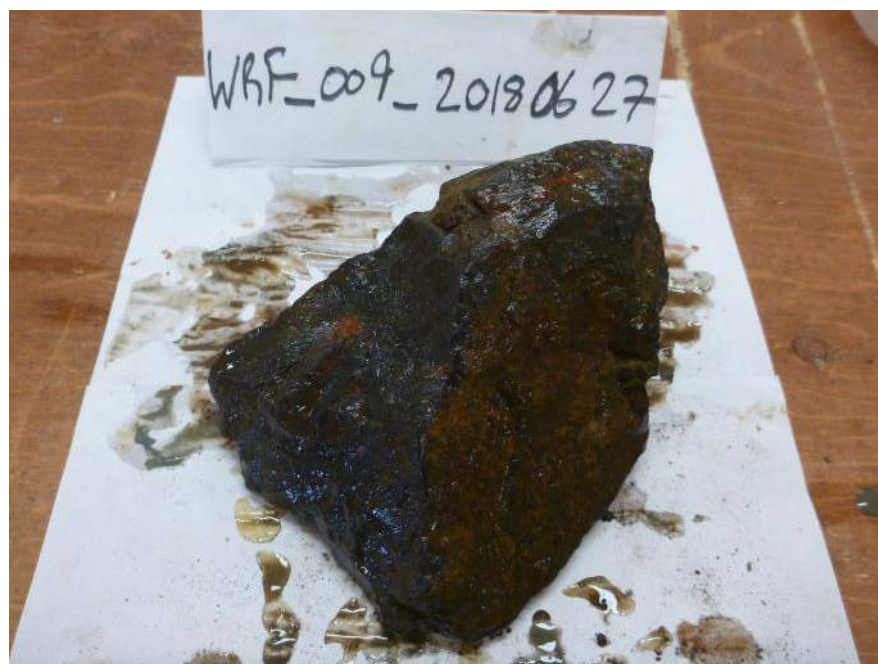
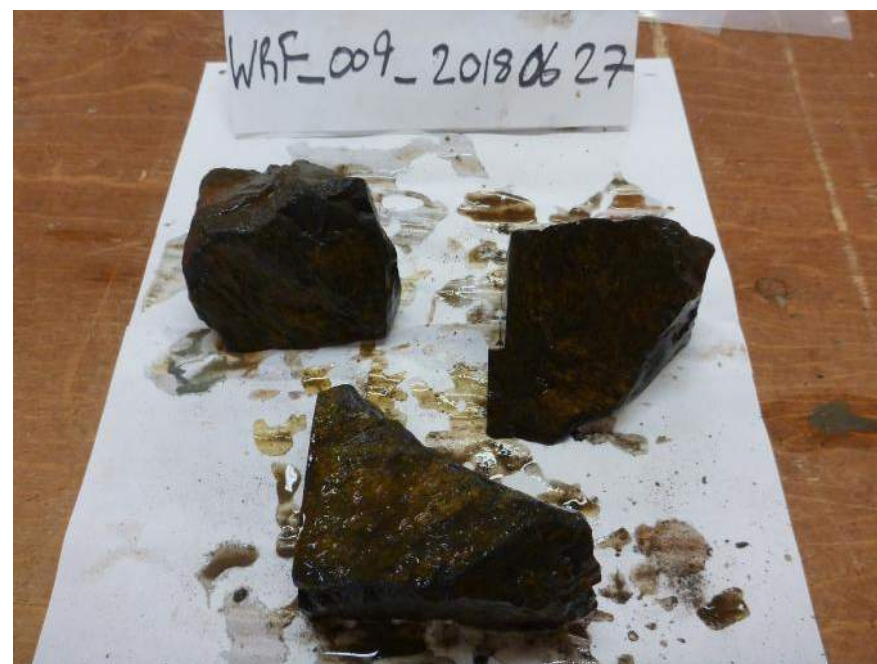
WRF_009_20180626

- Sample collected from top lift of stockpile
- Area is hard-packed. Mix of chlorite schist with minor ore.
- Sample is High Grade Iron Formation.
- Massive magnetite with clay filled vesicles.
No sulphides visible.

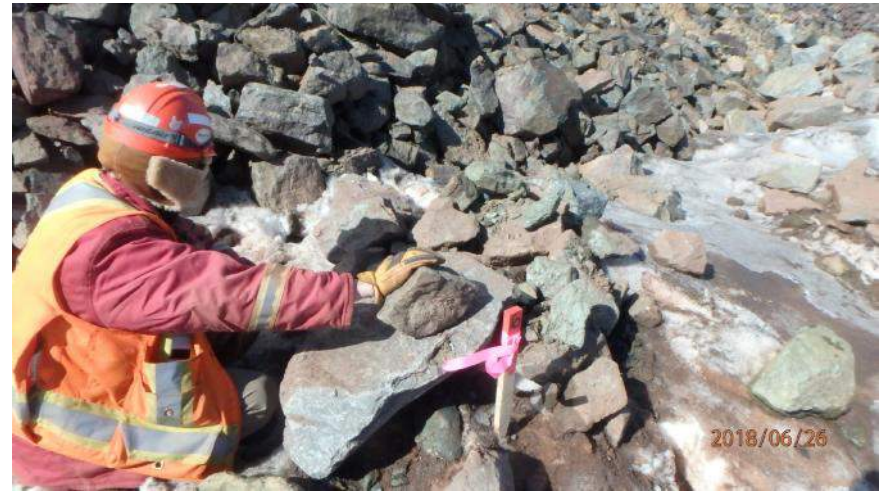
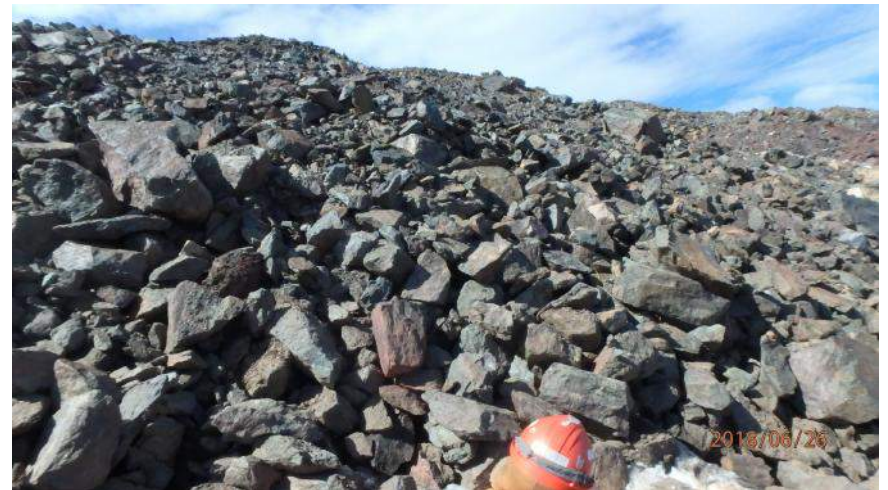
WRF_010_20180626

- Sample collected from base of eastern facing slope of stockpile
- Area is predominantly chlorite schist.
- Sample is Chlorite-Biotite-Garnet Schist.
- Chlorite and biotite dominant matrix with minor quartz and mm to cm scale garnet porphyroblasts. No visible sulphides.
