## 2019 Inspection of the Milne Inlet Tote Road and Associated Borrow Sources

PRESENTED TO  
**Baffinland Iron Mines Inc.**

OCTOBER 30, 2019  
ISSUED FOR REVIEW  
FILE: ENG.EARC03171-01

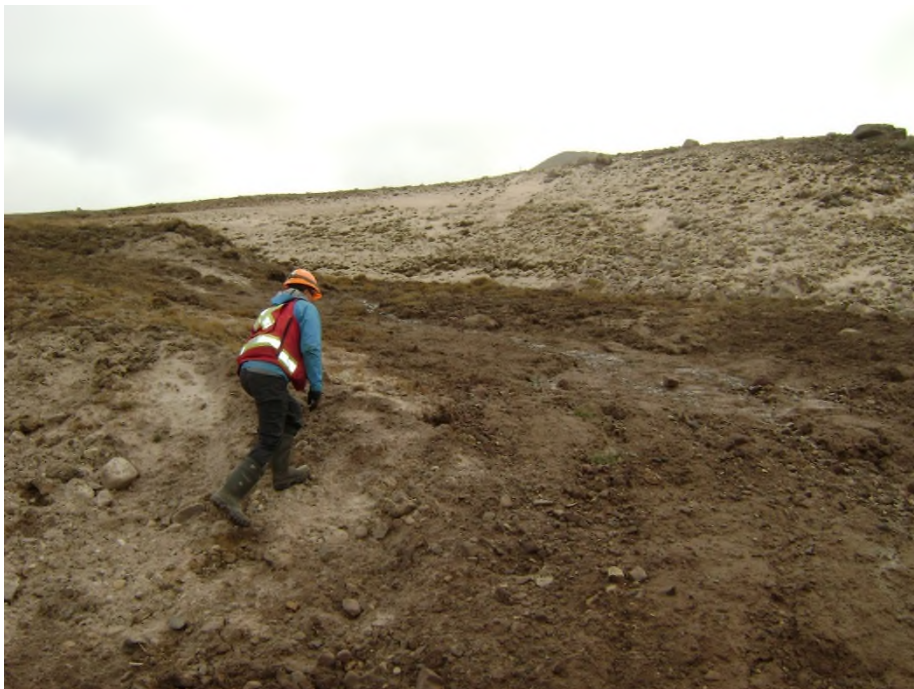
**Photo 37 (2523):**

KM 2.5 slope instability and mud slide adjacent to the Tote Road.

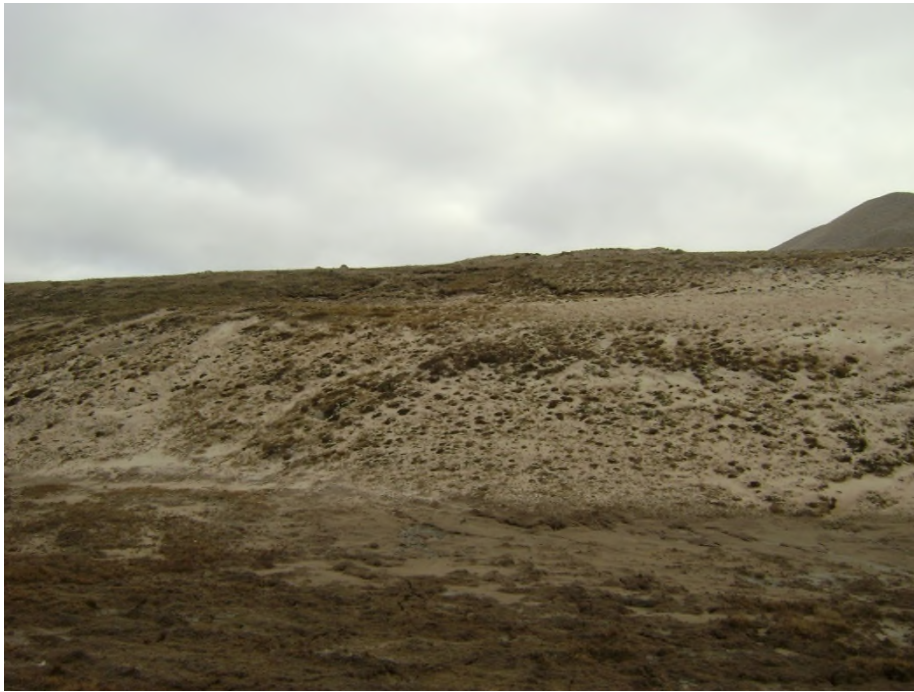
**Photo 38 (2524):**

KM 2.5 slope instability and mud slide adjacent to the Tote Road. Photo on terrace above the road, note evidence of a small instability near the top of the slope and thawed surficial materials on the terrace.

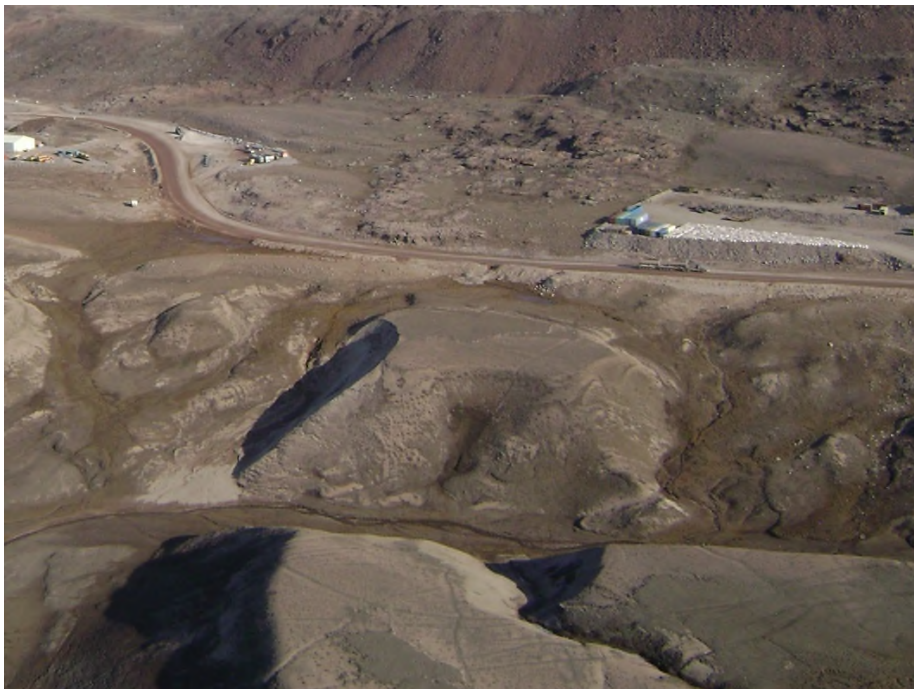
**Photo 39 (2526):**

KM 4.0 erosion location. Erosion is seen on the north (left in the photo) side of terrace (see also photo 40) with a large sedimentation fan near the creek, a wet area on the terrace below the road (see Photo 41) and secondary erosion feature (see Photo 42 on the south (right in the photo) side of the terrace.

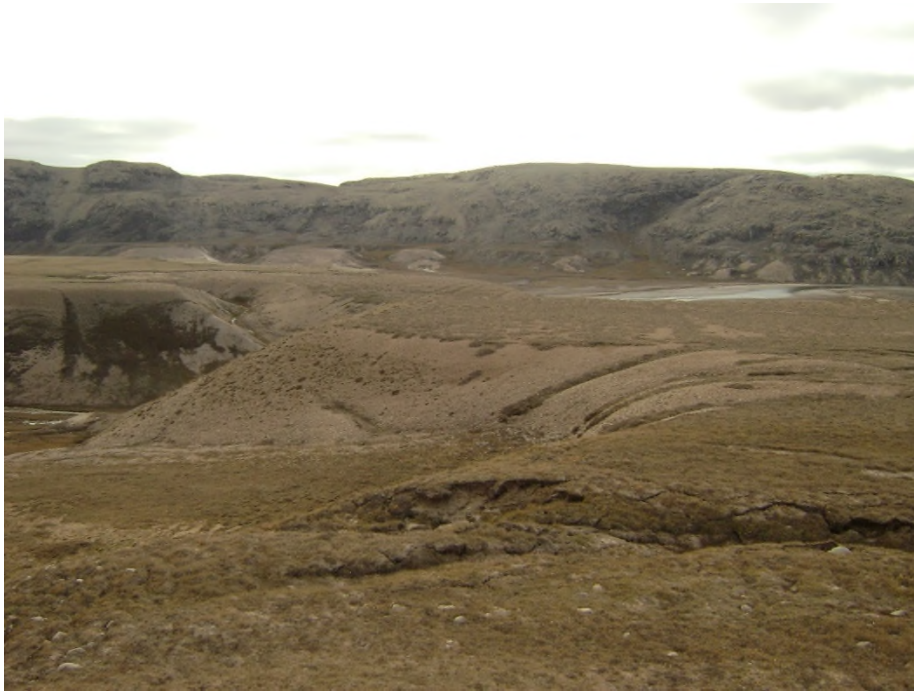
**Photo 42 (2527):**

KM 4.0 erosion location. Photo shows erosion at the edge of the south side of the terrace.

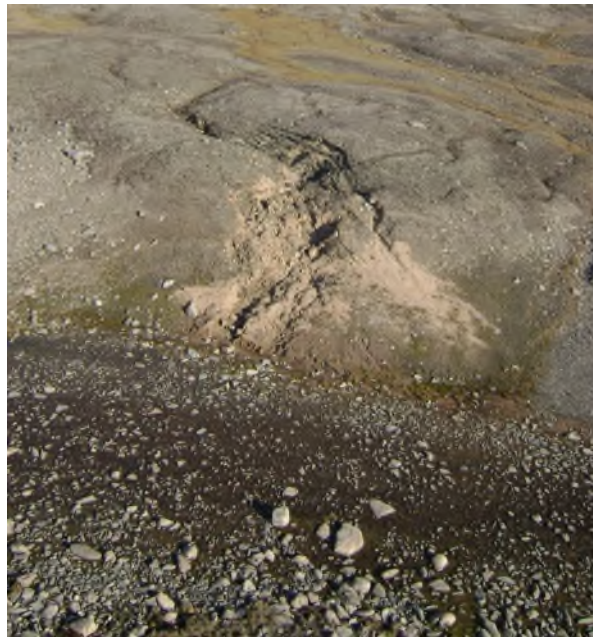
**Photo 43 (2728):**

Natural instability/erosion feature south of the Tote Road near KM 71. Surface water erosion leading to thaw and sediment release.

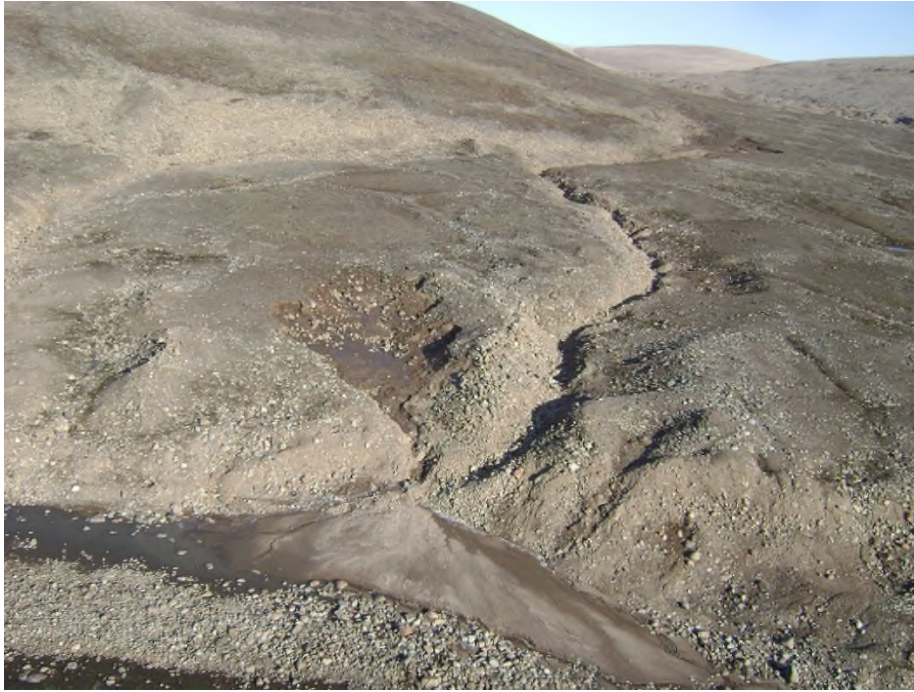
**Photo 44 (2721):**

Natural instability feature (active layer detachment side) on the headwaters of the Mary River 16 km east-northeast of the mine.

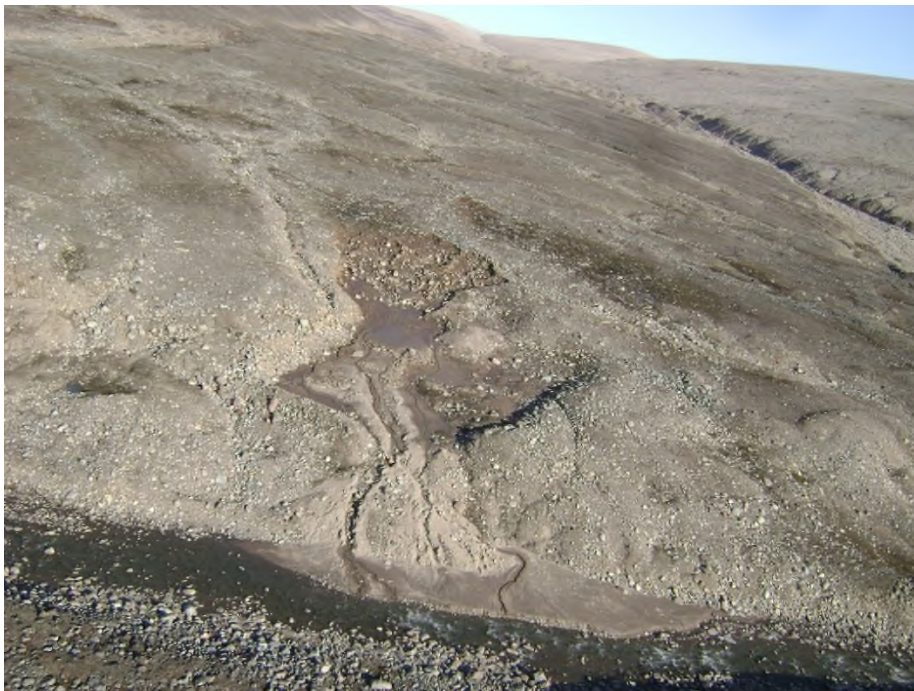
**Photo 45 (2722):**

Another natural instability feature (active layer detachment side) on the headwaters of the Mary River 16 km east-northeast of the mine. Note sedimentation into the river that lead to turbidity being observed in the river near the mine

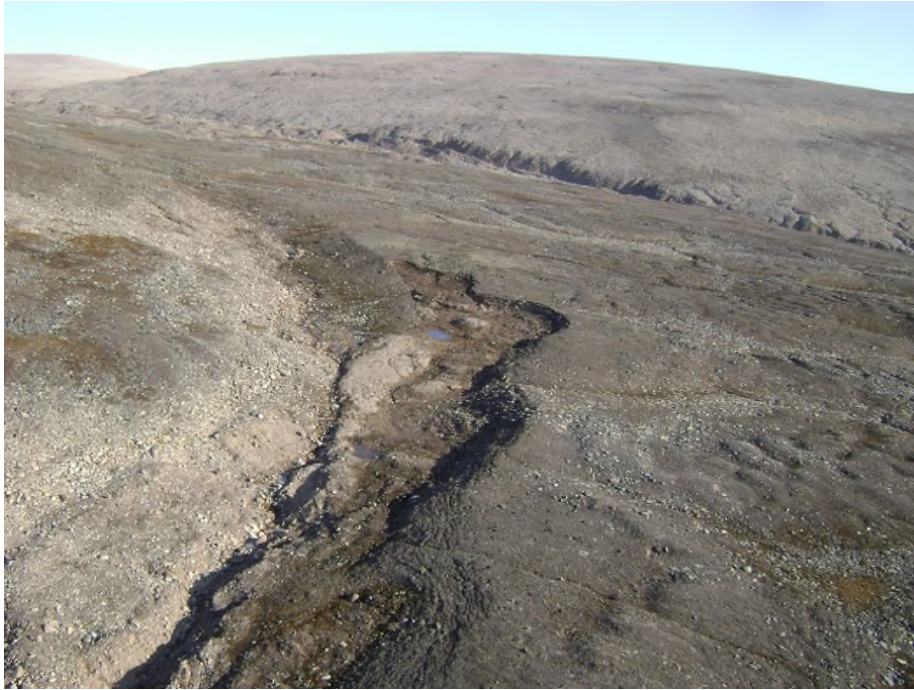
**Photo 46 (2724):**

More natural instability features (active layer detachment sides) uphill from the location shown in Photo 45 on the headwaters of the Mary River 16 km east-northeast of the mine.

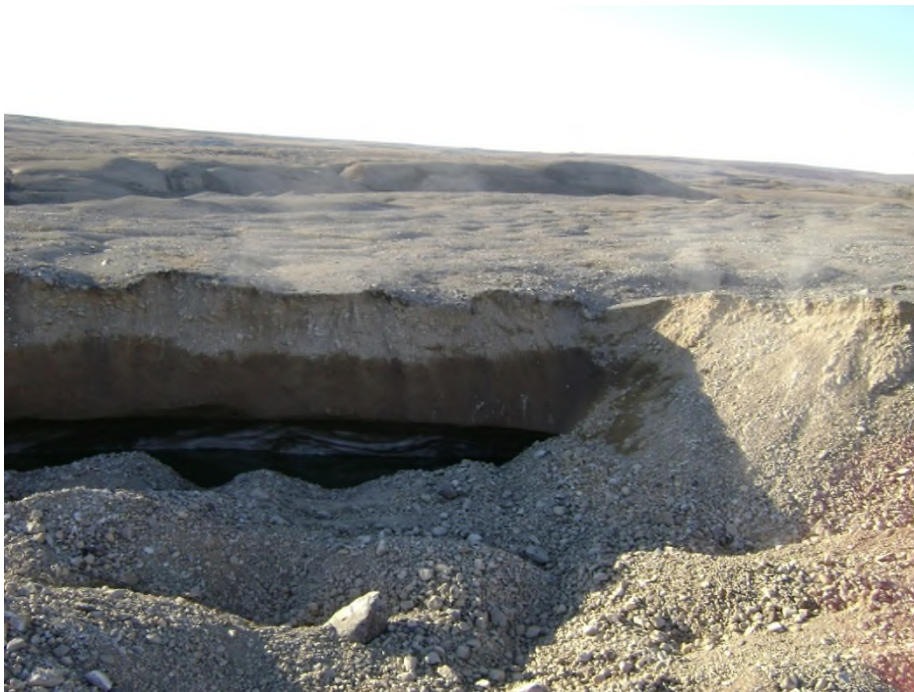
**Photo 47 (2014 photo):**

Photo of a natural collapse feature in undisturbed terrain. The photo clearly shows the active layer (light colour silty granular material), overlying frozen (darker material), overlying a massive ice body. Natural material over the ice is approximately 3.0 m thick. See Photo 48 taken in 2019 at the same location.

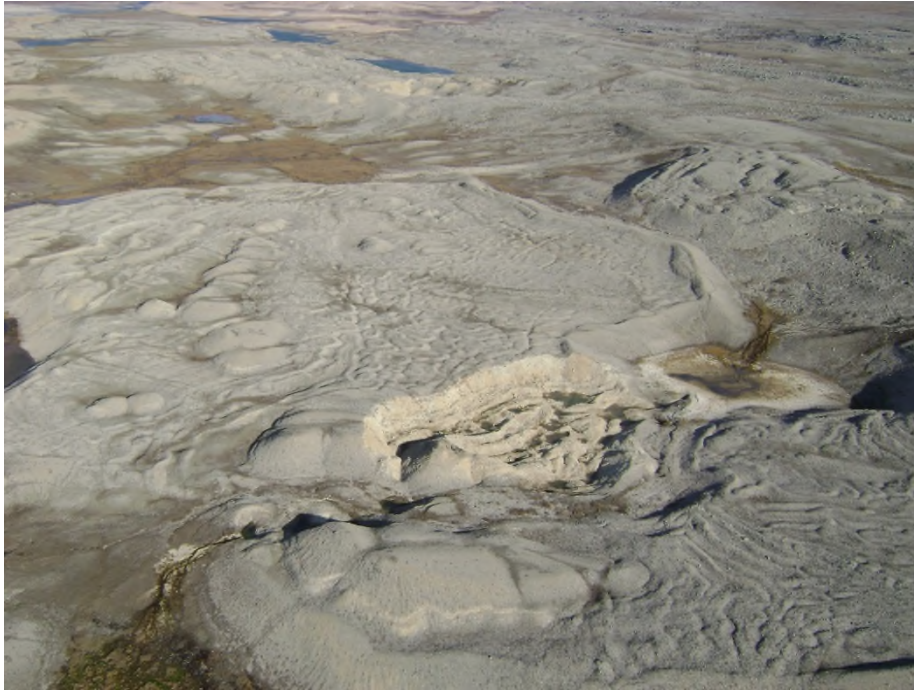
**Photo 48 (2638):**

2019 Aerial photo of the natural collapse feature shown in Photo 47. The size of the collapse feature has increased dramatically with extensive meltout of the massive ice. What can be learned from the photo is that terrain with this type of surface expression (“gummie worm”) is likely indicative of deposits of massive ice. This type of terrain is particularly prevalent in the area where the railway deviates to the south of the Tote Road.

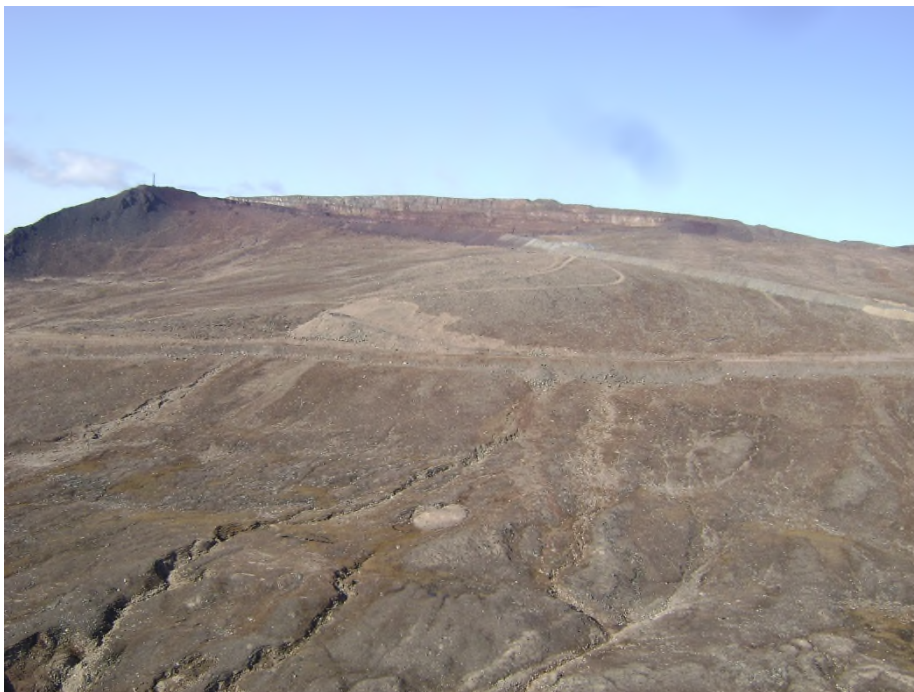
**Photo 49 (2650):**

Photos 49, 50, and 51 show several large erosion channels that have formed downslope of the main haul road from the open pit. The erosion has been the source of considerable amounts of sediment into the creek below the road that flows directly into the Mary River. The flowing water and erosion has caused permafrost thaw which reduces the soils strength making them considerably more prone to erosion. Most of the channels start immediately below the outlets of culverts on the road. Prior to construction of the road the flow on this slope would have been mostly sheet flow with most of the water flowing through the active layer soils and therefore the slope was not prone to erosion. Concentrated flow from the culverts now channelizes the flow causing both thermal and mechanical erosion.

Erosion channels downslope of the main mine haul road from the open pit.

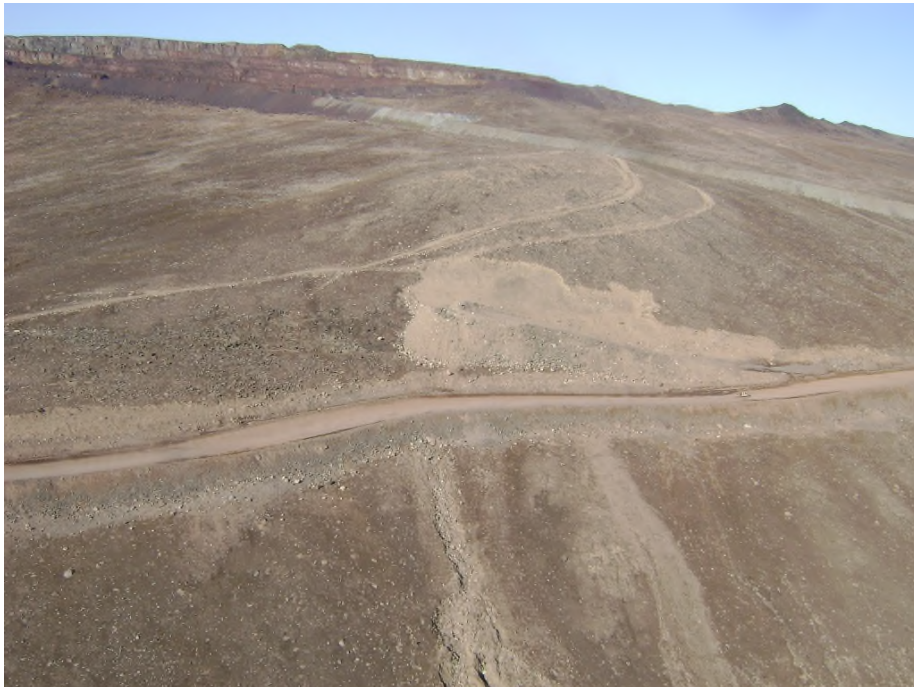
**Photo 51 (2643):**

Additional erosion channels downslope of the main mine haul road from the open pit.
