## APPENDIX E.11

### Freshet Monitoring Report

**BAFFINLAND IRON MINES CORPORATION**  
**MARY RIVER PROJECT****Freshet 2020 Monitoring Report****Rev 0**

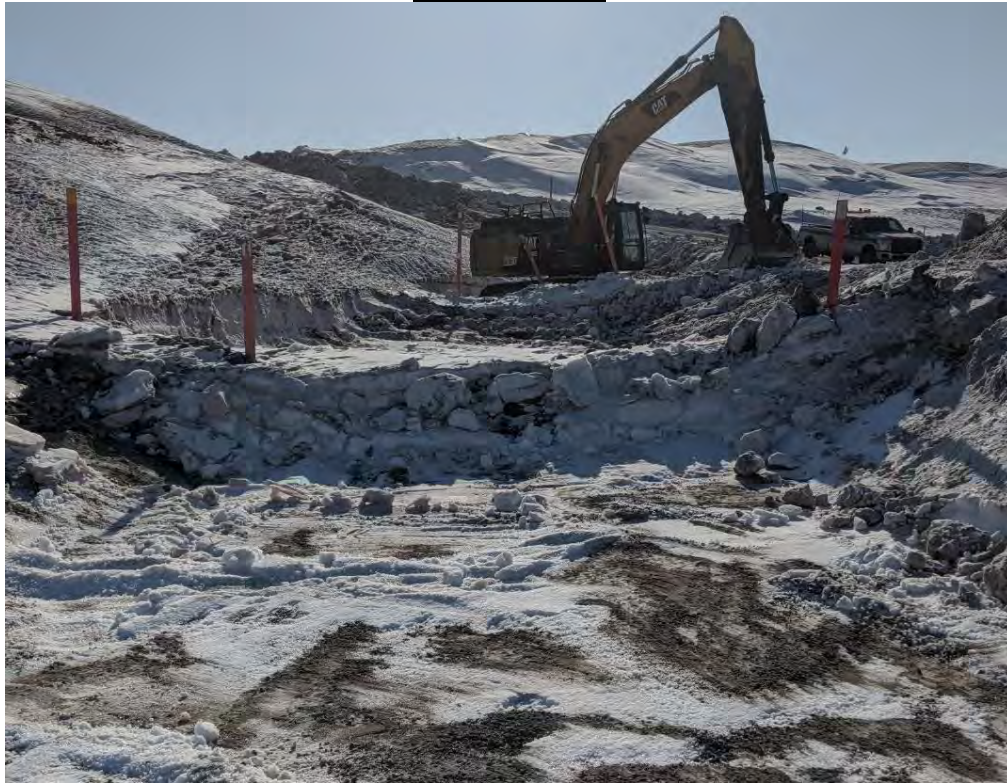
**Photo 1. Snow Removal at the Camp Lake Check Dams on April 21, 2020**

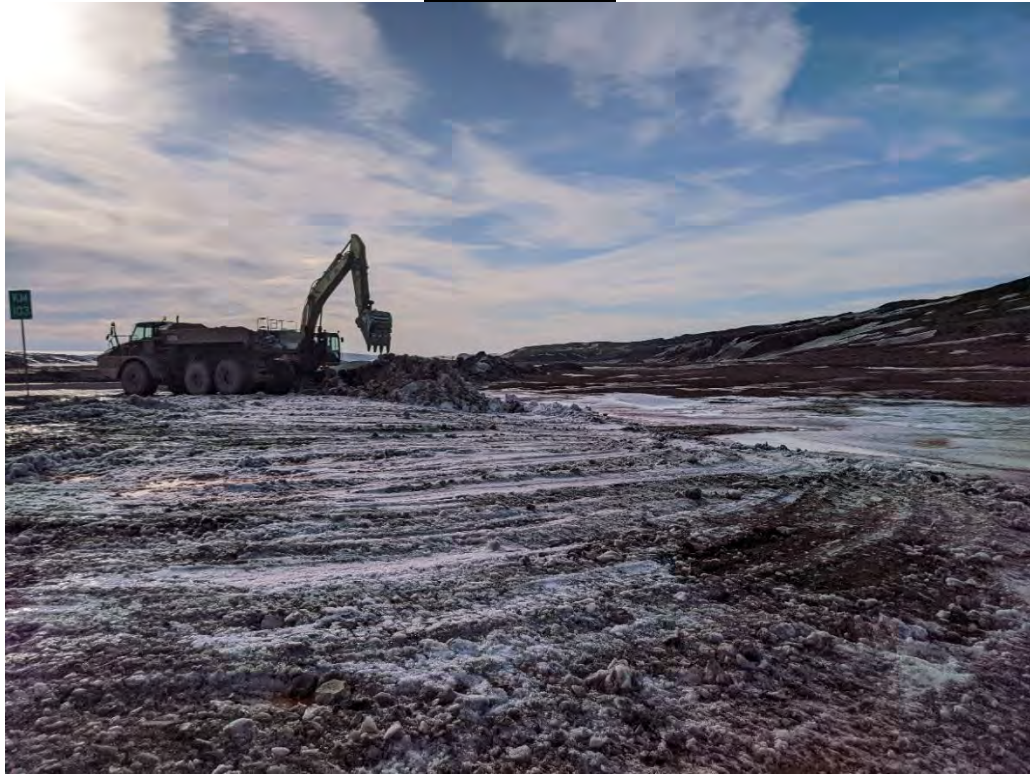
**Photo 1: Snow removal upstream of SDLT-OUT on May 16, 2020**

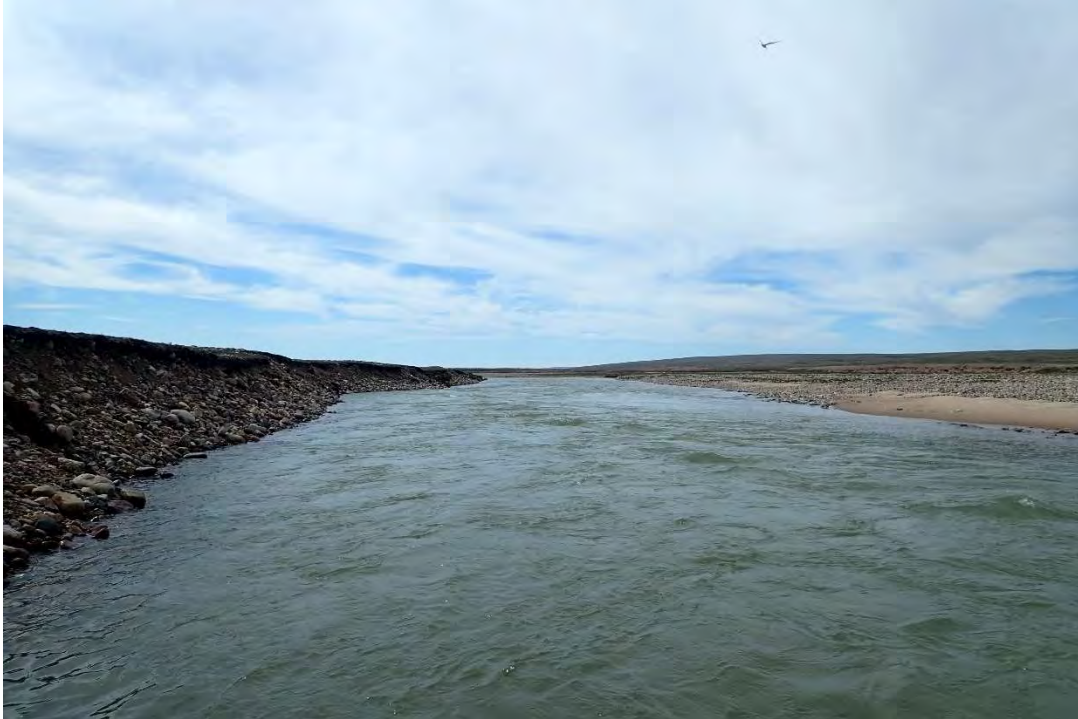
**Photo 5. Water quality at E0-20 on Mary River on July 3, 2020**

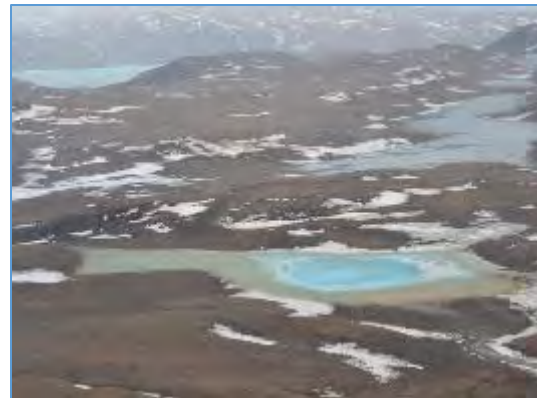
MIL-NATSED-1: Turbid flow was observed draining from an area located approximately 8 km north of Milne Port. UTM coordinates for the site are NAD83, Zone 17N, 506172 E, 7984204 N.

Figure 2. Overview of water bodies in the area.

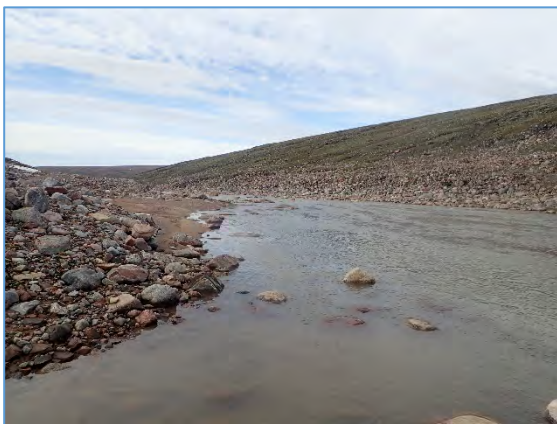
Figure 3. Downstream monitoring site.

Description: Substrate is an unstable mix of gravel, sand/silt and large boulders (Fig. 1). Turbid flow from the mudslide was observed entering the Mary River (Fig. 2). Instream water quality monitoring performed upstream (Fig. 3) and downstream (Fig. 4) of the affected stream section on July 15, 2020 indicated that downstream turbidity increased to 38.5 NTU from the upstream turbidity of 30.5 NTU due to the event. When the site was inspected on July 15, 2020, it appeared that the mudslide was not at risk of further movement at that time and the effects on the Mary River water quality would likely be short-lived.

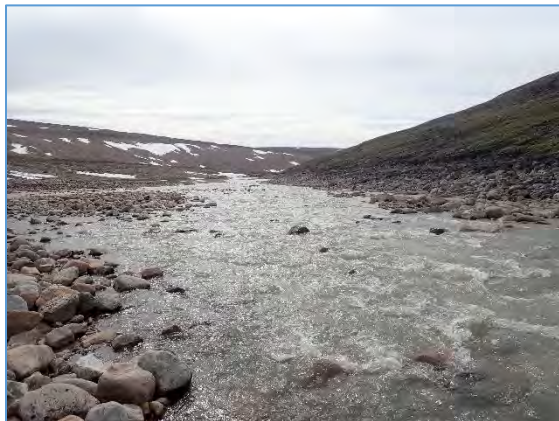
Figure 3. Downstream monitoring site.

Description: Substrate is an unstable mix of gravel, cobble and sand/silt (Fig. 1). Sediment from the sloughed hillside was observed entering the tributary of the Mary River (Fig. 2). The sediment carried into the Mary River from the affected tributary was observed to increase turbidity in the Mary River downstream of the confluence. UTM coordinates for a water quality monitoring location downstream of the confluence are NAD83, Zone 17N, 574946 E, 7920199, N. UTM coordinates for a water quality monitoring location upstream of the confluence are NAD83, Zone 17N, 574934 E, 7920838 N. Water quality samples collected upstream and downstream of the confluence of the tributary with the Mary River on July 15, 2020 indicated that downstream total suspended solids (TSS) increased to 18.1 mg/L from the upstream TSS of 15.5 mg/L due to the event. Water quality samples collected upstream and downstream of the confluence of the tributary with the Mary River on July 19, 2020 indicated that downstream TSS increased to 16.8 mg/L from the upstream TSS of 6.4 mg/L due to the event. The sloughed hillslope is considered an active source of sedimentation loading into the Mary River and will be monitored again during the 2021 freshet season.

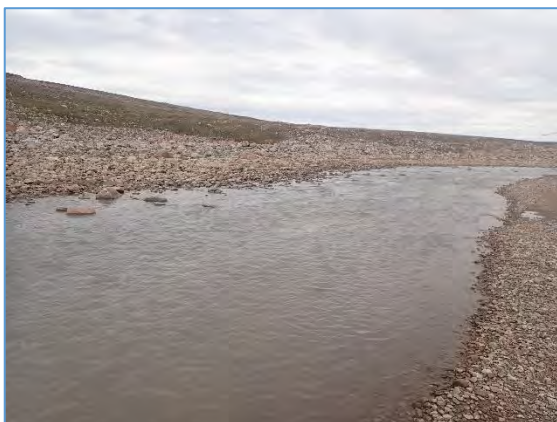
Figure 3. Downstream monitoring site.

MR-NATSED-3: Thawing conditions caused an active layer of granular material to slide down a slope above the Mary River approximately 15 km northeast of the Deposit 1 open pit resulting in sediment loading to the Mary River. UTM Coordinates for the site are NAD83, Zone 17N, 573802 E, 7925059 N.

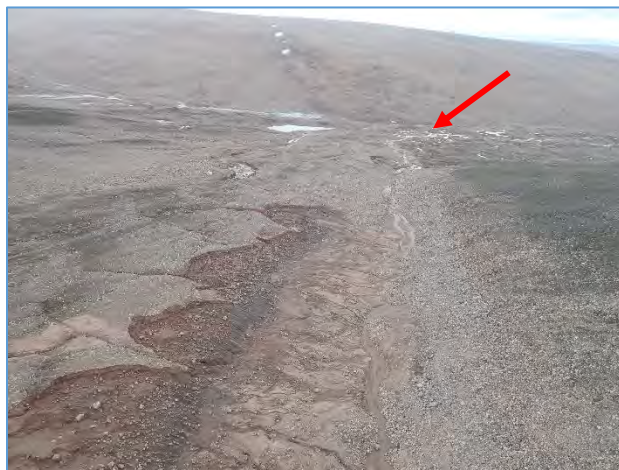
Figure 5. Downstream sampling location.

On August 1, 2020, elevated turbidity was observed in the Mary River at an existing water quality sampling location used for the Aquatic Environmental Effects Monitoring Program (E0-21). A helicopter fly-over inspection of upstream sections of the Mary River identified that the active layer on a long section of hillside located approximately 16 km northeast of the Deposit 1 open pit at the Mary River Mine had sloughed into a tributary of the Mary River resulting in sediment loading to the river. On August 3, 2020, water samples were collected in the tributary from sampling locations upstream and downstream affected section of the tributary. UTM coordinates for a water quality monitoring location downstream of the affected area (Fig. 5) are NAD83, Zone 17N, 577058 E, 7921123 N. UTM coordinates for a water quality monitoring location upstream of the affected area (Fig. 6) are NAD83, Zone 17N, 577188 E, 7921903 N. Water quality samples collected upstream and downstream of the affected section of the tributary on August 3, 2020 indicated that downstream total suspended solids (TSS) increased to 348.0 mg/L from the upstream TSS of 4.4 mg/L due to the event. The sloughed hillslope is considered an active source of sedimentation loading into the Mary River and will be monitored again during the 2021 freshet season.
