**August 28, 2024**

**Knight Piésold Ltd.**  
200-1164 Devonshire Avenue  
North Bay, Ontario P1B 6X7  
Canada  
T +1 705 476 2165  
E [northbay@knightpiesold.com](mailto:northbay@knightpiesold.com)  
[www.knightpiesold.com](http://www.knightpiesold.com)

## **RE: Construction Summary of CV-001 Remedial Measures**

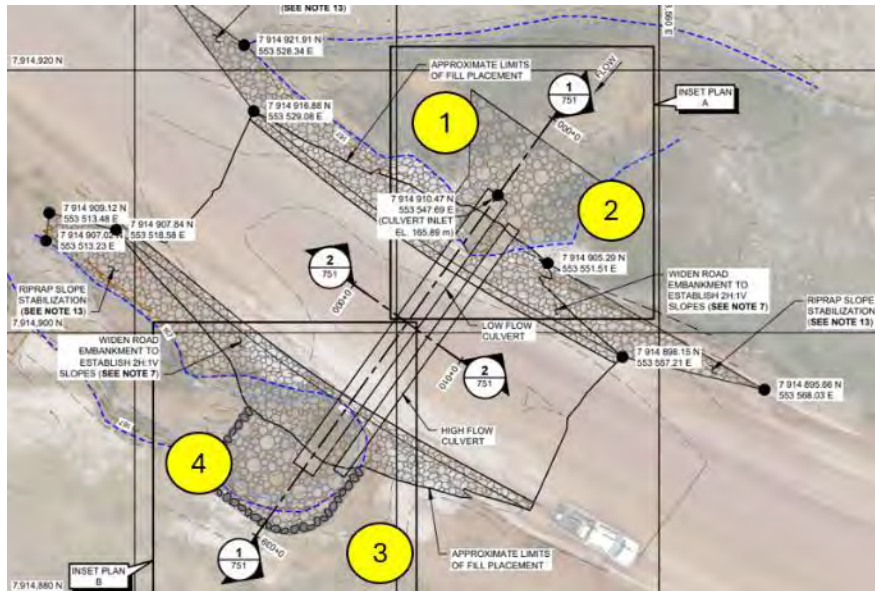
**PHOTO 1.** Culvert Crossing CV-001 - Photographic Vantage Points (Approximate Locations, Indicated with Yellow Circles).

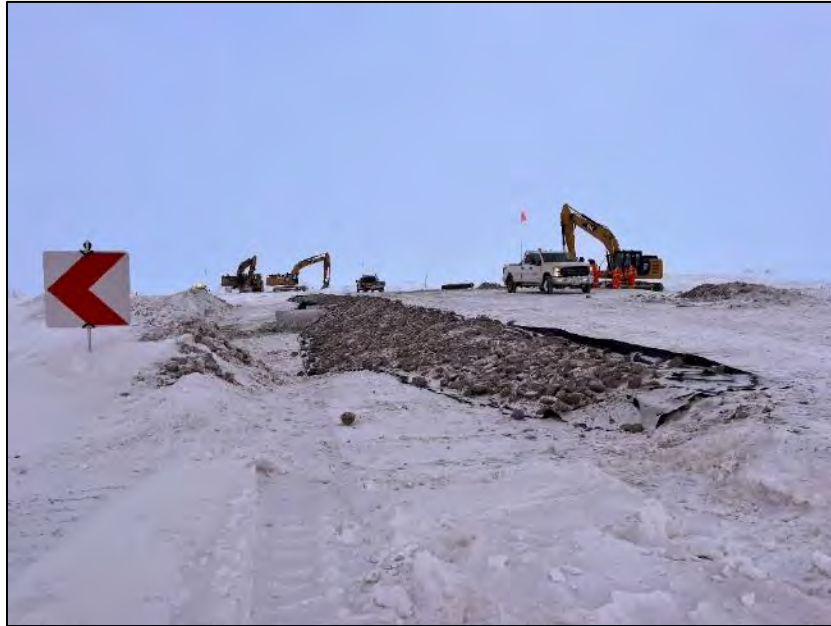
**PHOTO 13.** During Construction - Vantage Point 1 - Placement of geotextile on the north slope at CV-001 - Road crossing and upstream inlet - Looking South (April 5, 2024).

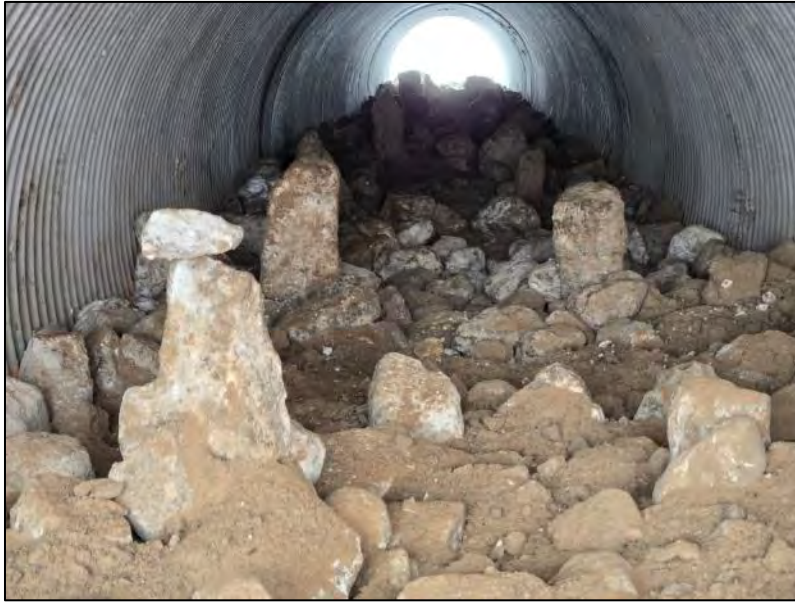
**PHOTO 19.** Following Construction - Completed placement of coarse riprap and stream substrate material within the interior of the low flow CSP culvert at CV-001 (April 1, 2024).

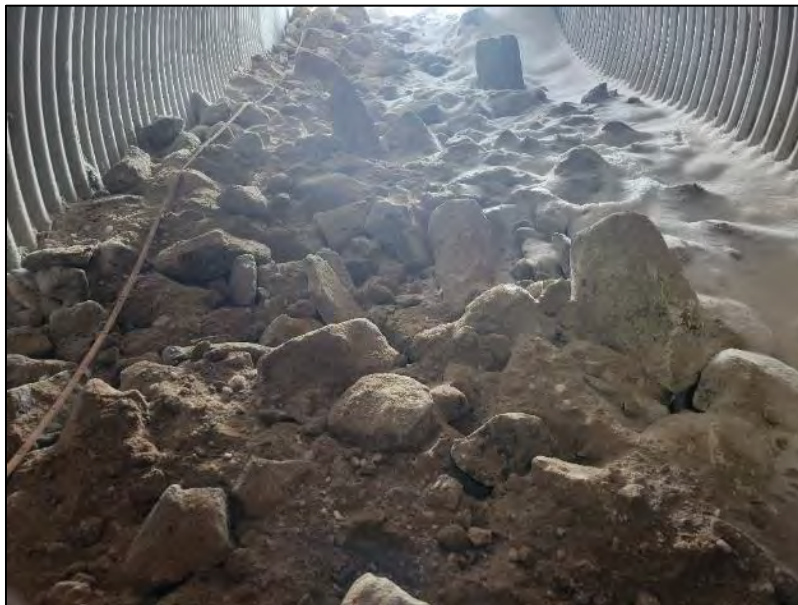
**PHOTO 20.** Following Construction - Completed placement of coarse riprap and stream substrate material within the interior of the low flow CSP culvert at CV-001 (April 16, 2024).

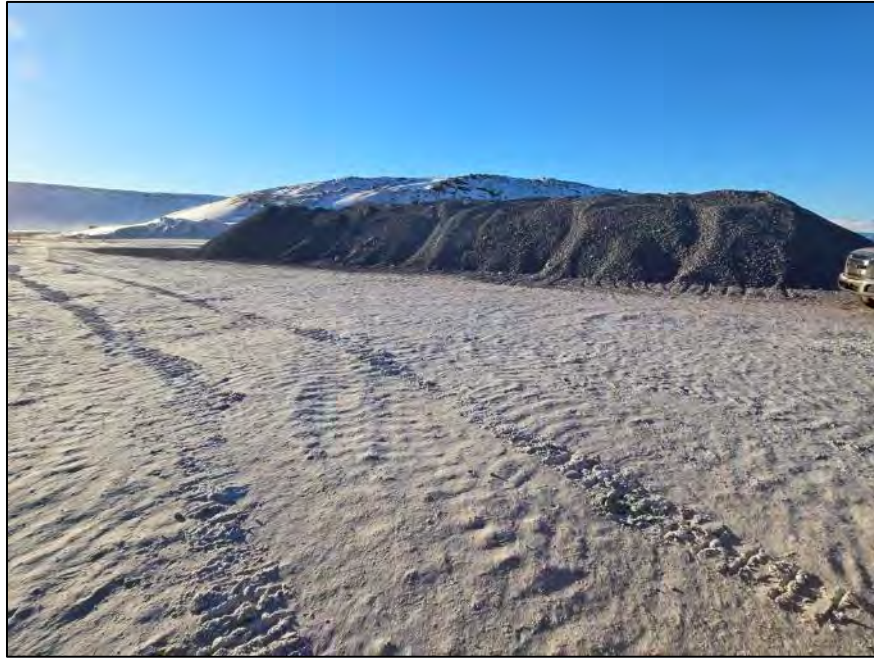
**PHOTO 21.** Material Stockpile - 32 mm minus culvert backfill material - km 94 laydown - Looking South (March 24, 2024).

- **Culvert Backfill** - Culvert Backfill material consisted of 32 mm minus material that was crushed and screened at the aggregate quarry located at the Milne Inlet Port. The material was backhauled to the km 36 laydown area on the Tote Road using Baffinland's ore hauling trucks (OHTs). Particle size gradations from laboratory tests show that the processed material met the material specifications, as shown on Figure 1. Two control samples and one record sample were collected for CV-102. The initial control test result (C-CBF-11) indicated that the stockpile was coarser than the specified envelope. It

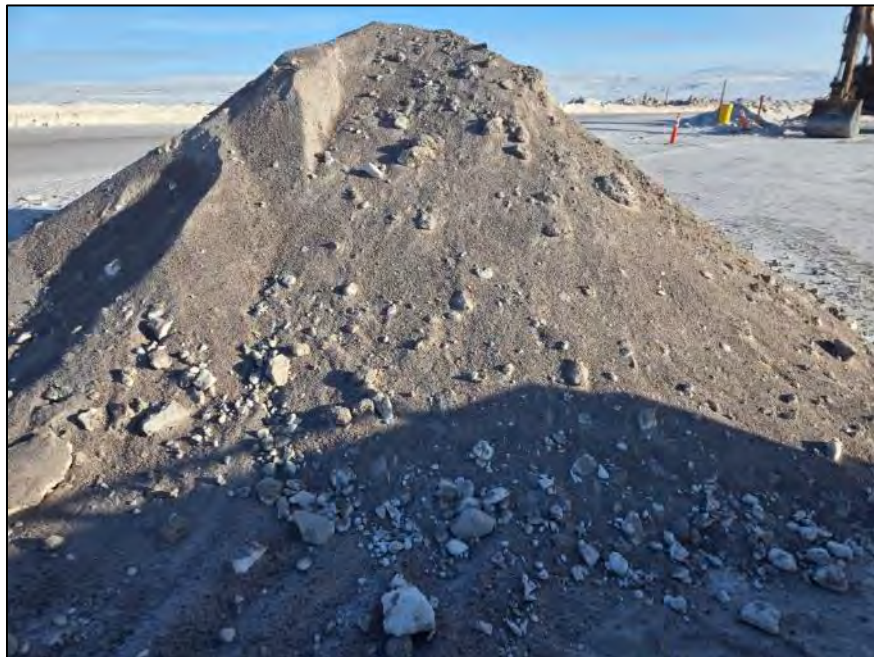
**PHOTO 22.** Material Stockpile - Culvert Bedding Material - km 94 laydown - Looking Southeast (March 27, 2024).

- Bedding Material - 3/16 inch (4.75 mm) minus material was used in limited quantities for the 2 inch (50 mm) thick uncompacted bedding material below the low and high flow culverts. Similar to the 32 mm minus material, the 3/16 inch minus material was crushed, screened, and hauled from the aggregate quarry at Milne Inlet Port and stockpiled at the km 36 laydown area. The maximum particle size for the Bedding Material was required to be half of the depth of the culvert undulations (corrugations), which are 13 mm as per the Manufacturer's Specifications. Particle size gradations from laboratory tests are shown on Figure 2 and show that approximately 5% of the particles in the record sample exceeded the maximum particle size of 6.5 mm. This small quantity of slightly larger particles was considered acceptable to meet the design intent.

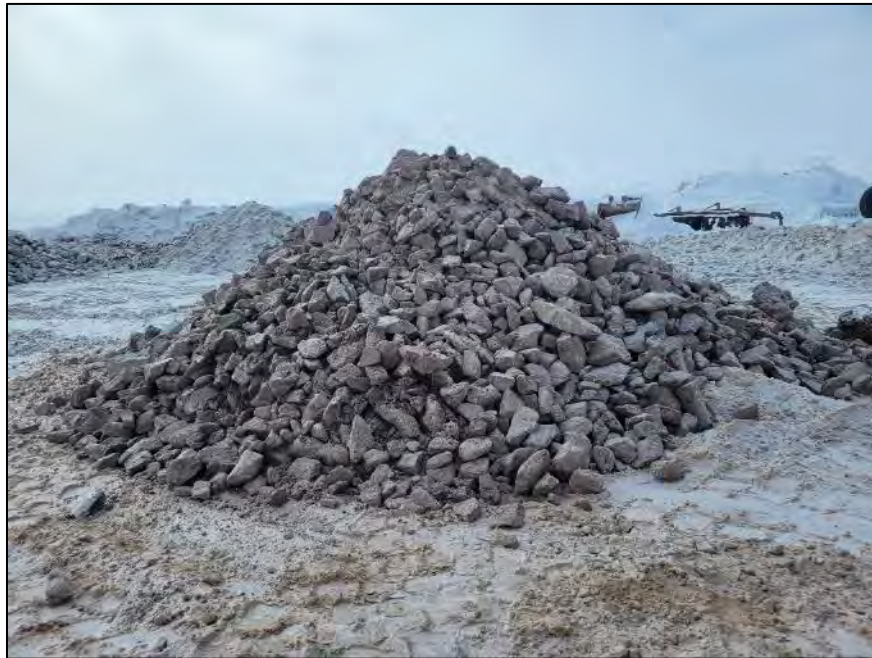
**PHOTO 23.** Material Stockpile - Fine Rip Rap - km 94 laydown - Looking South (April 5, 2024).

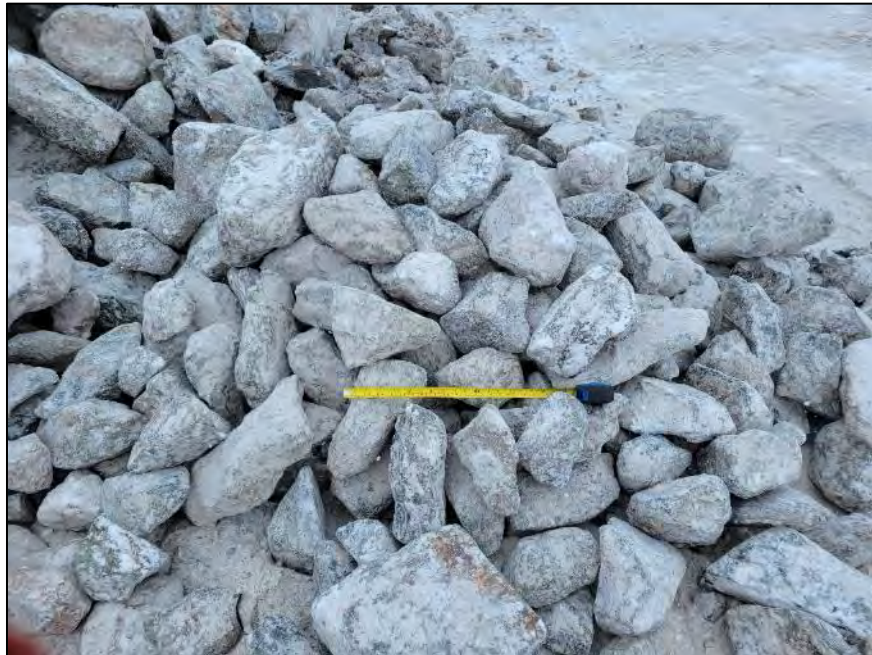
**PHOTO 24.** Material Stockpile - Coarse Rip Rap - km 94 laydown - Looking Northwest (April 5, 2024).

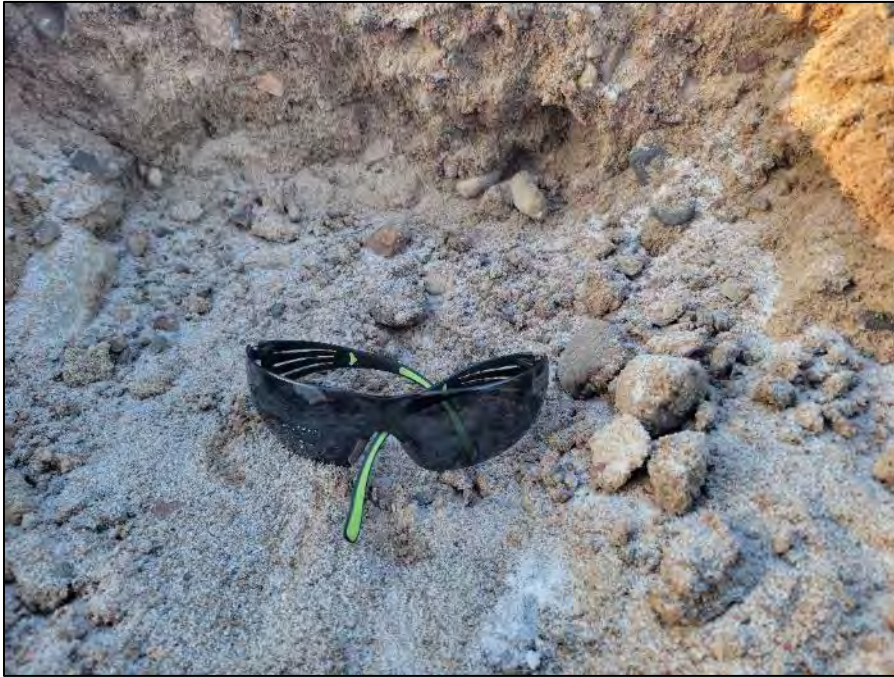
**PHOTO 25.** Material Stockpile - Stream Substrate Material - km 97 stockpile (February 29, 2024).

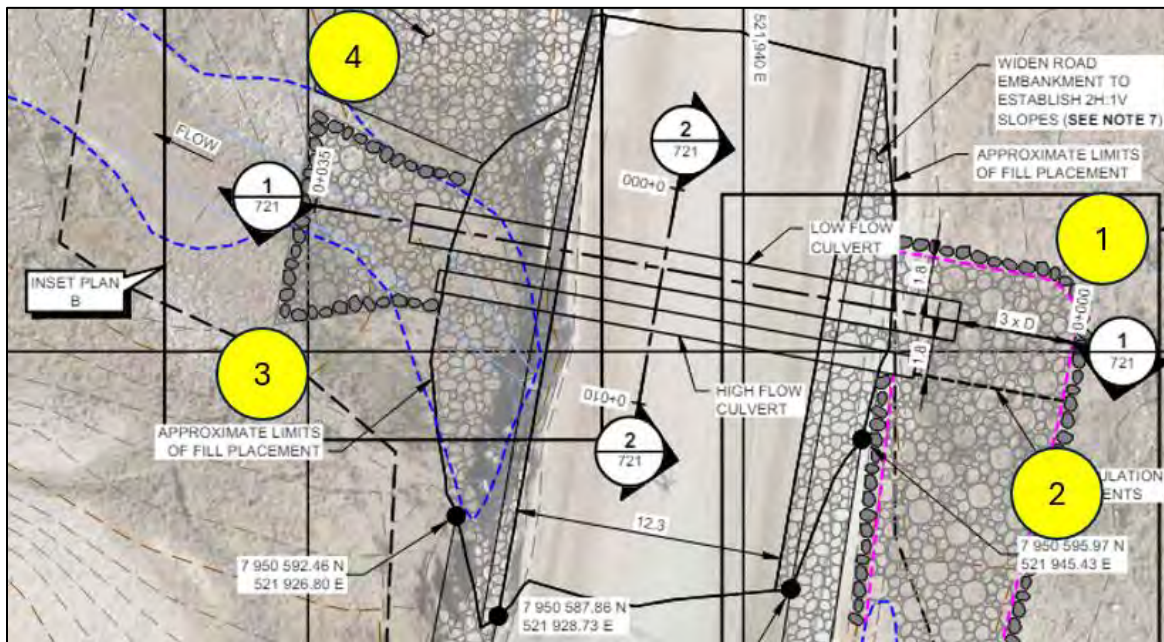
**PHOTO 1.** Culvert Crossing CV-102 - Photographic Vantage Points (Approximate Locations, Indicated with Yellow Circles).

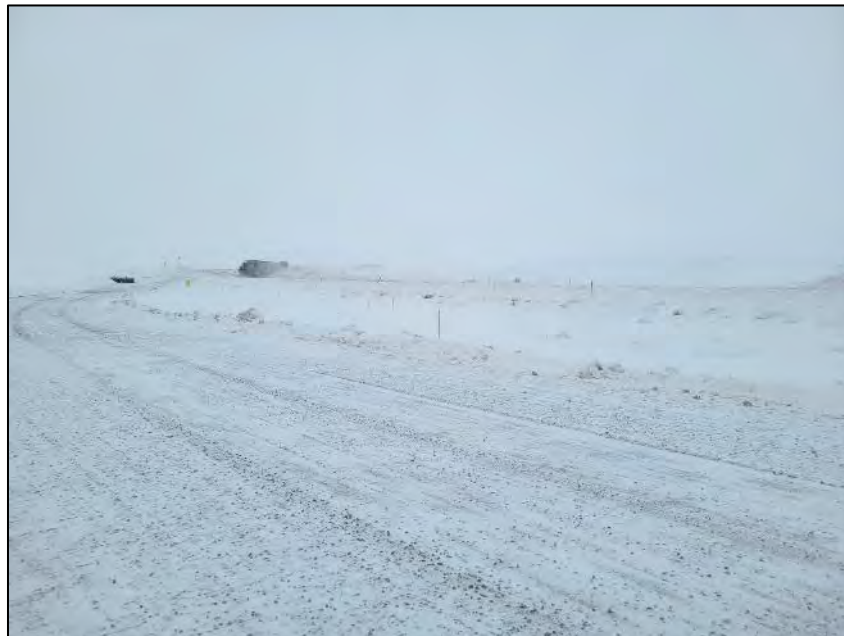
**PHOTO 2.** Prior to Construction - Vantage Point 4 - Upstream Side of Crossing - Looking Southeast (April 19, 2024).

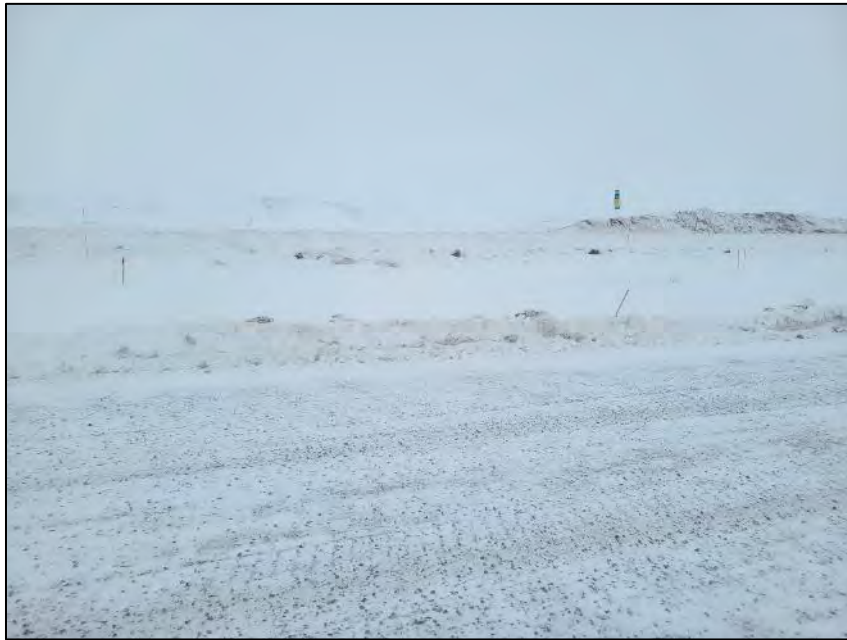
**PHOTO 3.** Prior to Construction - Vantage Point 2 - Upstream Side of Crossing - Looking Northwest (April 19, 2024).

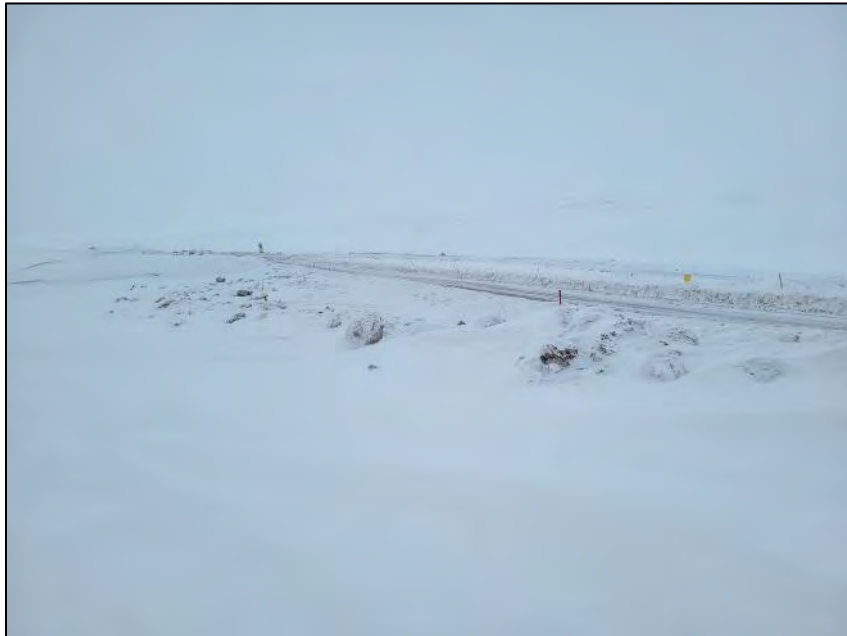
**PHOTO 4.** Prior to Construction - Vantage Point 3 - Downstream Side of Crossing - Looking Northeast (April 19, 2024).

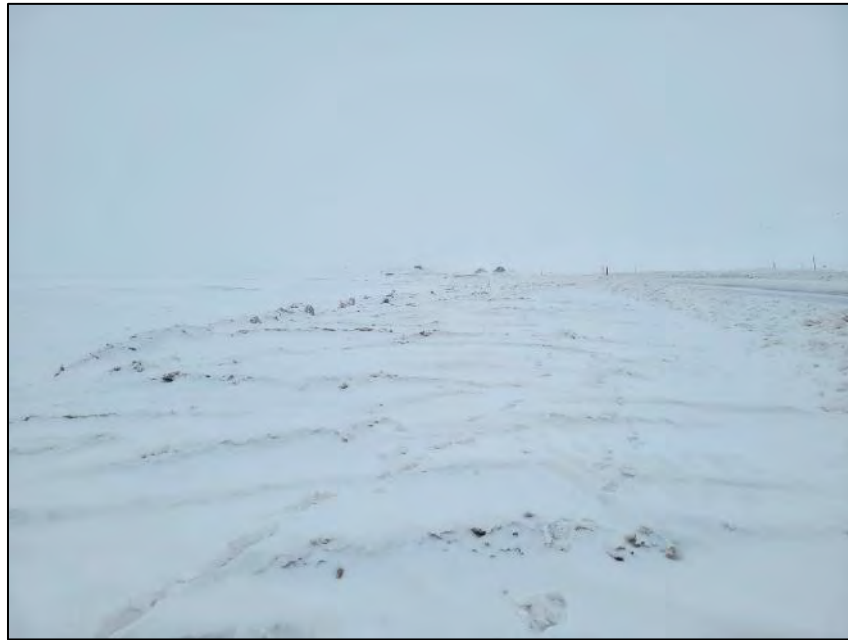
**PHOTO 5.** Prior to Construction - Vantage Point 4 - Downstream Side of Crossing - Looking Southeast (April 19, 2024).

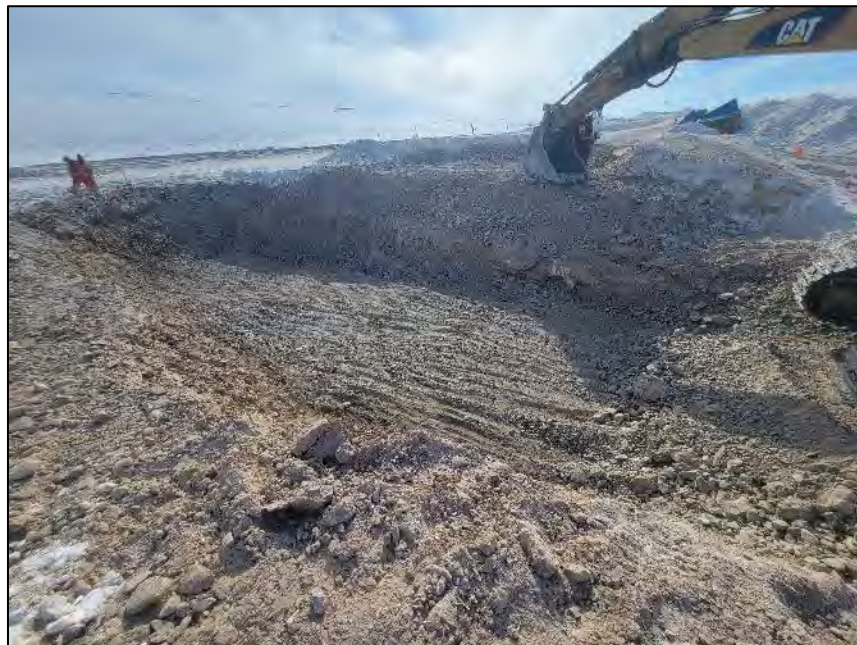
**PHOTO 6.** During Construction - Vantage Point 1 - Blasted Upstream Side of Crossing - Looking Southeast (April 24, 2024).

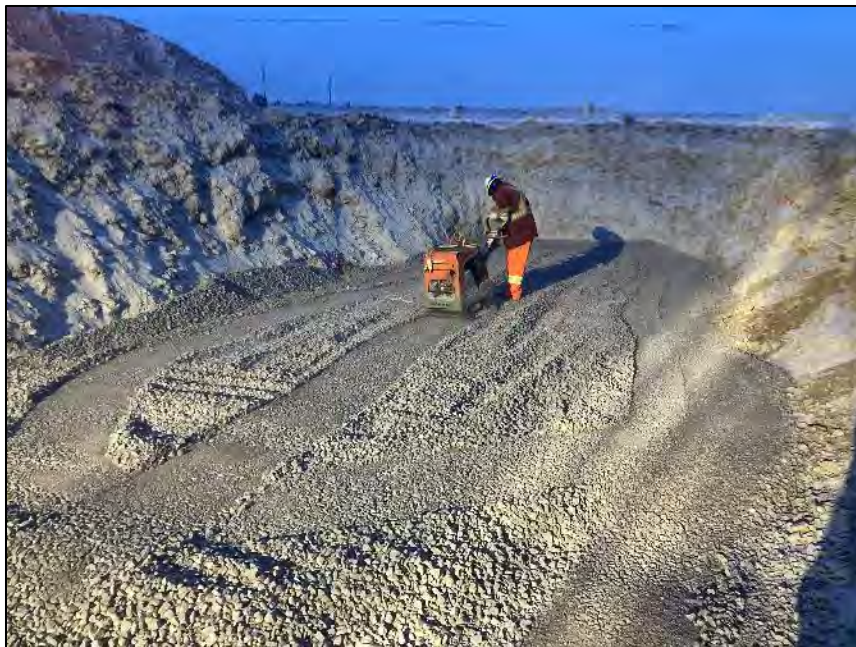
**PHOTO 8.** During Construction- Vantage Point 1 - Compaction of Culvert Backfill Material - Upstream inlet - Looking Southwest (April 24, 2024).

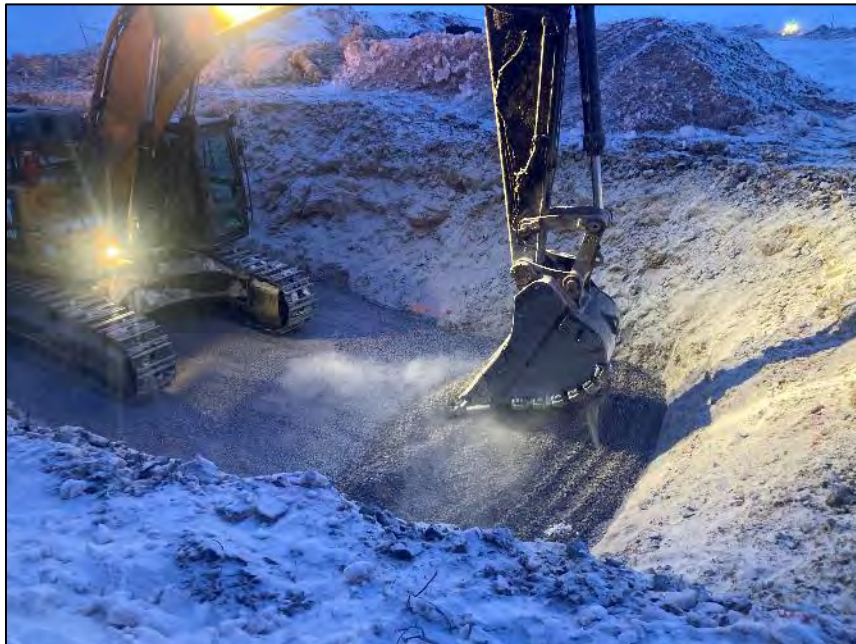
**PHOTO 10.** During Construction - Vantage Point 4 - Placement of Culvert Backfill Material - Road Crossing and downstream outlet - Looking Southeast (April 24, 2024).

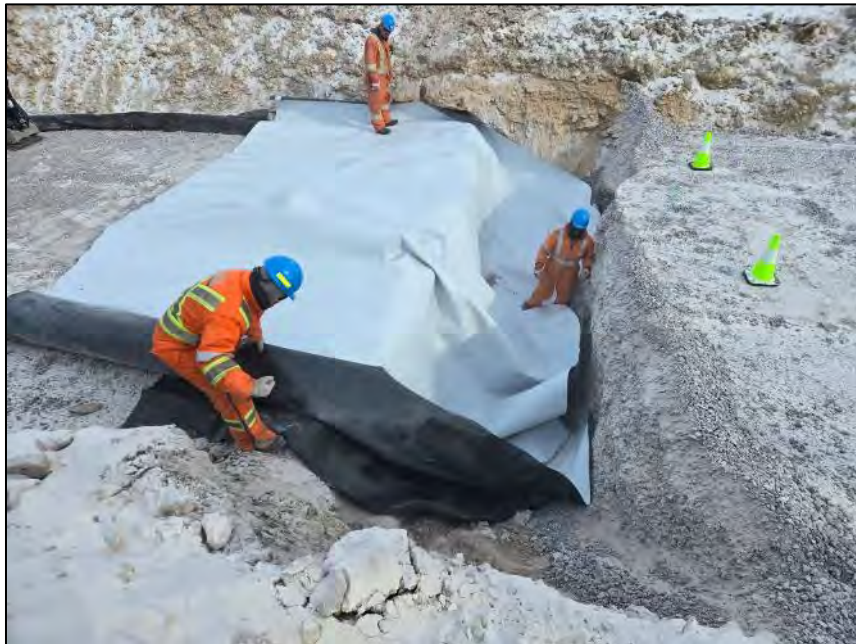
**PHOTO 12.** During Construction - Vantage Point 4 - Installation of geotextile and geomembrane in key-in trench in downstream end of crossing - Looking Southeast (April 26, 2024).

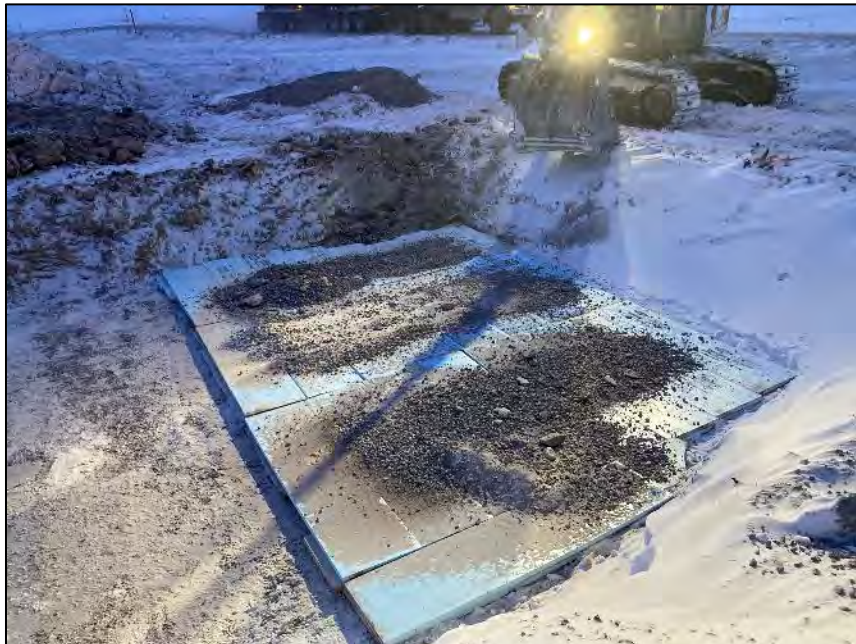
- Insulation - 50 mm thick Styrofoam™ Highload 60 Extruded Polystyrene Insulation was stored at the km 80 laydown. Two layers of insulation (total thickness of 100 mm) was installed across the foundation beneath the culverts.

**PHOTO 14.** During Construction - Vantage Point 1 - Placement of Styrofoam Insulation in downstream end of crossing - Looking Southwest (April 26, 2024).

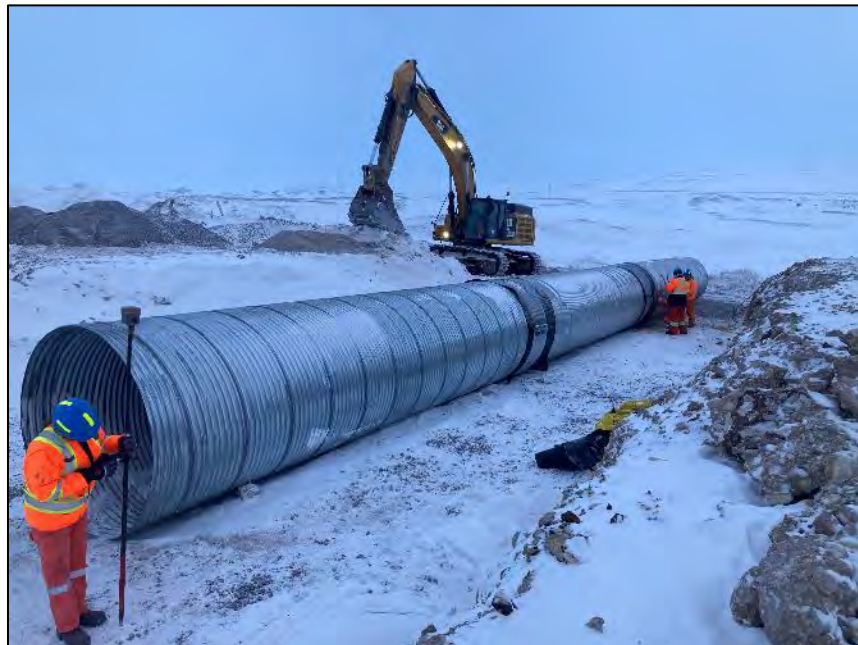
**PHOTO 18.** During Construction- Vantage Point 3 - Installation of 2.0 m diameter low flow culvert - Looking Northeast (April 29, 2024).

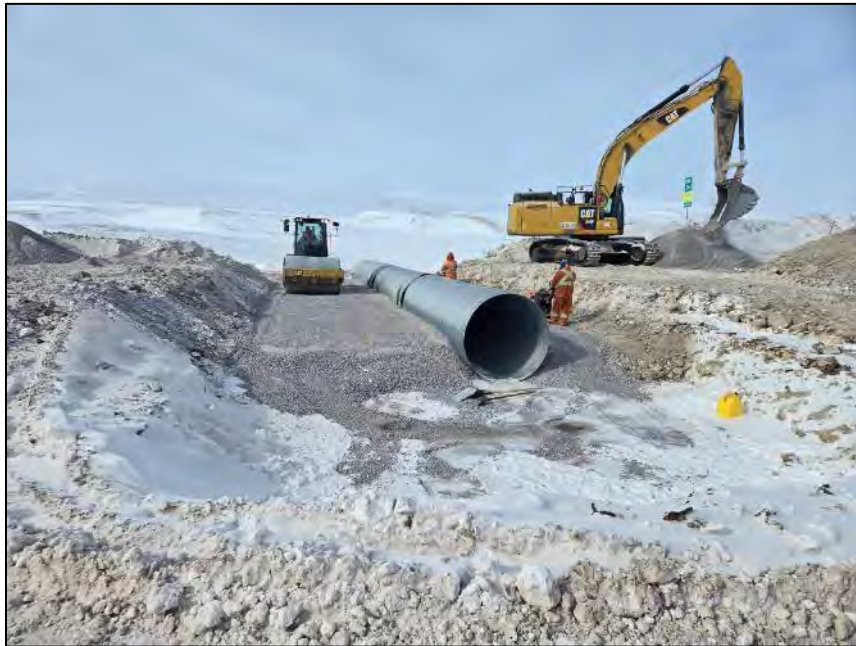
**PHOTO 19.** During Construction - Vantage Point 4 - Compaction of Culvert Backfill Material around low flow culvert - Looking Southeast (April 30, 2024).

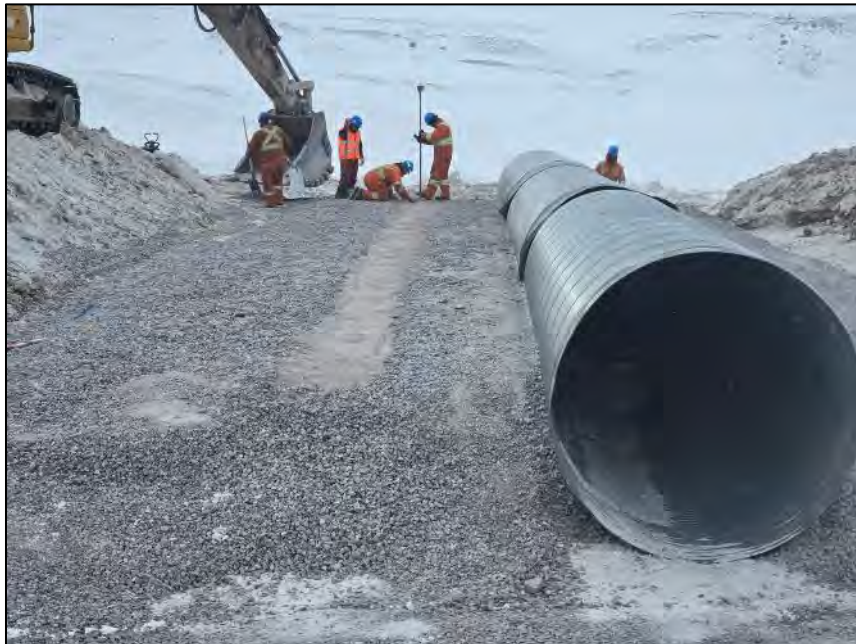
**PHOTO 20.** During Construction - Vantage Point 1 - Placement of Culvert Bedding Material under high flow culvert - Looking Southwest (April 30, 2024).

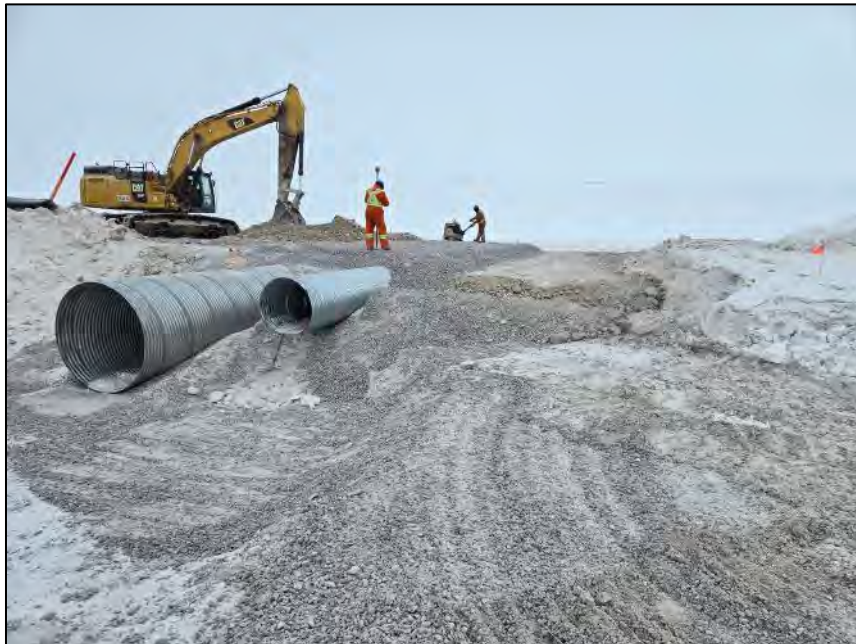
**PHOTO 22.** During Construction - Vantage Point 3 - Compaction of Culvert Backfill Material above high and low flow culverts - Looking Northeast (April 31, 2024).

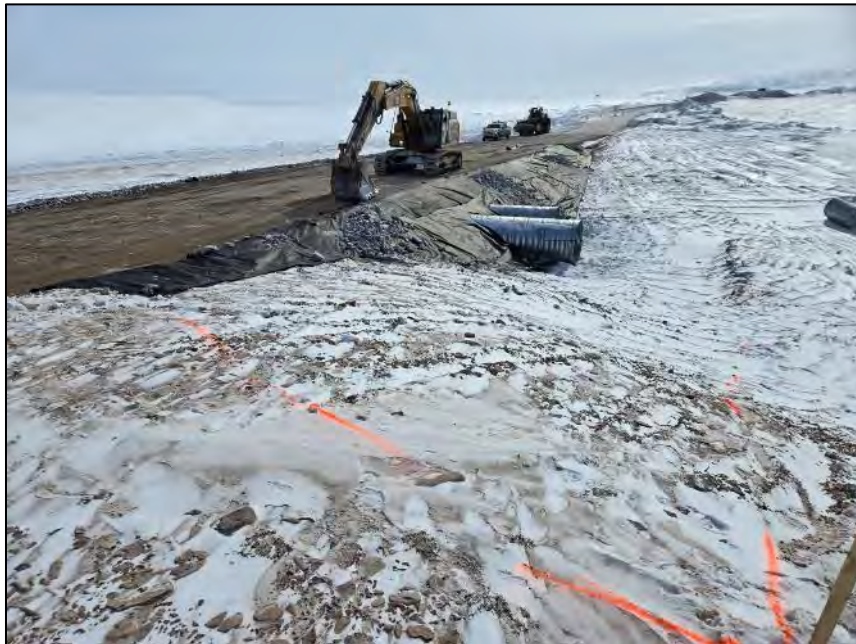
**PHOTO 24.** During Construction - Vantage Point 4 - Installation of geotextile on outlet side of crossing - Looking Southeast (May 04, 2024).

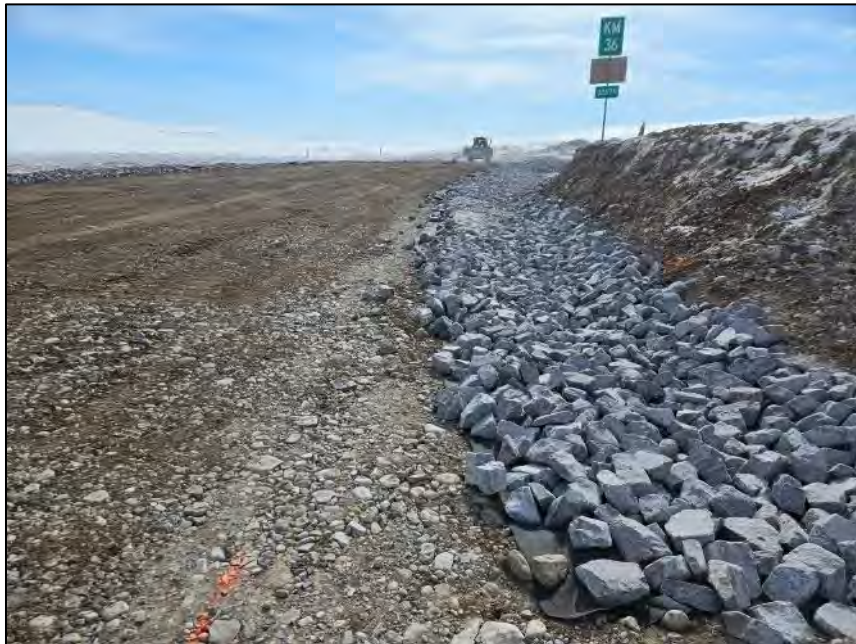
**PHOTO 26.** During Construction - Vantage Point 4 Riprap and geotextile placement in ditches on west side of crossing - Looking Southeast (May 05, 2024).

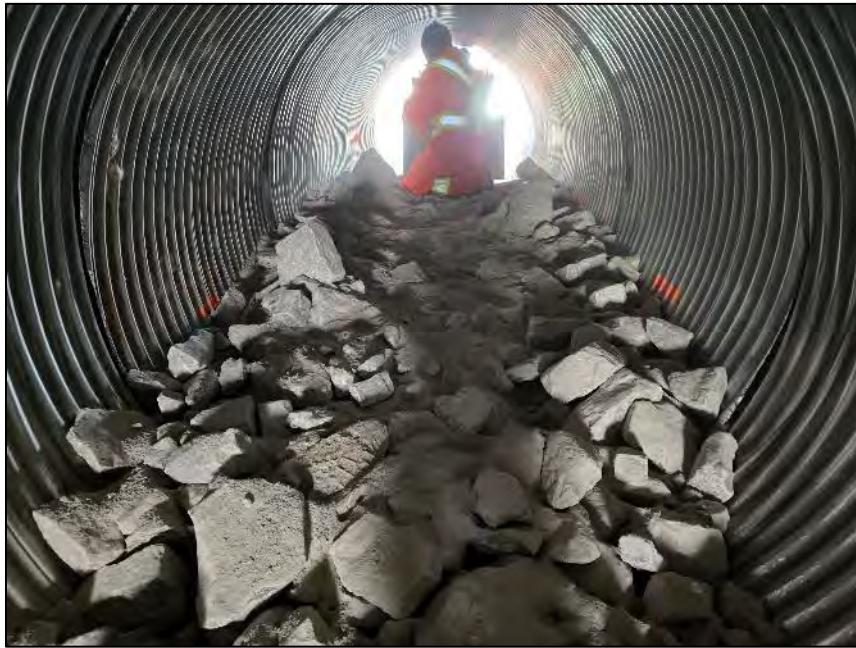
**PHOTO 27.** During Construction - Riprap and Stream Substrate Material placement in low flow culvert - Looking East (May 12, 2024).

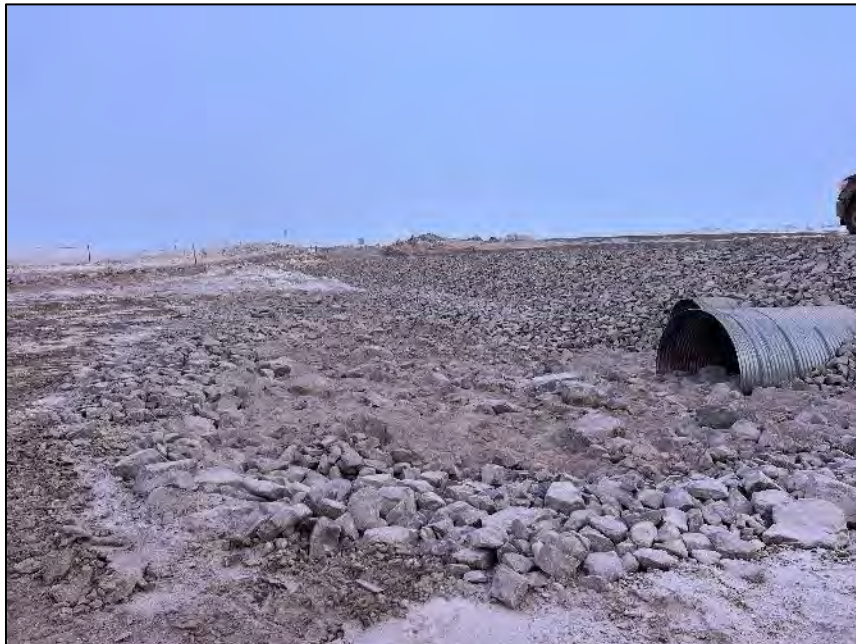
**PHOTO 28.** After Construction - Vantage Point 1 - Final arrangement of inlet apron - Looking Southeast (May 13, 2024).

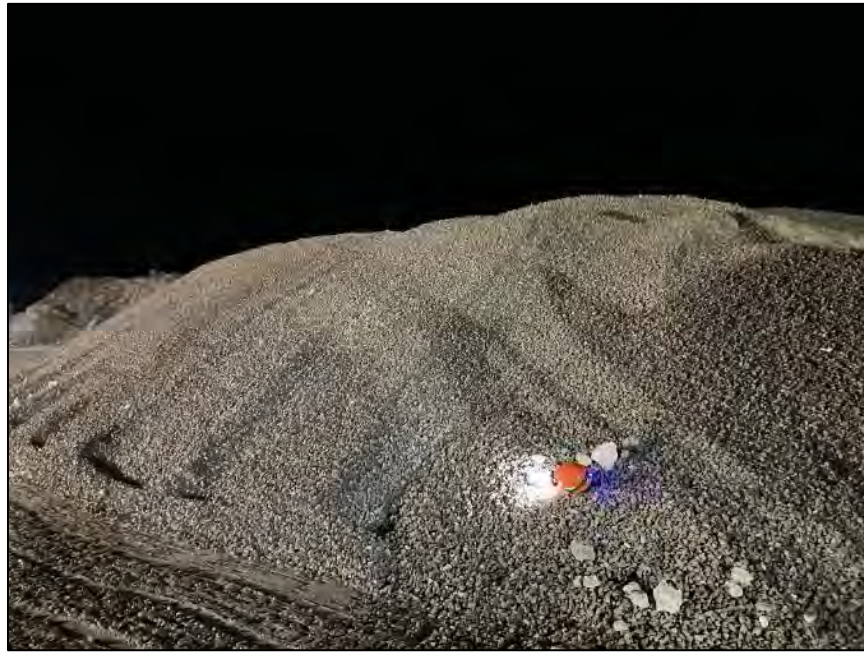
**PHOTO 29.** Material Stockpile - 32 mm minus Culvert Backfill Material - km 60 Laydown - Looking Northeast (March 10, 2024).

- **Culvert Backfill** - Culvert Backfill material consisted of 32 mm minus material that was crushed and screened at the aggregate quarry located at the Milne Inlet Port. The material was backhauled to the km 33 laydown area on the Tote Road using Baffinland's ore hauling trucks (OHTs). Particle size gradations from laboratory tests show that the processed material met the material specification, as shown on Figure 1. Two control samples and one record sample were collected for CV-106. The initial control test result (C-CBF-12) indicated that the stockpile was coarser than the specified envelope. It was determined that the stockpile had become segregated and that the sample was not representative.

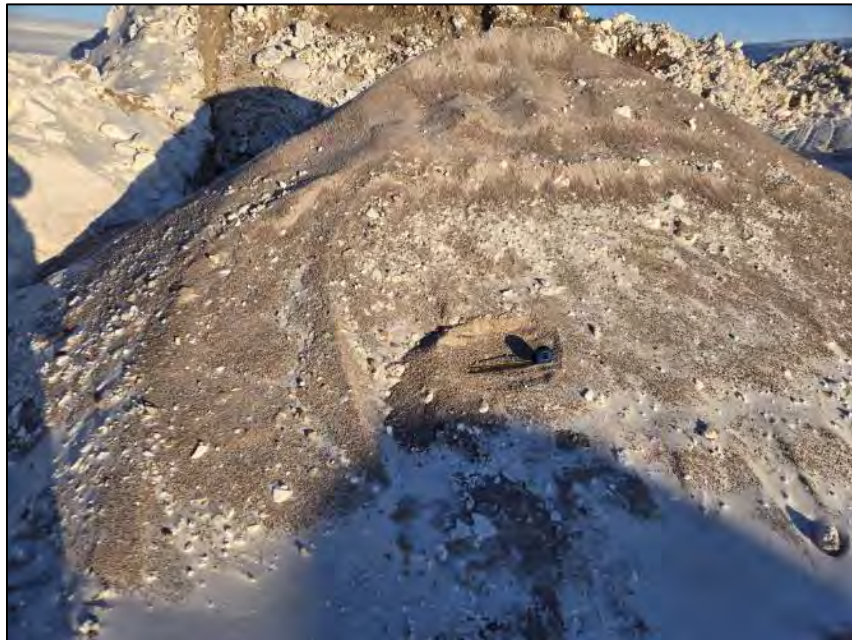
**PHOTO 30.** Material Stockpile - Culvert Bedding Material - km 60 Laydown - Looking North (March 15, 2024).

- Bedding Material - 3/16 inch (4.75 mm) minus material was used in limited quantities for the 2 inch (50 mm) thick uncompacted bedding material below the low and high flow culverts. Similar to the 32 mm minus material, the 3/16 inch minus material was crushed, screened, and hauled from the aggregate quarry at Milne Inlet Port and stockpiled at the km 33 laydown area. The maximum particle size for the Bedding Material was required to be half of the depth of the culvert undulations (corrugations), which are 13 mm as per the Manufacturer's Specifications. Particle size gradations from laboratory tests are shown on Figure 2 and show that approximately 7% of the particles in the record sample exceeded the maximum particle size of 6.5 mm. The small quantity of slightly larger particles was considered acceptable to meet the design intent.

2. Design Change 01 (No. CVDC-01, KP, 2024c) was issued on February 28, 2024 documenting the approved design change to use a finer bedding material to meet the culvert manufacturer's recommendations. The specified 25 mm minus was changed to a 3/16 inch minus material to meet the revised recommendations.

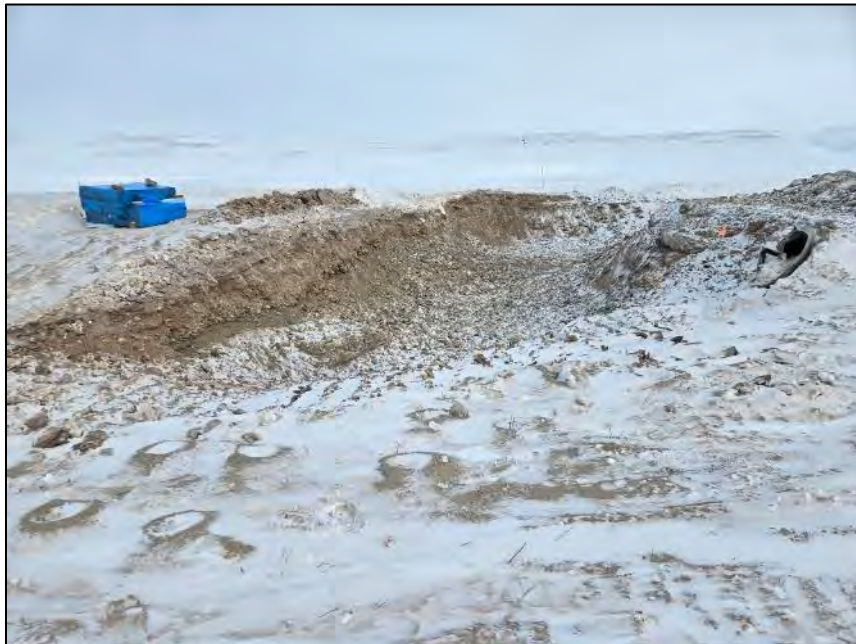
**PHOTO 6.** During Construction - Vantage Point 3 - Blast Excavation - Looking Northeast (April 30, 2024).

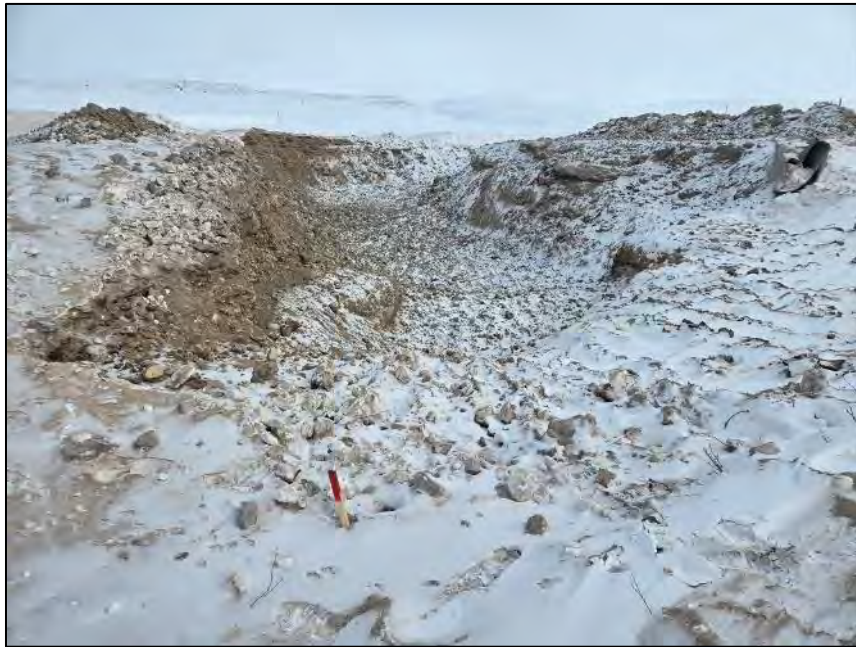
**PHOTO 7.** During Construction - Vantage Point 4 - Blast Excavation - Looking Southeast  
(April 30, 2024).

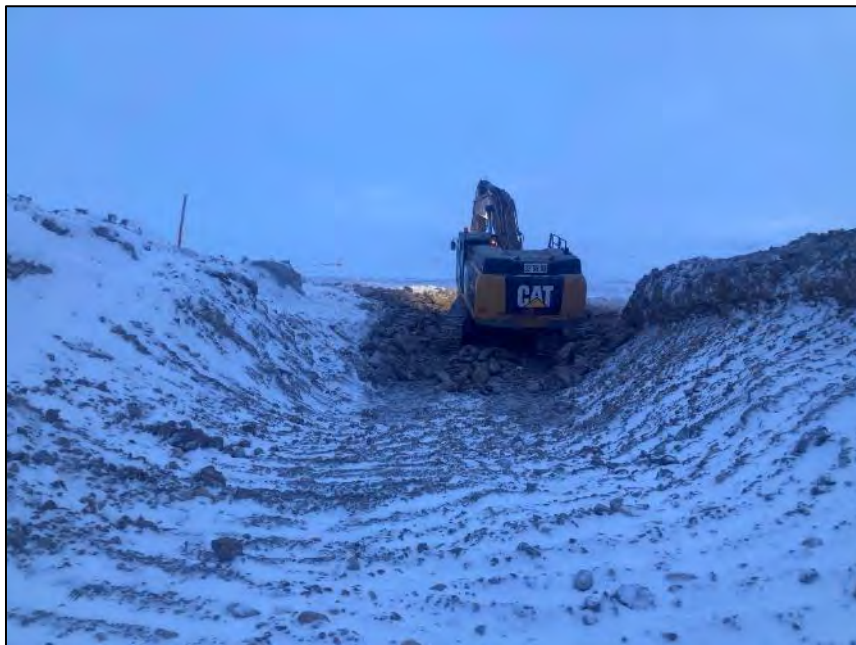
**PHOTO 8.** During Construction - Vantage Point 1 - Blast Excavation - Looking Southwest  
(May 03, 2024).

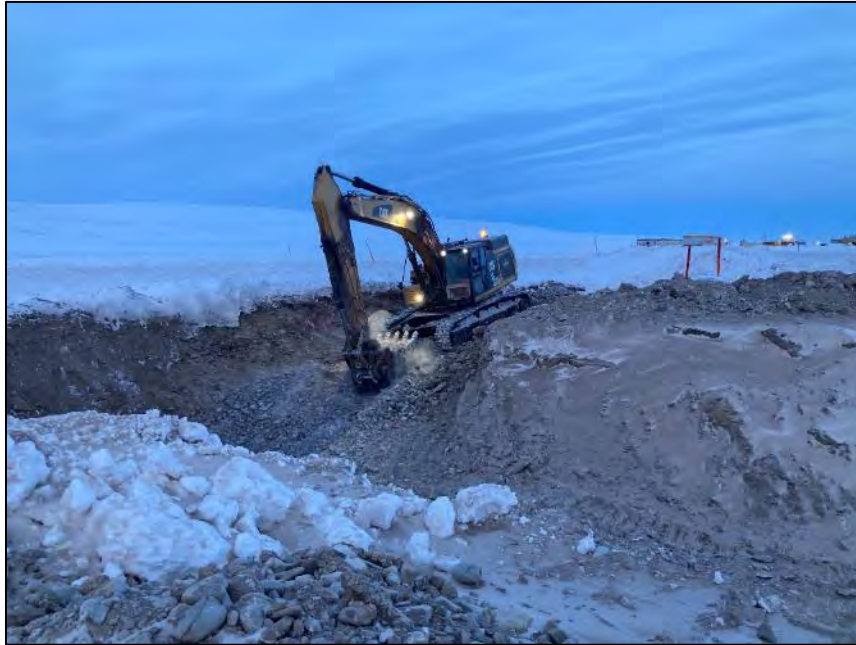
**PHOTO 9.** During Construction - Vantage Point 1 - Excavation of Unsuitable Material from Inlet Apron - Looking South (May 04, 2024).

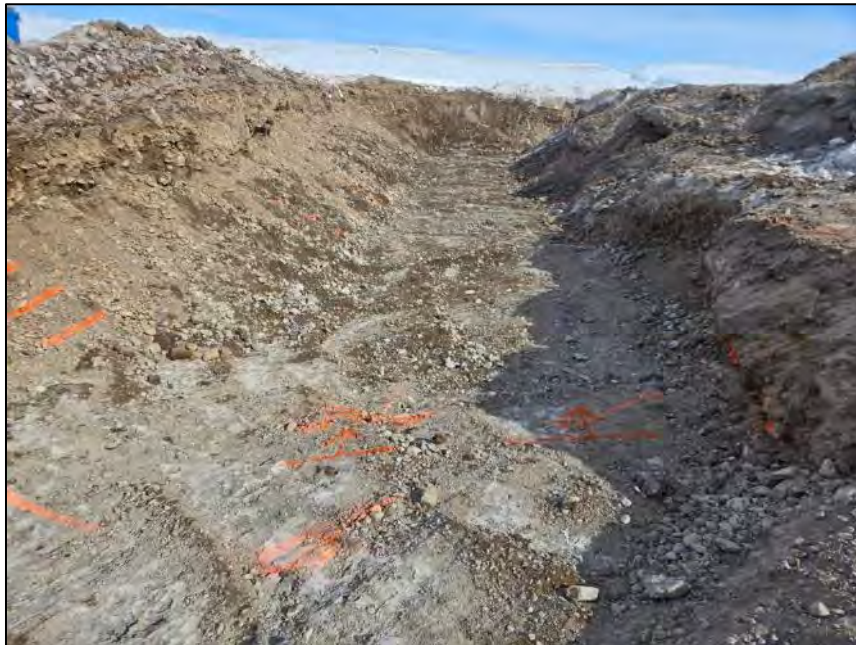
**PHOTO 10.** During Construction - Vantage Point 3 - Completed Blast Excavation - Looking East (May 05, 2024).

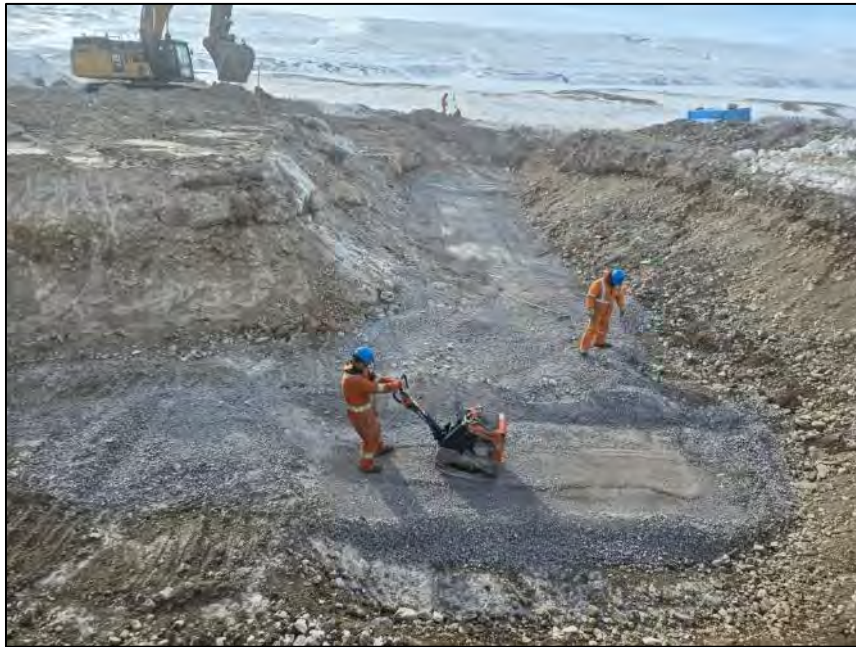
**PHOTO 11.** During Construction - Vantage Point 2 - Compaction of Culvert Backfill Material - Looking Northwest (May 05, 2024).

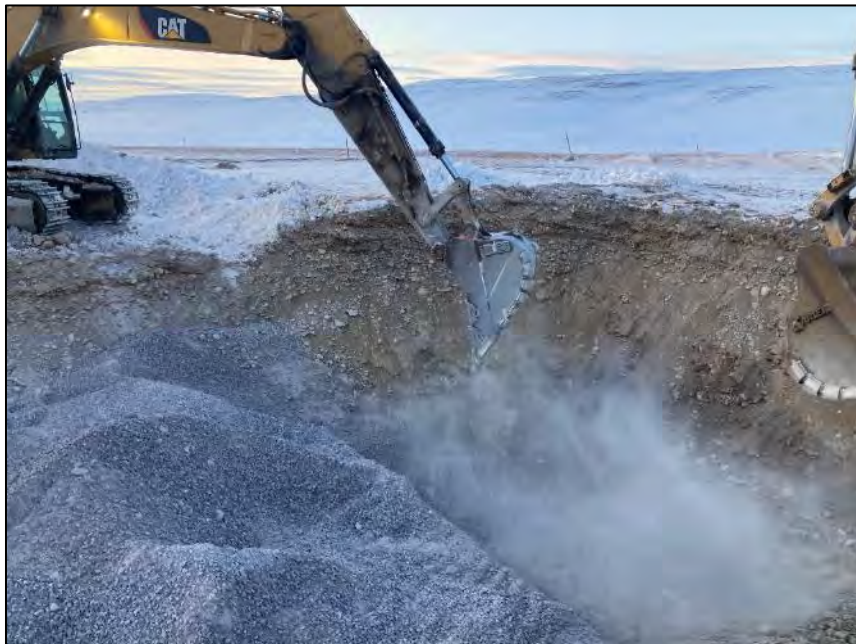
**PHOTO 12.** During Construction - Vantage Point 3 - Placement of Culvert Backfill Material in Inlet Apron - Looking North (May 05, 2024).

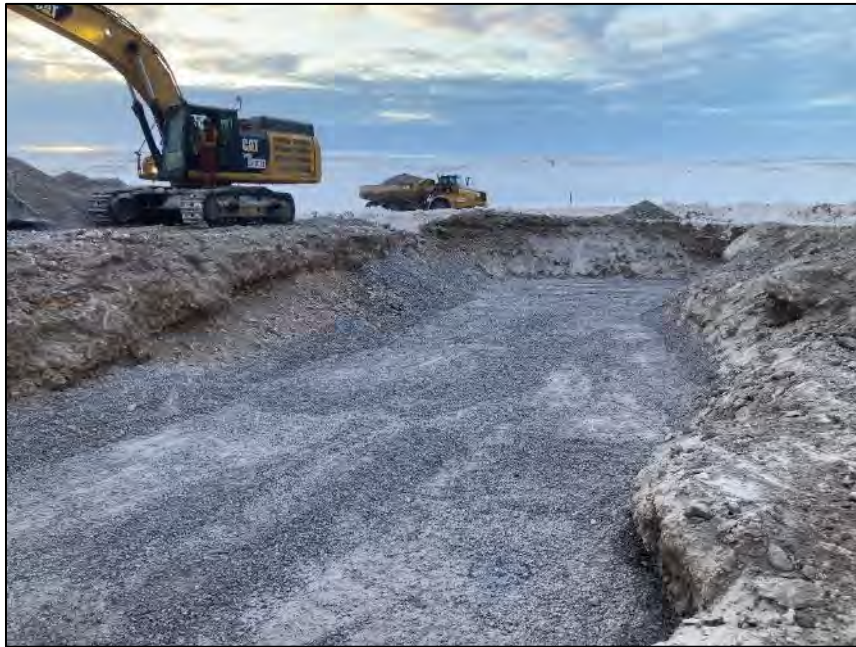
**PHOTO 13.** During Construction - Vantage Point 3 - Compacted Culvert Backfill Material - Looking Northeast (May 05, 2024).
