**August 28, 2024**

**Knight Piésold Ltd.**  
200-1164 Devonshire Avenue  
North Bay, Ontario P1B 6X7  
Canada  
T +1 705 476 2165  
E [northbay@knightpiesold.com](mailto:northbay@knightpiesold.com)  
[www.knightpiesold.com](http://www.knightpiesold.com)

## **RE: Construction Summary of CV-001 Remedial Measures**

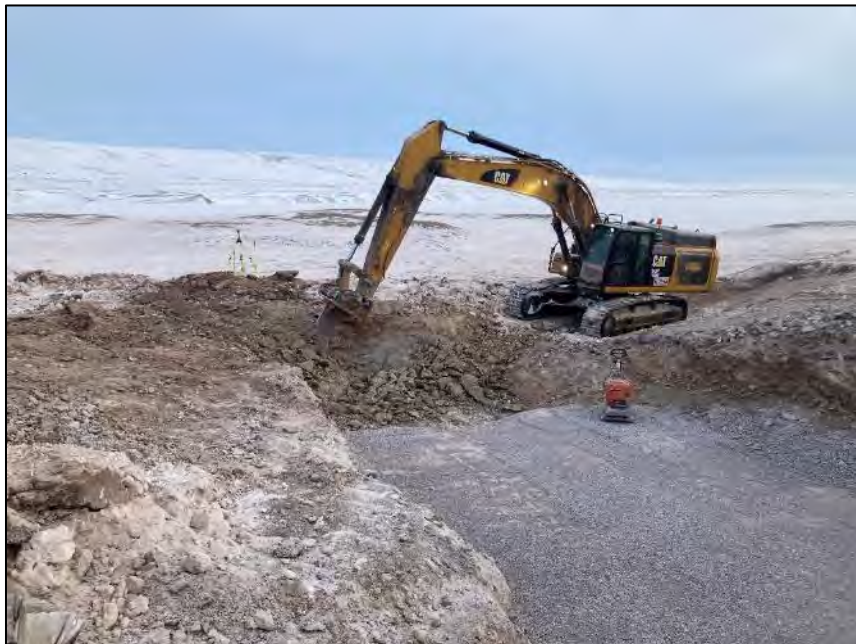
**PHOTO 14.** During Construction - Vantage Point 2 - Ripping of Outlet Apron - Looking Northeast (May 05, 2024).

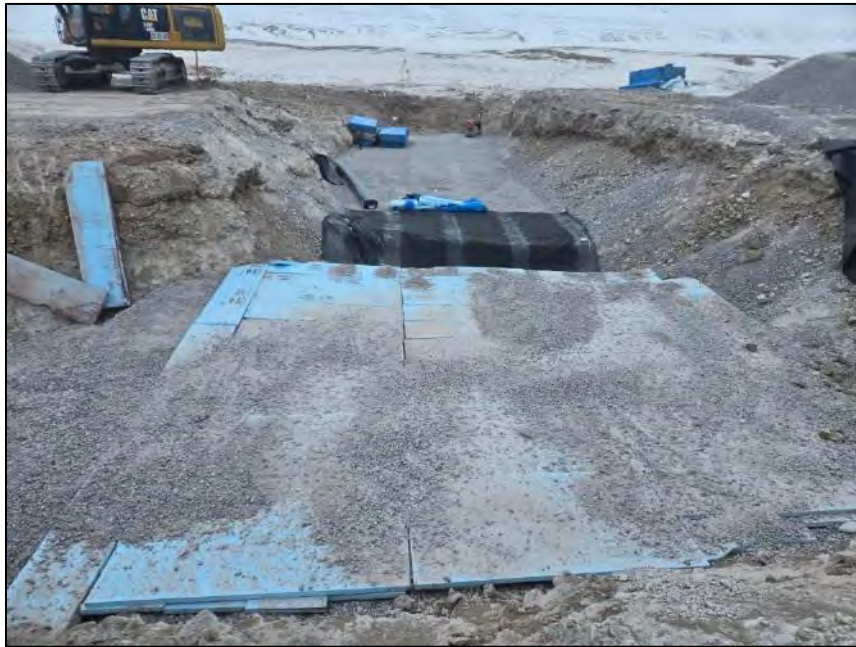
**PHOTO 15.** During Construction - Vantage Point 2 - Installation of Geotextile and Geomembrane Anchor Trench and Styrofoam - Looking Northwest (May 06, 2024).

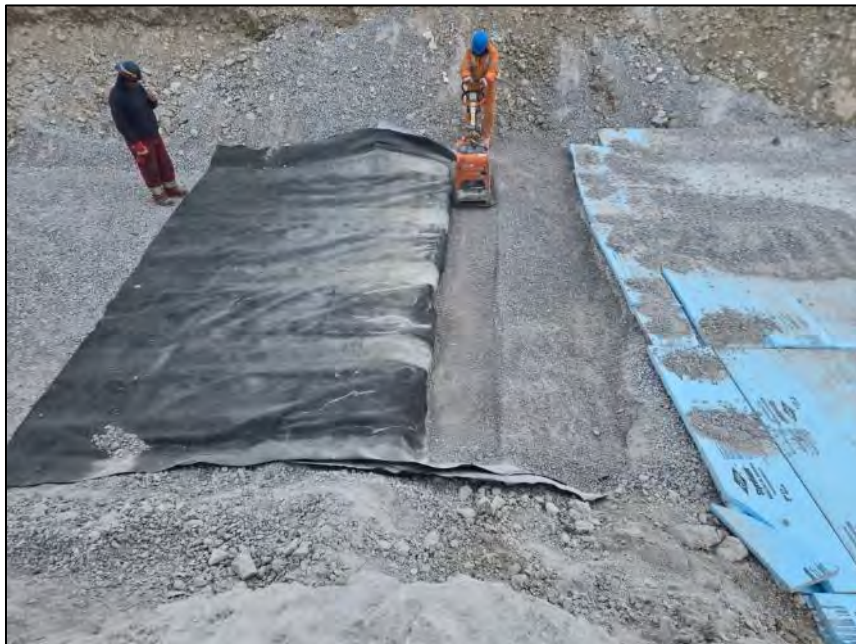
**PHOTO 16.** During Construction - Vantage Point 2 - Compaction of Culvert Backfill Material in Anchor Trench - Looking North (May 06, 2024).

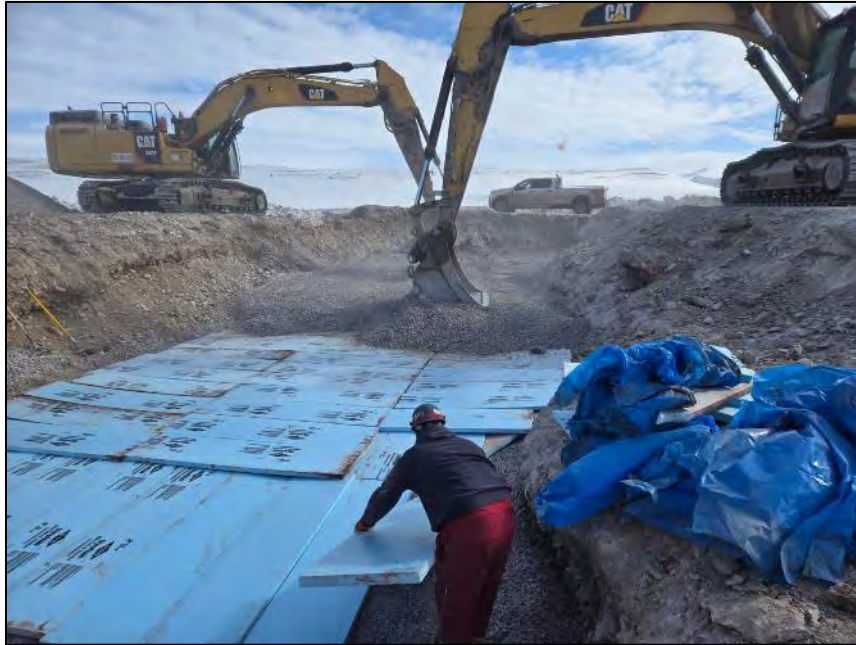
**PHOTO 17.** During Construction - Vantage Point 3 - Placement of Culvert Backfill Material and Installation of Styrofoam Insulation - Looking Northeast (May 06, 2024).

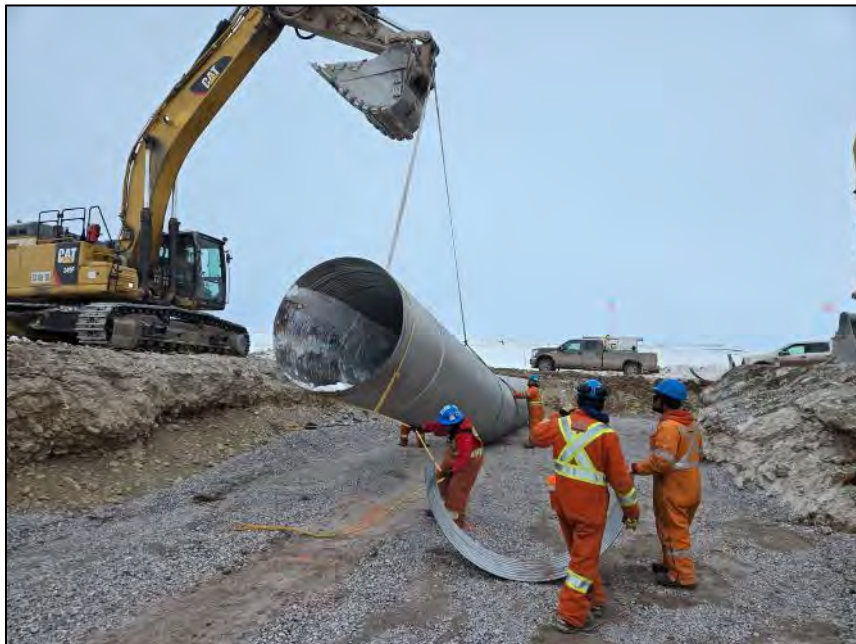
**PHOTO 18.** During Construction - Vantage Point 3 - Installation of Low Flow Culvert - Looking Northeast (May 06, 2024).

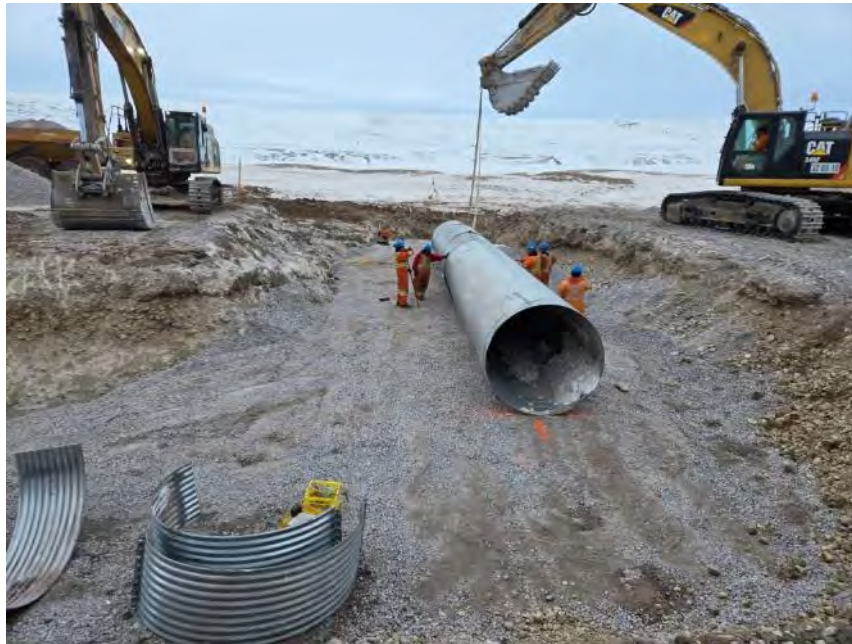
**PHOTO 19.** During Construction - Vantage Point 2 - Installation of Low Flow Culvert - Looking Northwest (May 06, 2024).

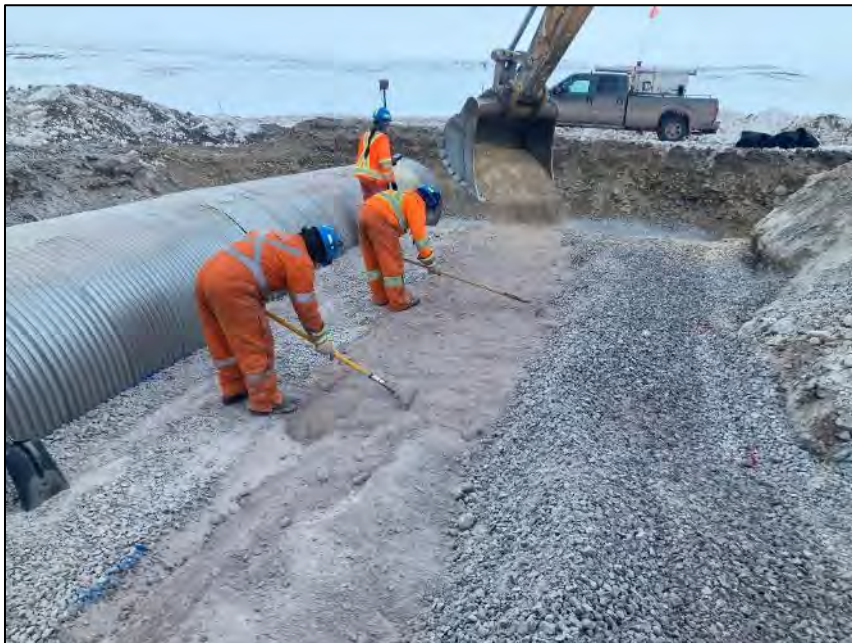
**PHOTO 20.** During Construction - Vantage Point 3 - Placement and Grading of Culvert Bedding Material - Looking Northeast (May 06, 2024).

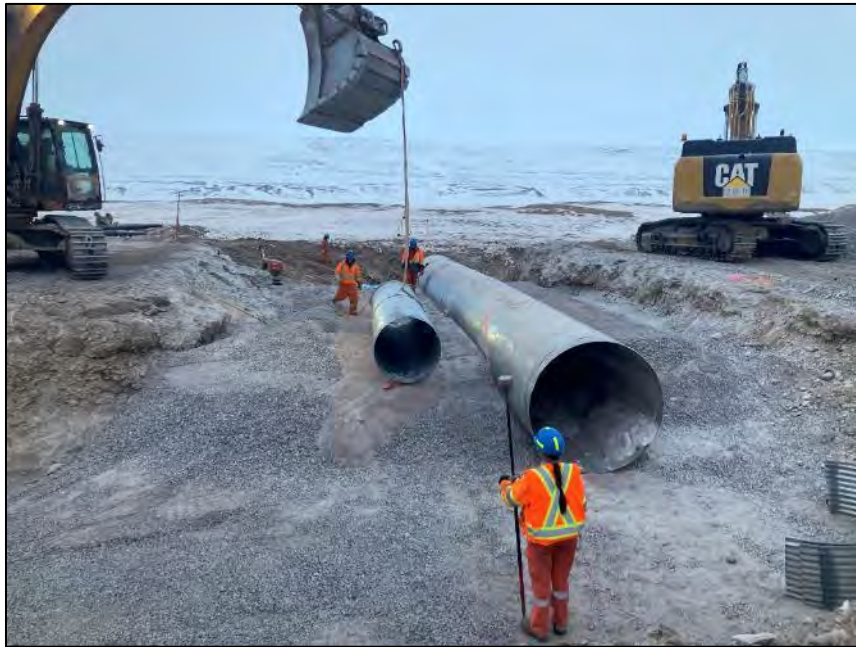
**PHOTO 21.** During Construction - Vantage Point 2 - Installation of High Flow Culvert - Looking Northeast (May 06, 2024).

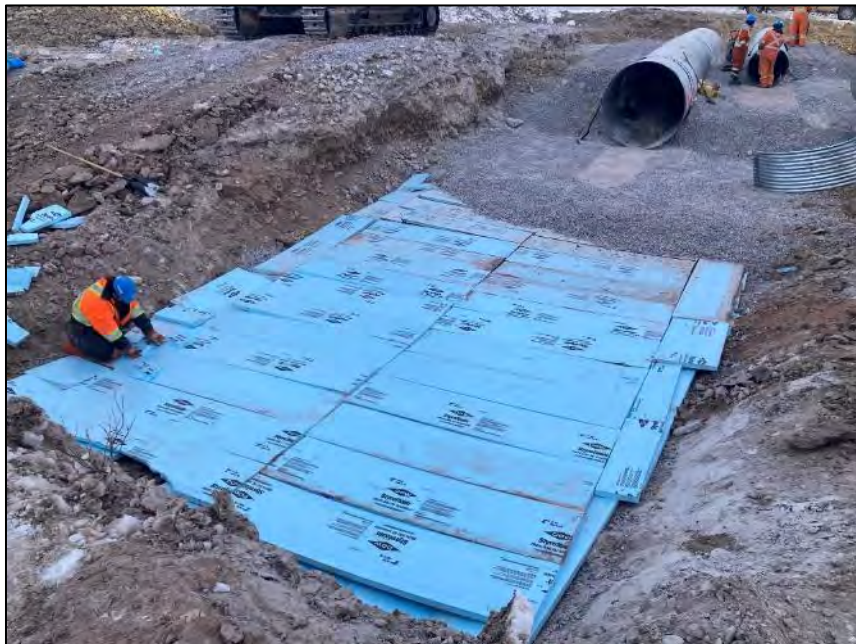
**PHOTO 22.** During Construction - Vantage Point 3 - Installation of Styrofoam Insulation - Looking Northeast (May 06, 2024).

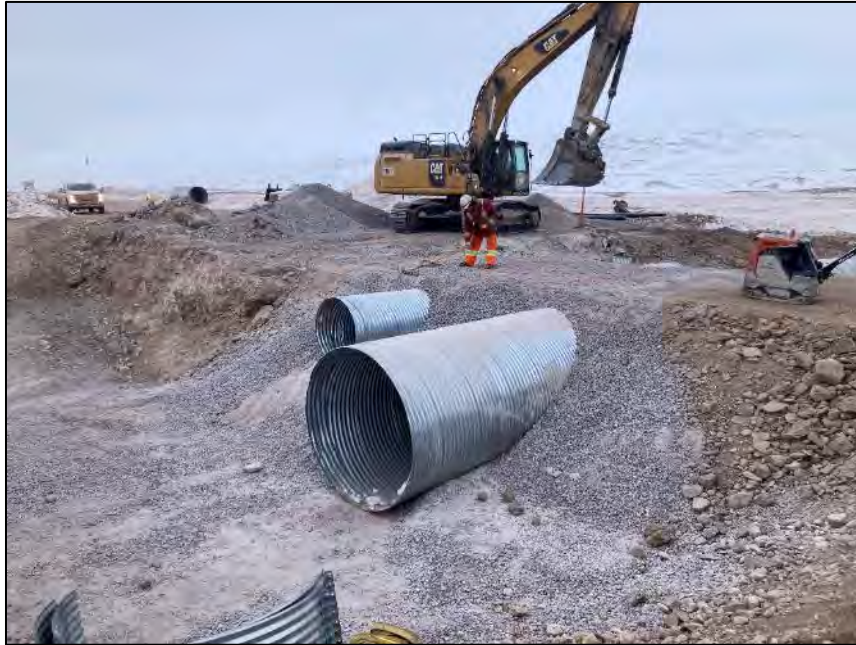
**PHOTO 23.** During Construction - Vantage Point 1 - Compaction of Culvert Backfill Material around Culverts - Looking Southwest (May 06, 2024).

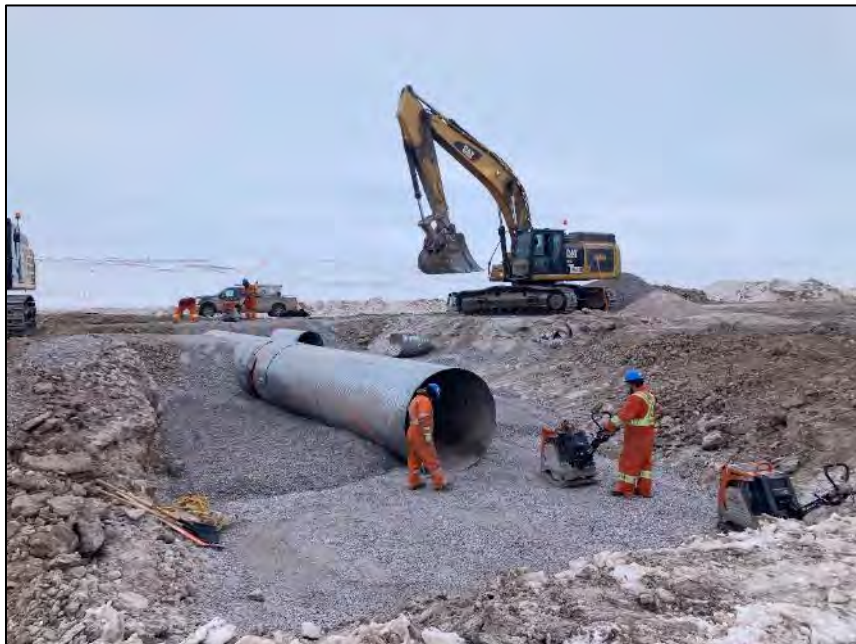
**PHOTO 24.** During Construction - Vantage Point 4 - Compaction of Culvert Backfill Material around Culverts - Looking Southeast (May 06, 2024).

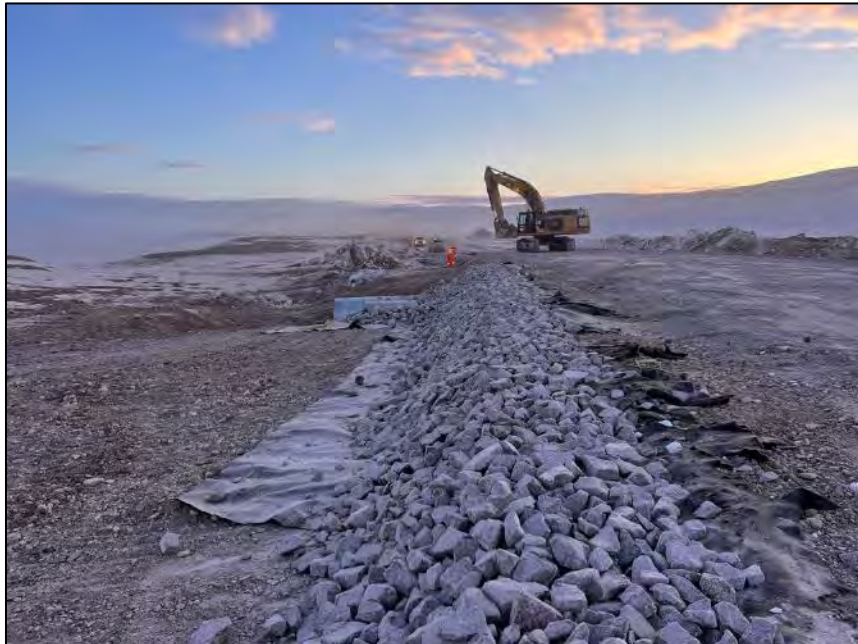
**PHOTO 26.** During Construction - Vantage Point 3 - Placement of Riprap for Slope Stabilization - Looking North (May 09, 2024).

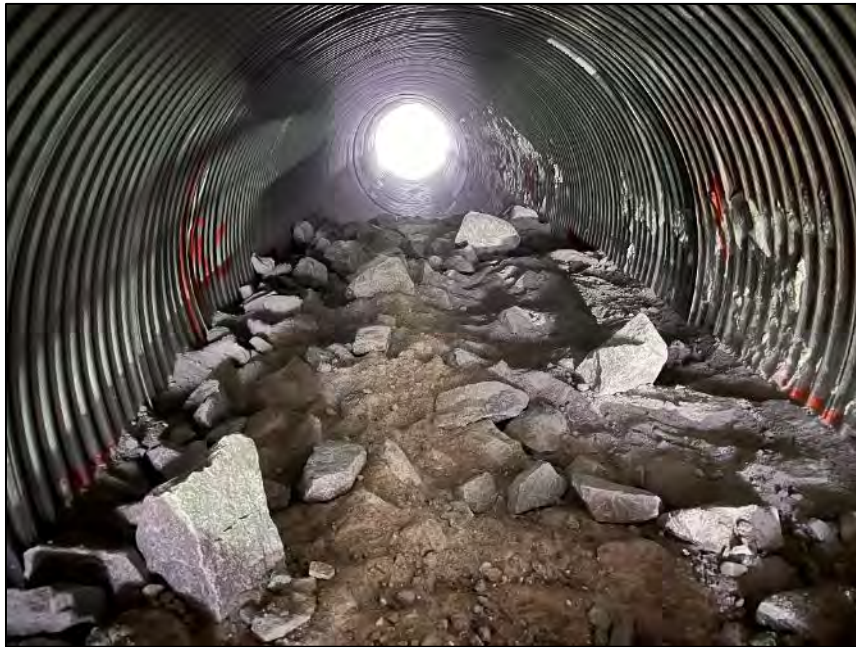
**PHOTO 27.** During Construction - Culvert Infill in Low Flow Culvert - Looking West (May 10, 2024).

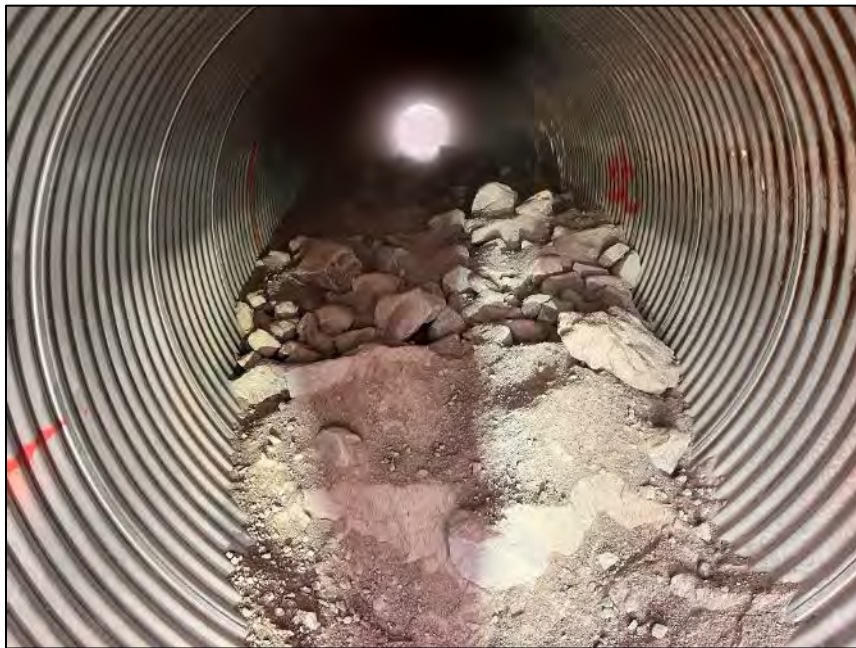
**PHOTO 28.** During Construction - Culvert Infill in Low Flow Culvert - Looking East (May 10, 2024).

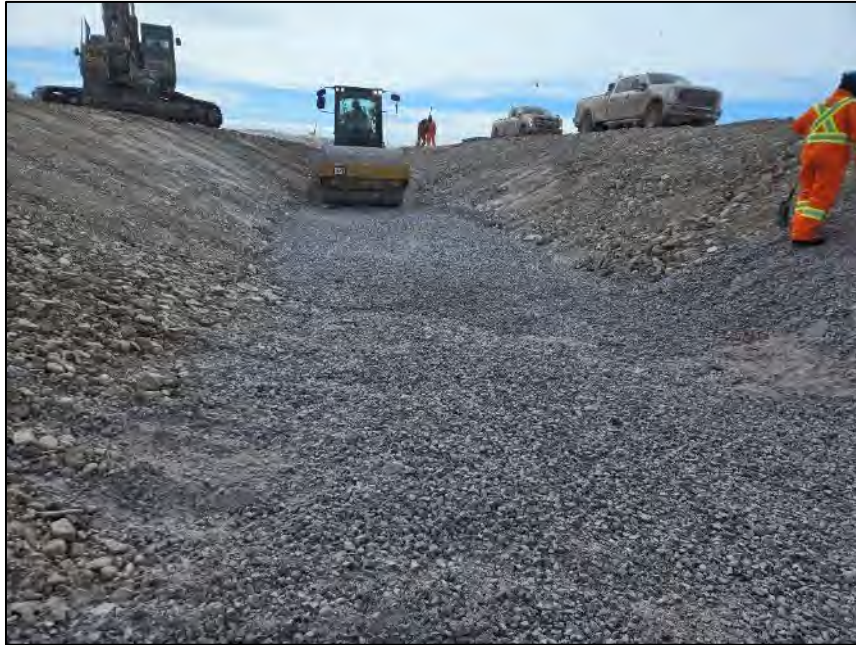
**PHOTO 29.** During Construction - Vantage Point 1 - Compaction of Culvert Backfill Material in Inlet Apron - Looking South (May 10, 2024).

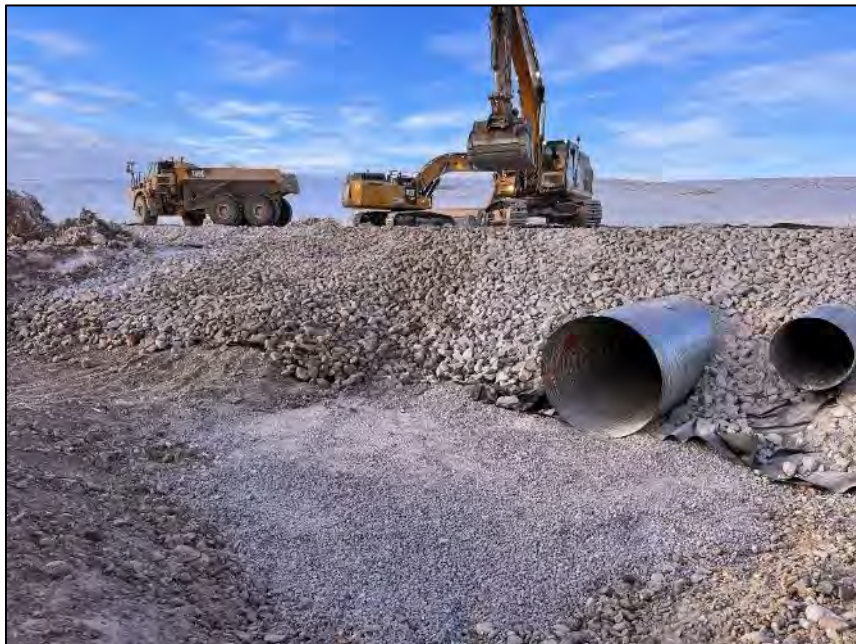
**PHOTO 30.** During Construction - Vantage Point 3 - Placement of Riprap for Slope Stabilization - Looking Northeast (May 10, 2024).

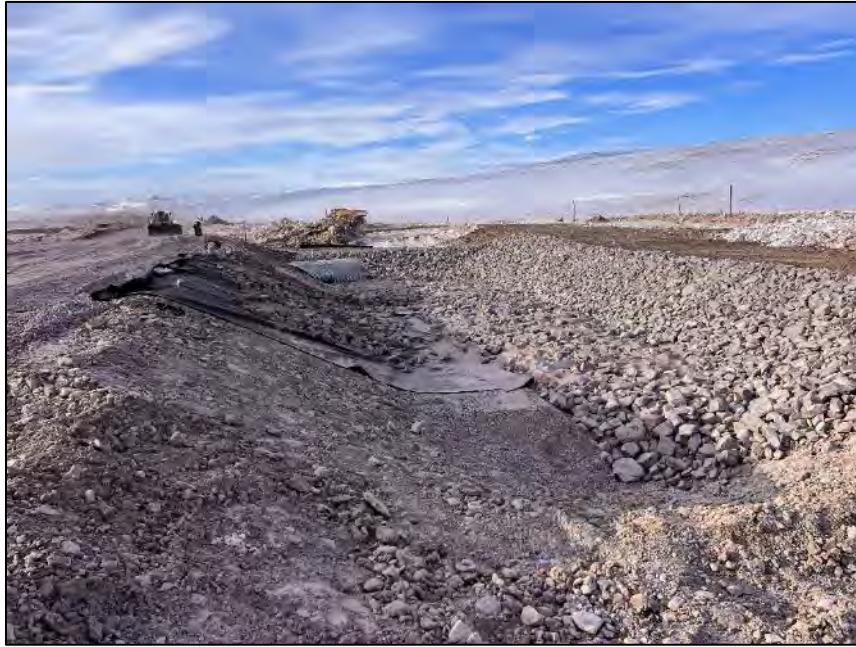
**PHOTO 31.** During Construction - Vantage Point 2 - Placement of Coarse Riprap and Stream Substrate Material in Inlet Apron - Looking North (May 11, 2024).

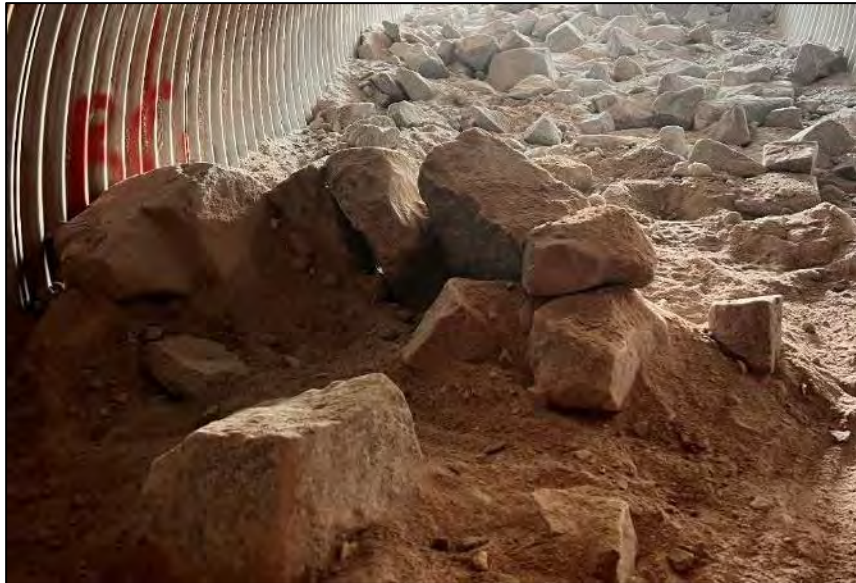
**PHOTO 32.** During Construction - Completed Boulder Cluster in Low Flow Culvert - Looking West (May 11, 2024).

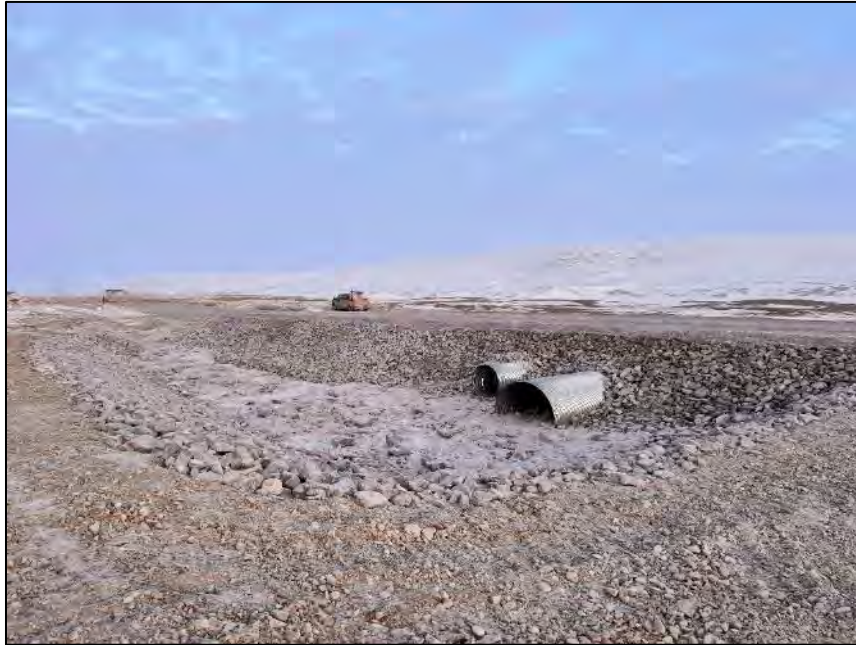
**PHOTO 33.** After Construction - Vantage Point 1 - Inlet Apron and Road Crossing - Looking Southwest (May 14, 2024).

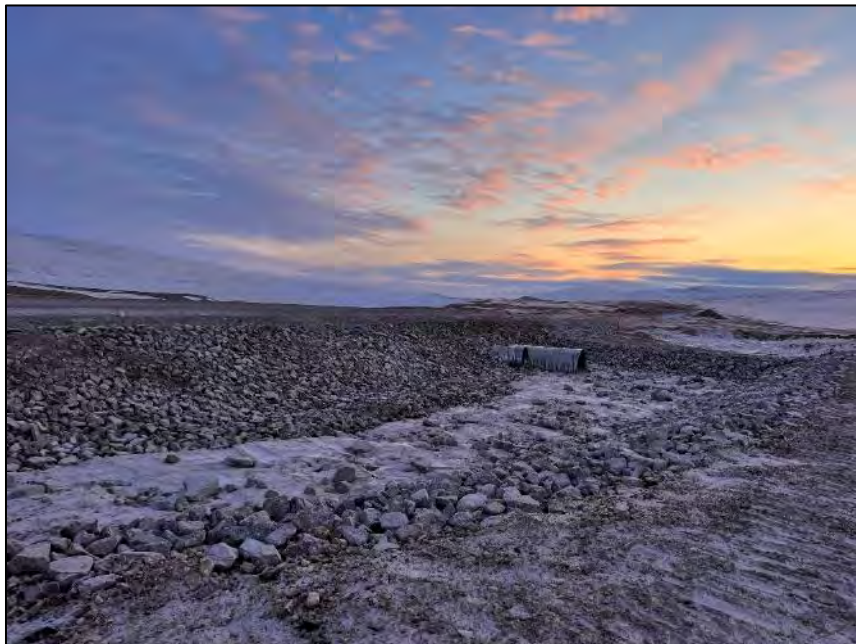
**PHOTO 34.** After Construction - Vantage Point 2 - Inlet Apron and Road Crossing - Looking Northwest (May 14, 2024).

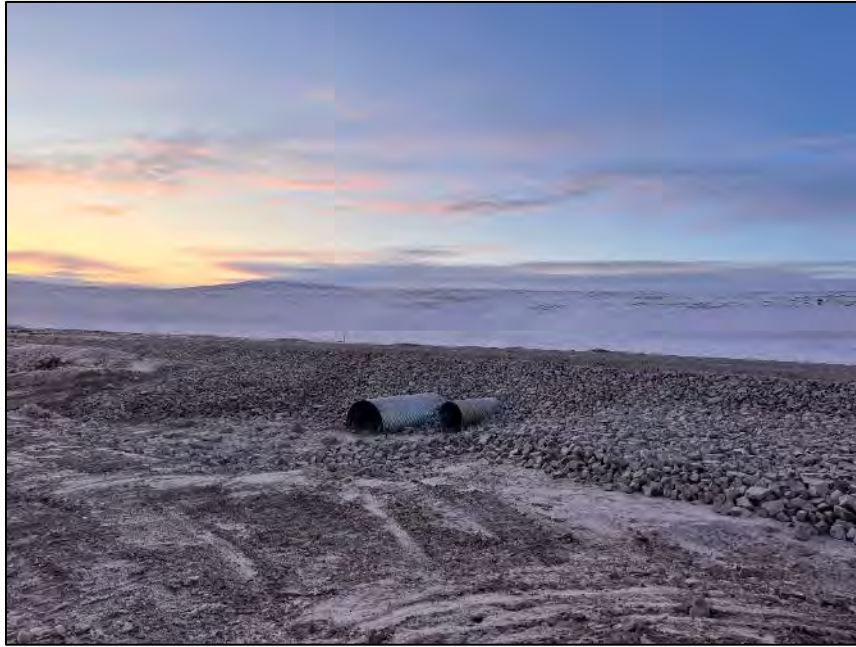
**PHOTO 35.** During Construction - Vantage Point 3 - Outlet Apron and Road Crossing - Looking Northeast (May 11, 2024).

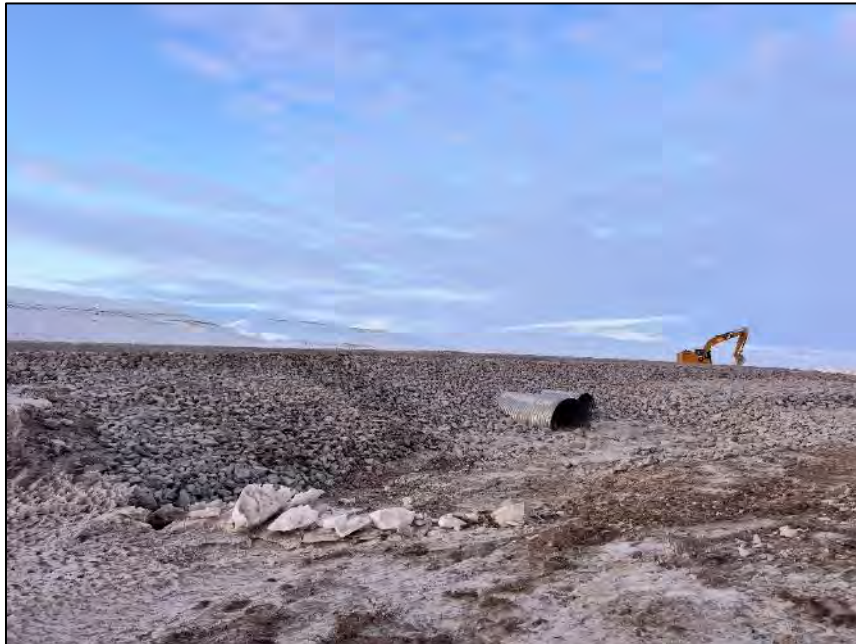
**PHOTO 36.** During Construction - Vantage Point 4 - Outlet Apron and Road Crossing - Looking Southeast (May 11, 2024).

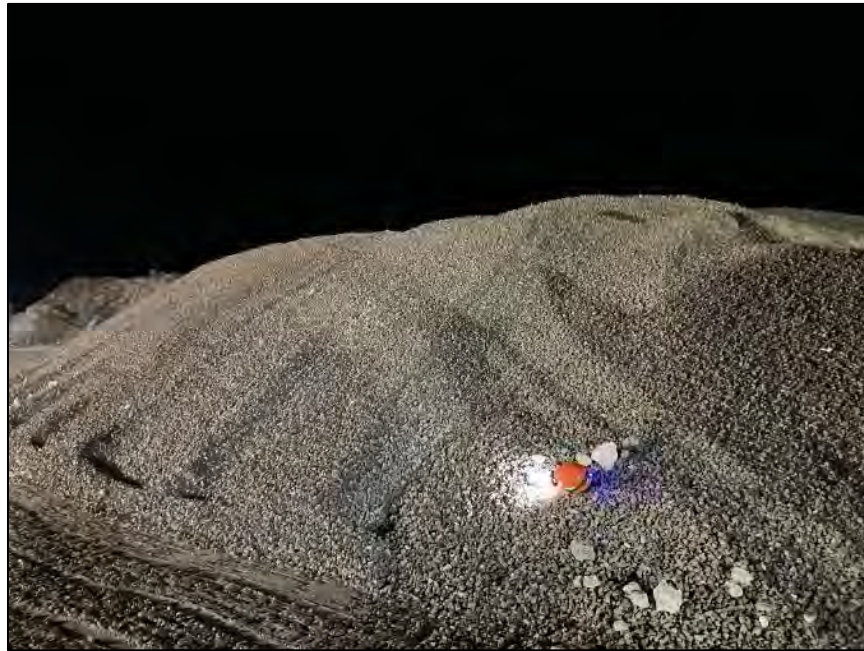
**PHOTO 37.** Material Stockpile - 32 mm minus Culvert Backfill Material - km 60 Laydown - Looking Northeast (March 10, 2024).

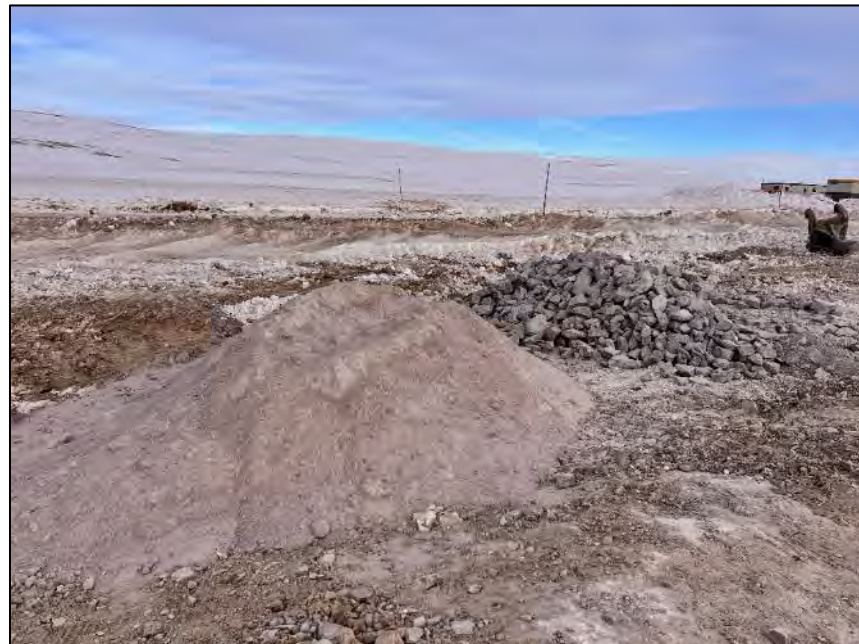
**PHOTO 38.** Material Stockpile - Culvert Bedding Material - km 30 Laydown - Looking West (May 10, 2024).

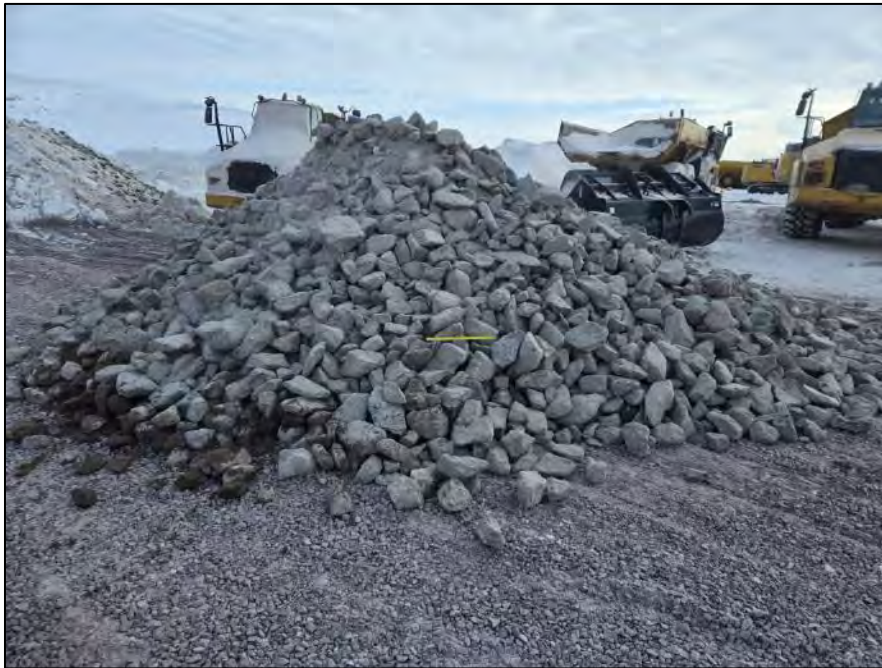
**PHOTO 39.** Material Stockpile - Fine Rip Rap - km 60 Laydown - Looking Southeast (March 22, 2024).

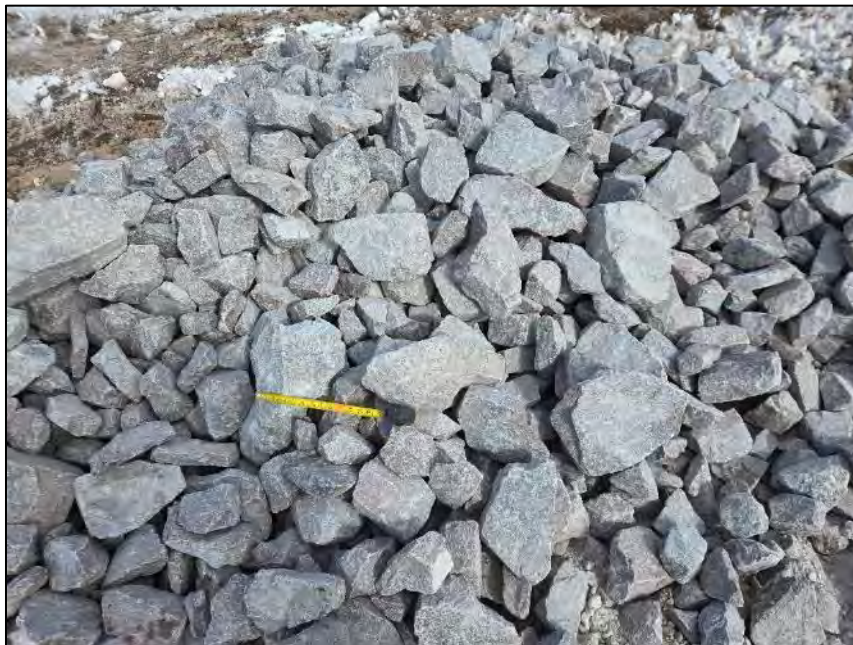
**PHOTO 40.** Material Stockpile - Coarse Rip Rap - km 30 Laydown - Looking West (May 10, 2024).

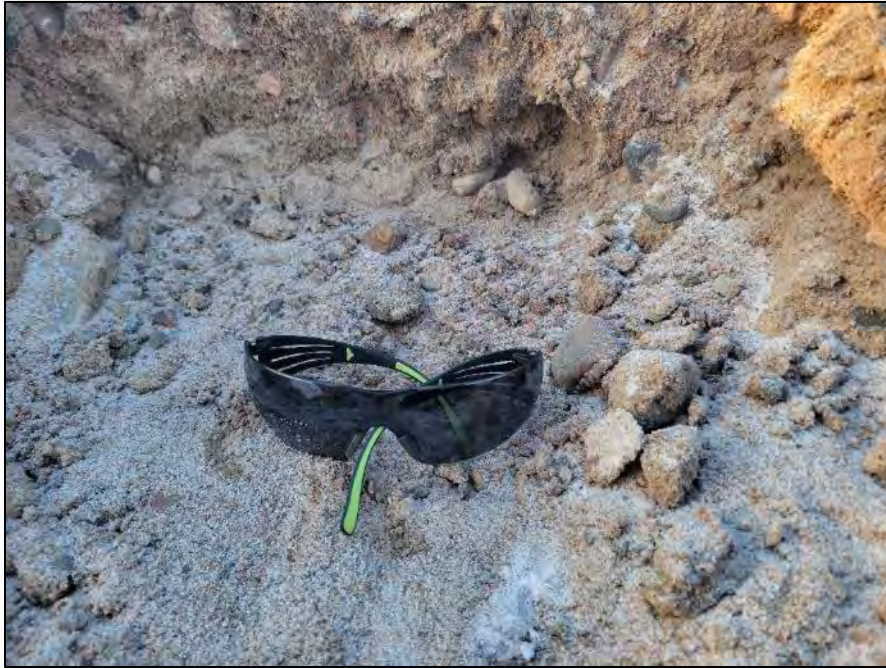
**PHOTO 41.** Material Stockpile - Stream Substrate Material - km 97 Stockpile (February 29, 2024).

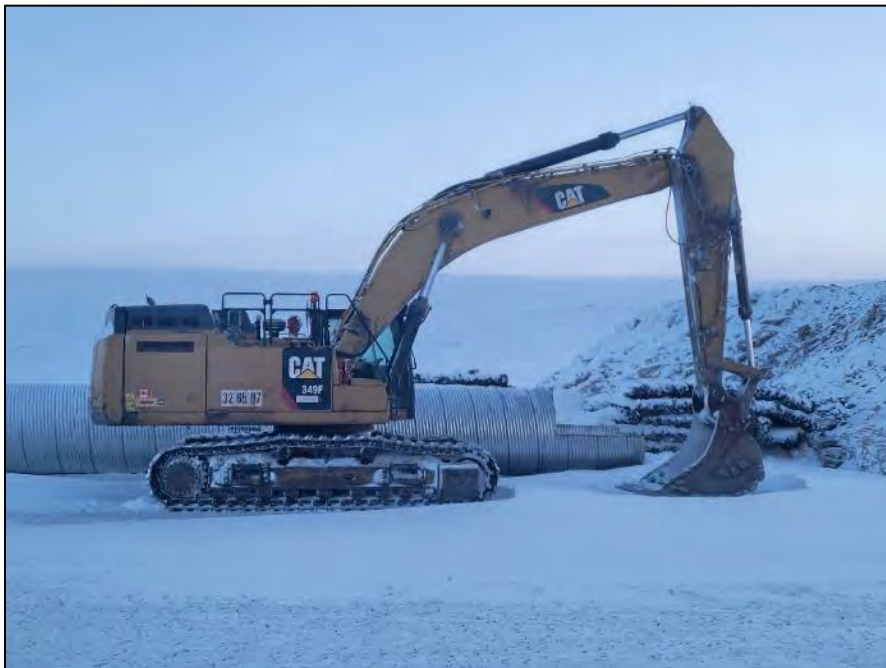
**PHOTO 42.** Equipment - CAT 349F Excavator - km 60 Laydown - looking East (March 08, 2024).

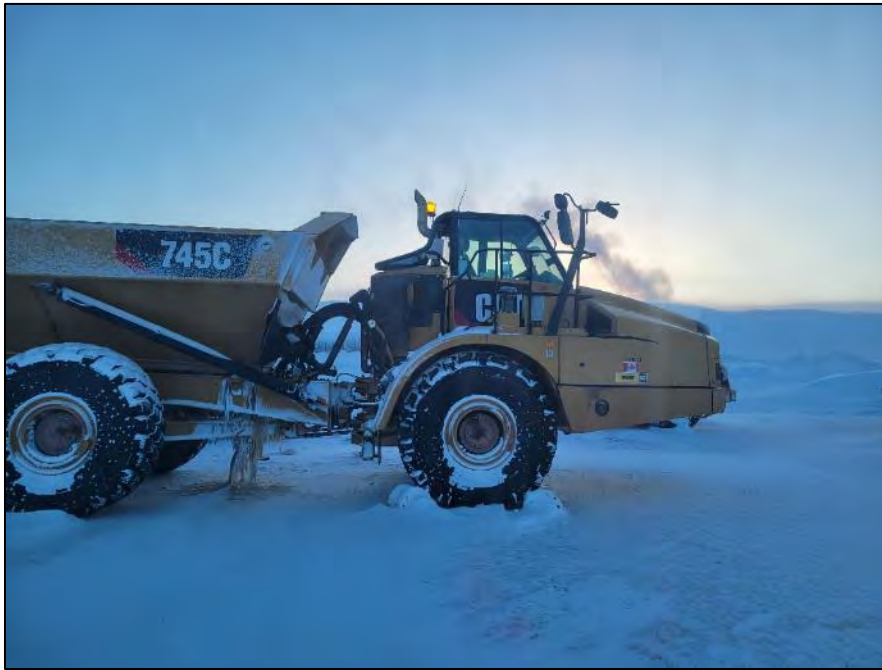
**PHOTO 43.** Equipment - CAT 745C articulated dump truck - km 60 Laydown (February 08, 2024).

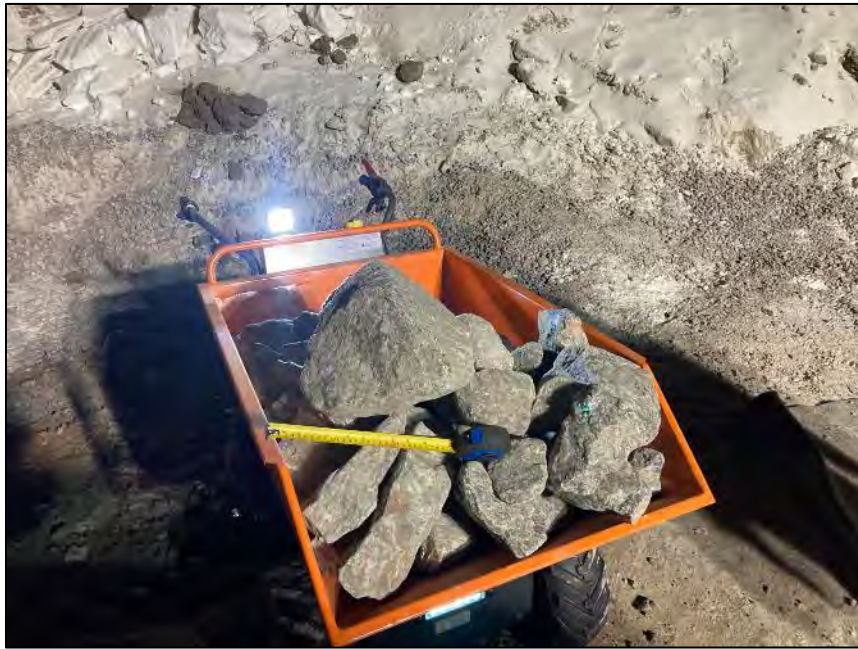
**PHOTO 45.** Equipment - Ducar Motorized Wheel Barrow loaded with Coarse Riprap - CV-059 (March 26, 2024).

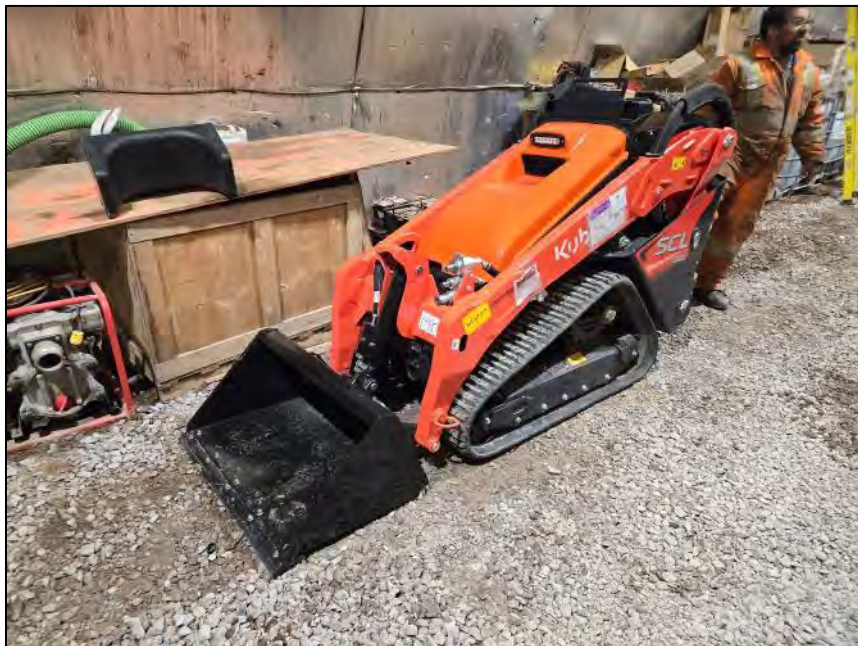
**PHOTO 46.** Equipment - Kubota Stand-on Compact Loader (April 30, 2024).

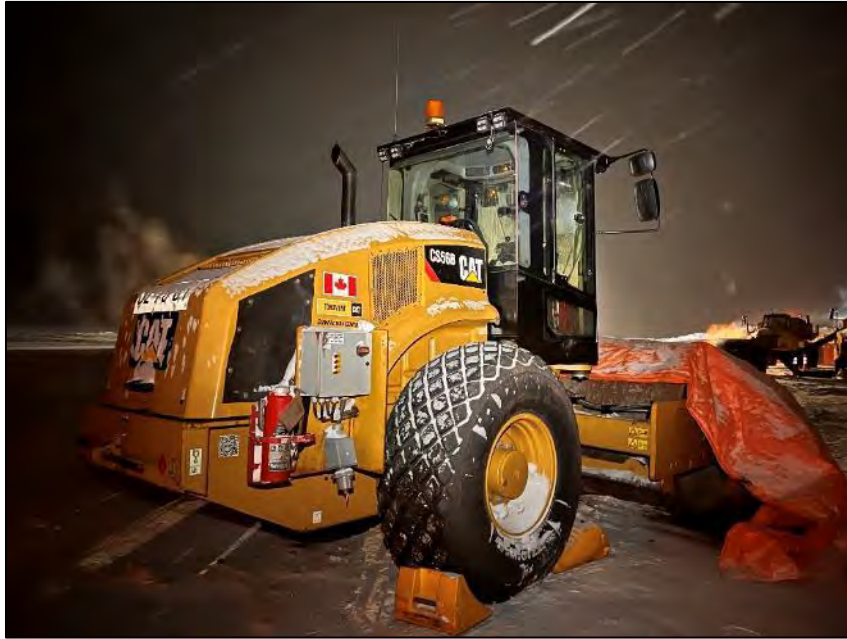
**PHOTO 47.** Equipment - CAT CS56B Smooth Drum Compactor (March 02, 2024).
