RE: Construction Summary of CV-059 Remedial Measures

CV-059 AS-BUILT PHOTO LOG

CV-057 AS-BUILT PHOTO LOG

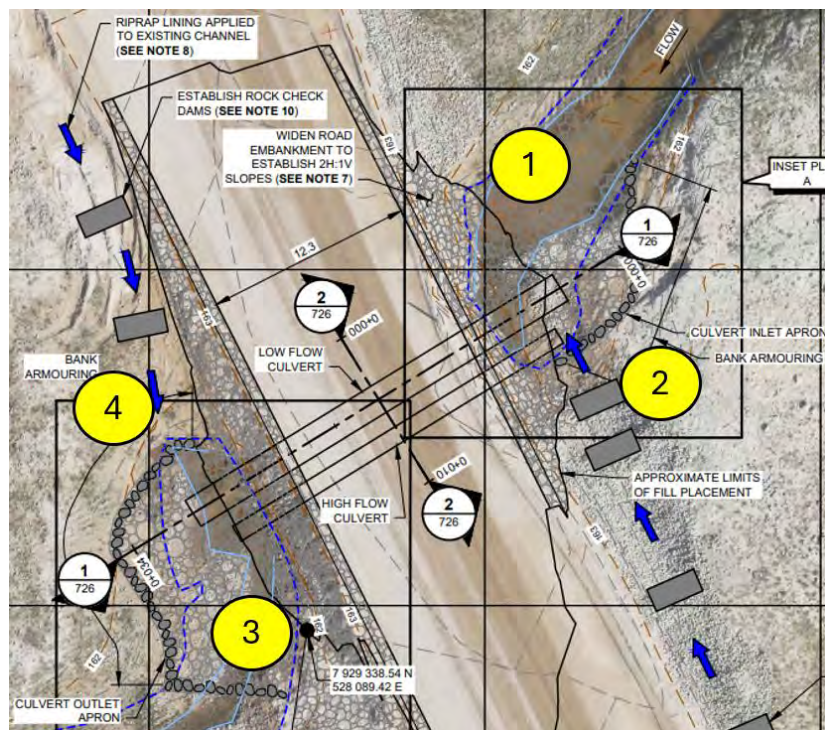
PHOTO 1. Culvert Crossing CV-059 - Photographic Vantage Points (approximate locations indicated with yellow circles).

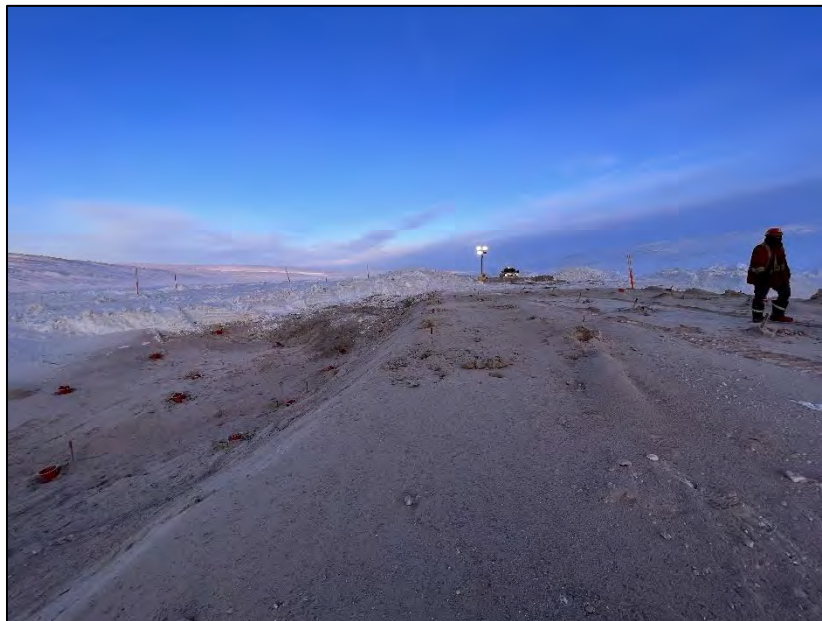
PHOTO 2. Prior to Construction - Vantage Point 1 - Upstream side of crossing - looking south (February 19, 2024).

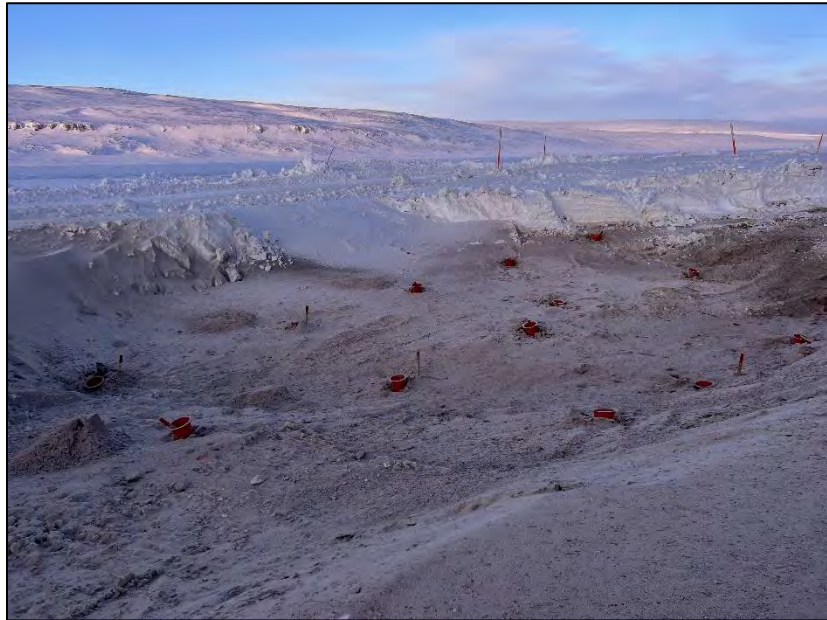
PHOTO 3. Prior to Construction - Vantage Point 2 - Upstream side of crossing - looking east (February 19, 2024).

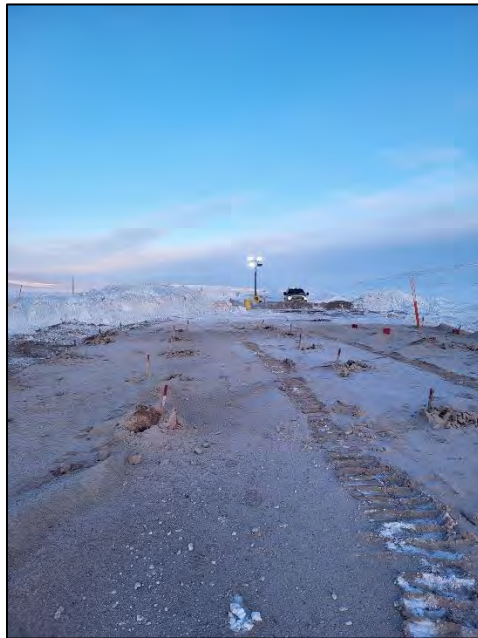
PHOTO 4. Prior to Construction - Vantage Point 3 - Road crossing - looking south (February 20, 2024).

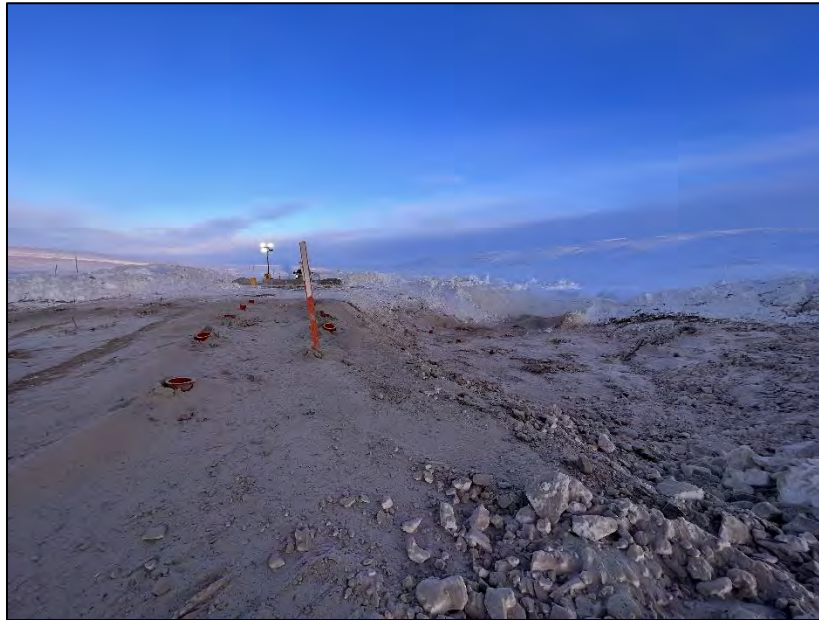
PHOTO 5. Prior to Construction - Vantage Point 4 - Downstream side of crossing - looking south (February 19, 2024).

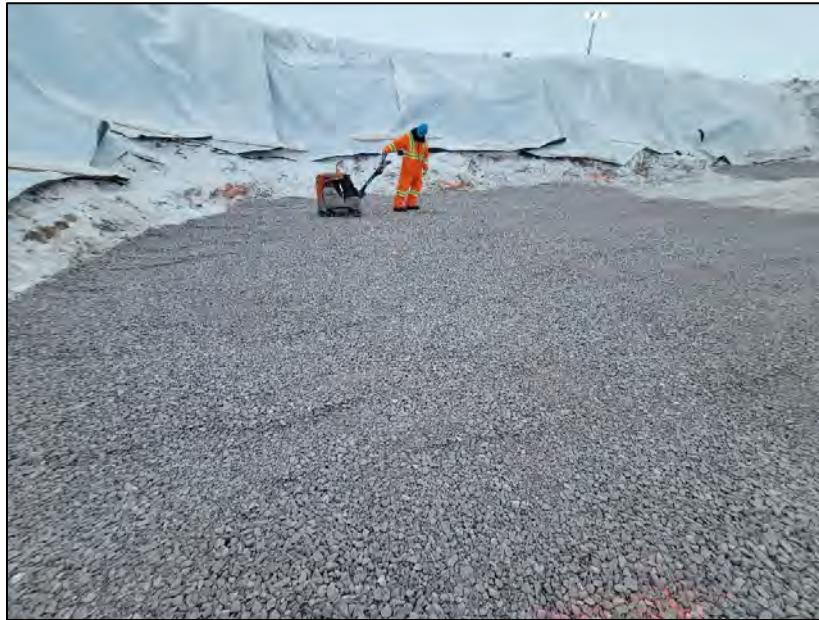
PHOTO 9. During Construction- Vantage Point 1 - Compaction of culvert backfill material - upstream inlet - looking south (March 12, 2024).

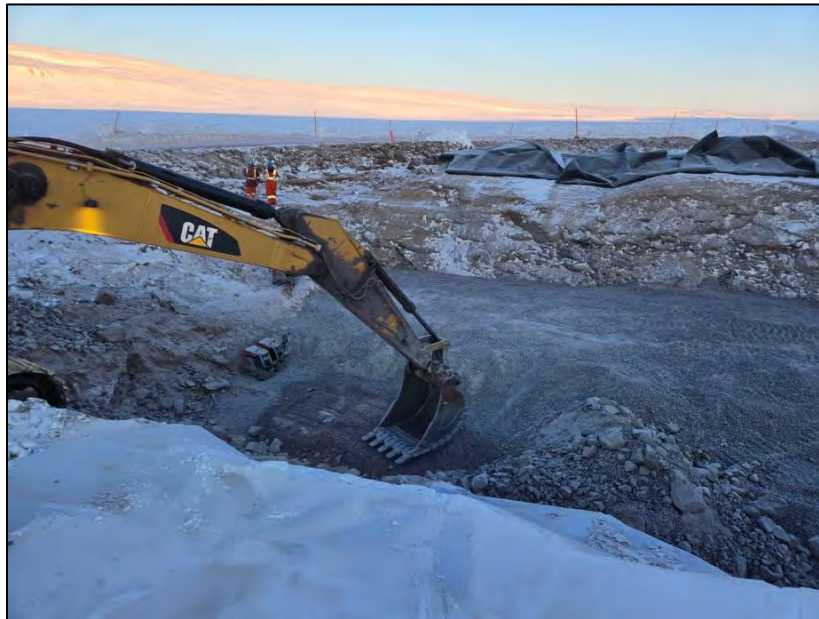
PHOTO 10. During Construction - Vantage Point 2 - Placement of culvert backfill material - upstream inlet - looking west (March 14, 2024).

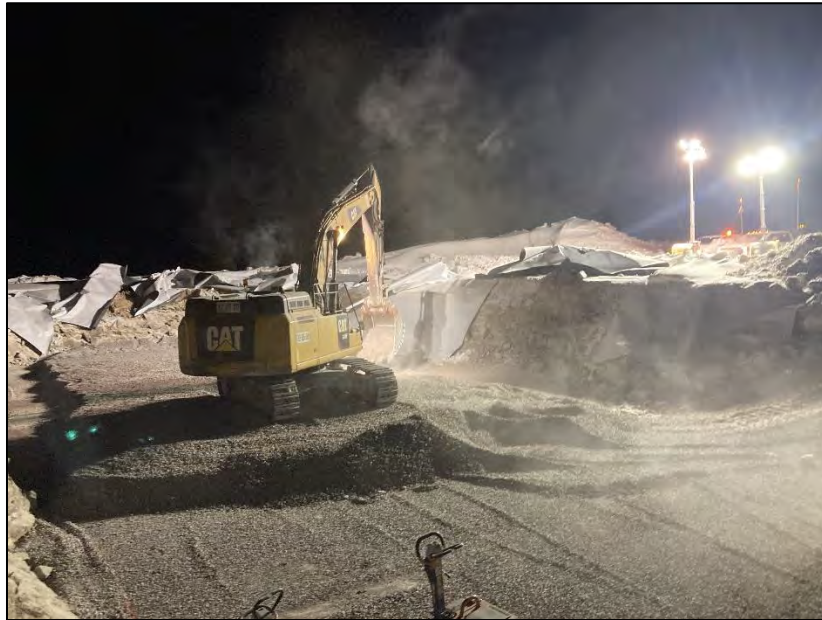
PHOTO 11. During Construction - Vantage Point 4 - Placement of culvert backfill material - road crossing and downstream outlet - looking southeast (March 15, 2024).

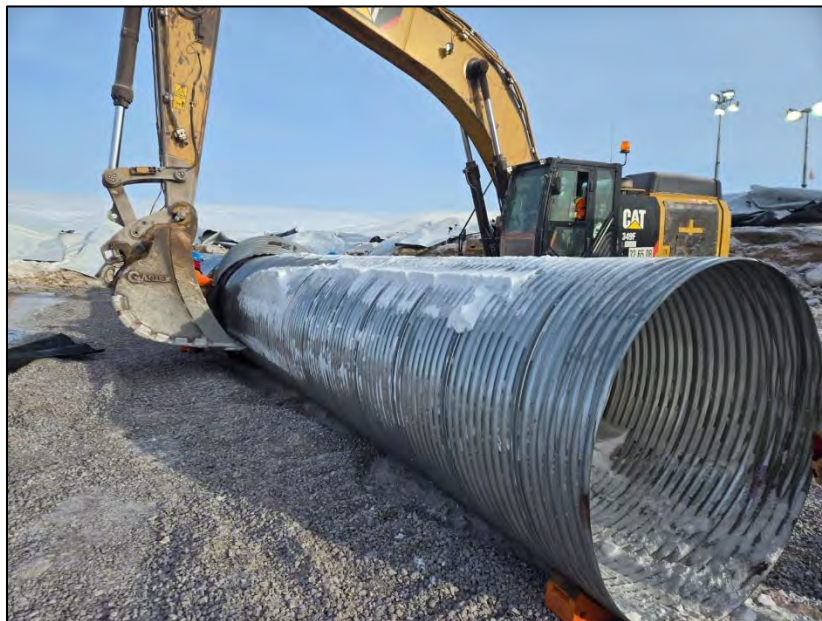
PHOTO 12. During Construction - Vantage Point 4 - Installation of 1.8 m diameter corrugated steel pipe low flow culvert - looking southeast (March 17, 2024).

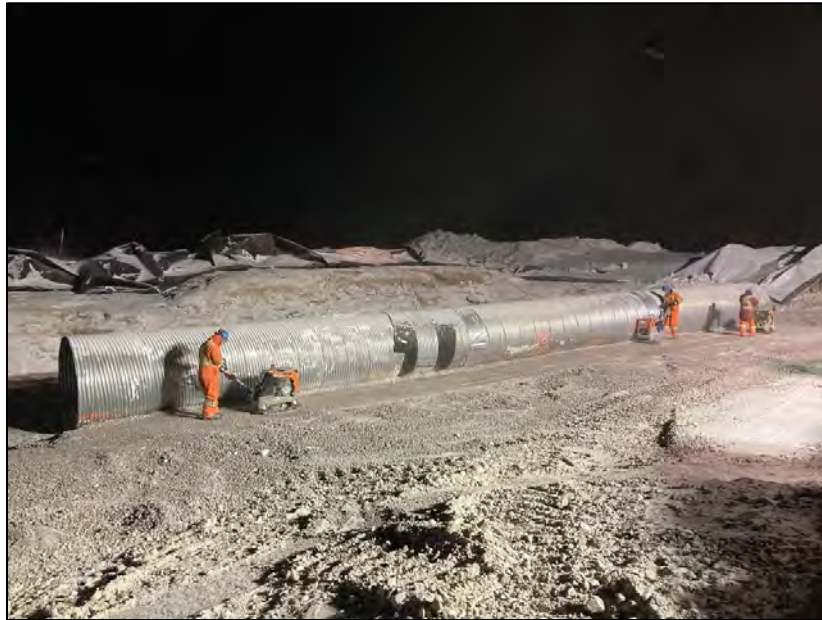
PHOTO 13. During Construction - Vantage Point 3 - Installation of 1.8 m diameter corrugated steel pipe low flow culvert - looking north (March 17, 2024).

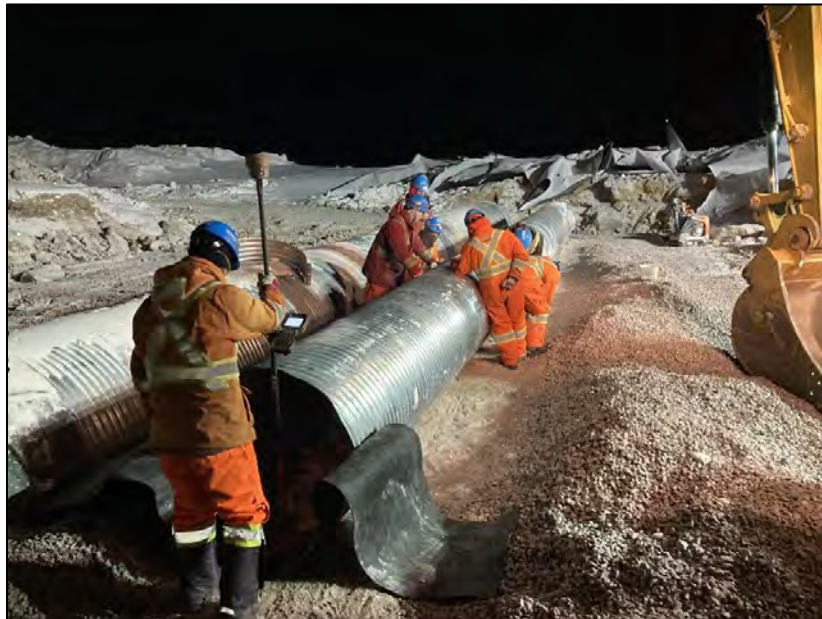
PHOTO 14. During Construction - Vantage Point 3 - Installation of 1.0 m diameter corrugated steel pipe high flow culvert - looking northeast (March 19, 2024).

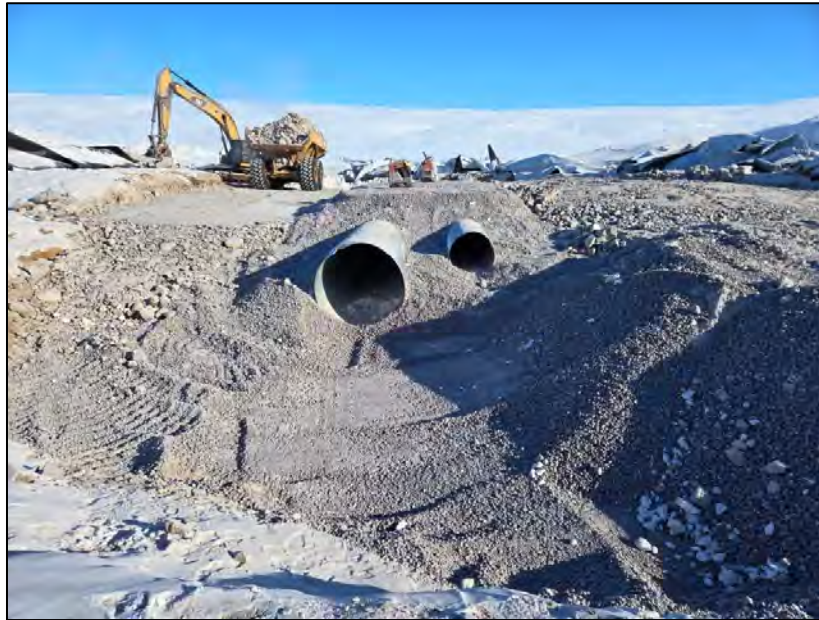
PHOTO 15. During Construction - Vantage Point 4 - Installation of high flow and low flow culverts - downstream outlet area - looking northeast (March 21, 2024).

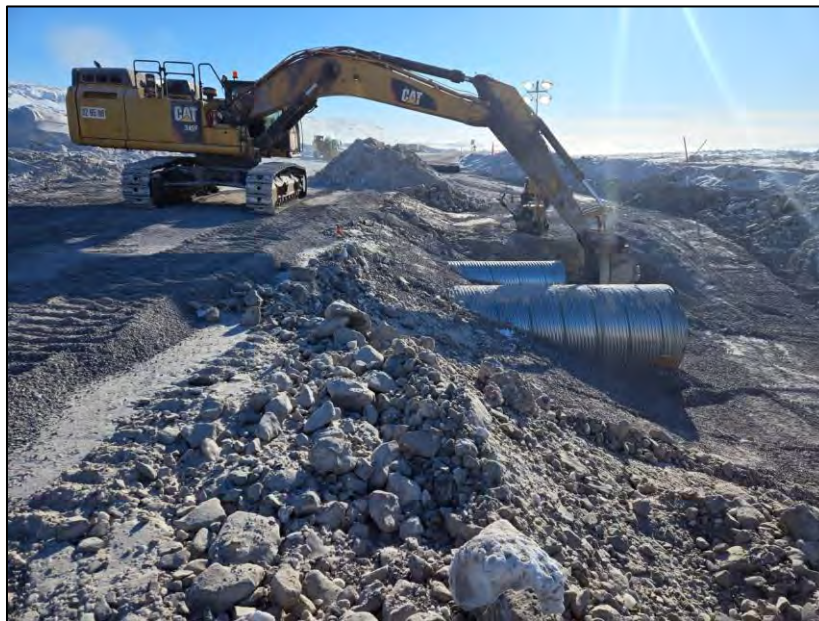
PHOTO 16. During Construction - Vantage Point 4 - Grading 2H:1V west side slope at CV-059 - looking southwest (March 24, 2024).

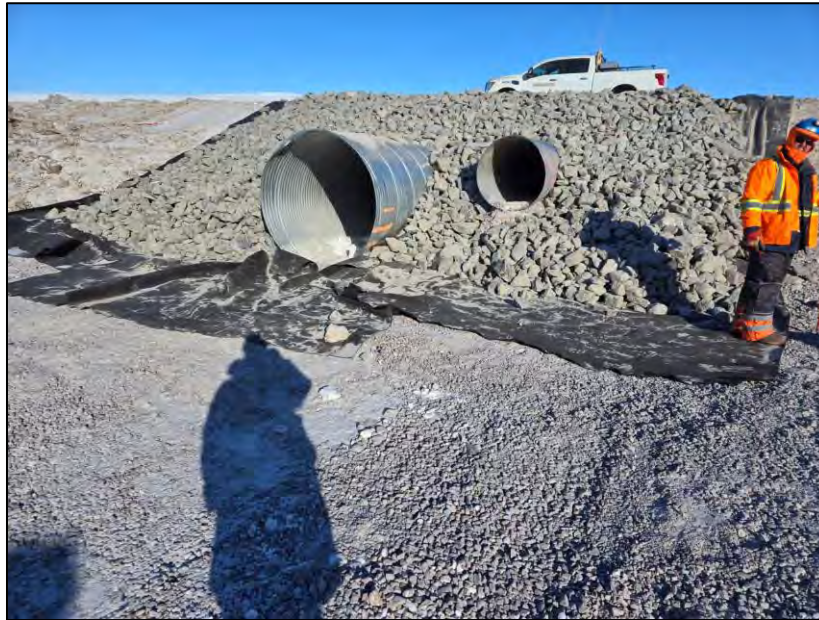
PHOTO 17. During Construction - Vantage Point 3 - Placing geotextile and riprap on west side slope at CV-059 - looking north (March 25, 2024).

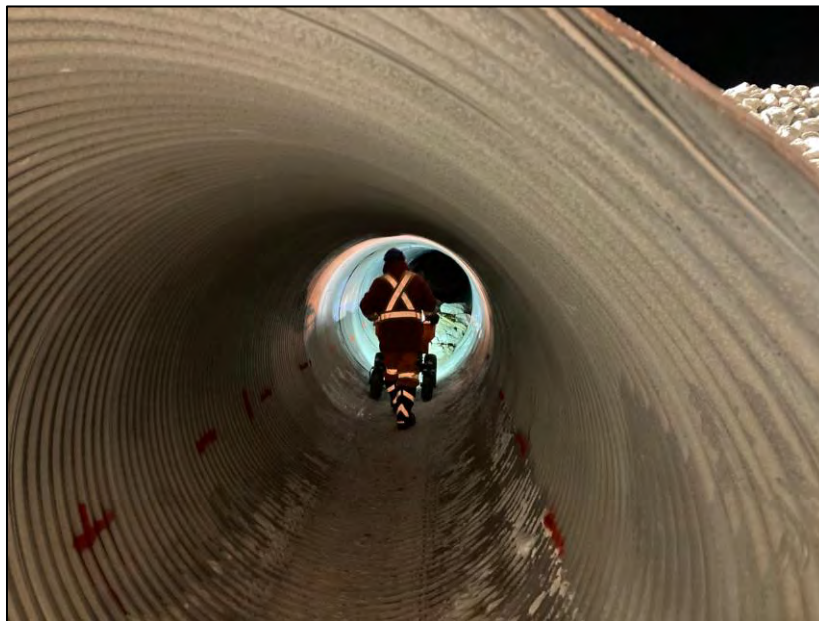
PHOTO 18. During Construction - Placement of coarse riprap and stream substrate material using electric wheelbarrow within the interior of the low flow CSP culvert at CV-059 - west (outlet) - looking northeast (March 27, 2024).

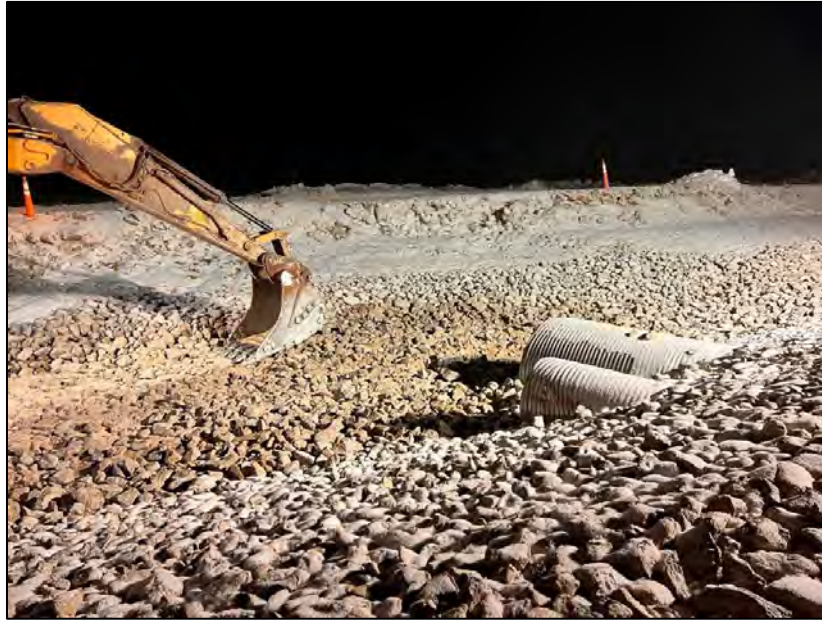
PHOTO 19. Following Construction - Vantage Point 3 - Completed CV-059 west (outlet) apron with coarse riprap and stream substrate material - looking northwest (March 29, 2024).

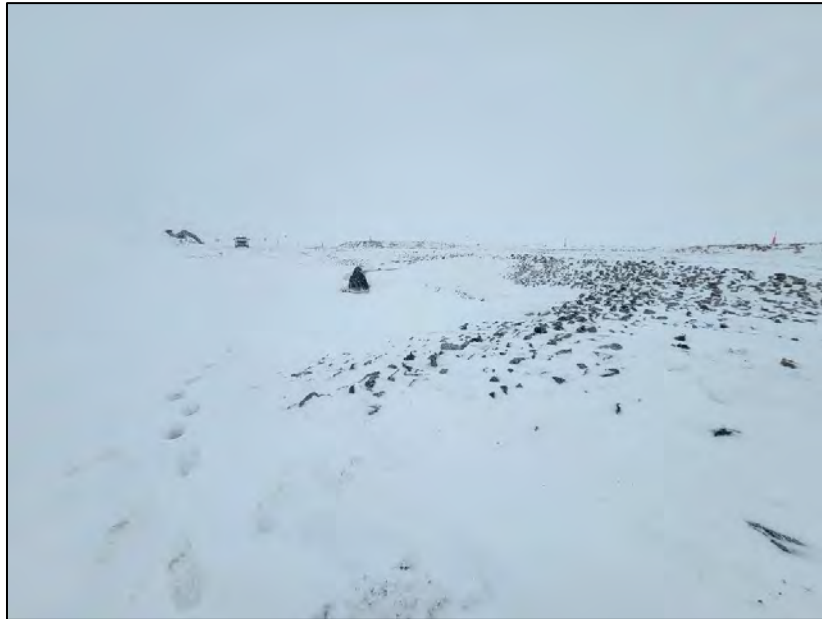
PHOTO 20. Following Construction - Vantage Point 1 - Completed installation of high flow and low flow culverts - upstream inlet area - looking southwest (April 5, 2024).

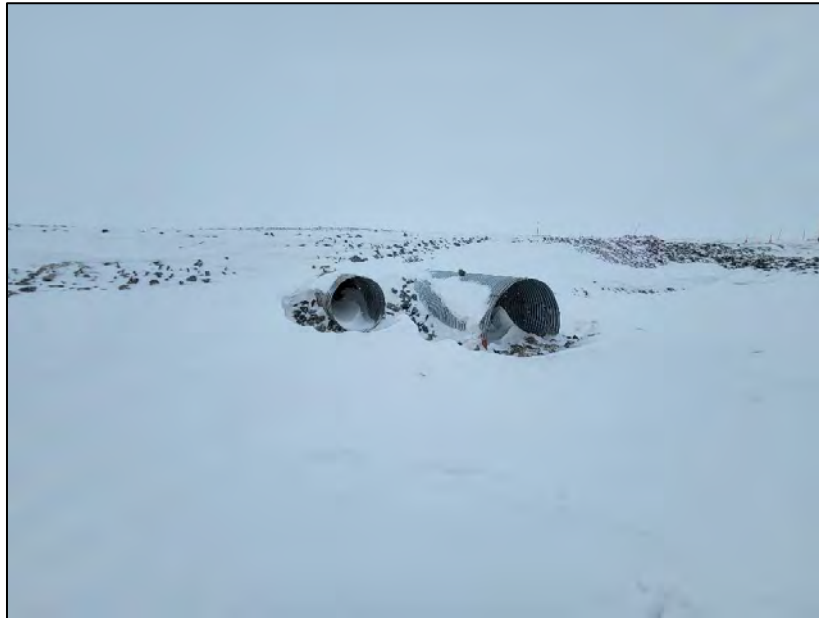
PHOTO 21. Following Construction - Vantage Point 2 - Completed installation of high flow and low flow culverts - upstream inlet area - looking northwest (April 5, 2024).

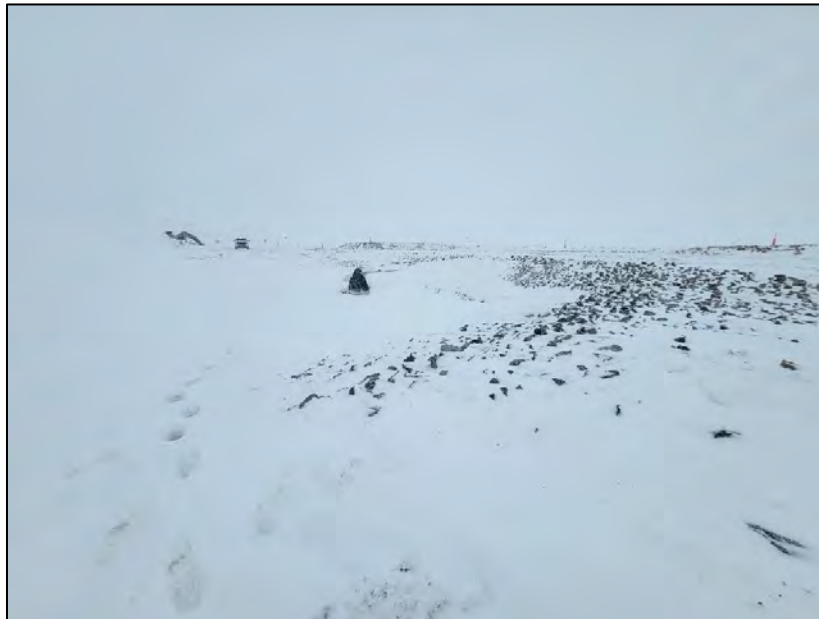
PHOTO 22. Following Construction - Vantage Point 3 - Installation of high flow and low flow culverts - downstream outlet area - looking northeast (April 5, 2024).

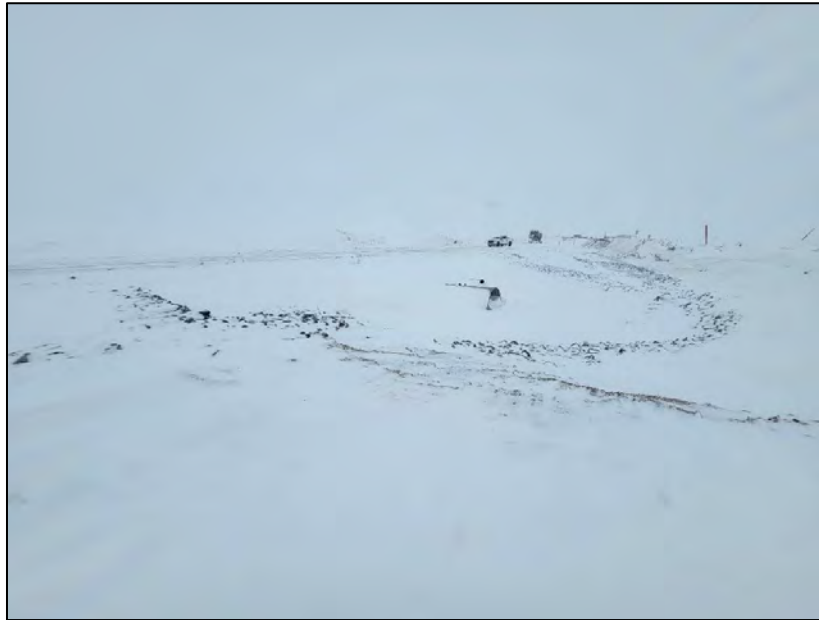
PHOTO 23. Following Construction - Vantage Point 4 - Installation of high flow and low flow culverts - downstream outlet area - looking southeast (April 5, 2024).

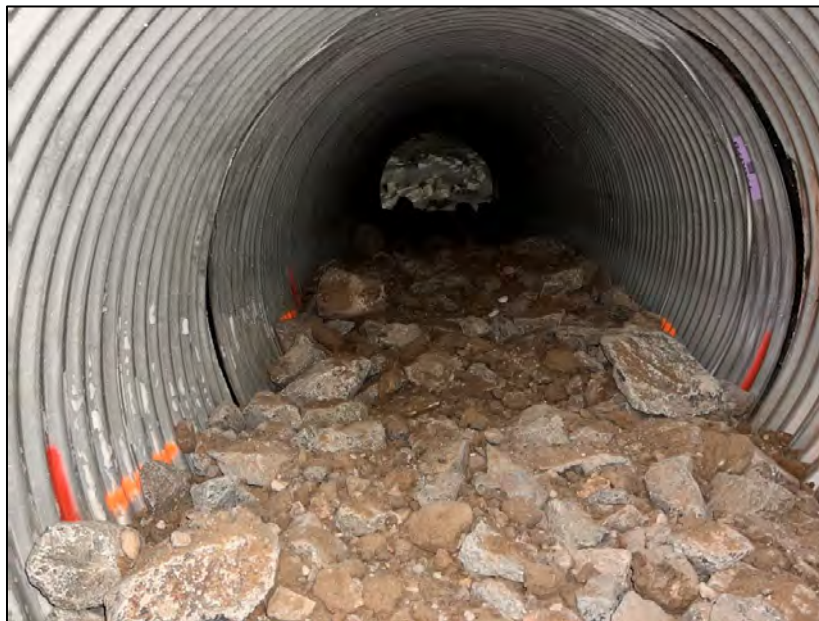
PHOTO 24. Following Construction - Completed placement of coarse riprap and stream substrate material within the interior of the low flow CSP culvert at CV-059 (March 28, 2024).

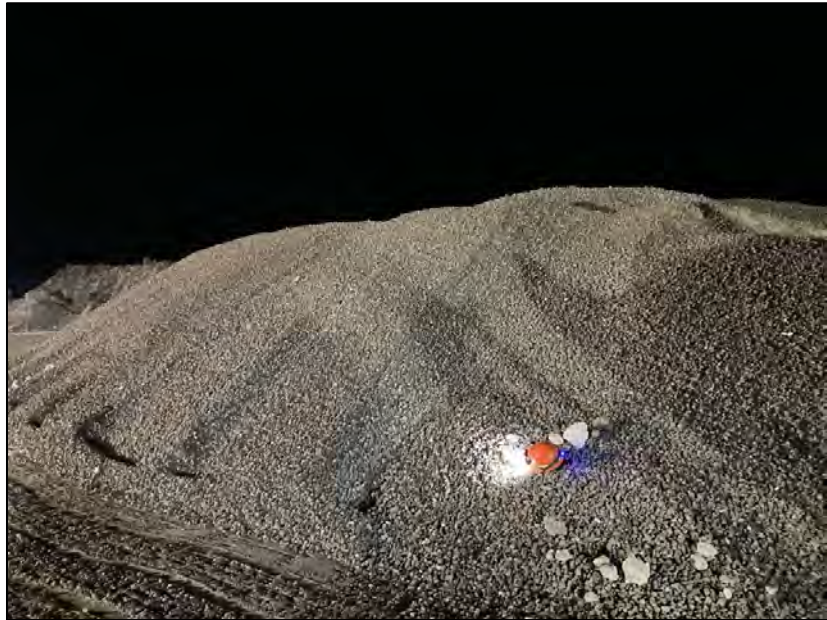
PHOTO 25. Material stockpile - 32 mm minus culvert backfill material - km 60 laydown - looking northeast (March 10, 2024).

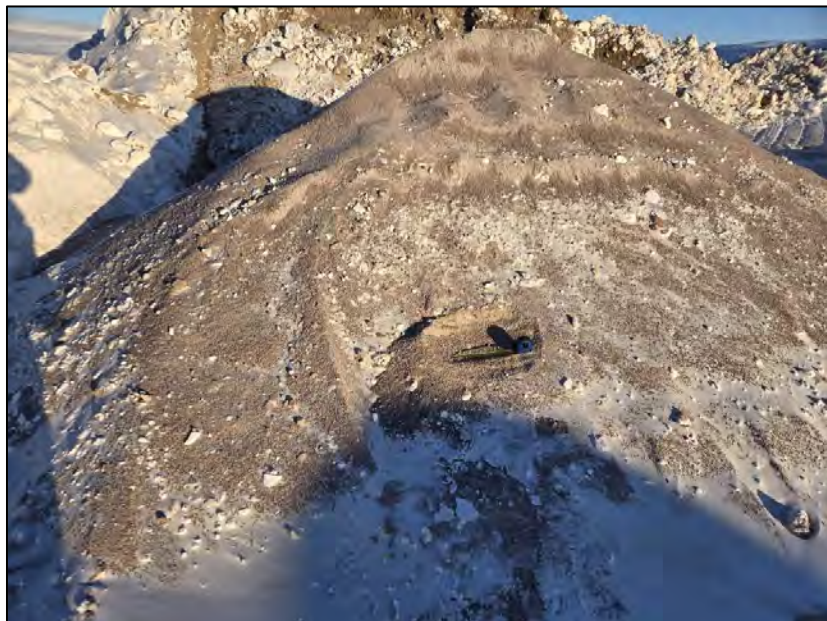
32 mm minus material, the 3/16 inch minus material was crushed, screened, and hauled from the aggregate quarry at Milne Inlet Port and stockpiled at the km 60 laydown area. The maximum particle size for the Bedding Material was required to be half of the depth of the culvert undulations (corrugations), which are 13 mm as per the Manufacturer's Specifications. Particle size gradations from laboratory tests are shown on Figure 2 and show that approximately 5% of the particles in the record samples were greater than the maximum particle size of 6.5 mm. This small quantity of slightly larger particles was considered acceptable to meet the design intent.

PHOTO 26. Material Stockpile - Culvert Bedding Material - km 60 laydown - looking north (March 15, 2024).

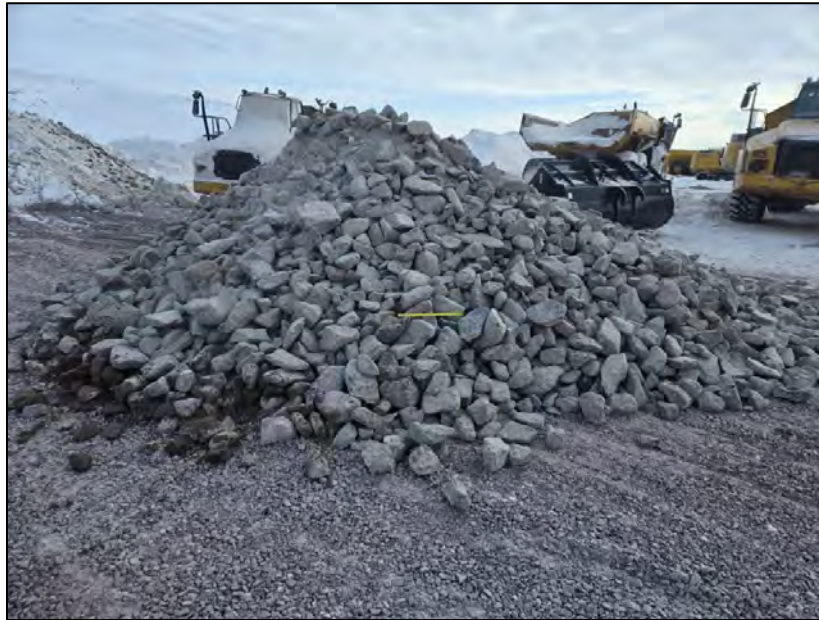
PHOTO 27. Material Stockpile - Fine Riprap - km 60 laydown - looking southeast (March 22, 2024).

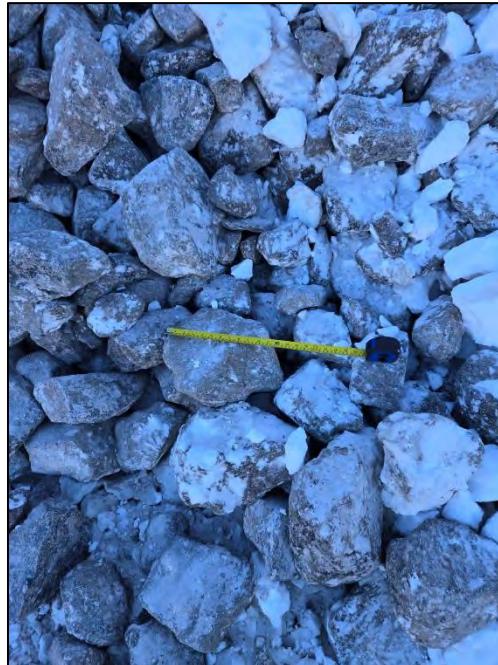
PHOTO 28. Material Stockpile - Coarse Riprap - km 60 laydown (March 21, 2024).

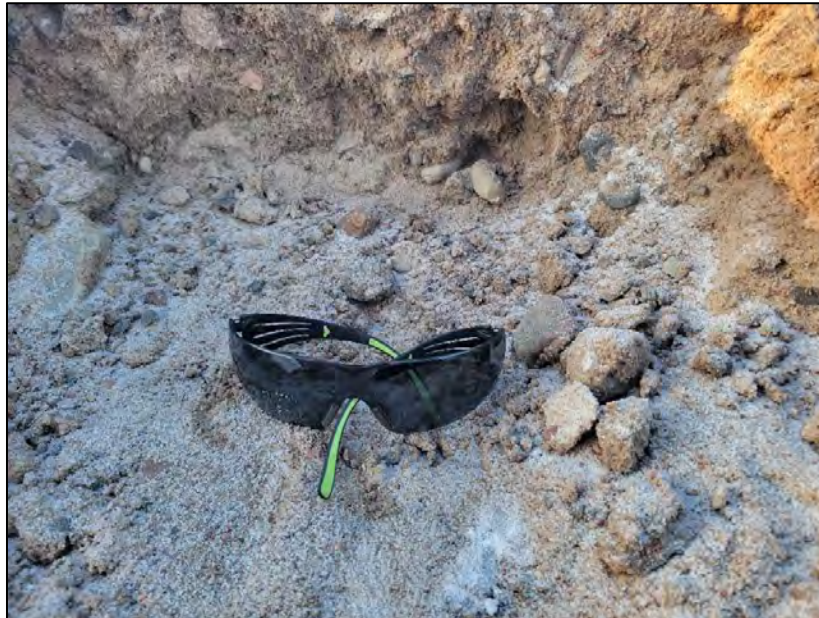
PHOTO 29. Material Stockpile - Stream Substrate Material - km 97 stockpile (February 29, 2024).

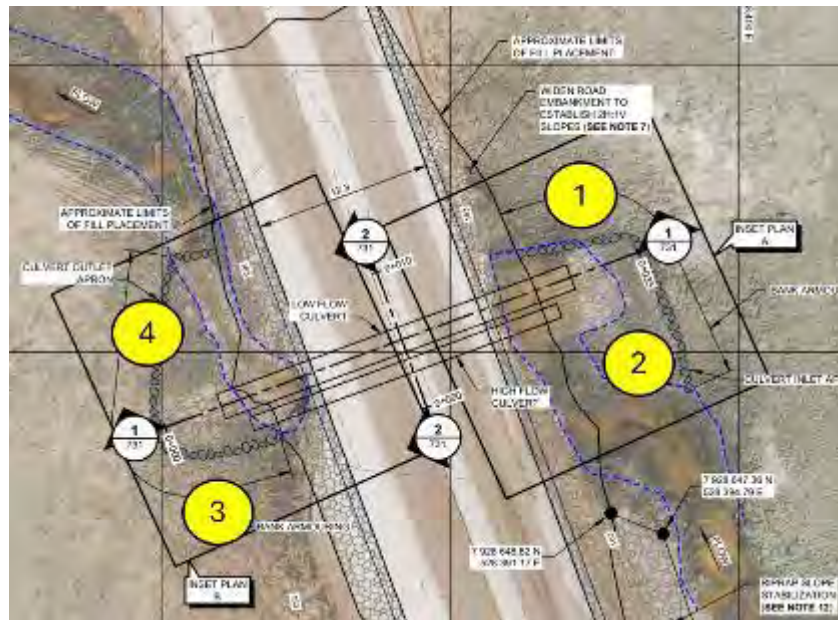
PHOTO 1. Culvert Crossing CV-057 - Photographic vantage points (Approximate locations, indicated with yellow circles).

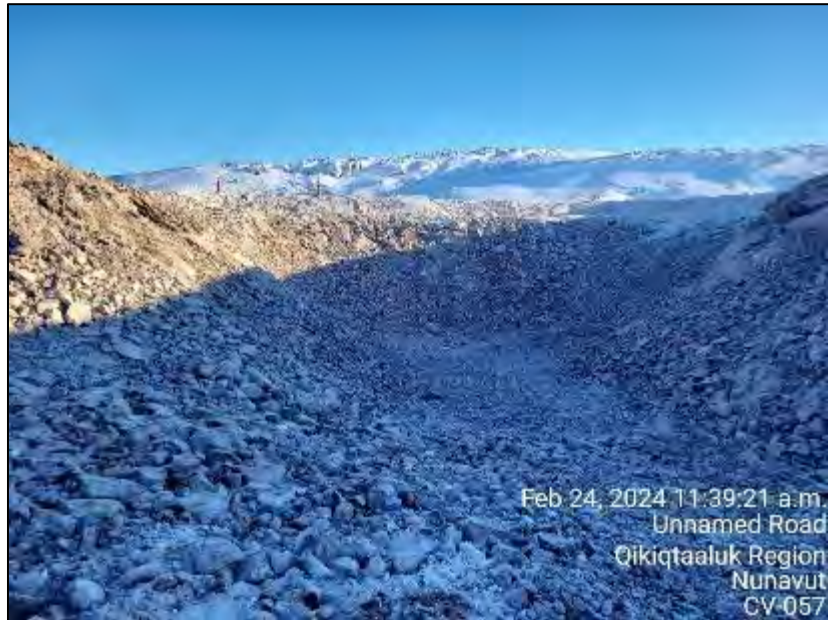
PHOTO 3. During - Vantage Point 2 - Blast excavation - Road crossing and downstream outlet - looking west (February 24, 2024).

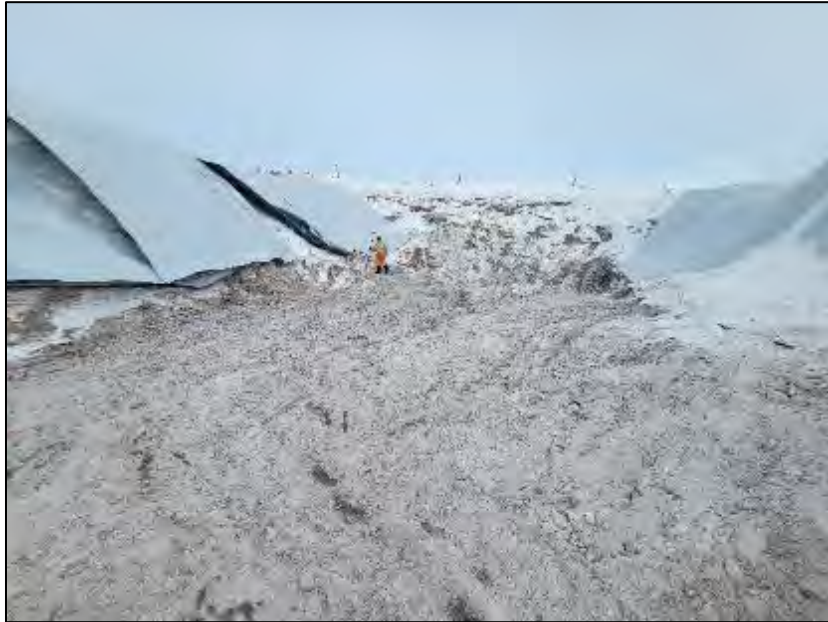
PHOTO 5. During - Vantage Point 1 - Completed blast excavation with slope stabilization - Road crossing and downstream outlet - looking southwest (March 11, 2024).

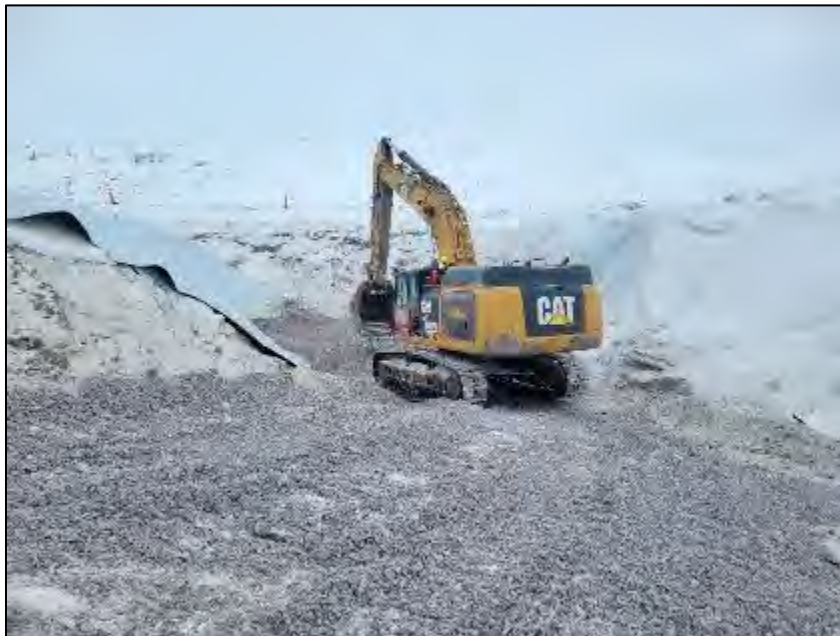
PHOTO 6. During - Vantage Point 2 - Placement of culvert backfill material - Road crossing and downstream outlet - looking west (March 12, 2024).

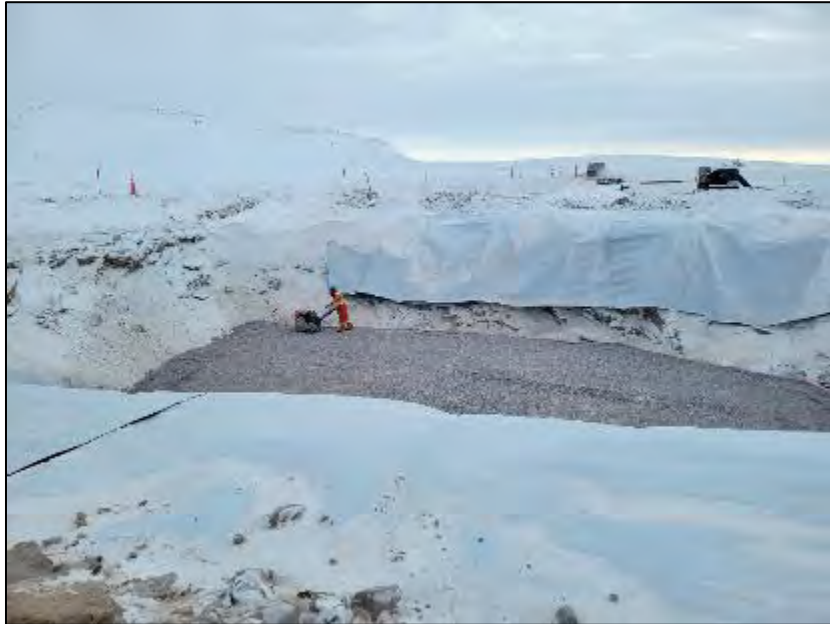
PHOTO 7. During - Vantage Point 3 - Compaction of culvert backfill material - Road crossing and downstream outlet - looking north (March 13, 2024).

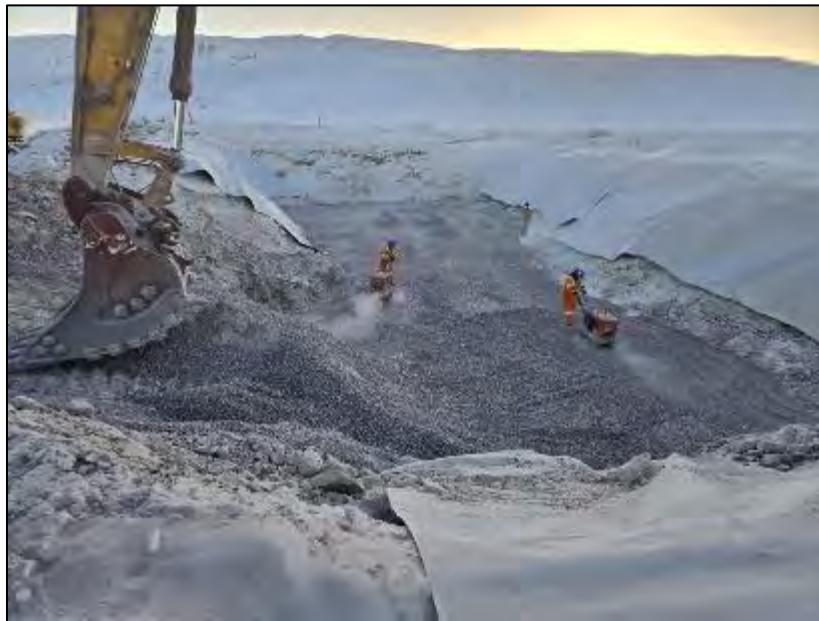
PHOTO 8. During - Vantage Point 2 - Compaction of culvert backfill material - Road crossing and upstream inlet - looking west (March 15, 2024).

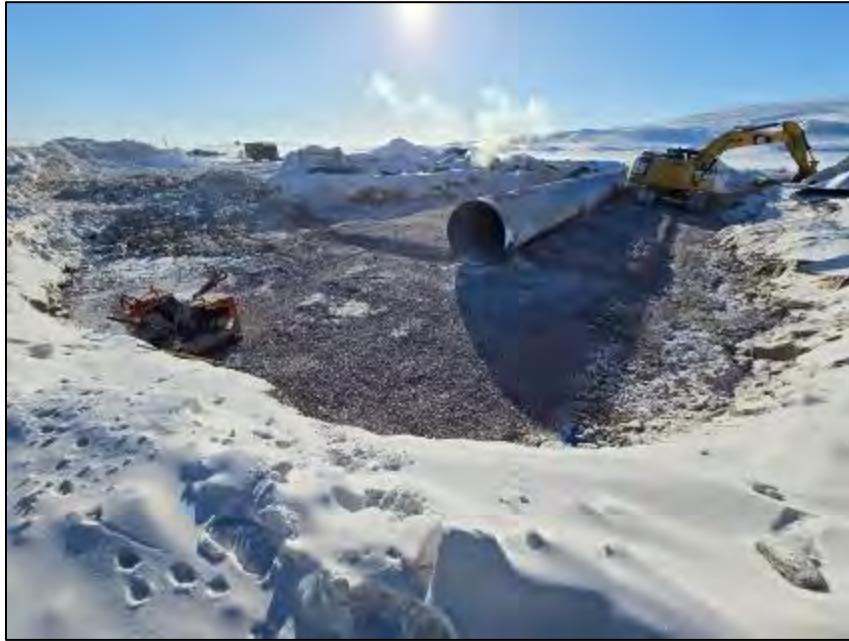
PHOTO 9. During - Vantage Point 3 - Installation of 1.8 m diameter corrugated steel pipe low flow culvert - Road crossing and downstream outlet - looking northeast (March 20, 2024).

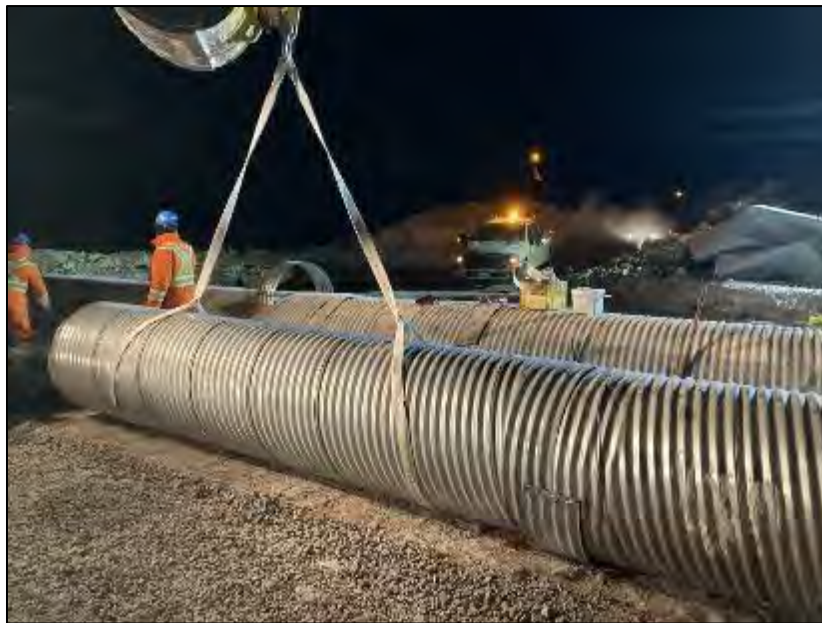
PHOTO 10. During - Vantage Point 2 - Installation of 1.0 m diameter corrugated steel pipe high flow culvert - looking northwest (March 19, 2024).

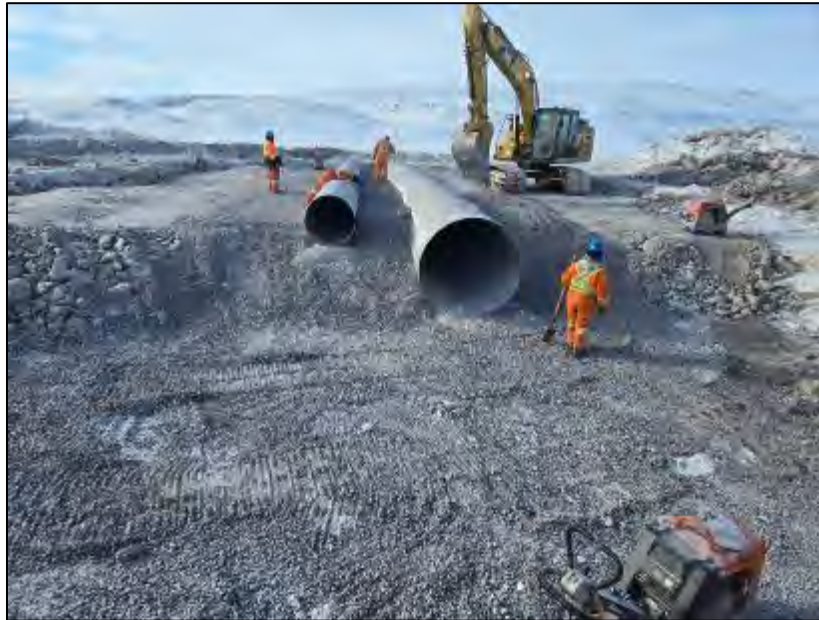
PHOTO 11. During - Vantage Point 2 - Installation of 1.8 m diameter corrugated steel pipe low flow culvert and 1.0 m diameter corrugated steel pipe high flow culvert - Upstream inlet - looking southwest (March 22, 2024).

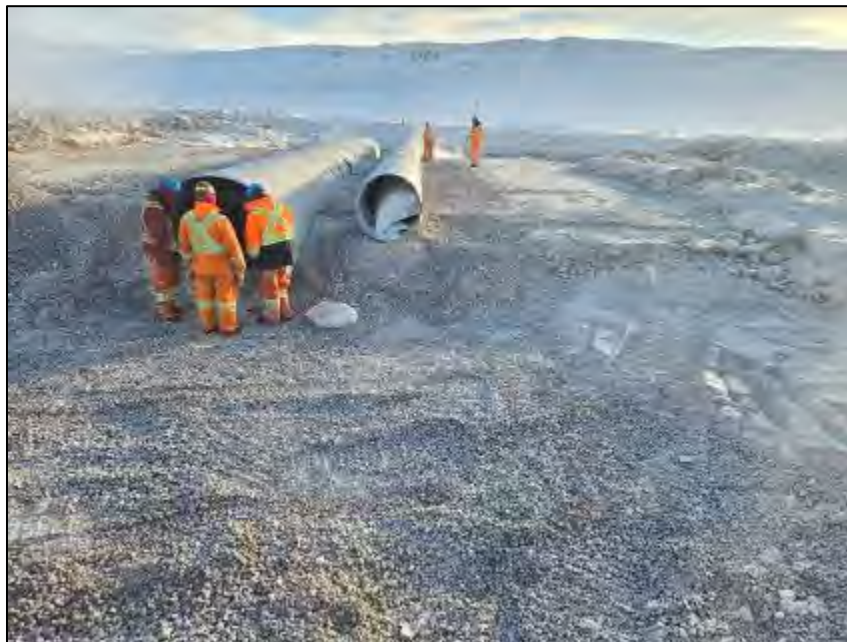
PHOTO 12. During - Vantage Point 3 - Installation of 1.8 m diameter corrugated steel pipe low flow culvert and 1.0 m diameter corrugated steel pipe high flow culvert - Downstream outlet - looking northeast (March 22, 2024).

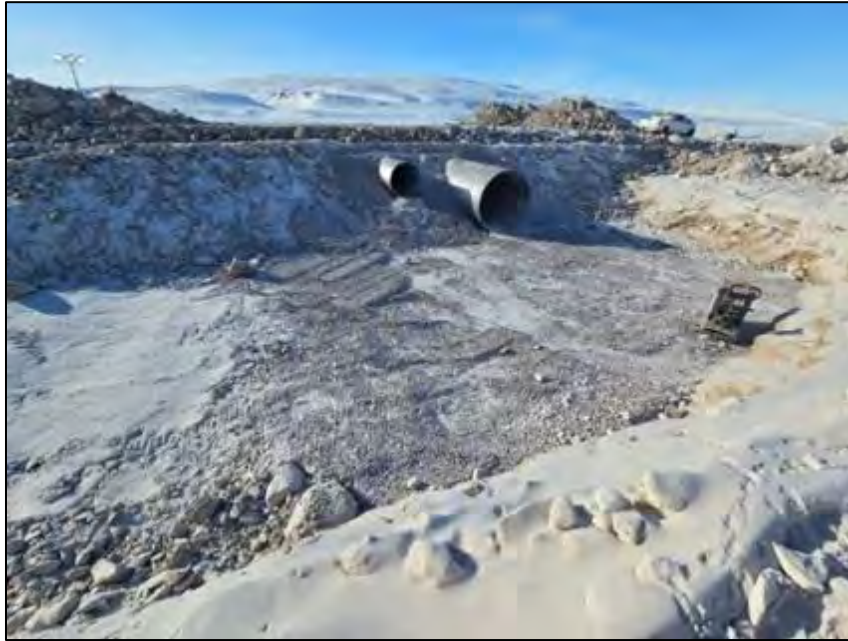
PHOTO 13. During - Vantage Point 2 - Placement of culvert backfill material above the low and high flow CSP culverts - Upstream inlet - looking west (March 26, 2024).

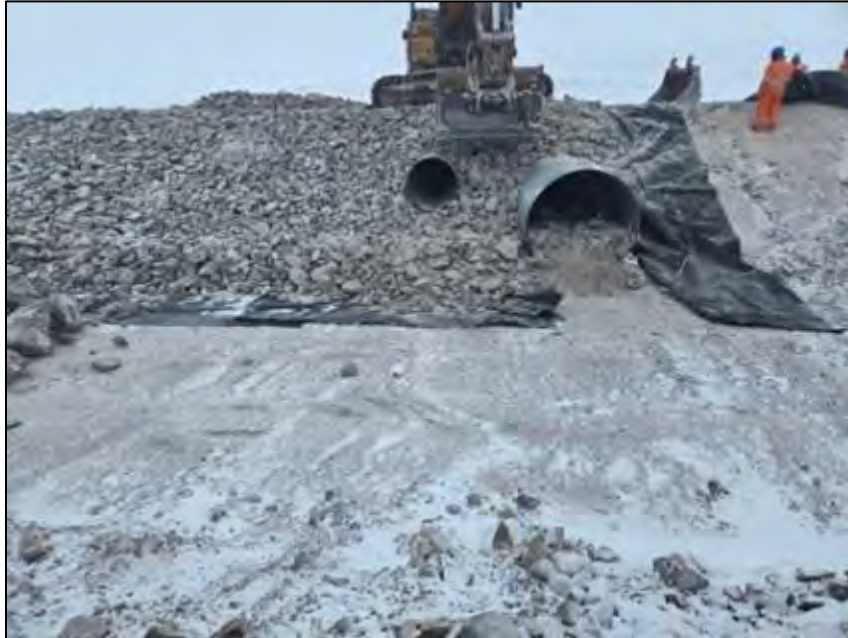
PHOTO 14. During - Vantage Point 2 - Placement of geotextile and riprap on west side slope at CV-057 - Upstream inlet - looking west (March 30, 2024).

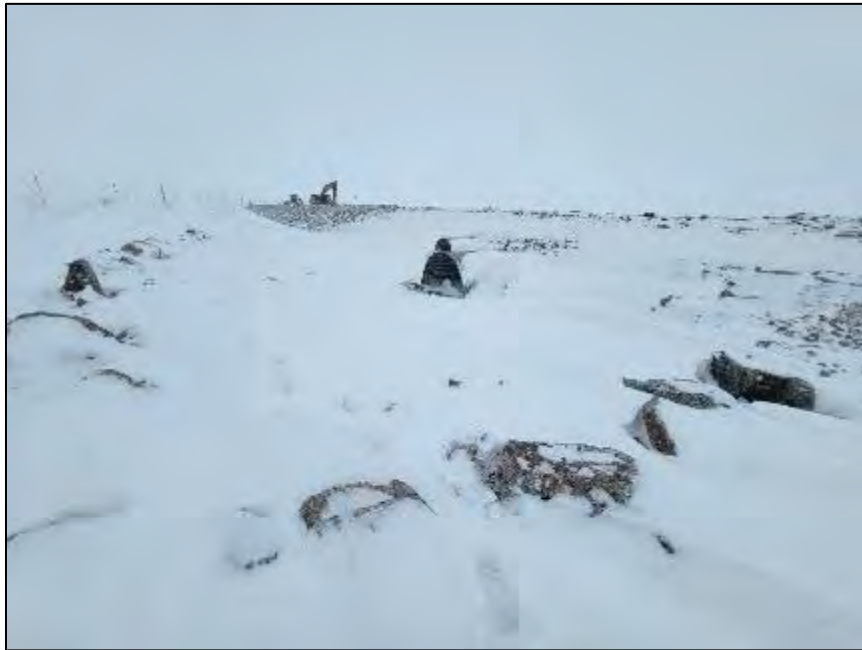
PHOTO 15. After - Vantage Point 1 - Completed installation of high flow and low flow culverts - Upstream Inlet Area - looking southwest (April 5, 2024).

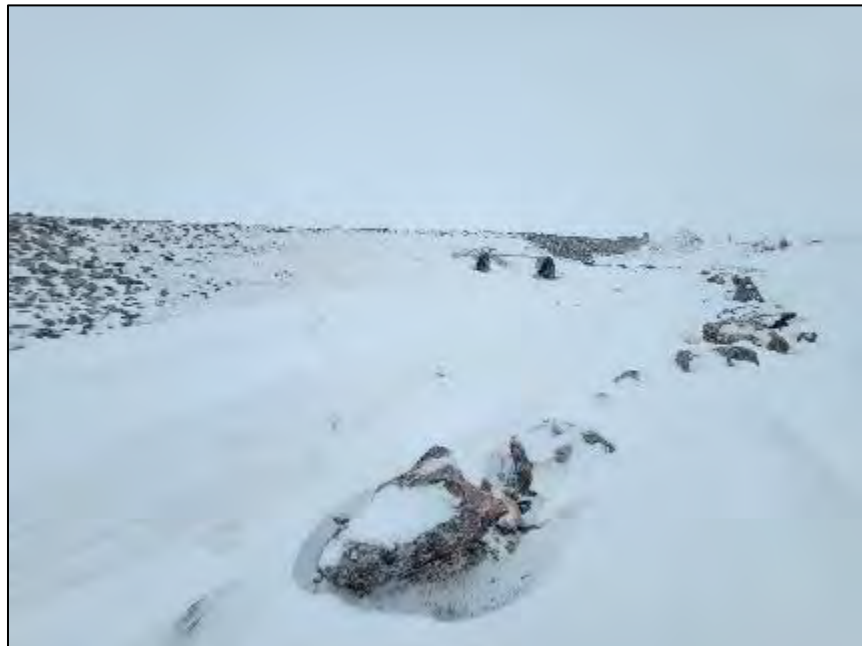
PHOTO 16. After - Vantage Point 2 - Completed installation of high flow and low flow culverts - Upstream Inlet Area - looking northwest (April 5, 2024).

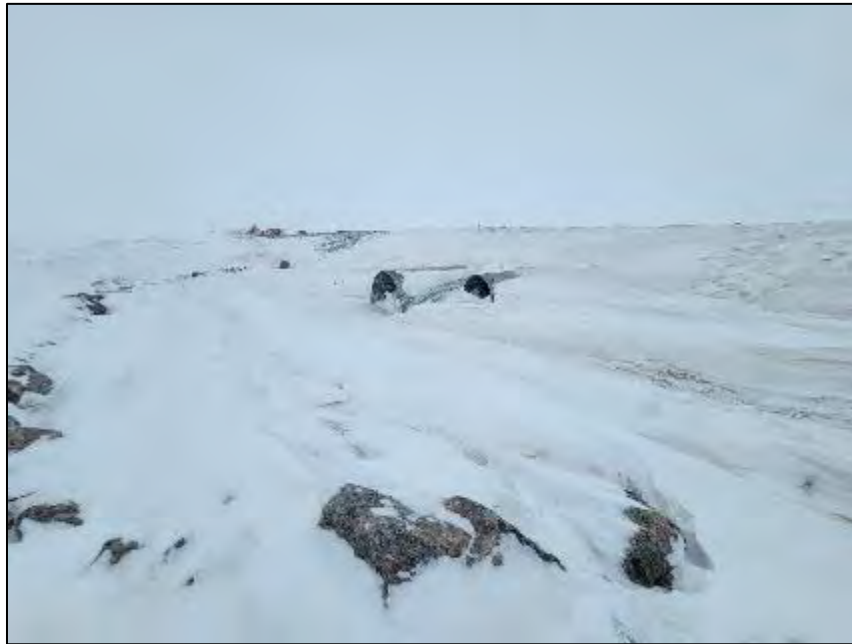
PHOTO 17. After - Vantage Point 2 - Completed installation of high flow and low flow culverts - Upstream Inlet Area - looking northwest (April 5, 2024).
