RE: Construction Summary of CV-059 Remedial Measures

CV-059 AS-BUILT PHOTO LOG

CV-057 AS-BUILT PHOTO LOG

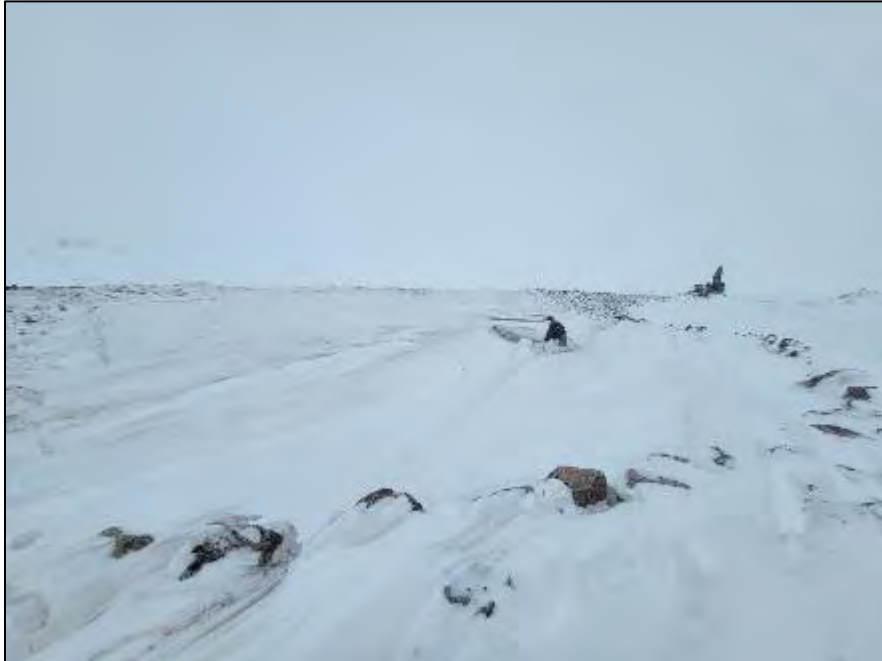
PHOTO 18. After - Vantage Point 4 - Installation of high flow and low flow culverts - Downstream Outlet Area - looking southeast (April 5, 2024).

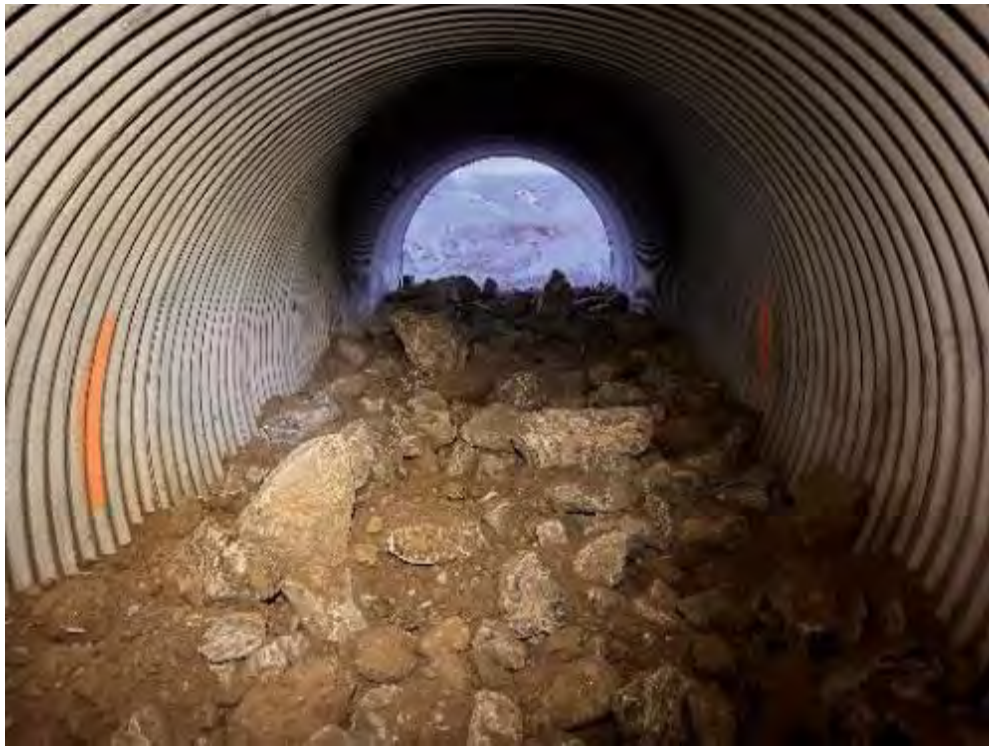
PHOTO 19. After - Completed placement of coarse riprap and stream substrate material within the interior of the low flow CSP culvert at CV-057 (March 29, 2024).

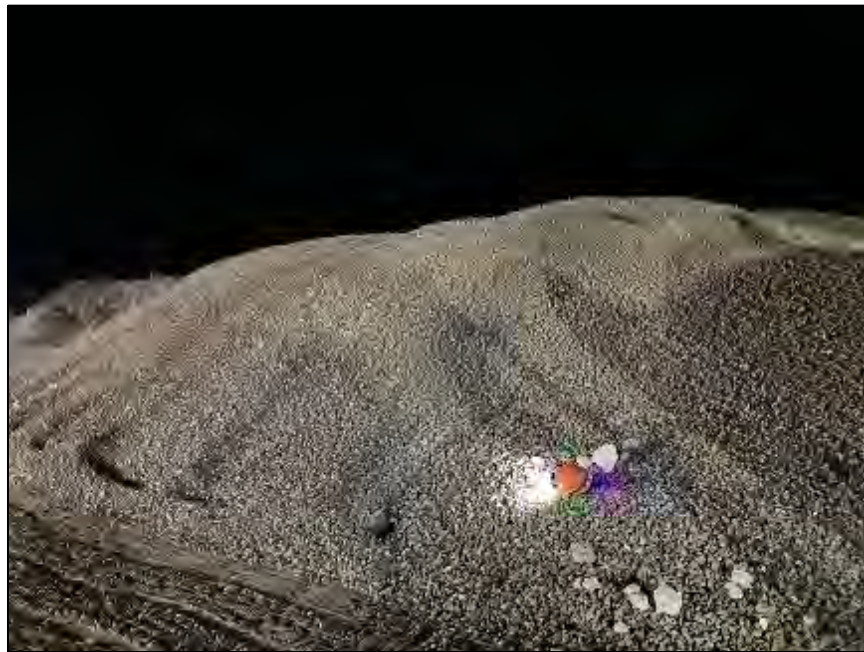
- **Culvert Backfill** - Culvert Backfill material consisted of 32 mm minus material that was crushed and screened at the aggregate quarry located at the Milne Inlet Port. The material was backhauled to the km 60 laydown area using Baffinland's ore hauling trucks (OHTs) southbound on the Tote Road. The 32 mm minus material was stockpiled at the km 60 laydown area for use at both water crossings CV-059 and CV-057. Particle size gradations from laboratory tests show that the processed material met the material specifications as shown on Figure 1. Two control samples and two record samples were collected for CV-057. The control test results indicated that the samples exhibited a coarser

PHOTO 20. Material stockpile - 32 mm minus culvert backfill material - km 60 laydown - looking northeast (March 10, 2024).

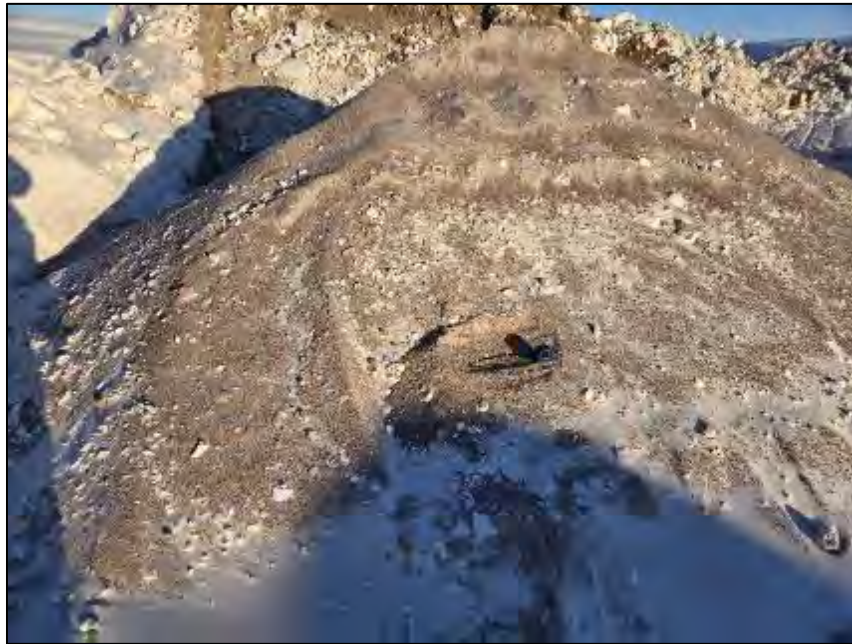
PHOTO 21. Material stockpile - 32 mm minus culvert backfill material - km 60 laydown - looking northeast (March 10, 2024).

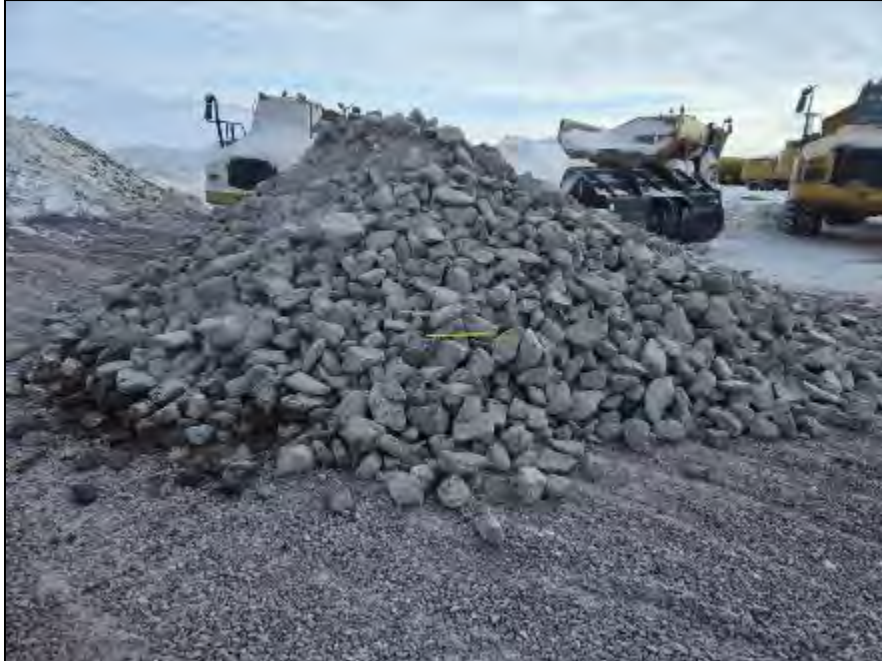
PHOTO 22. Material stockpile - Fine riprap - km 60 Laydown - looking southeast (March 22, 2024).

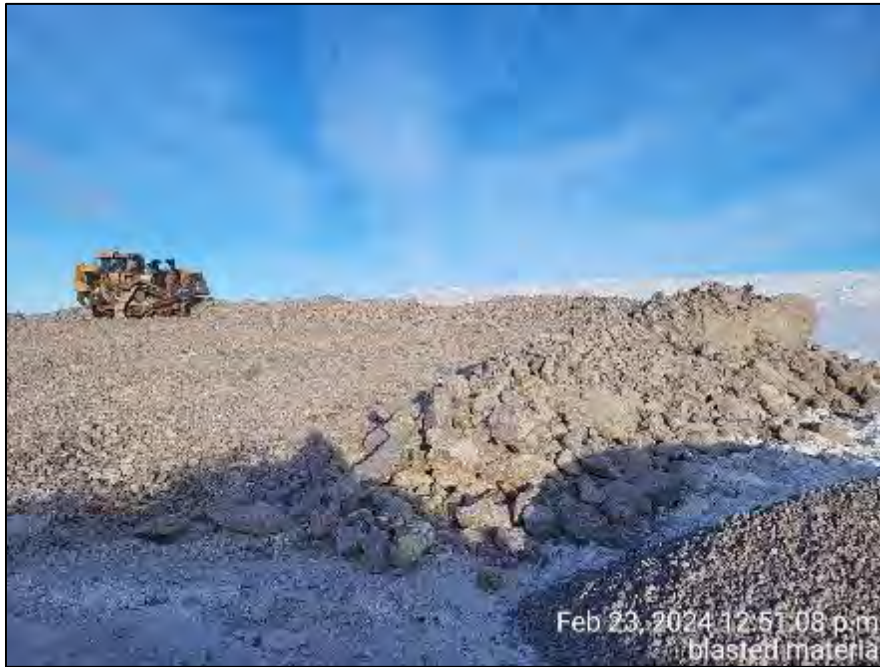
PHOTO 23. Material stockpile - Blasted material - km 60 laydown - looking northeast (February 23, 2024).

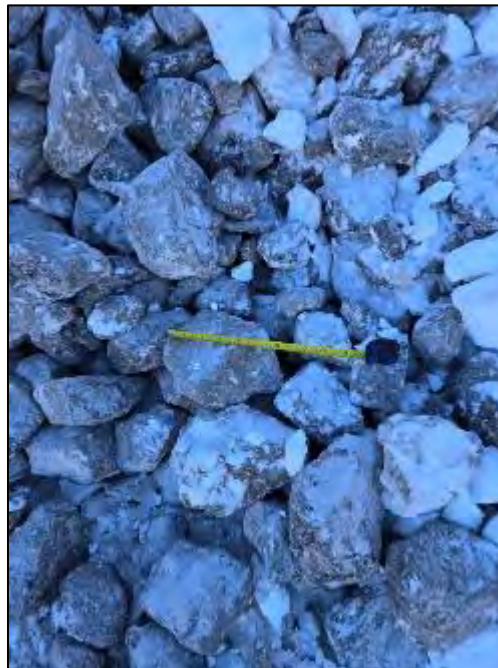
PHOTO 24. Material stockpile - Blasted material - km 60 laydown - looking northeast (February 23, 2024).

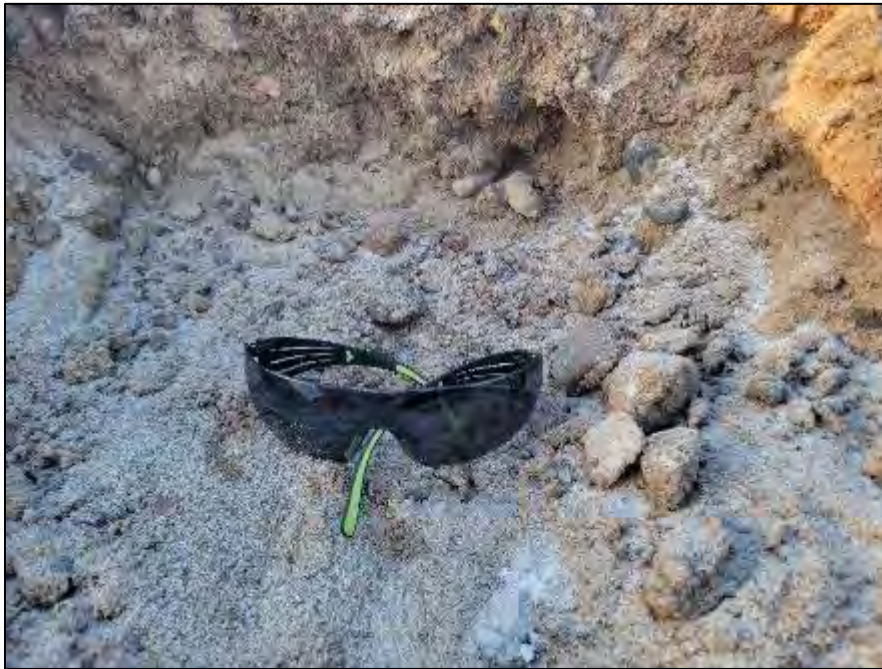
PHOTO 25. Material stockpile - Stream substrate material - km 97 stockpile (February 29, 2024).

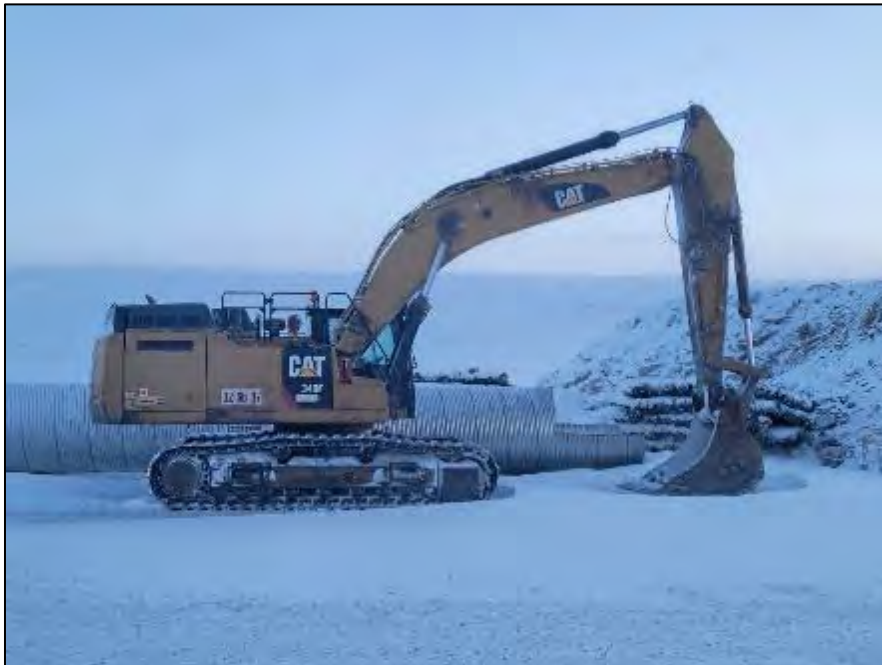
PHOTO 26. Equipment - CAT 349F excavator - km 60 laydown - looking east (March 08, 2024).

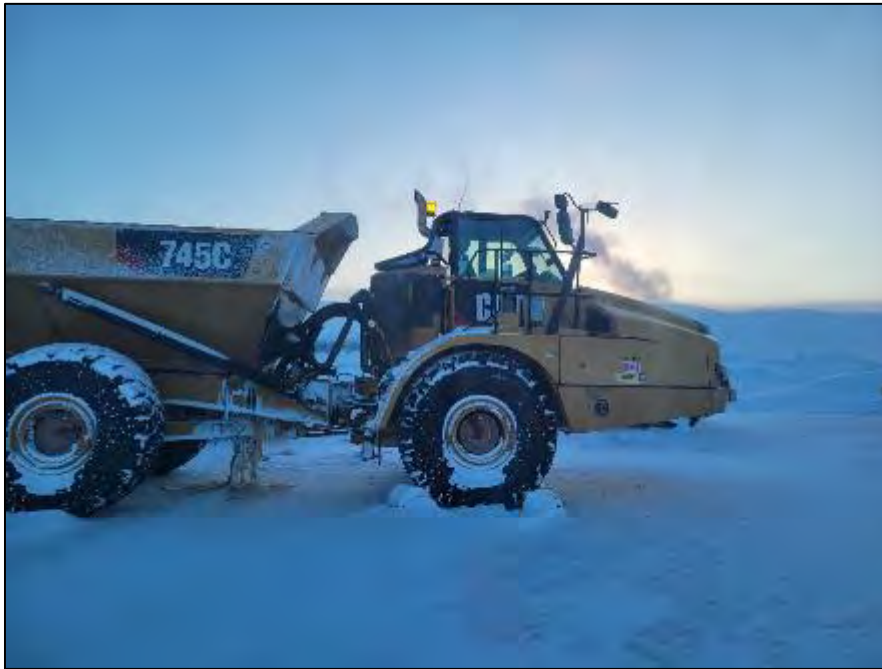
PHOTO 27. Equipment - CAT 745C articulated dump truck - km 60 laydown (February 08, 2024).

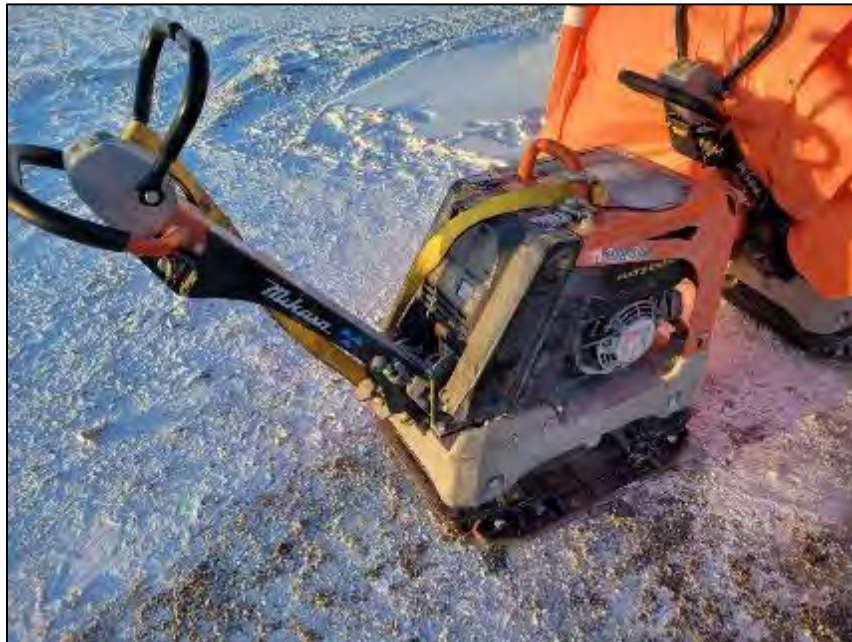
PHOTO 28. Equipment - Mikasa MVH408 1000 lb plate compactor - km 60 laydown (March 05, 2024).

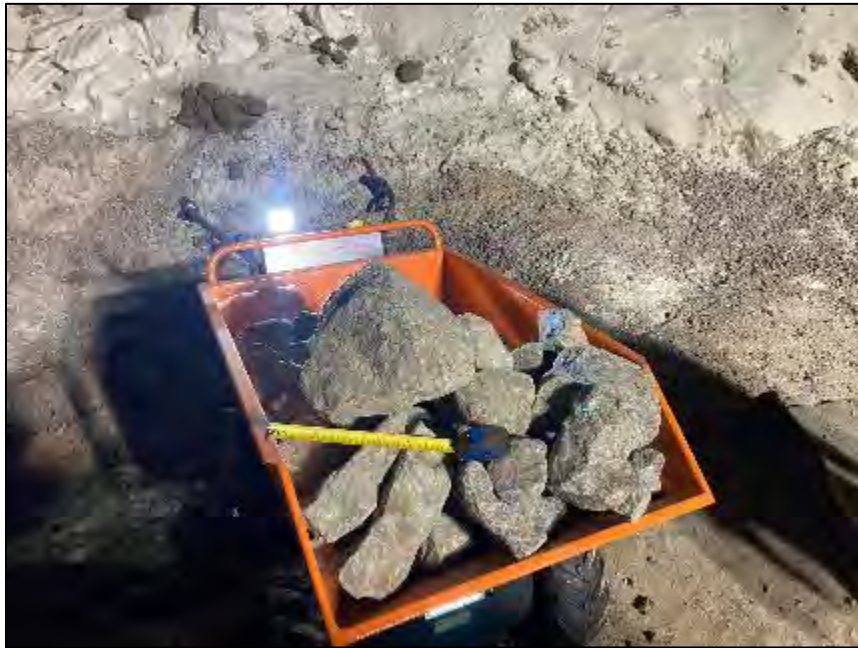
PHOTO 29. Equipment - Ducar motorized wheel barrow loaded with coarse riprap - CV-059 (March 26, 2024).
