MARY RIVER MINE

TOTE ROAD PERMANENT CROSSING PLAN - ROUND CSP CULVERT INSTALLATIONS

WEEKLY PROGRESS REPORT

WEEK 8 – March 31 to April 6, 2024

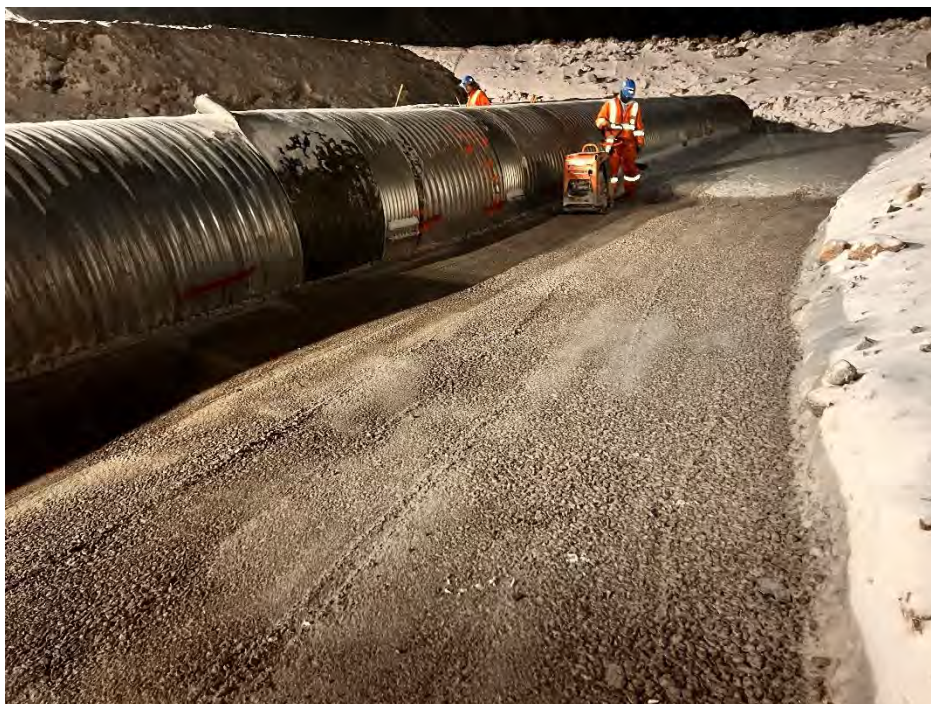
Photo 7 **Compaction of 32 mm minus culvert backfill material lift on south side at BG-04. Photo taken March 31, 2024, facing north.**

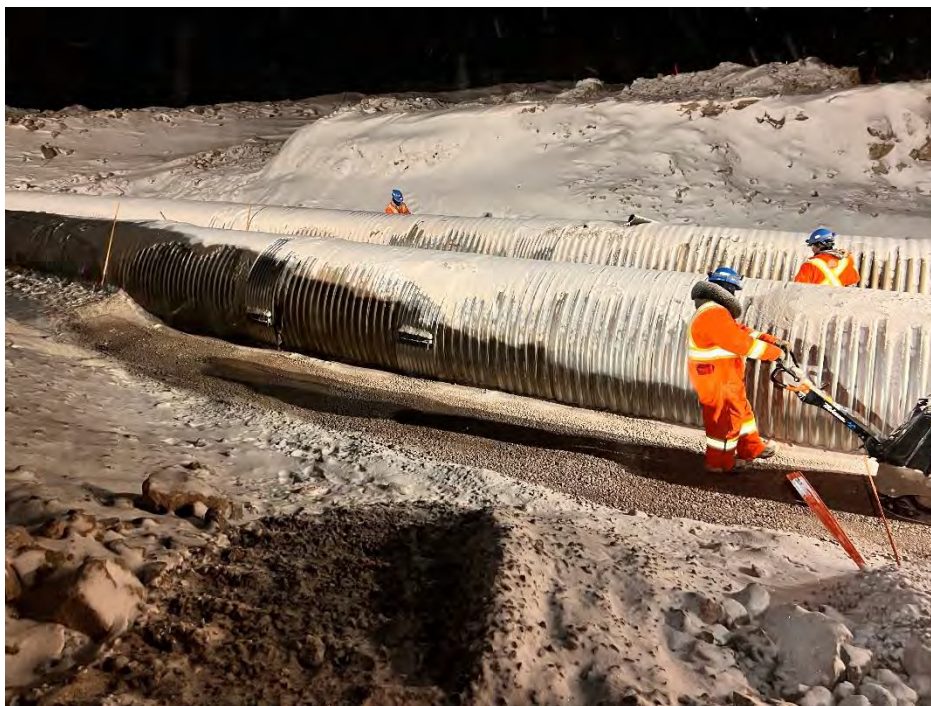
Photo 8 **Compaction of 32 mm minus culvert backfill lift on south side at BG-04. Photo taken March 31, 2024, facing northeast.**

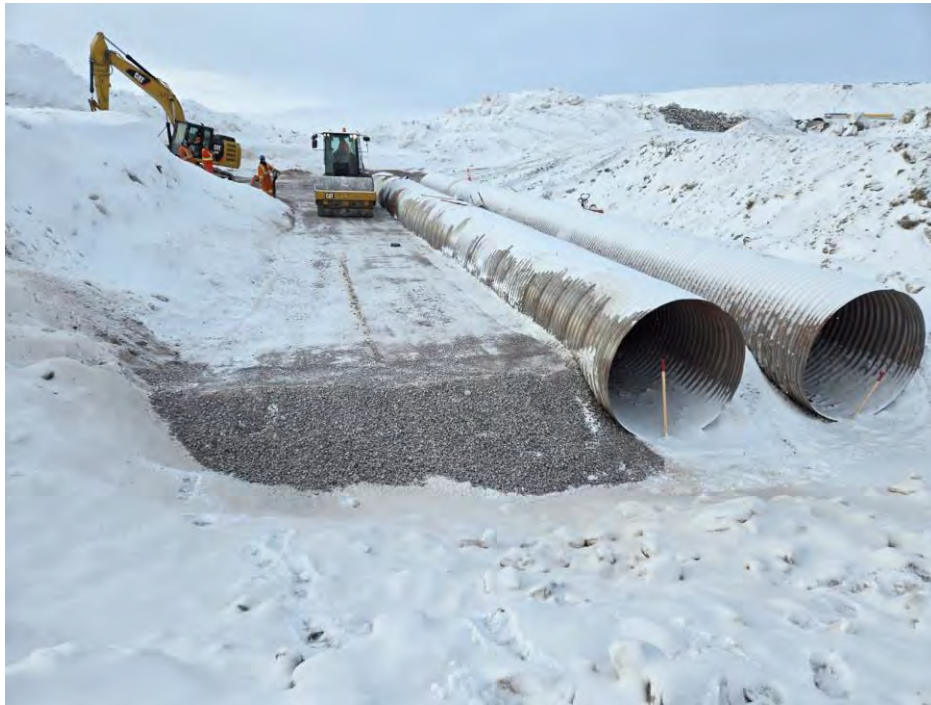
Photo 9 Compacting 32 mm minus material under the high flow CSP culvert location at BG-04. Photo taken April 1, 2024, facing south.

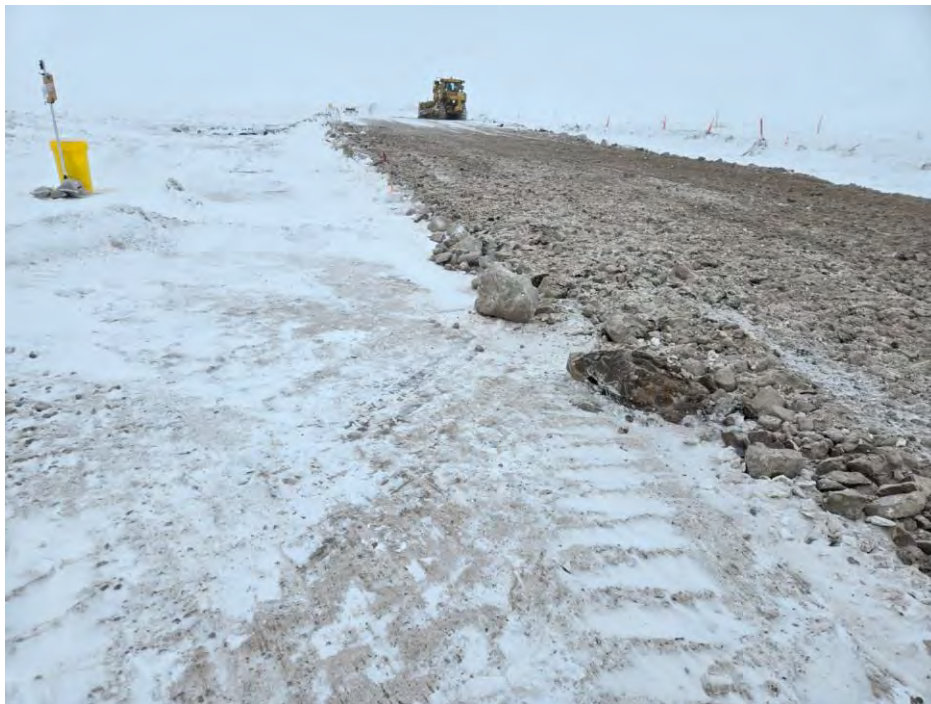
Photo 10 Placed and graded local fill material for the construction of the south approach ramp at CV057. Photo taken April 1, 2024, facing north.

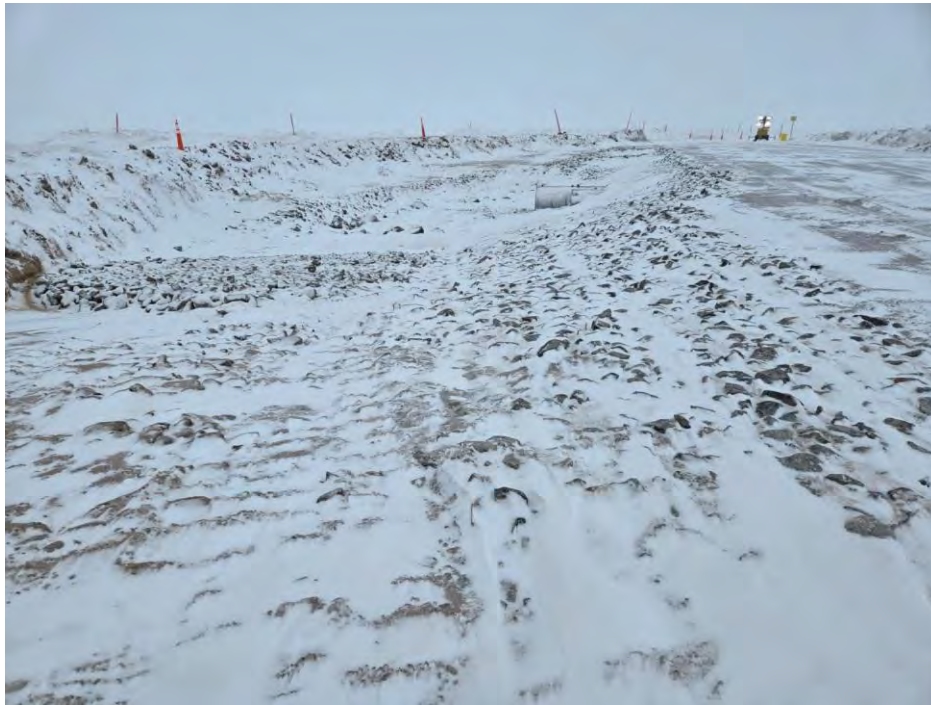
Photo 11 Completed riprap placement in the west apron at CV-059. Photo taken April 1, 2024, facing north.

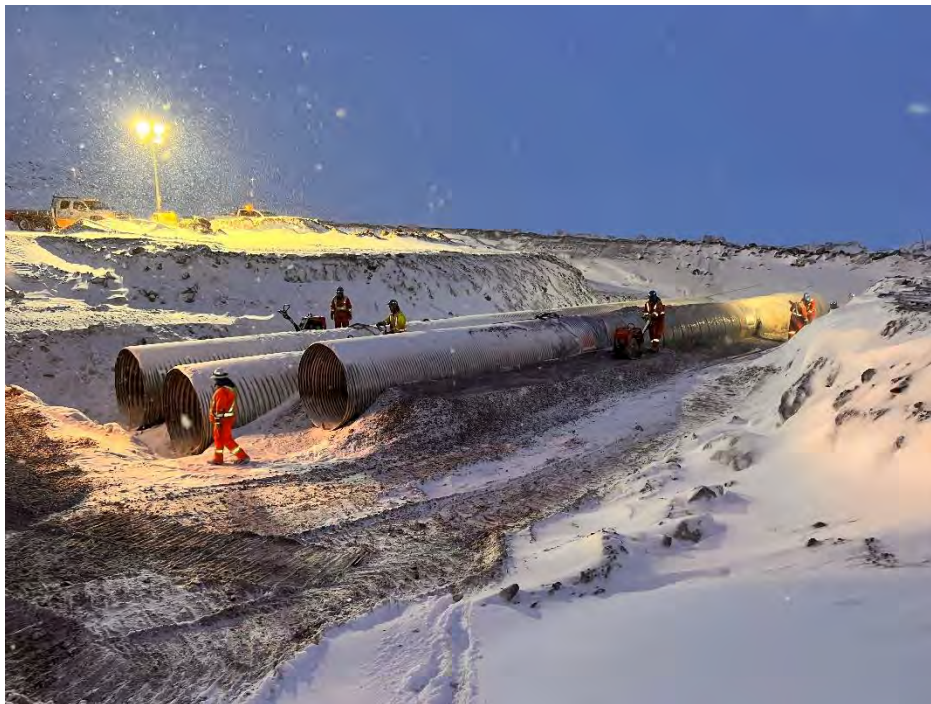
Photo 14

Placed and compacted 32 mm minus culvert backfill lifts at BG-04. Photo taken April 1, 2024, facing northwest.

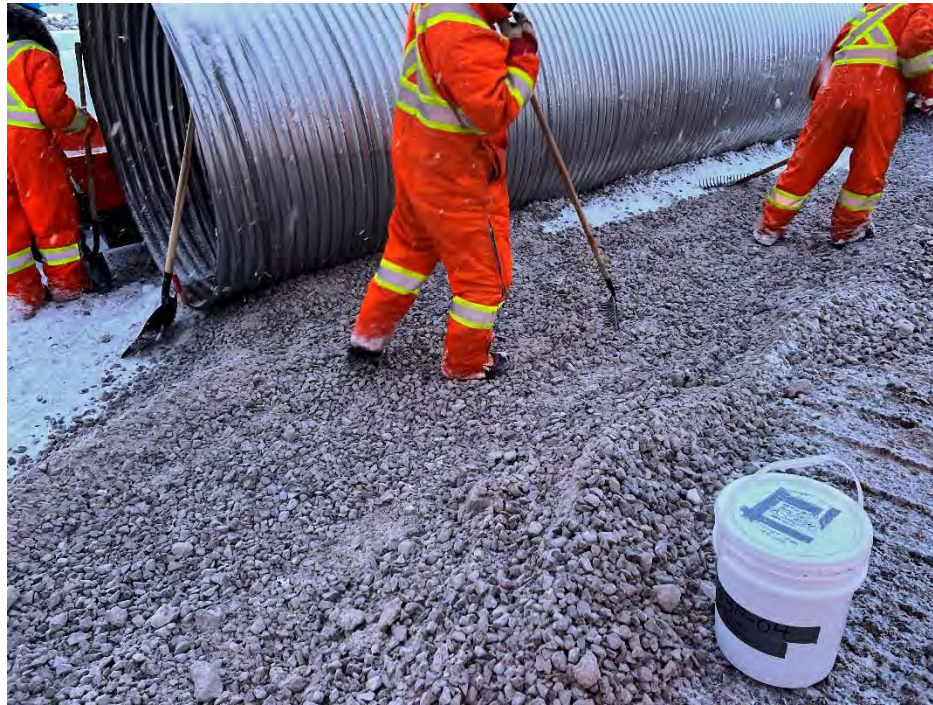
Photo 15 32 mm minus Culvert Backfill Material record sample R-CBF-04 collected from BG-04. Photo taken April 1, 2024, facing northwest behind high flow culvert.

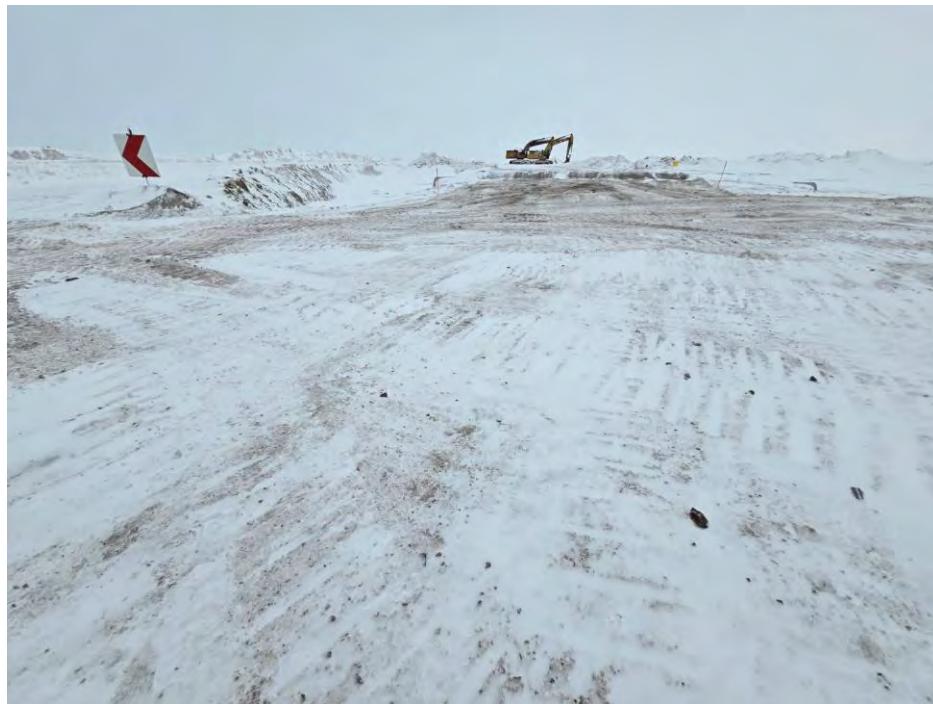
Photo 16 Cleaned approach ramp and above top of 32 mm minus material areas at CV-001 for placing local fill. Photo taken April 2, 2024, facing southeast.

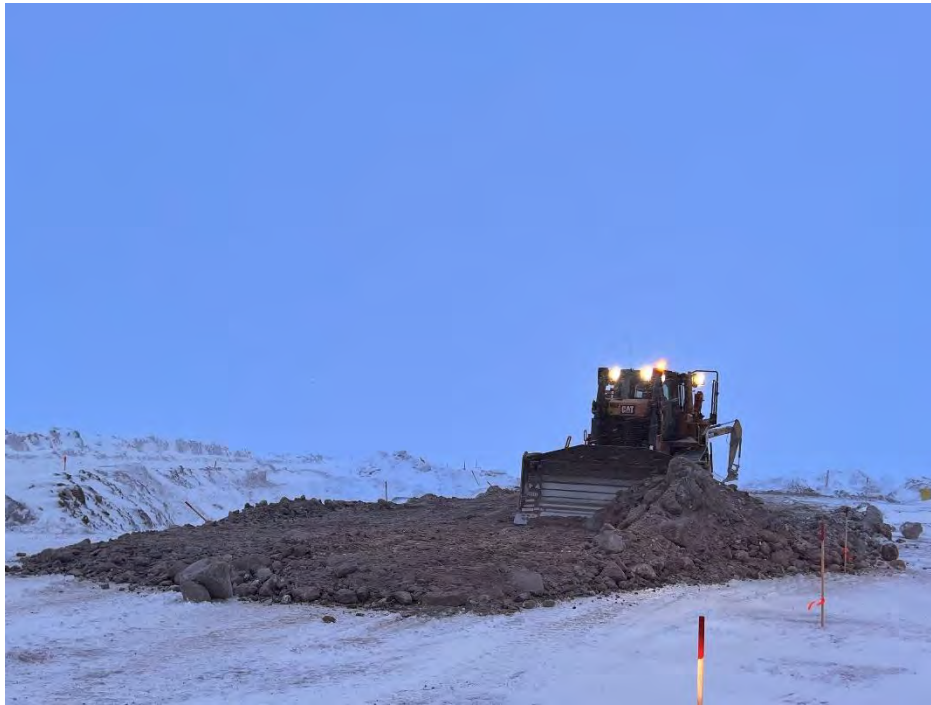
Photo 17 Local fill material placed by dozer over CV-001 culvert. Photo taken April 2, 2024, facing west.

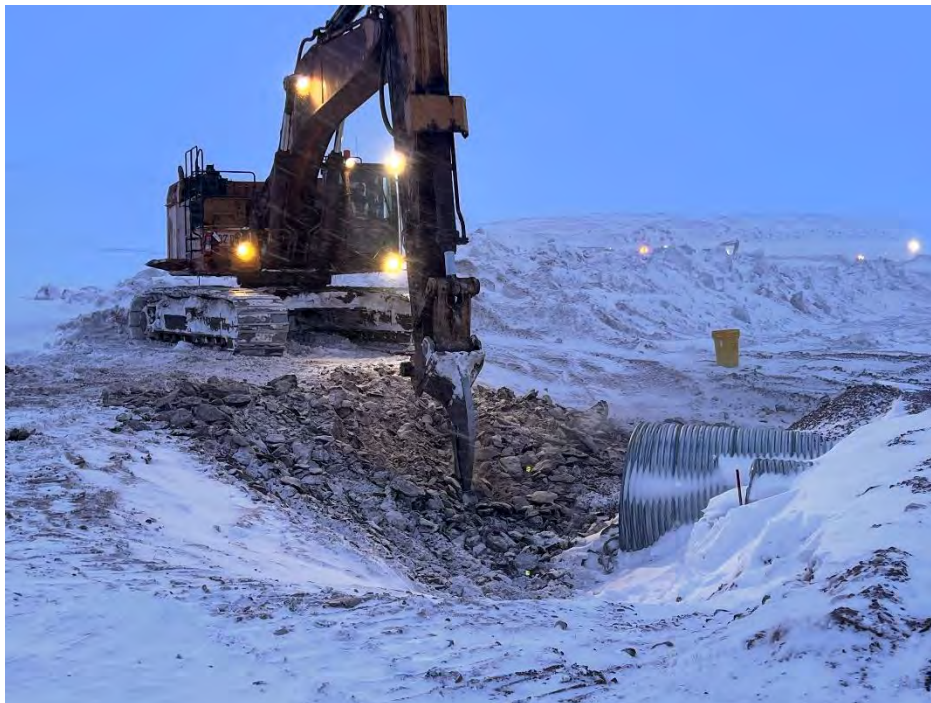
Photo 18 Ripping of outlet culvert apron at CV-001 culvert. Photo taken April 2, 2024, facing west.

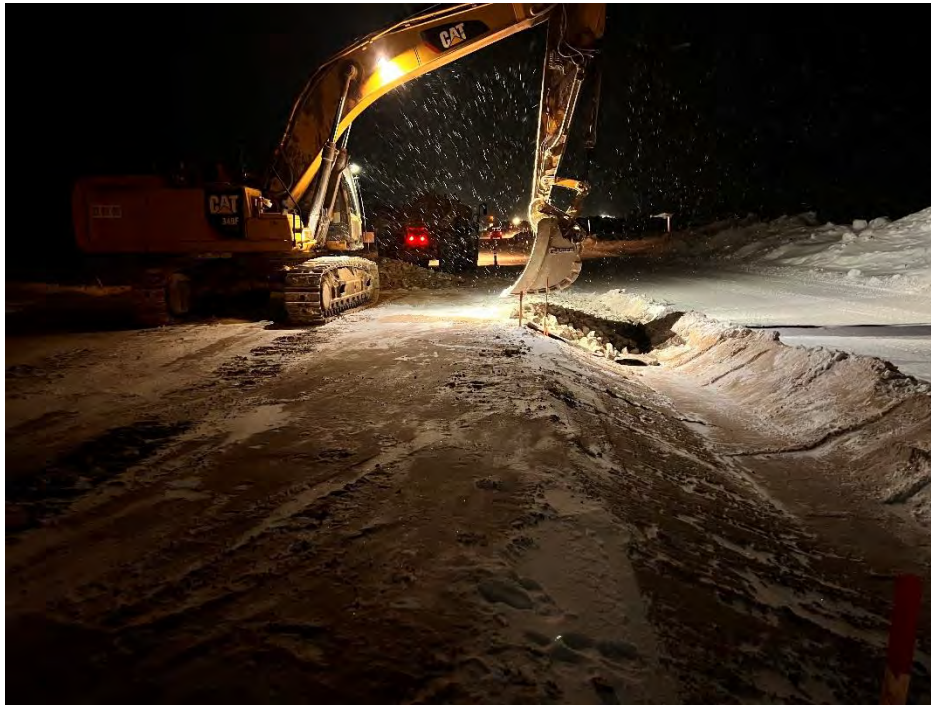
Photo 19

Shaped slope with Fine Riprap being placed over non-woven geotextile at CV-057. Photo taken April 2, 2024, facing north.

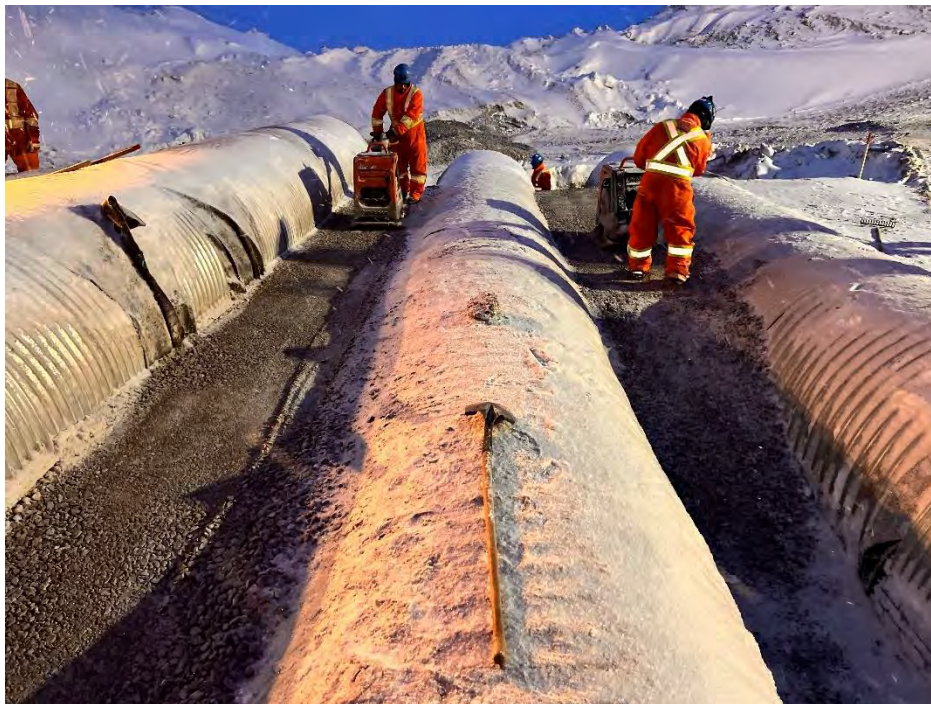
Photo 20

Placed and compacted 32 mm minus Culvert Backfill Material around sides of the high and flow culvert at BG-04. Photo taken April 3, 2024, facing south.

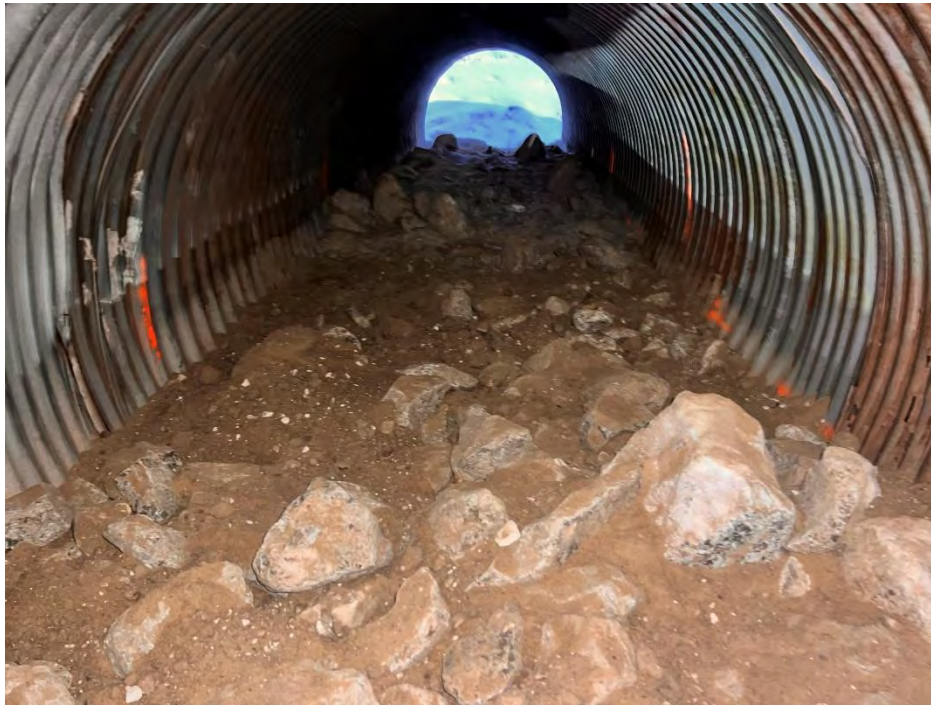
Photo 23 Boulder cluster placement in west low flow culvert at BG-04. Photo taken April 3, 2024, facing inlet.

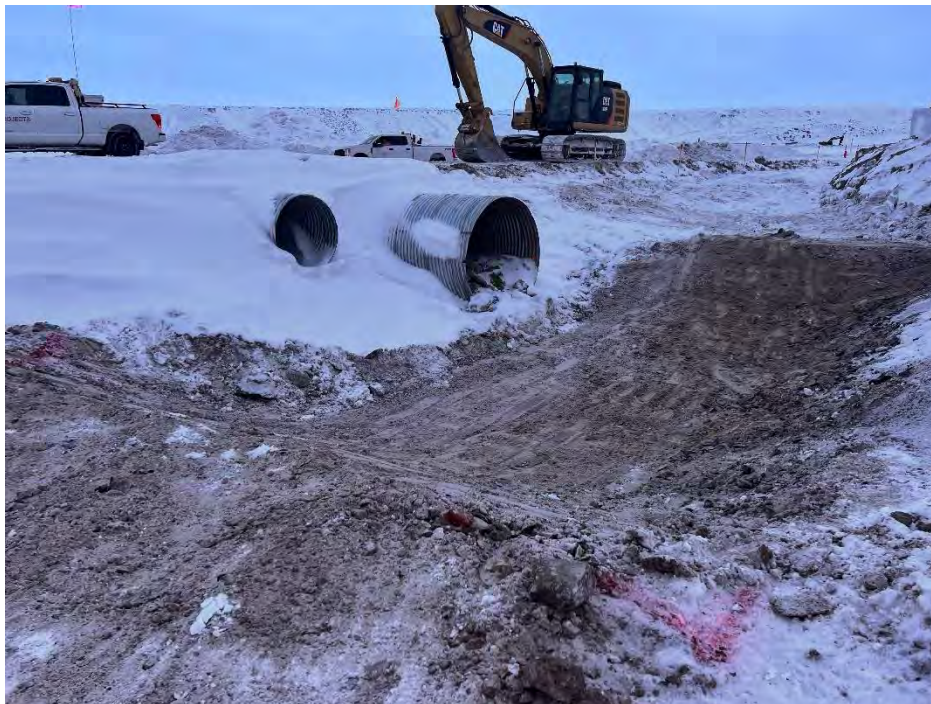
Photo 24 CV-001 excavated inlet apron. Photo taken April 3, 2024, facing northwest.

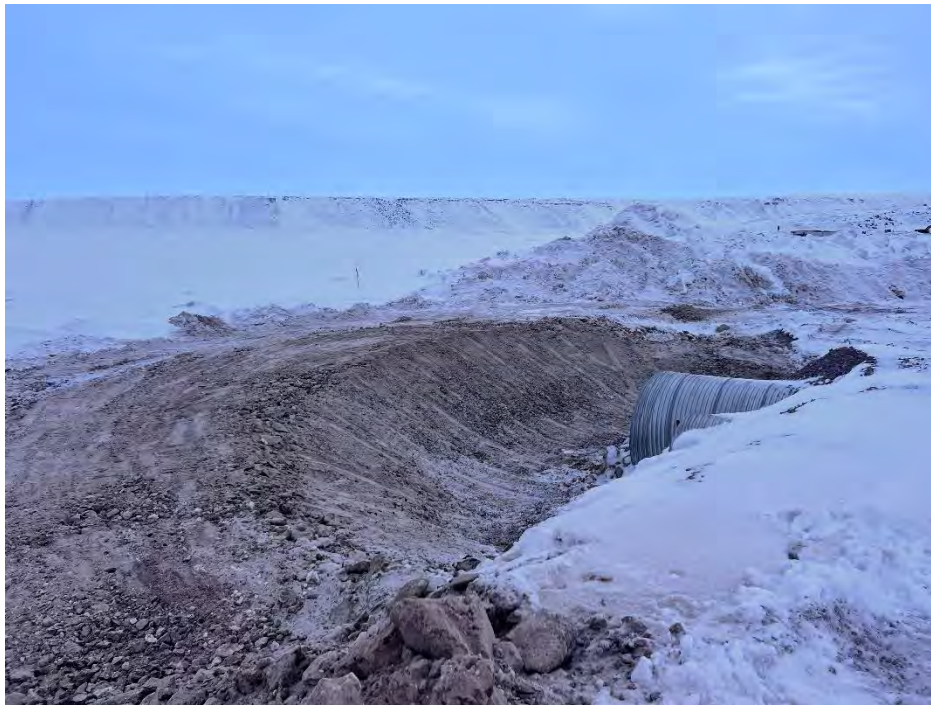
Photo 25 CV-001 excavated outlet apron. Photo taken April 3, 2024, facing northwest.

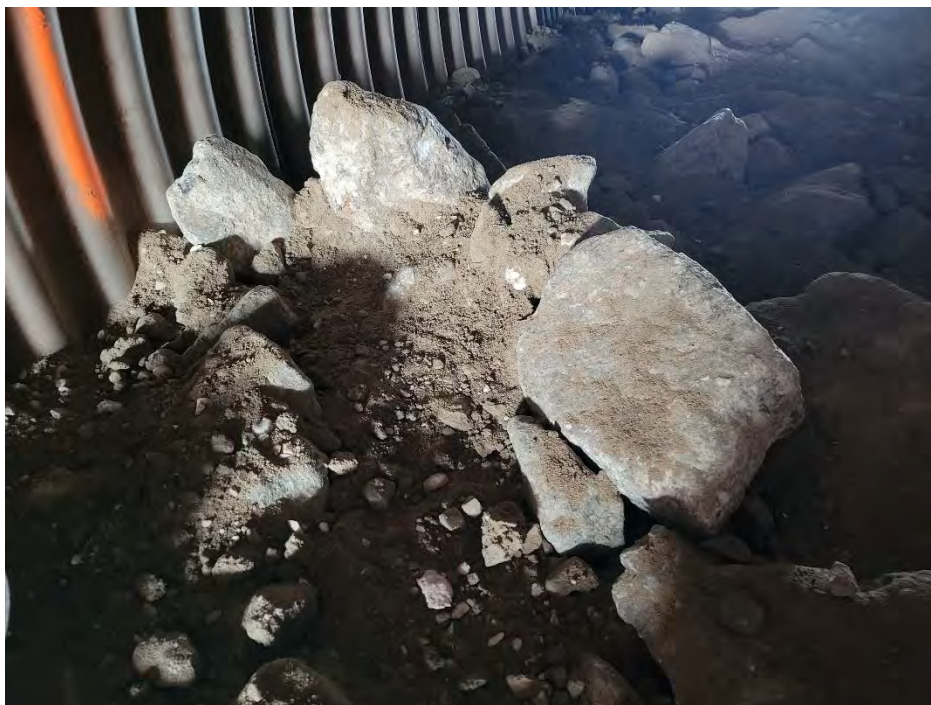
Photo 26 Boulder cluster placement at BG-04. Photo taken April 4, 2024.

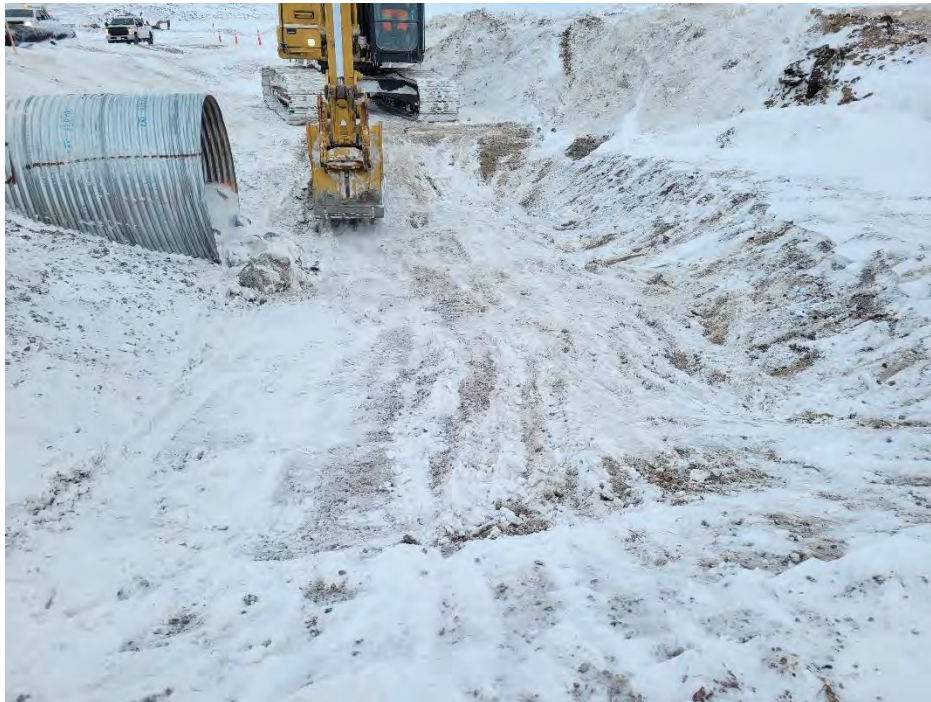
Photo 28 Snow removal from the inlet of CV-001. Photo taken April 5, 2024, facing north.

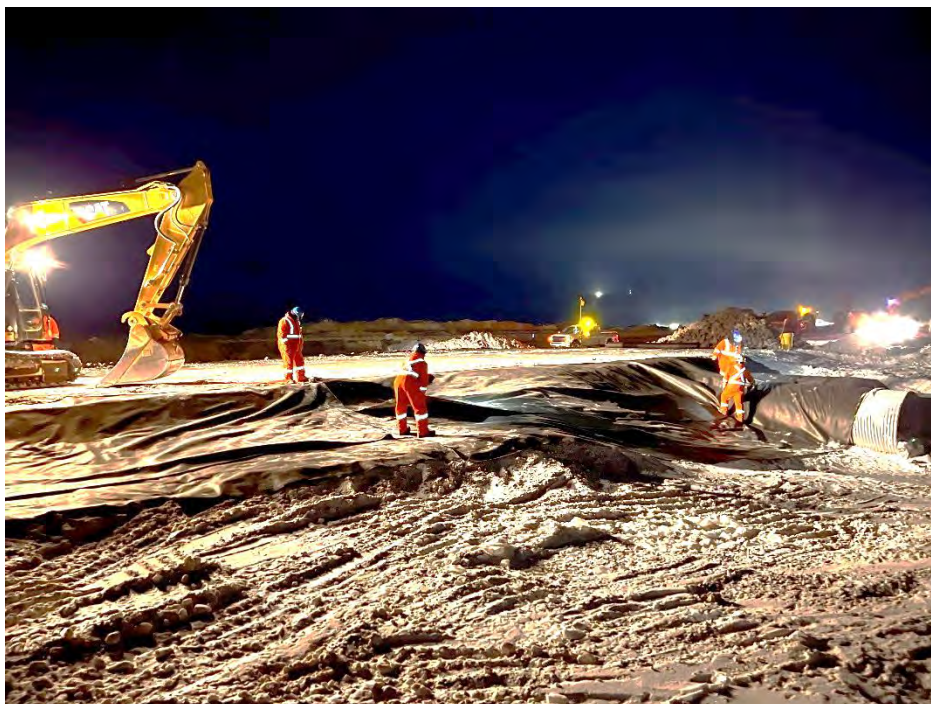
Photo 29 **Geotextile placement on the outlet road slope at CV-001. Photo taken April 5, 2024, facing east.**

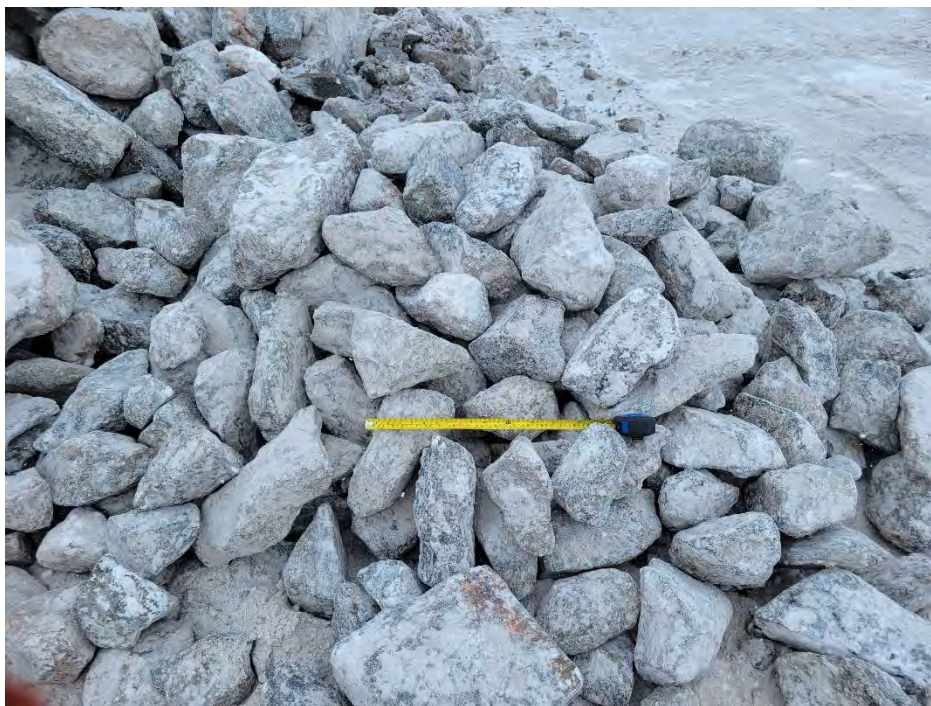
Photo 30 **Zoomed out size of coarse riprap used at CV-001. Photo taken April 5, 2024.**

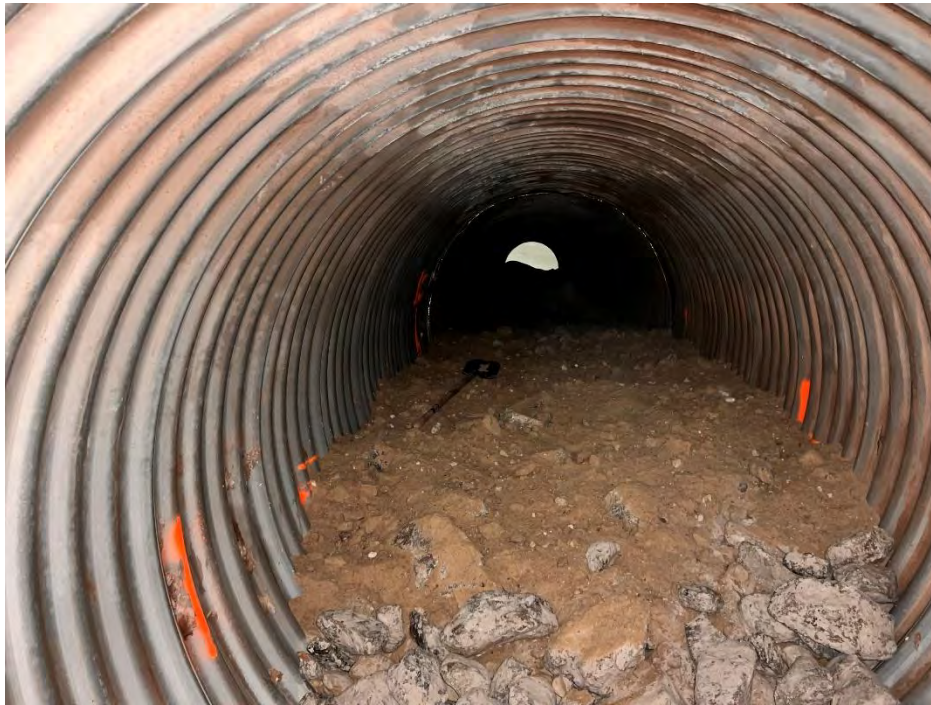
- Mike Burns and Greg Johnstone discussed the snow within the culvert infill material. Greg informed Mike that the snow and ice within the culvert infill material may settle and cause fish passage issues within the culvert. Greg stated that it is recommended that the material is replaced with culvert infill material without snow and ice.

Photo 31 Culvert Infill Material progress during nightshift at BG-04 East low flow culvert. Photo taken April 5, 2024.

- Don from Nuna stated that it would be very difficult to remove the culvert infill material.
- Abid from Baffinland stated that they will leave the material within the culvert, but ensure that material going forward will be without ice and snow.

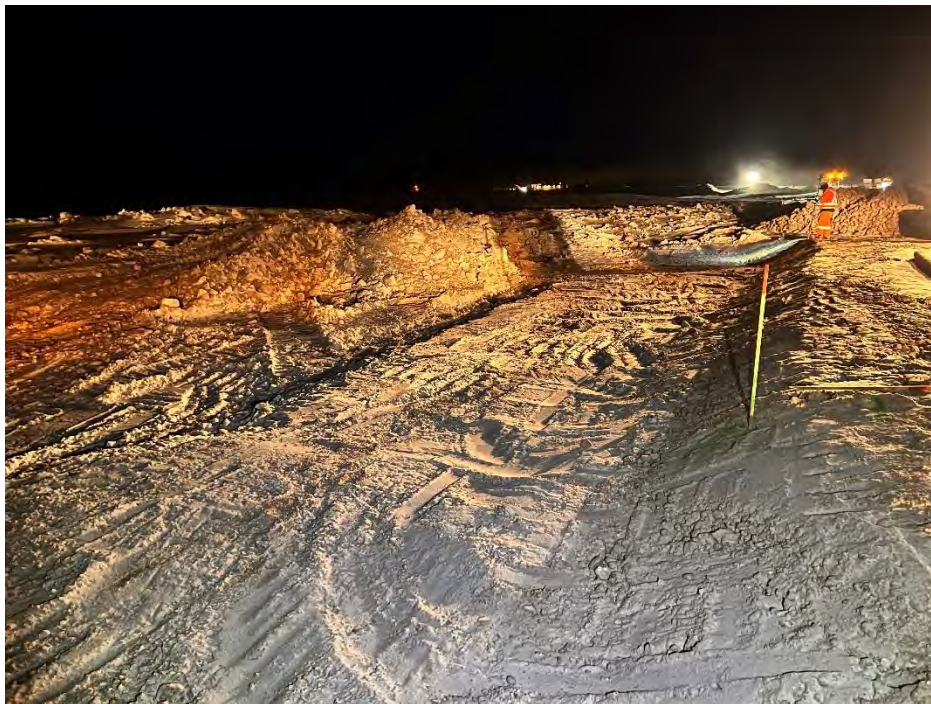
Photo 32 Side slope stabilization surface before Non-Woven Geotextile. Photo taken April 5, 2024, facing northwest.

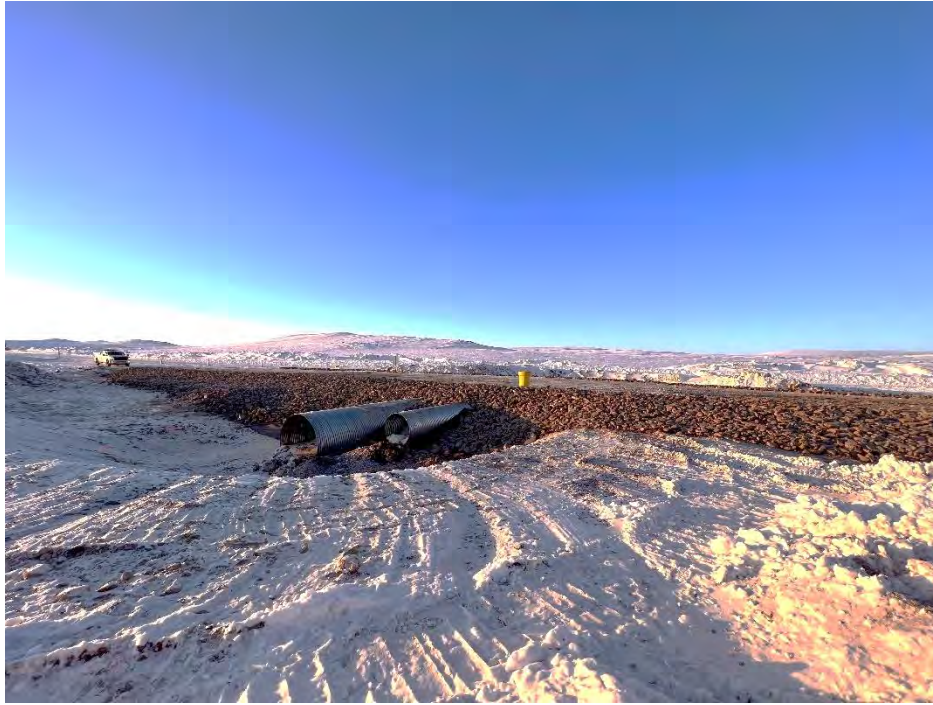
Photo 33

**Fine Riprap placed on top of Geotextile at CV-001 along the southbound lane side slopes.
Photo taken April 6, 2024, facing north.**

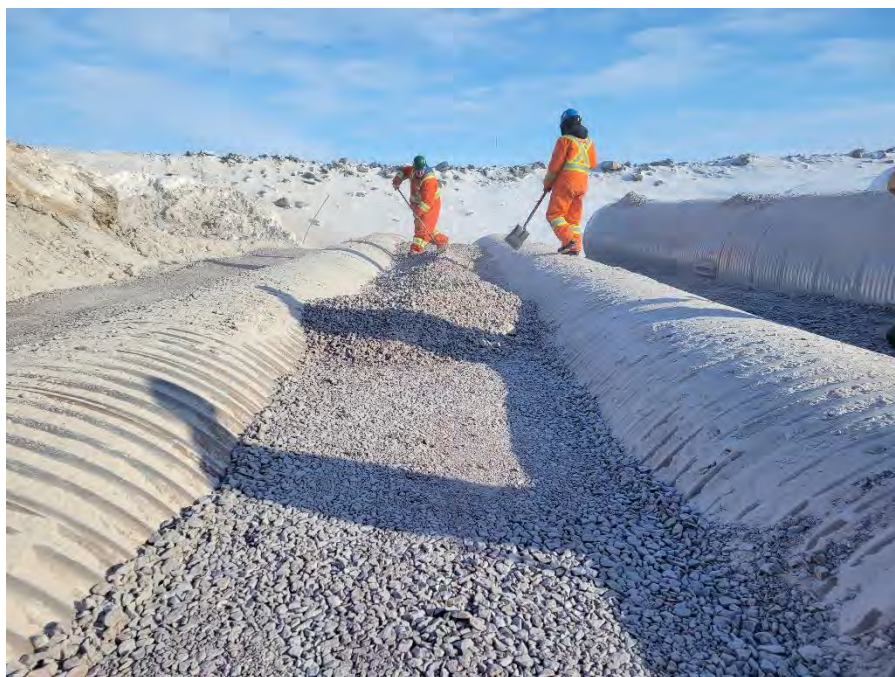
Photo 1 Placement and grading of 20 cm lift of 32 mm minus material at BG-04. Photo taken April 7, 2024, facing east.

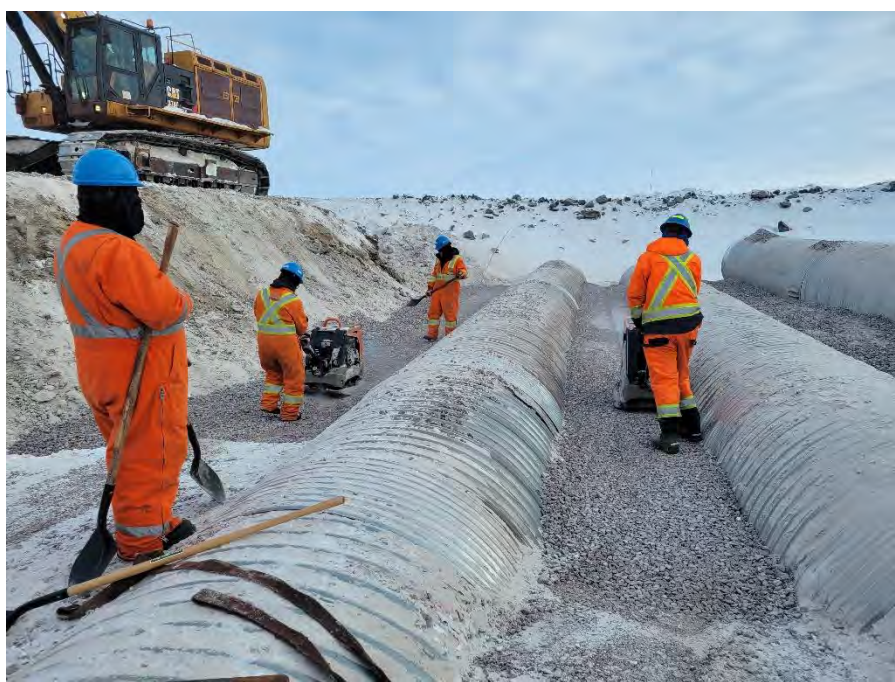
- Ice was encountered during the excavation of CV-216. A survey point found that the ice (at least 2 m thick) lies below the design culvert placement depth (see Photo 2).

Photo 2 Compaction of 20 cm lift of 32 mm minus material at BG-04. Photo taken April 7, 2024, facing east.

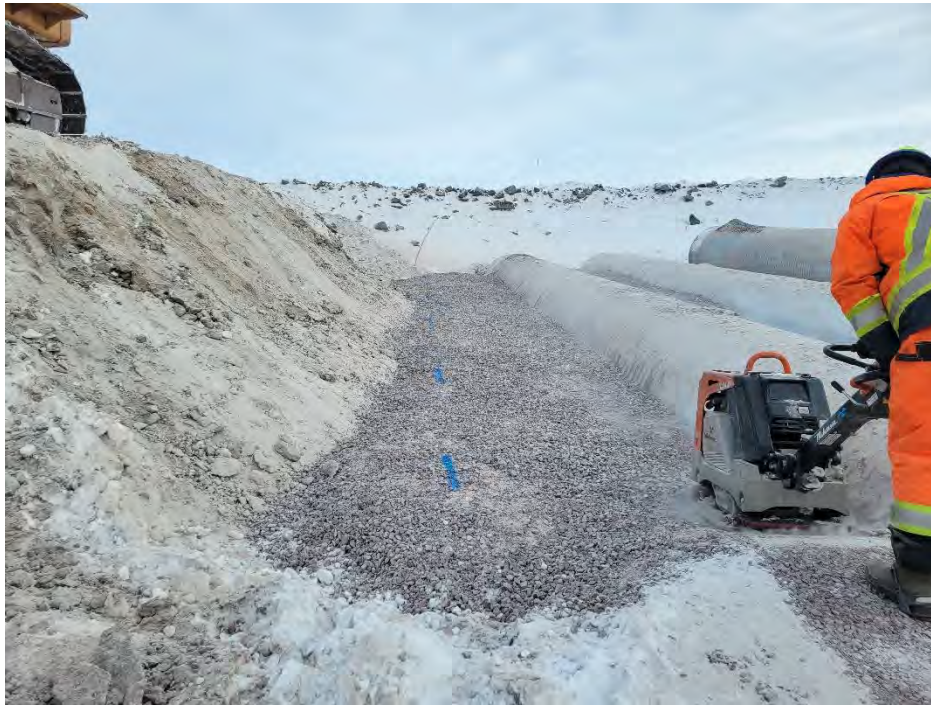
Photo 3 Edge of 32 mm minus material trapezoid marked out in blue paint. Photo taken April 7, 2024, facing east.

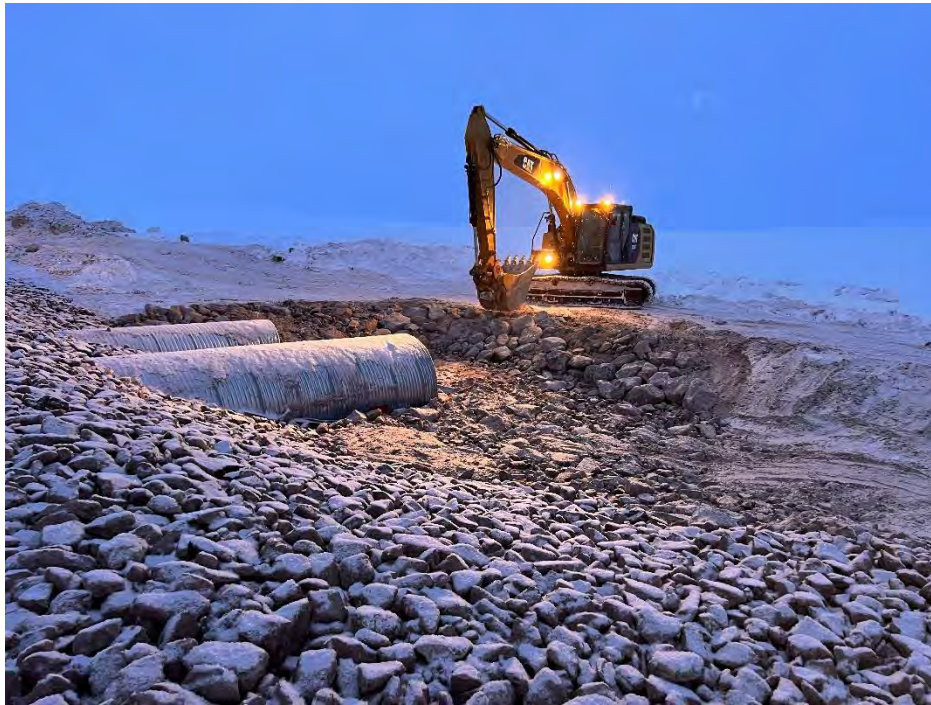
Photo 5 Coarse Riprap mixed with Stream Substrate Material placed for CV-001 outlet apron. Photo taken April 7, 2024, facing southeast.

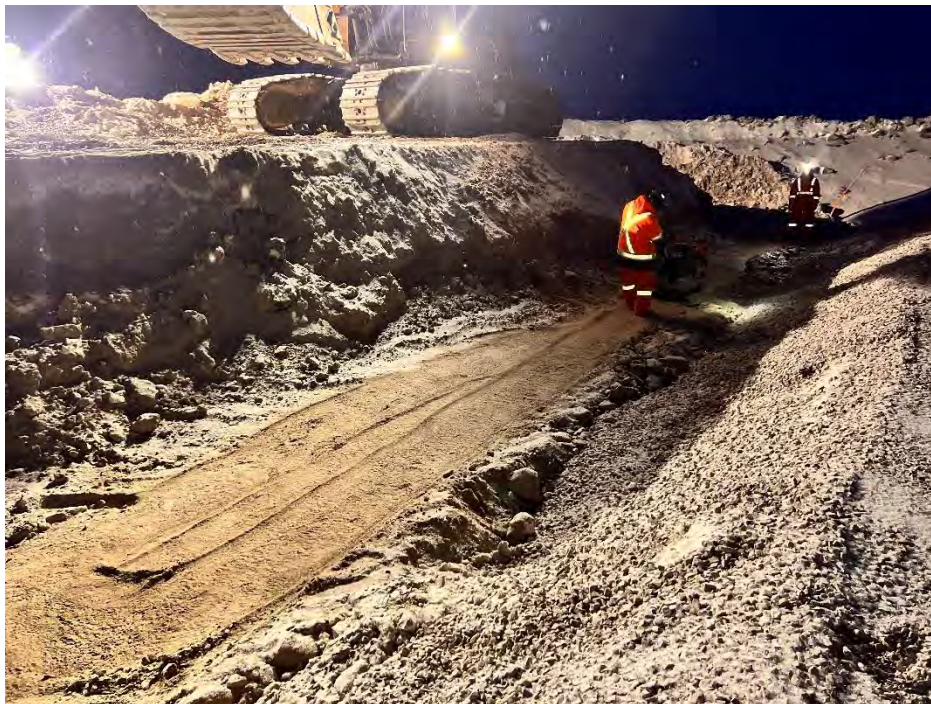
Photo 6 Local borrow area fill placement and compaction against the 32 mm minus Culvert Backfill Material on the west side of the low flow culverts at BG-04. Photo taken April 7, 2024, facing north.

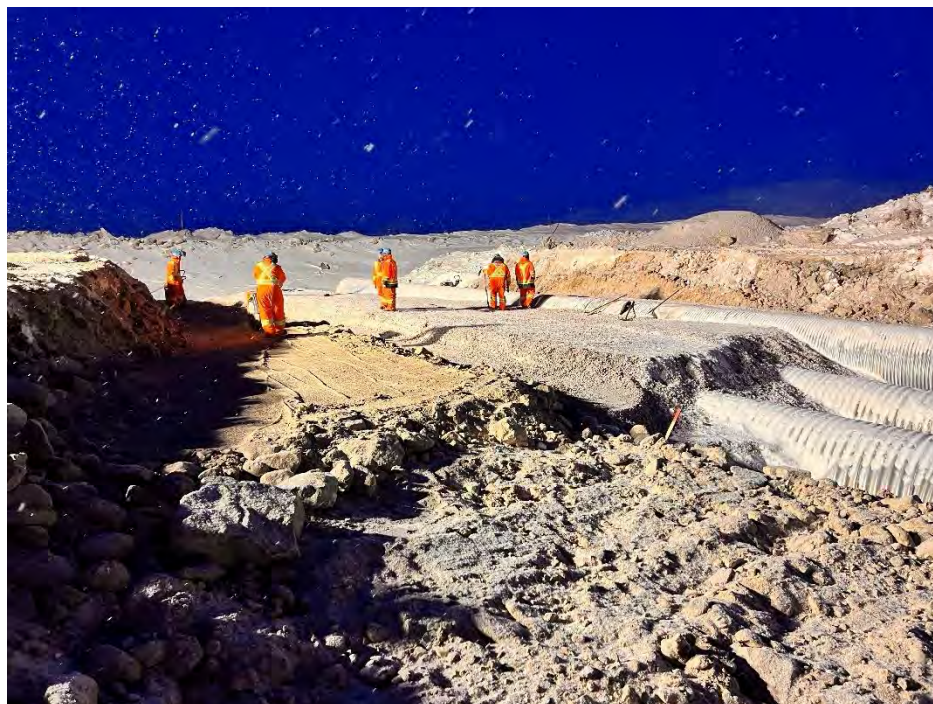
Photo 7 Local borrow area fill placement and compaction against the 32 mm minus Culvert Backfill Material on the west side of the low flow culverts at BG-04. Photo taken April 7, 2024, facing northeast.

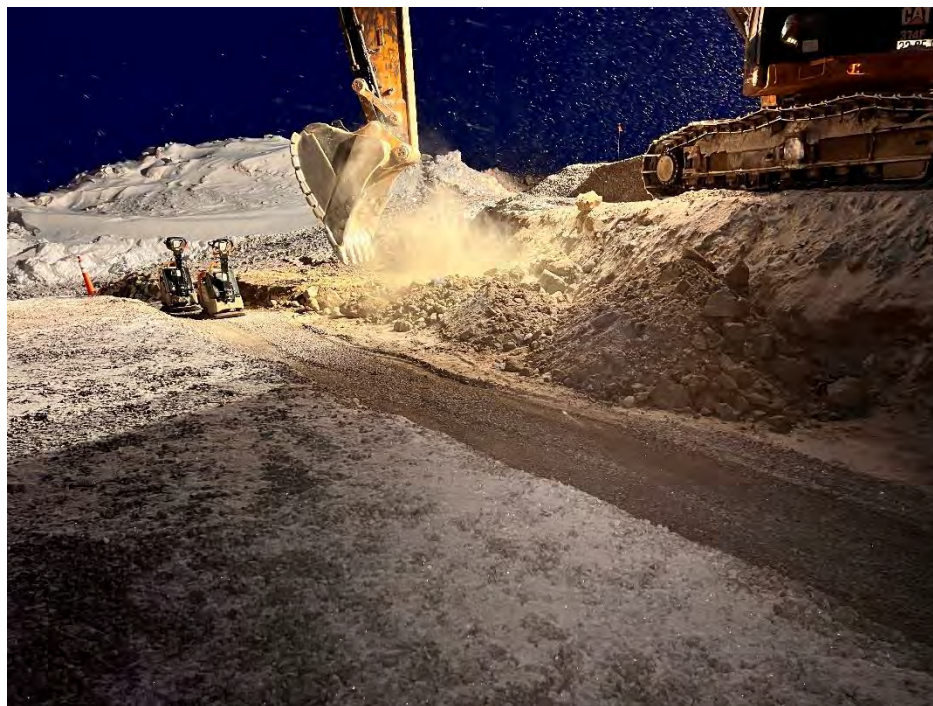
Photo 8 Local borrow area fill placement beside compacted 32 mm minus Culvert Backfill material at BG-04. Photo taken April 7, 2024, facing southwest.

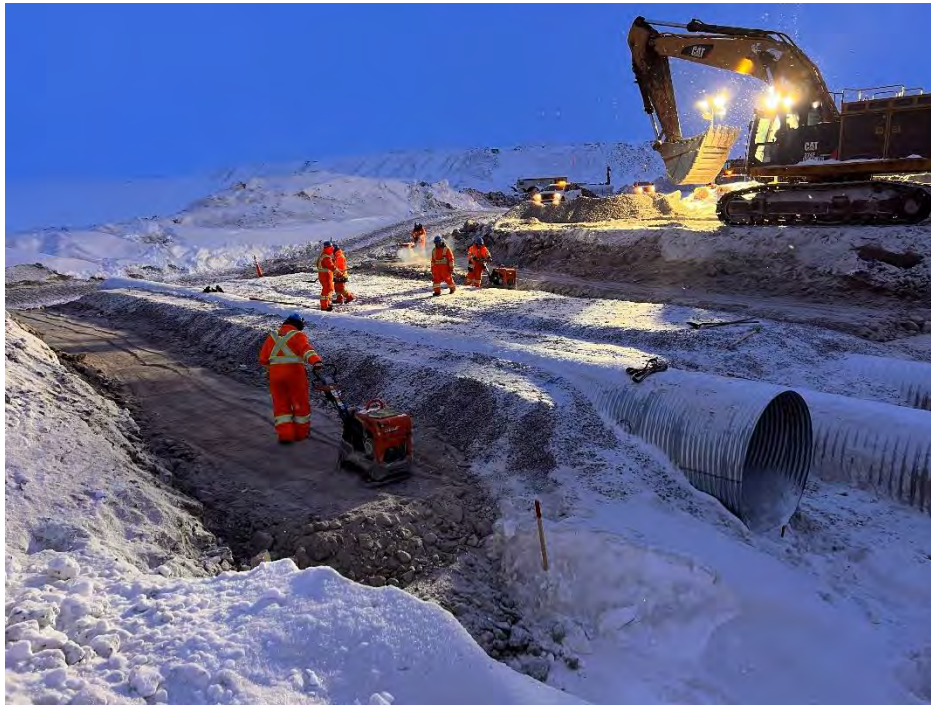
Photo 9 Local borrow area fill and 32 mm minus Culvert Backfill placement and compaction at BG-04. Photo taken April 7, 2024, facing southeast.

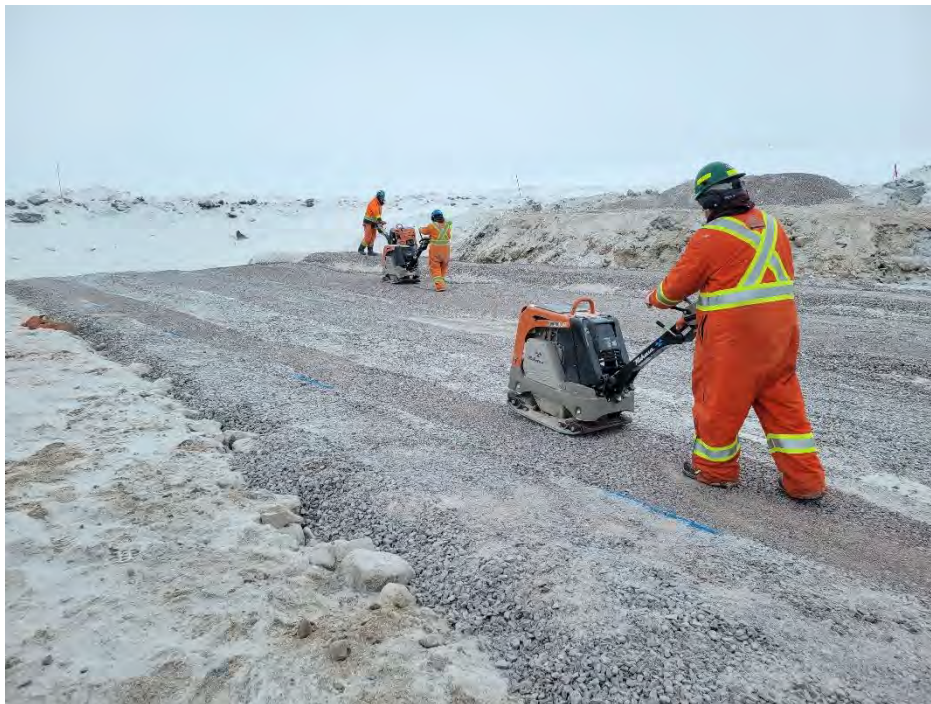
Photo 10 Compaction of 20 cm lift of 32 mm minus material at BG-04. Photo taken April 8, 2024, facing east.

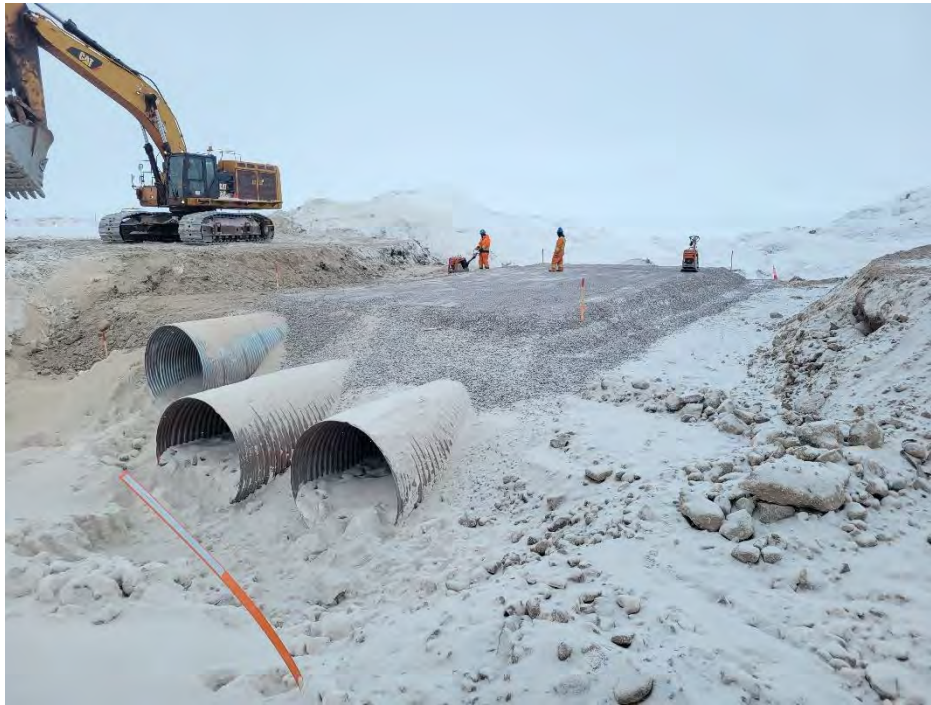
Photo 11

**Compacting final lift of 32 mm minus material at BG-04 at top of 32 mm minus trapezoid.
Photo taken April 8, 2024, facing south.**

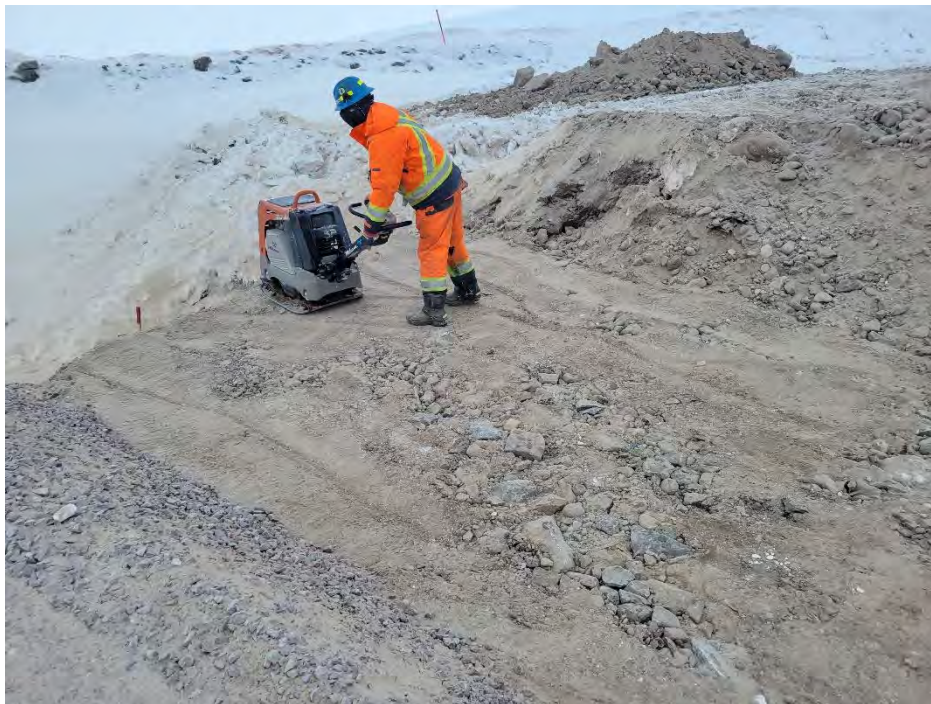
Photo 12

**Compacting 30 mm lift of common borrow material outside the 32 mm minus trapezoid.
Photo taken April 8, 2024, facing east.**
