MARY RIVER MINE

TOTE ROAD PERMANENT CROSSING PLAN - ROUND CSP CULVERT INSTALLATIONS

WEEKLY PROGRESS REPORT

WEEK 8 – March 31 to April 6, 2024

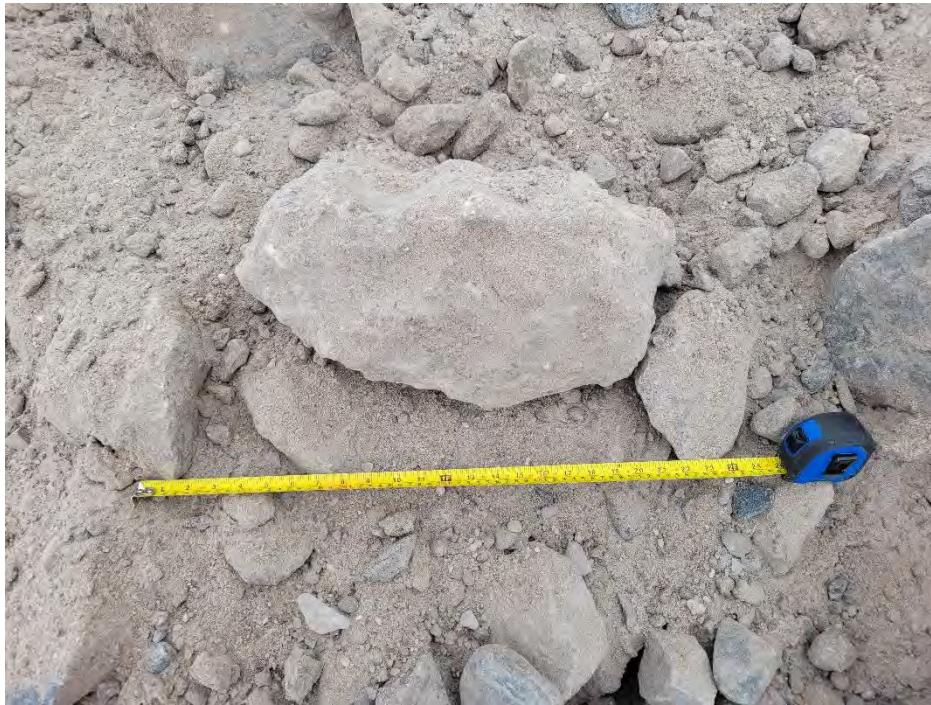
Photo 13 **Zoomed in sizing of common borrow material used outside of 32 mm minus trapezoid at BG-04. Photo taken April 8, 2024.**

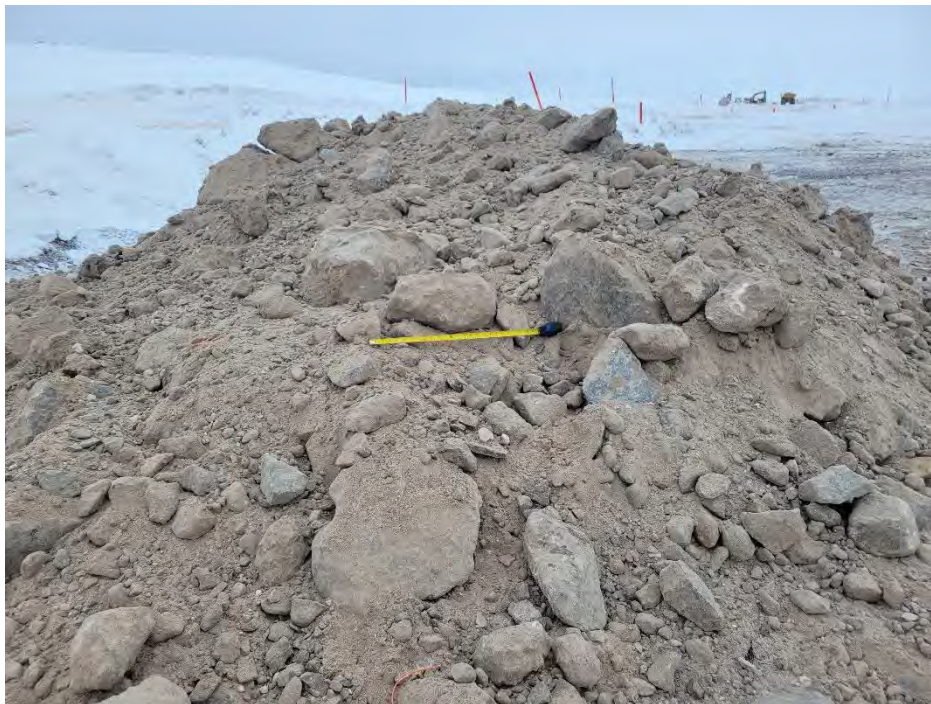
Photo 14 **Zoomed out sizing of common borrow material used outside of 32 mm minus trapezoid at BG-04. Photo taken April 8, 2024.**

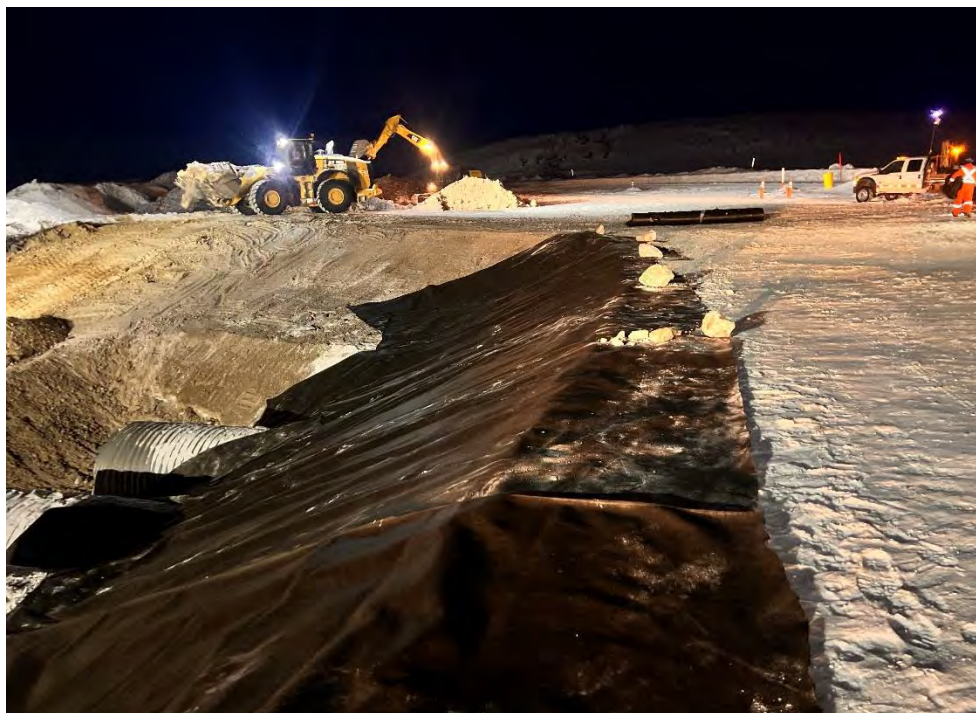
Photo 15 Non-woven geotextile installed on the outlet apron side slopes in preparation of Fine Riprap placement at BG-04. Photo taken April 12, 2024, facing west.

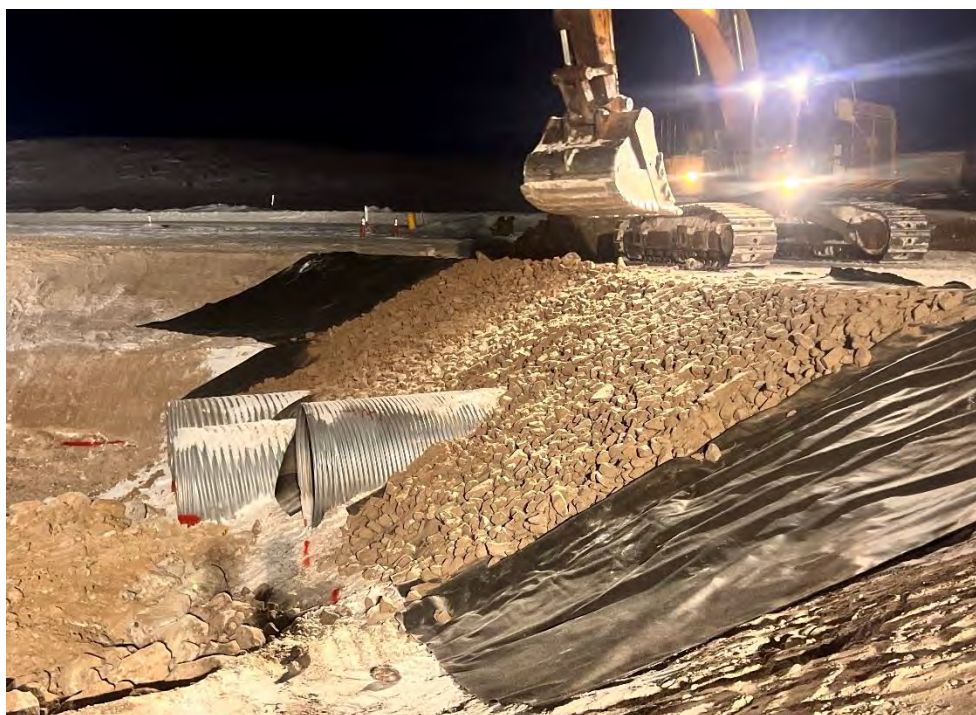
Photo 16 Fine Riprap placement on top of non-woven geotextile installed on the outlet apron side slopes at BG-04. Photo taken April 12, 2024, facing west.

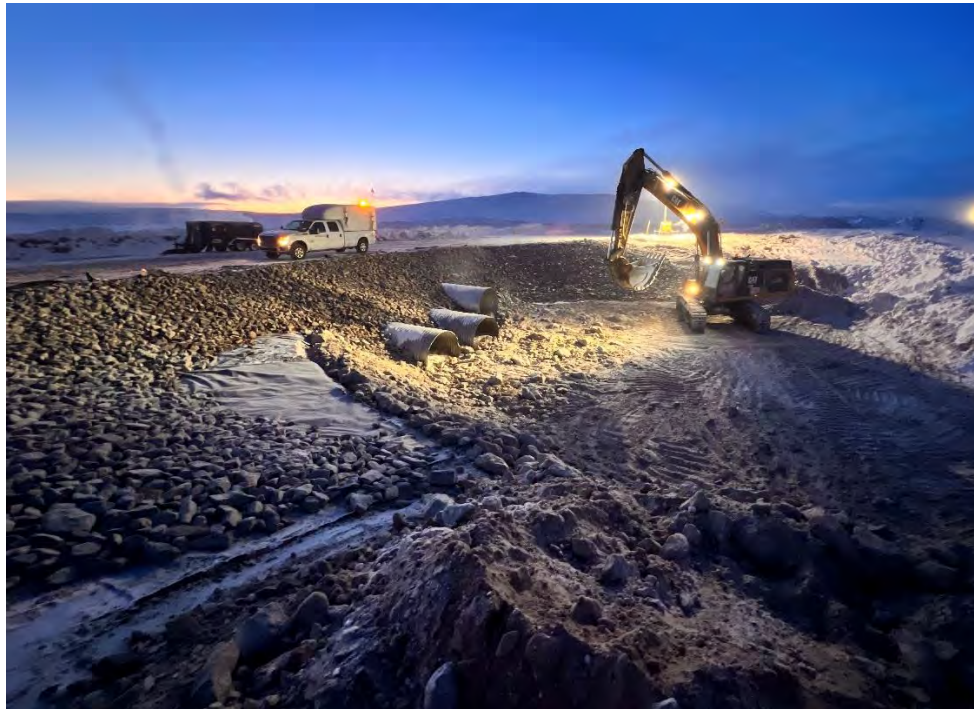
Photo 17 Outlet apron and side slopes at BG-04. Photo taken April 12, 2024, facing east.

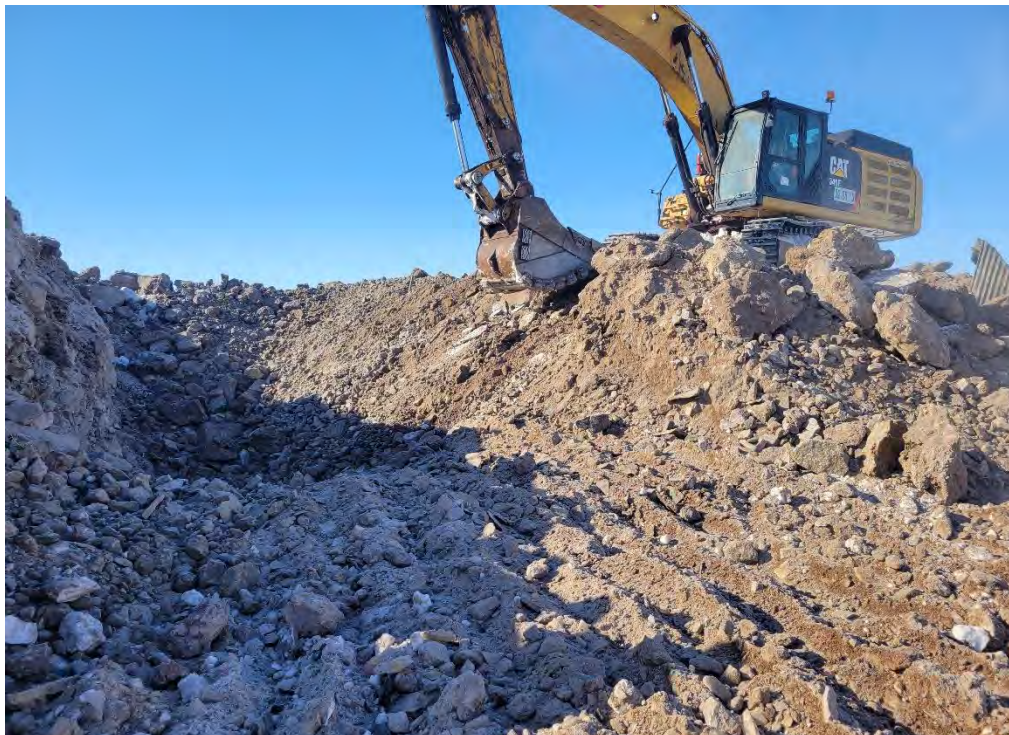
Photo 19 Frozen blasted material being excavated by Nuna at CV-216. Photo taken April 12, 2024, facing southwest.

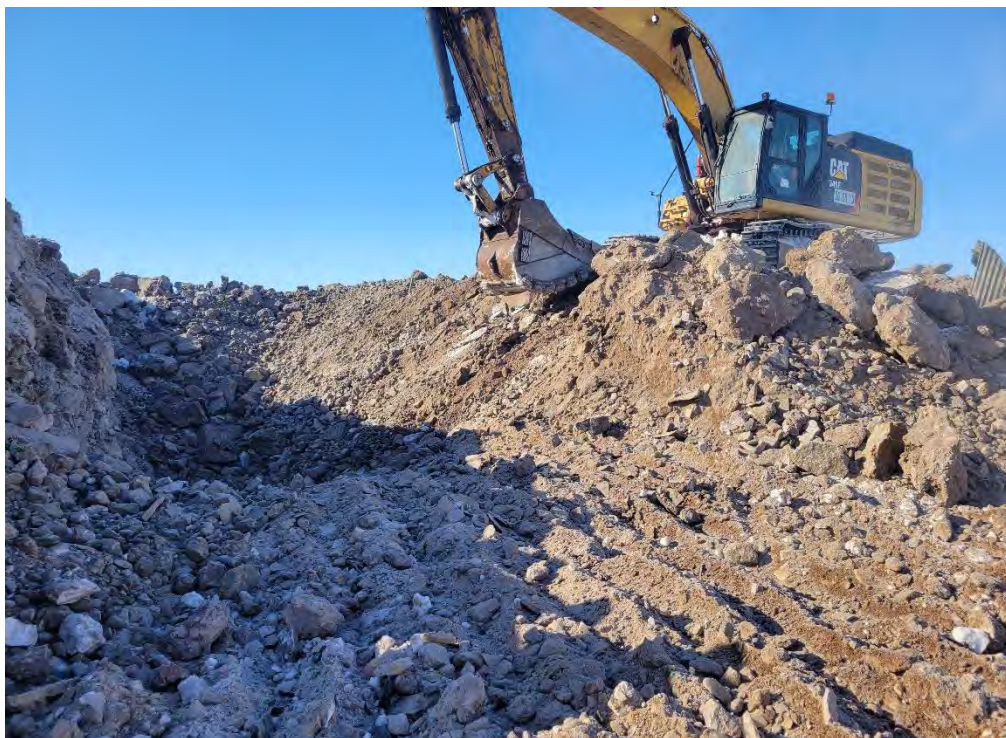
Photo 21 Frozen blasted material being excavated by Nuna at CV-216. Photo taken April 12, 2024, facing southwest.

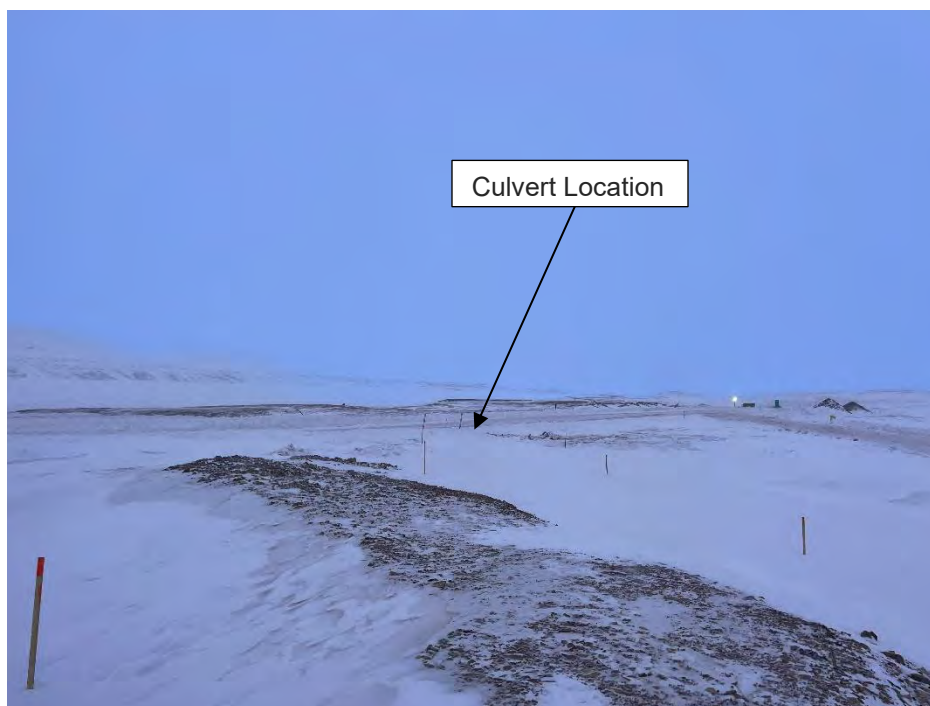
Photo 22 CV-106 Culvert location facing west towards the inlet. Photo taken April 12, 2024.

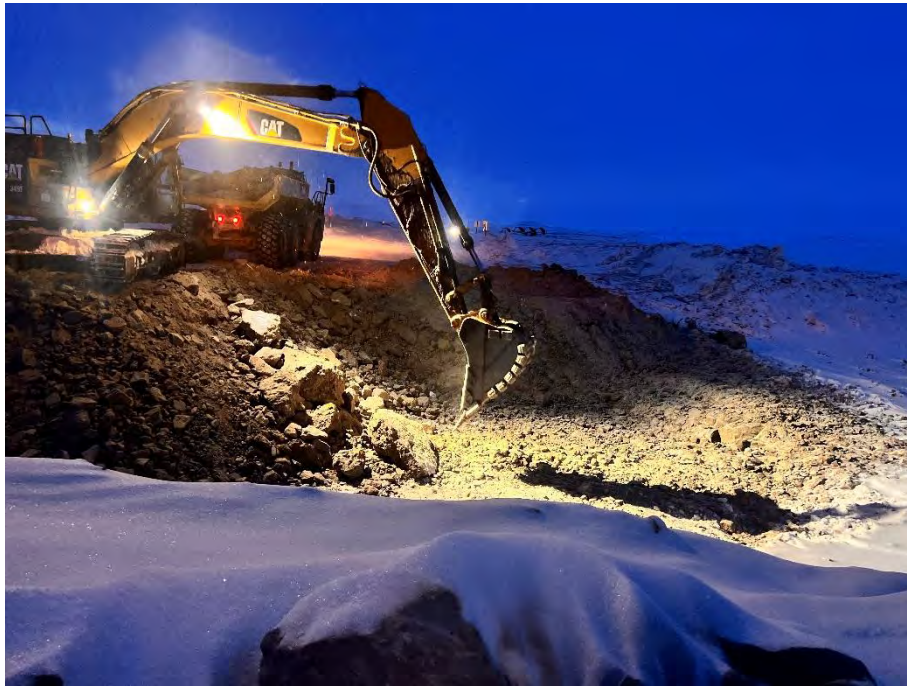
Photo 25 Ongoing excavation of blasted material at CV-216. Photo taken April 13, 2024, facing northbound on the tote road.
