MARY RIVER MINE

TOTE ROAD PERMANENT CROSSING PLAN - ROUND CSP CULVERT INSTALLATIONS

WEEKLY PROGRESS REPORT

WEEK 10 – April 14 to April 20, 2024

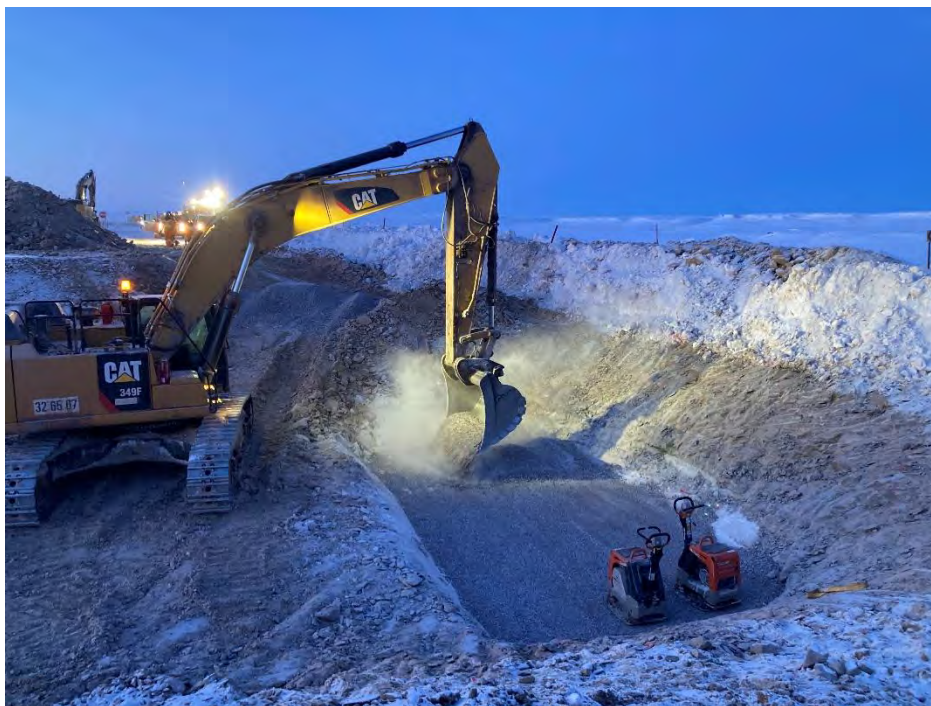
Photo 10 Placement of 32 mm minus material at the inlet apron at CV-216. Photo taken April 18, 2024, facing southeast.

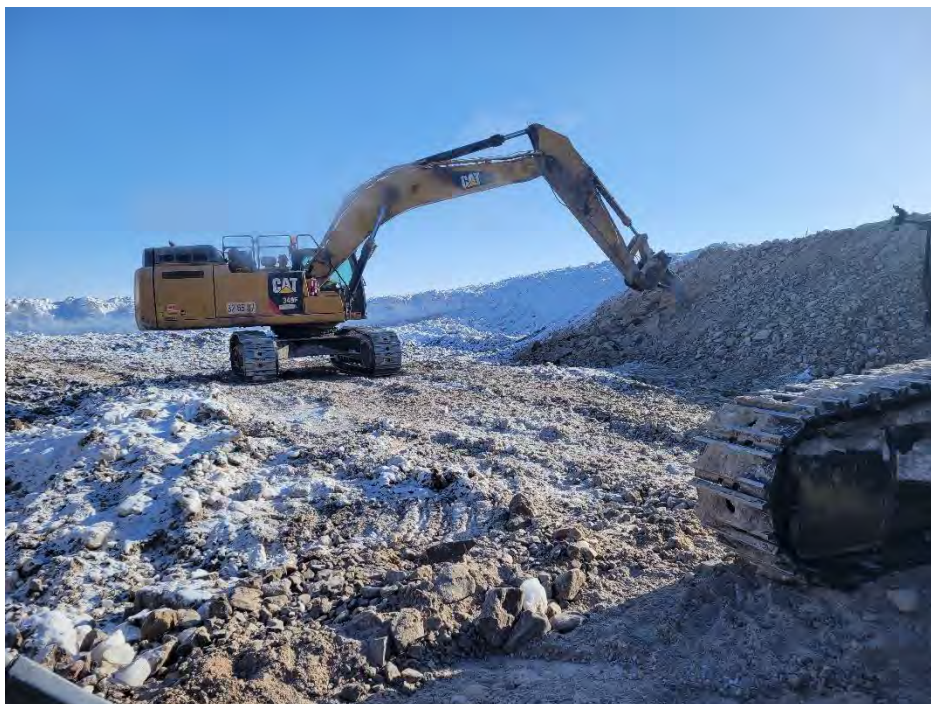
Photo 11 Widening of the excavation at CV-216. Photo taken April 19, 2024, facing east.

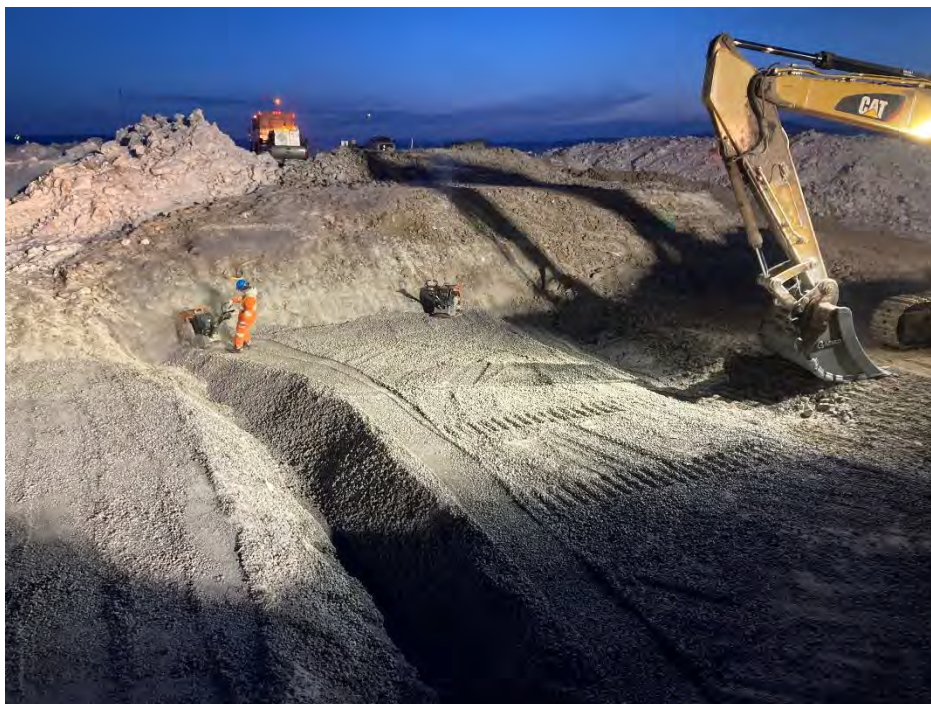
Photo 13 **Compaction of 32 mm minus material and location of geomembrane/geotextile key in trench at the inlet of CV-216. Photo taken April 19, 2024, facing northwest.**

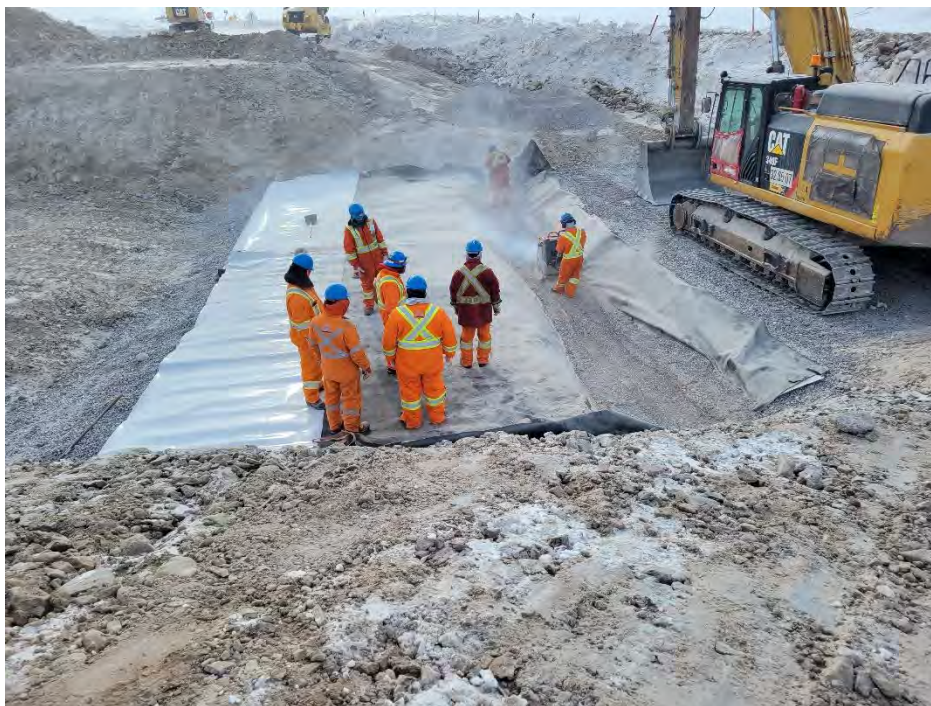
Photo 14 **Compaction of 200 mm lift of 3/4 inch material in the trench at the inlet of CV-216. Photo taken April 20, 2024, facing southeast.**

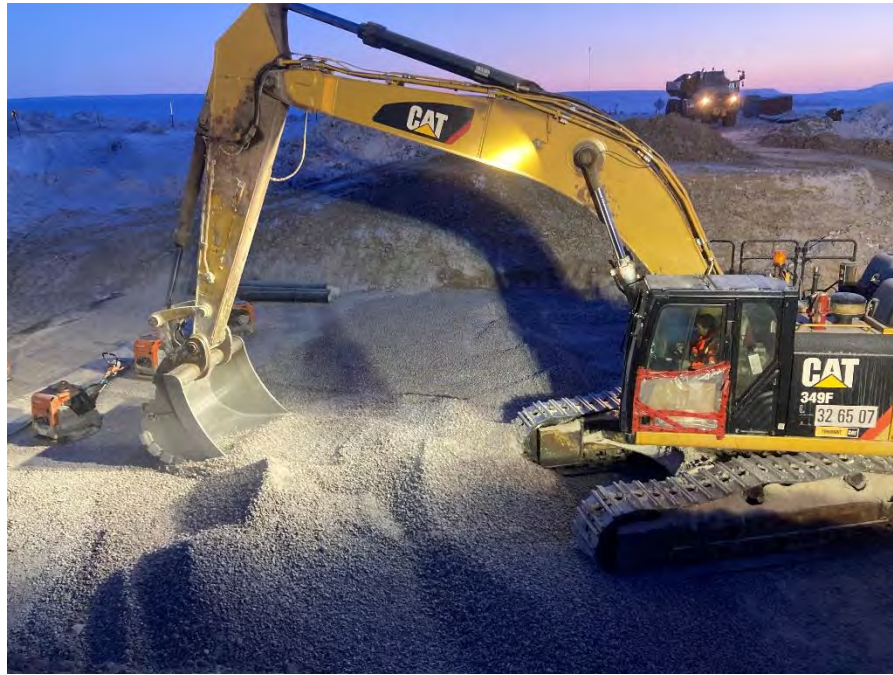
Photo 15 **Placement of 32 mm minus material at the CV-216 road crossing area. Photo taken April 20, 2024, facing west.**

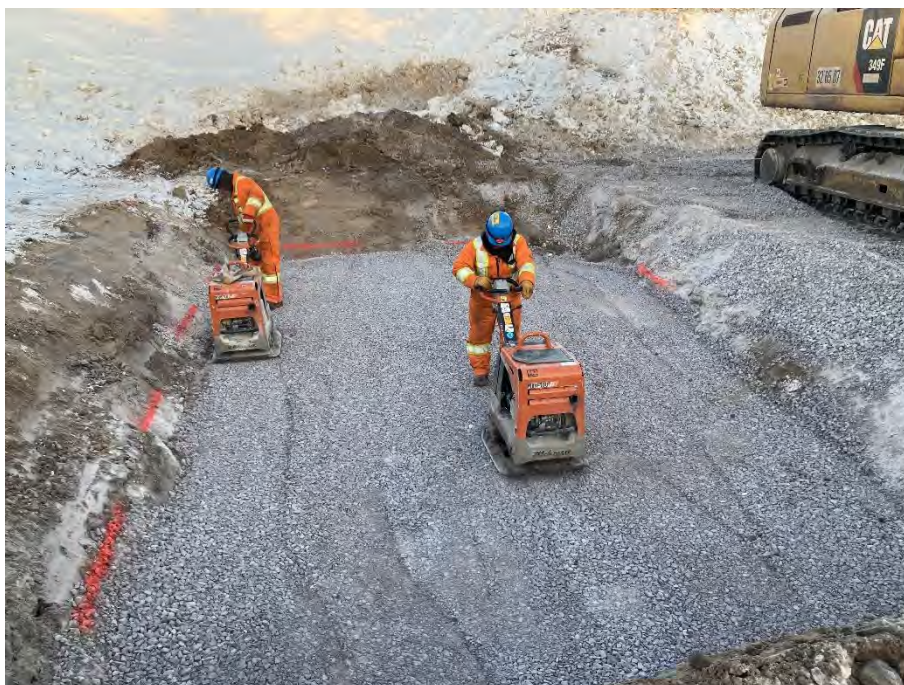
Photo 2 Compaction of 32 mm minus material at the outlet apron at CV-216. Photo taken April 21, 2024, facing east.

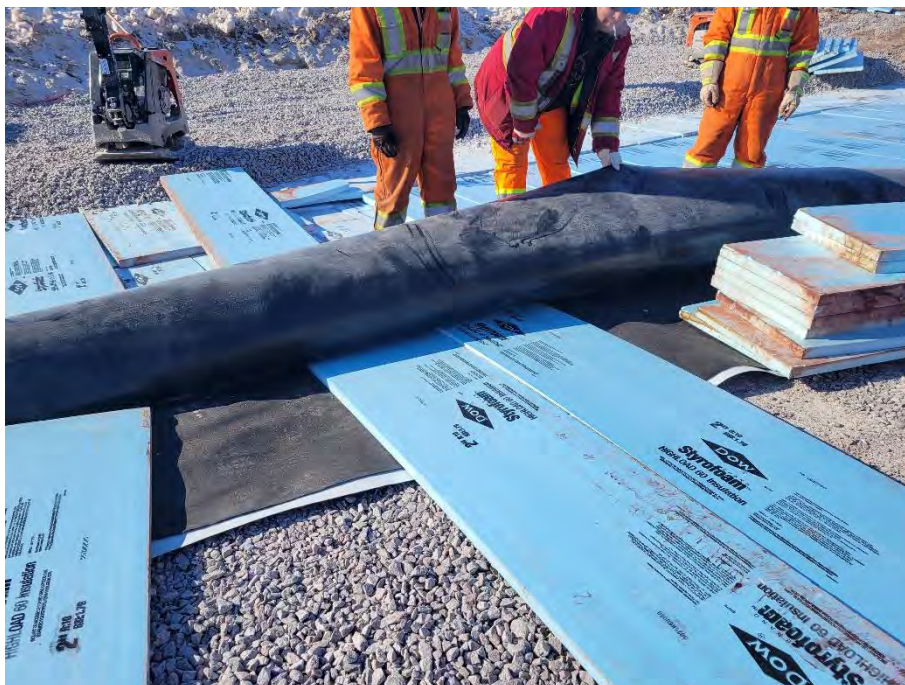
Photo 3

Anchoring geotextile and geomembrane into the insulation at the inlet trench of CV-216.
Photo taken April 22, 2024, facing southwest.

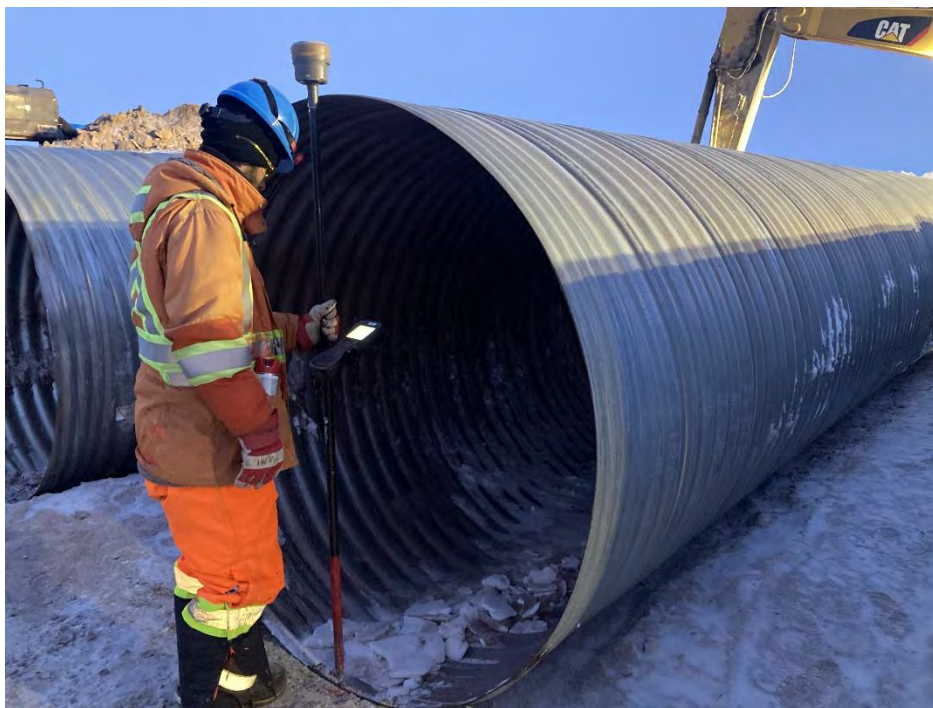
Photo 4

Survey verifying the inlet invert elevation of the 2.0 m diameter low flow CSP culverts at CV-216. Photo taken April 22, 2024, looking northwest.

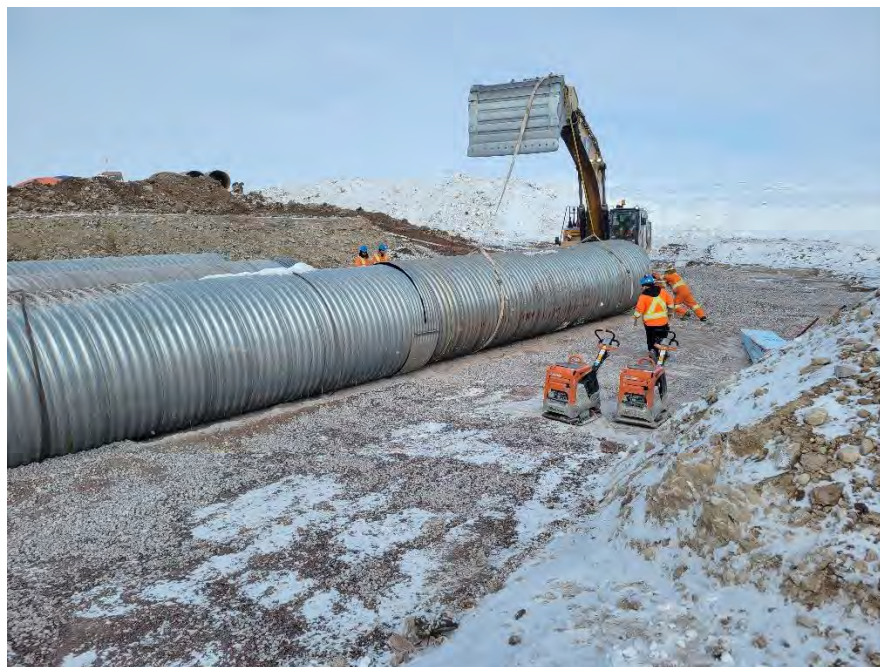
Photo 5 Installation of the second 9.0 m long segment of the 2.0 m diameter low flow CSP culverts at CV-216. Photo taken April 23, 2024, facing south.

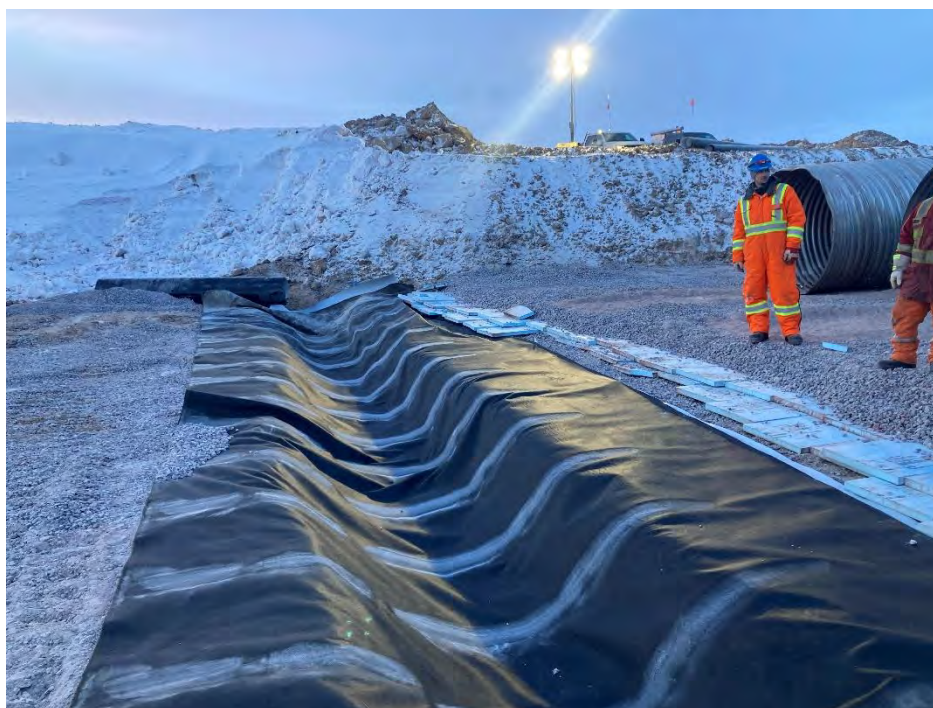
Photo 6 Second layer of plug (geotextile) placed atop the geomembrane in the outlet trench at CV-216. Photo taken April 23, 2024, facing east.

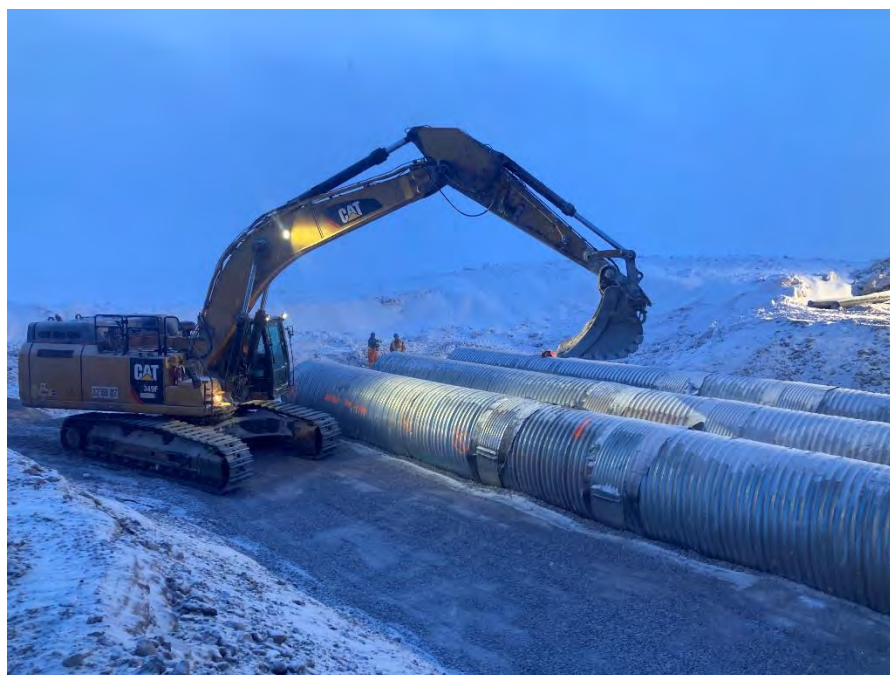
Photo 7

Placement of 32 mm minus culvert backfill material between the low flow CSP culverts at CV-216. Photo taken April 24, 2024, facing northeast.

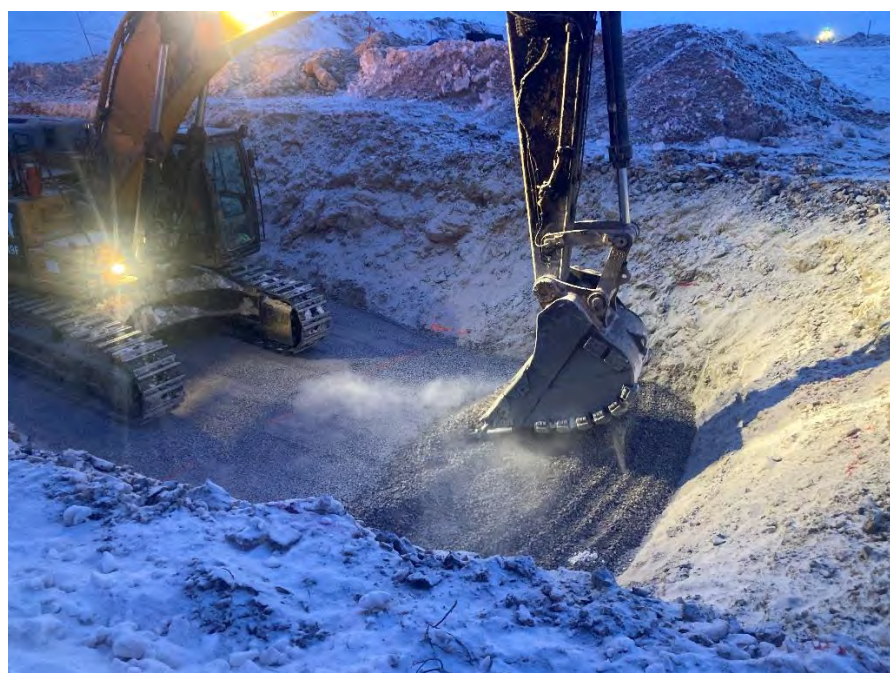
Photo 8

Placement of 32 mm minus culvert backfill material at CV-102. Photo taken April 24, 2024, facing north.

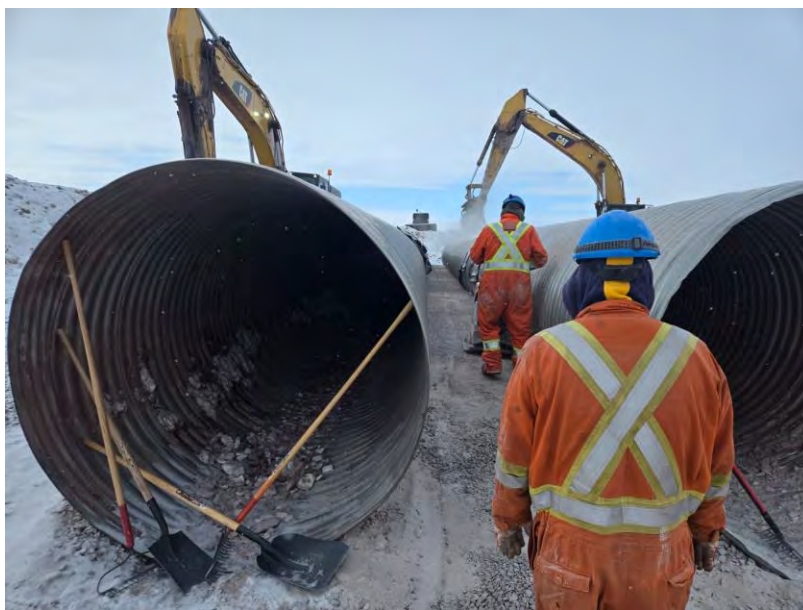
Photo 9 Compacting second lift of culvert backfill material between placed low flow CSP culverts at CV-216. Photo taken April 25, 2024, facing southwest.

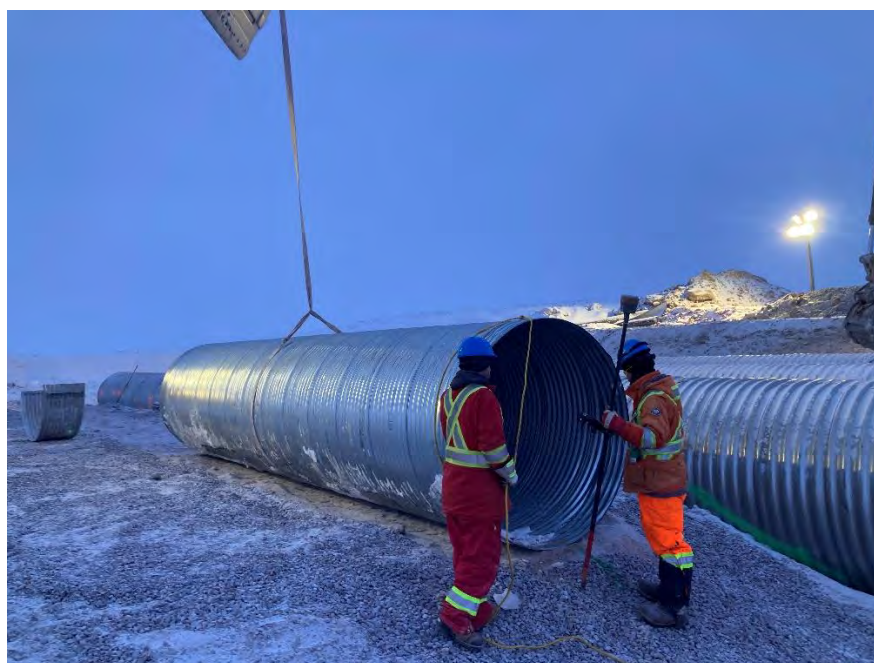
Photo 10 Installation of the first 8.0 m long segment of the eastern 1.8 m diameter high flow CSP culvert at CV-216. Photo taken April 25, 2024, facing northeast.

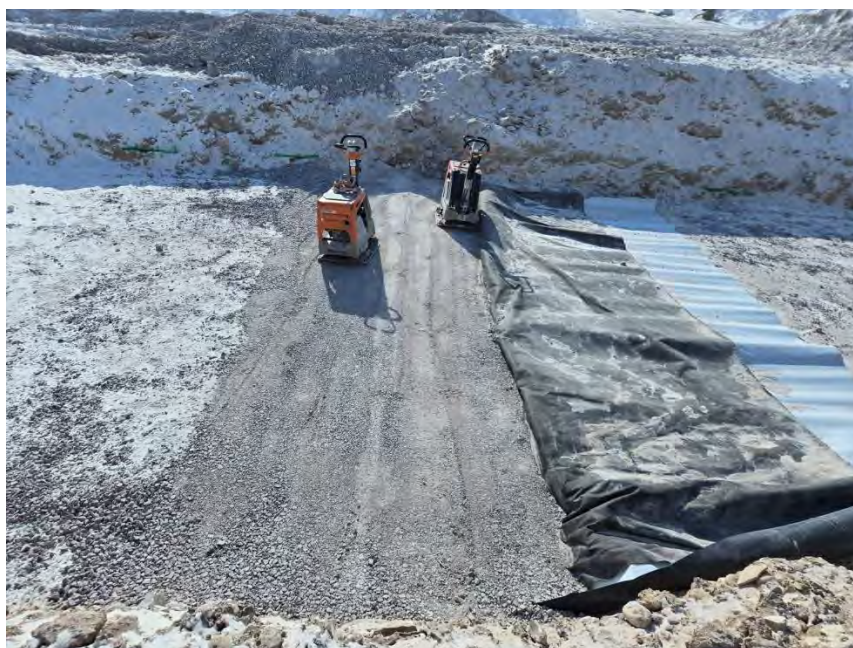
Photo 11 Backfilled and compacted anchor-trench with $\frac{3}{4}$ inch minus material at CV-102. Photo taken April 26, 2024, facing south.

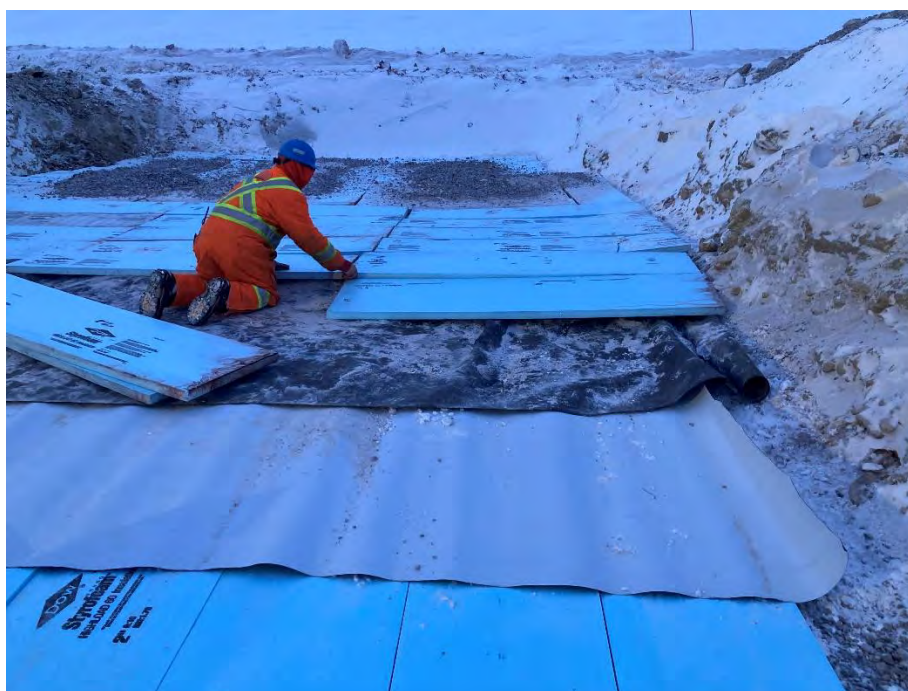
Photo 12 Installation of the insulation material layered with the excess geomembrane and geotextile material from the geomembrane anchor-trench at CV-102. Photo taken April 26, 2024, facing east.

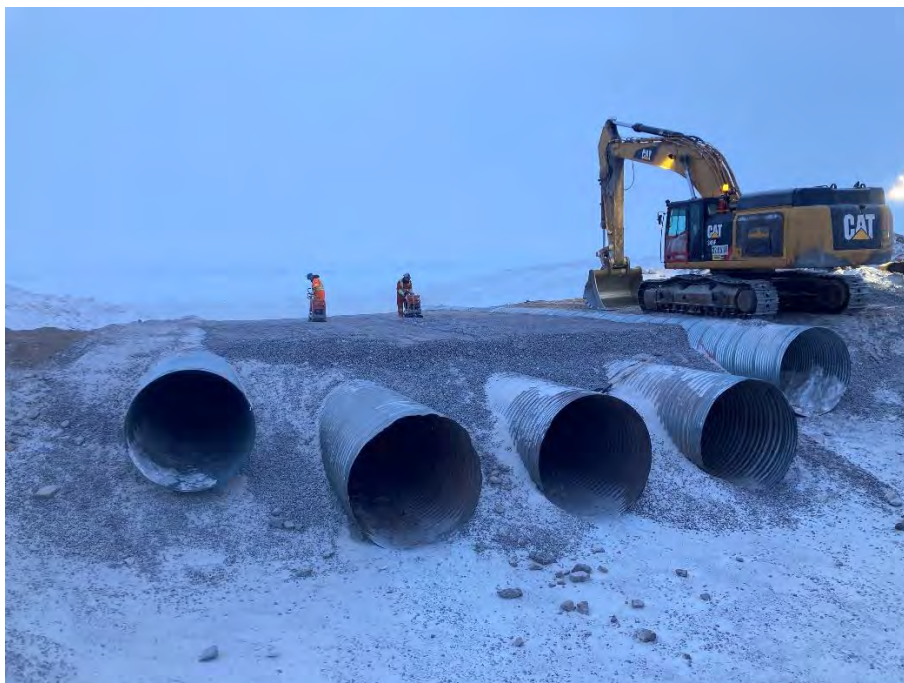
Photo 13 Current backfill progress at the end of nightshift at CV-216. Photo taken April 26, 2024, facing northeast.

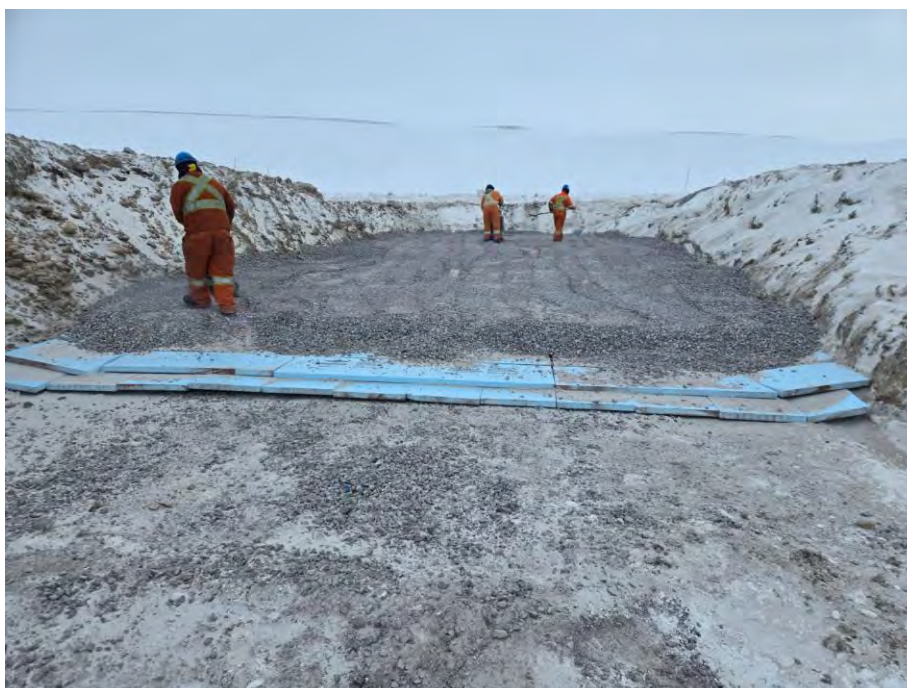
Photo 14 Compaction of the first 200 mm lift of 32 mm minus material above insulation at CV-102. Photo taken April 27, 2024, facing east.

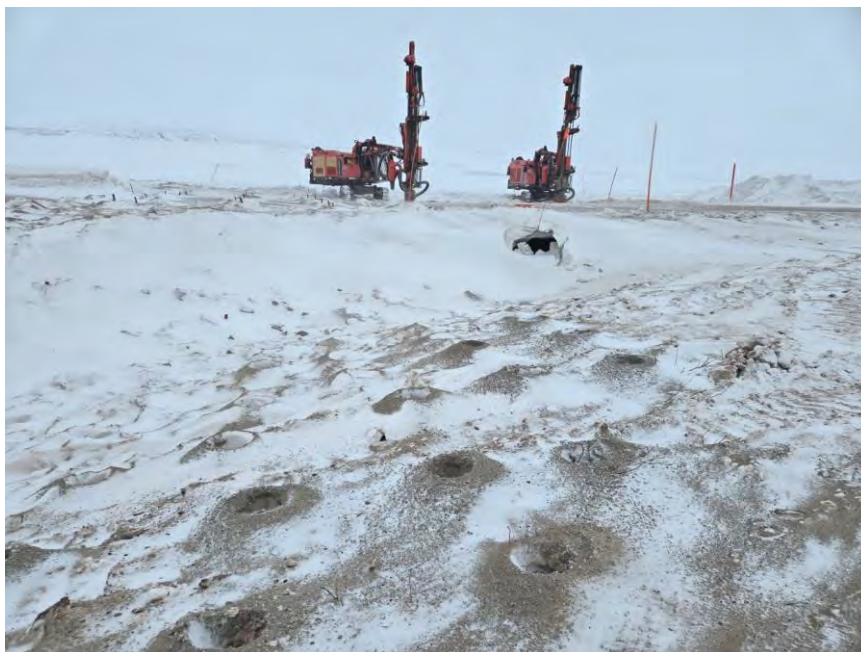
Photo 15 Continued drilling at CV-106. Photo taken April 27, 2024, facing southeast.

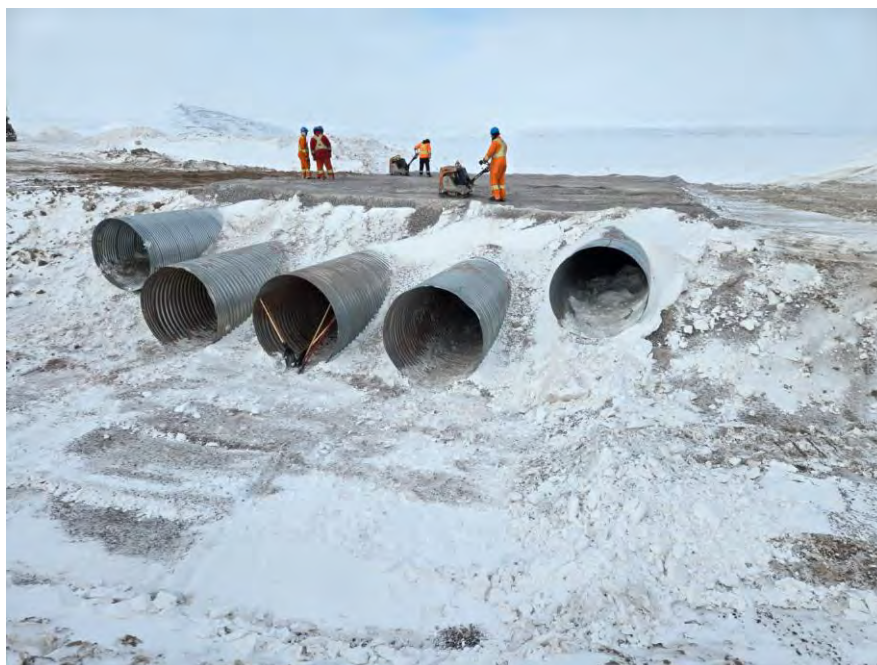
Photo 1

Compacting 32 mm minus material on top low and high flow CSP culverts at CV-216. Photo taken afternoon of April 28, 2024, facing north.

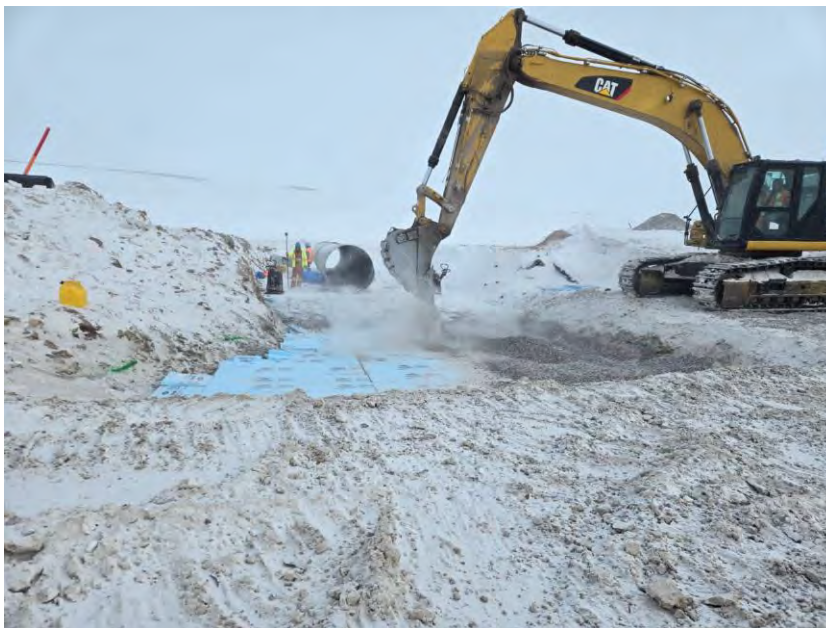
Photo 4 Placement of 32 mm minus material over installed insulation in the western apron area at CV-102. Photo taken April 29, 2024, facing east.

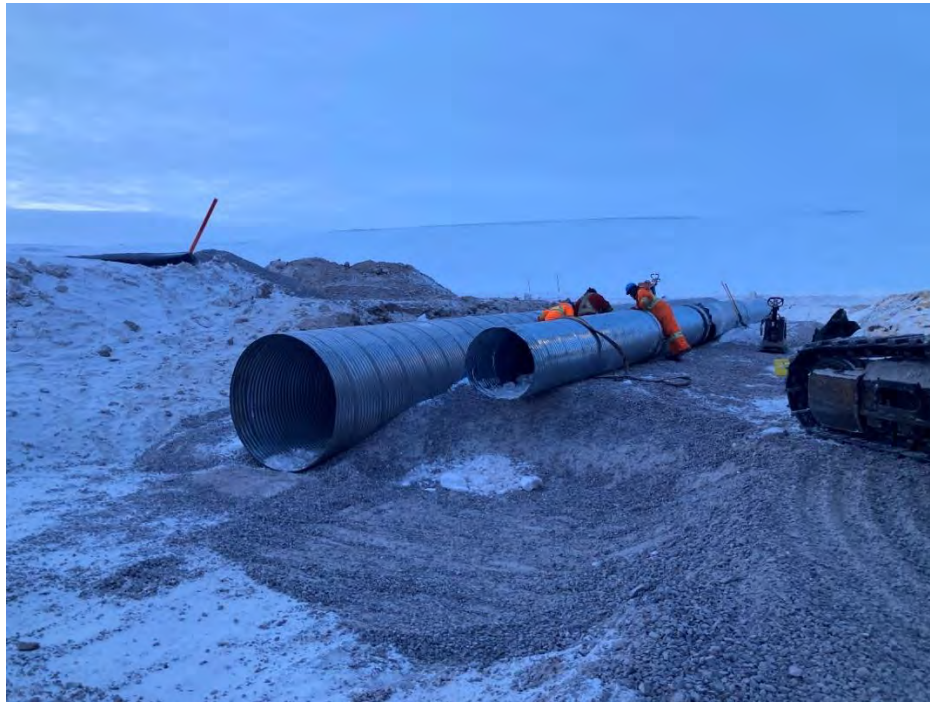
Photo 7

Fully installed low and high flow CSP culverts at CV-102. Photo taken April 30, 2024, facing northeast.

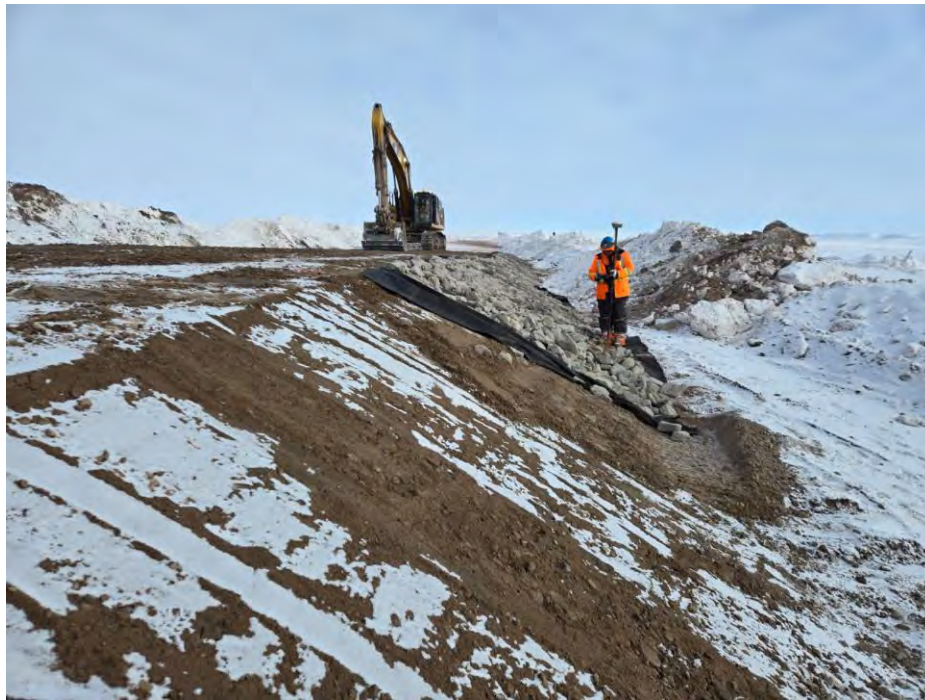
Photo 8

Southeast side slopes graded to 2H:1V with non-woven geotextile and riprap placed at CV-216. Photo taken May 1, 2024, facing southeast.

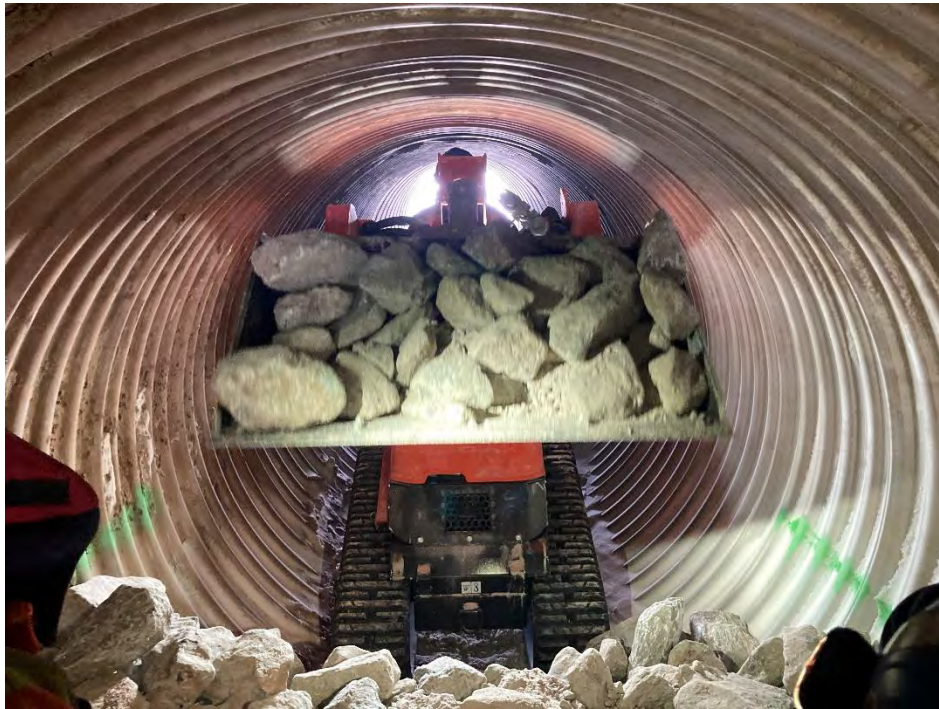
Photo 9

Placing riprap using the Kubota mini skid steer inside the middle low flow CSP culvert at CV-216. Photo taken May 1, 2024.

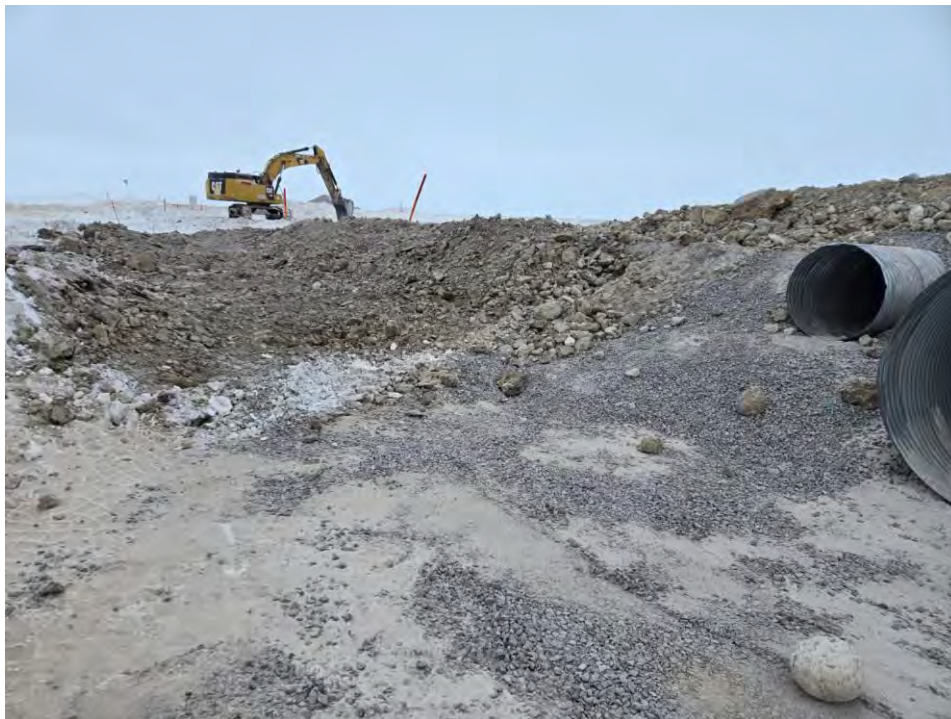
Photo 10

Ripped and excavated approach inlet apron at CV-102. Photo taken May 2, 2024, facing southwest.

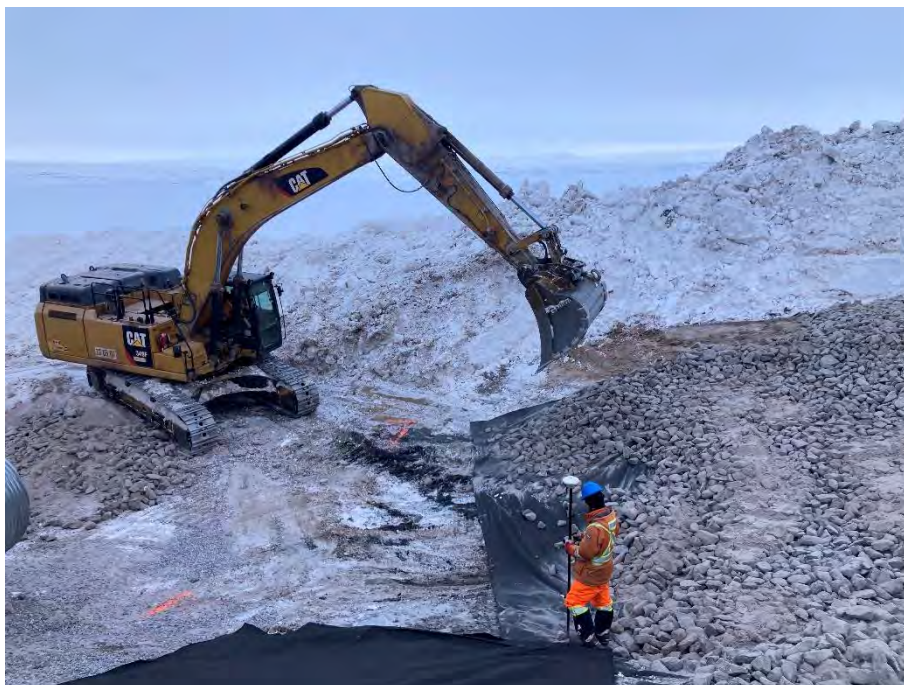
Photo 11 Placement of fine riprap on the northeastern apron side slopes at CV-216. Photo taken May 2, 2024, facing north.

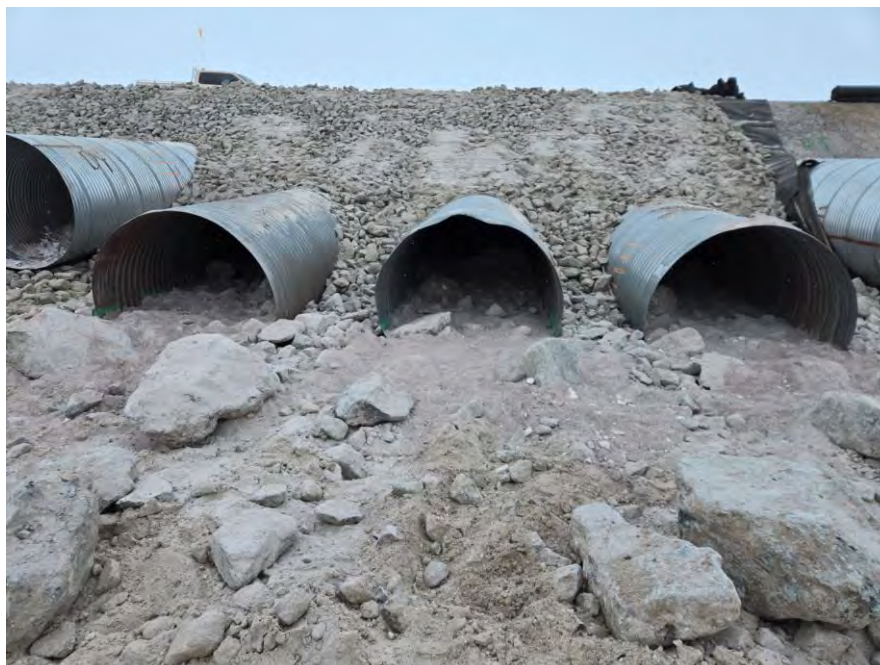
Photo 12 Outlet low flow CSP culverts and outlet apron area at CV-216. Photo taken May 3, 2024, facing southwest.

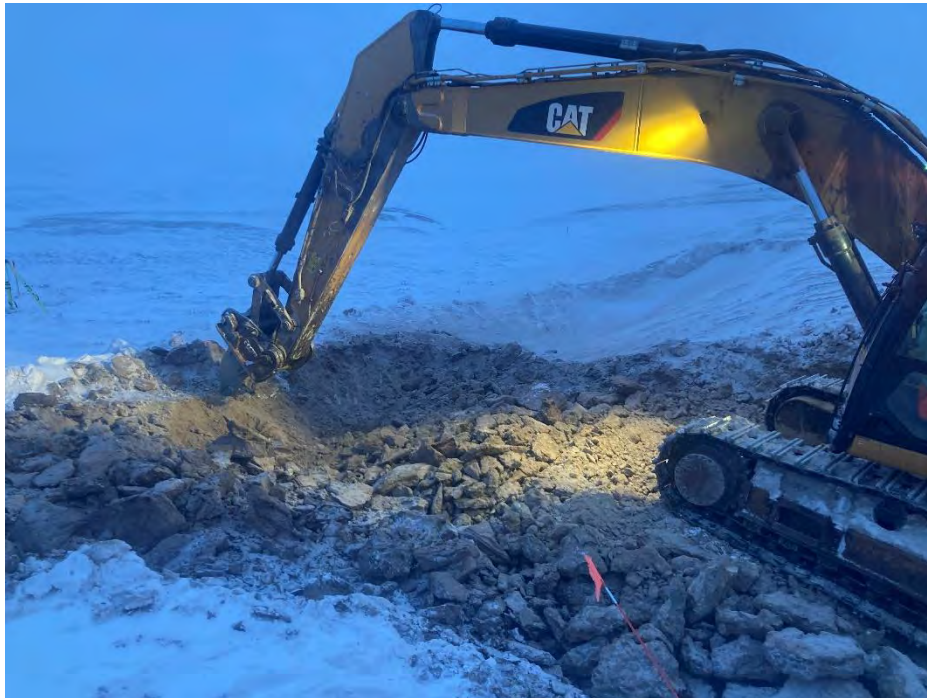
Photo 13 Ripping and excavation of the western outlet apron at CV-106. Photo taken May 3, 2024, facing northwest.

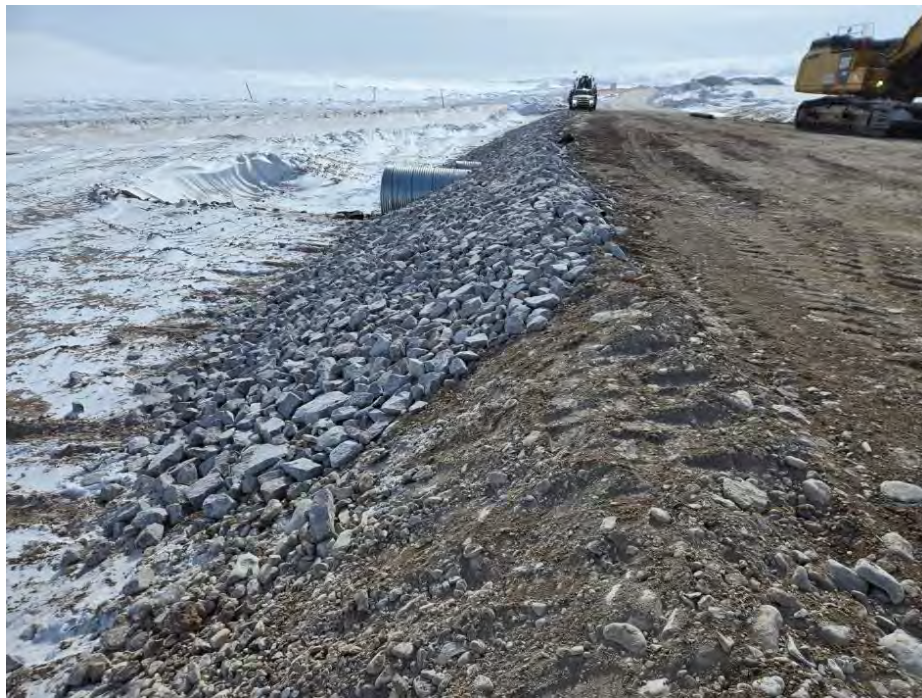
Photo 14 Eastern side slopes with geotextile and fine riprap placed at CV-102. Photo taken May 4, 2024, facing south.

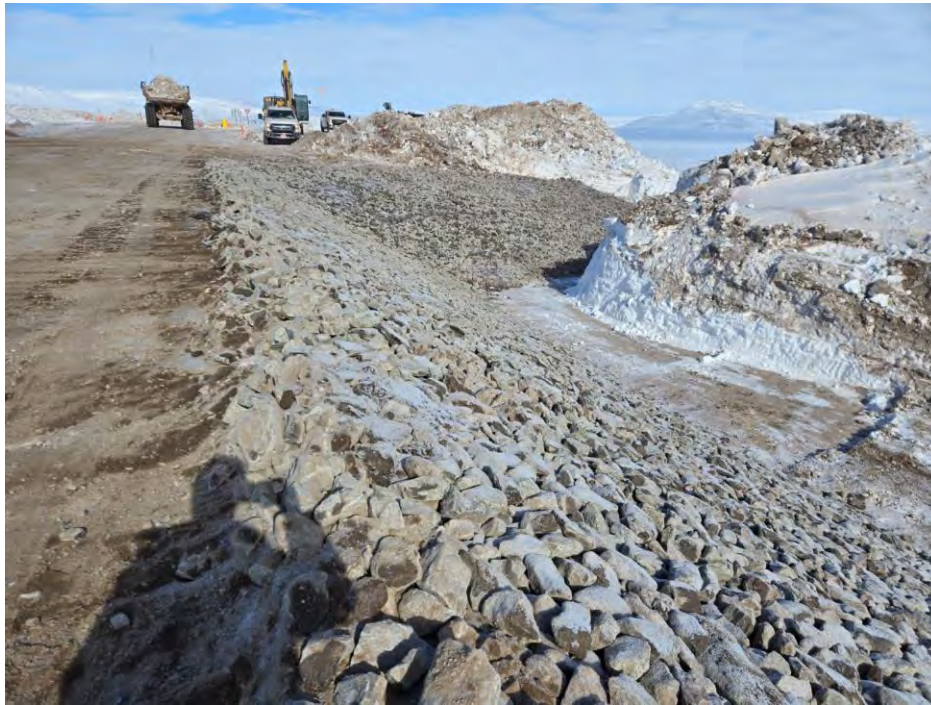
Photo 15 Northwest outlet apron side slopes stabilized with non-woven geotextile and fine riprap at CV-216. Photo taken May 4, 2024, facing northwest.

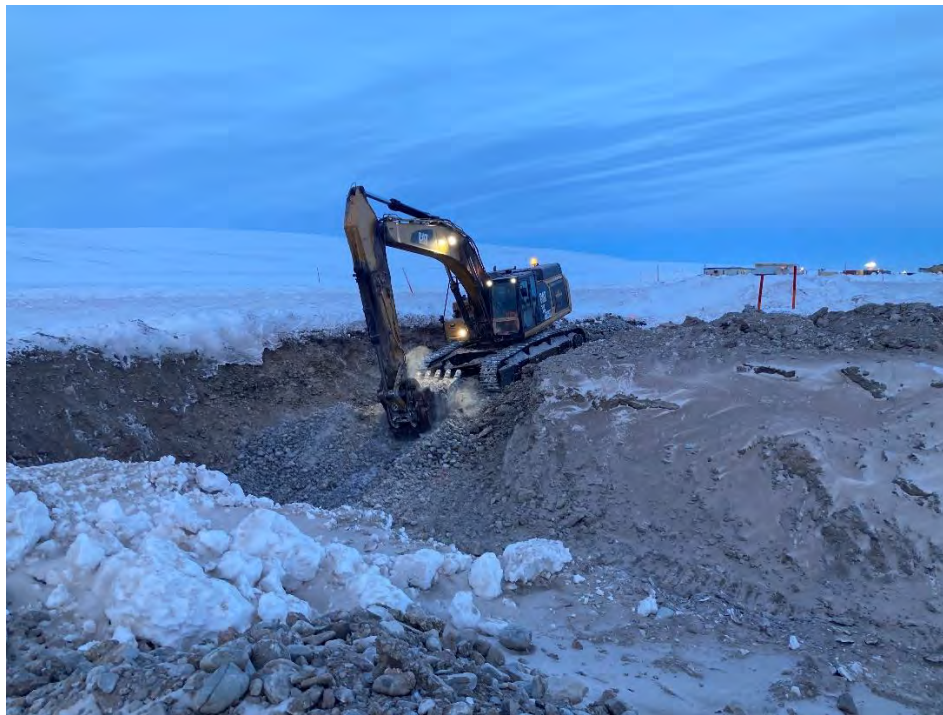
Photo 16 Excavation of unsuitable materials from the inlet apron area at CV-106. Photo taken May 4, 2024, facing southeast.

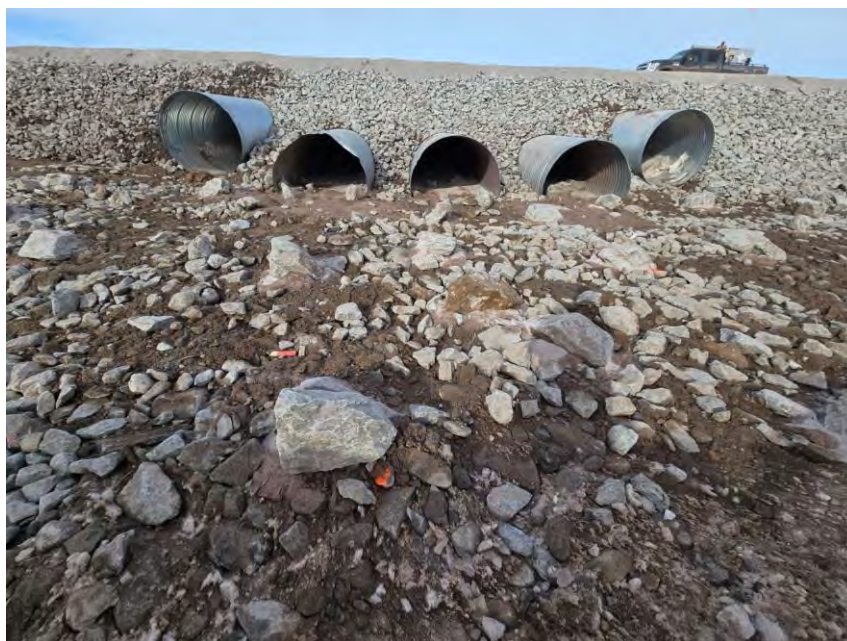
Photo 2 **Completed inlet apron area and culvert inverts at CV-216. Photo taken May 5, 2024, facing east.**

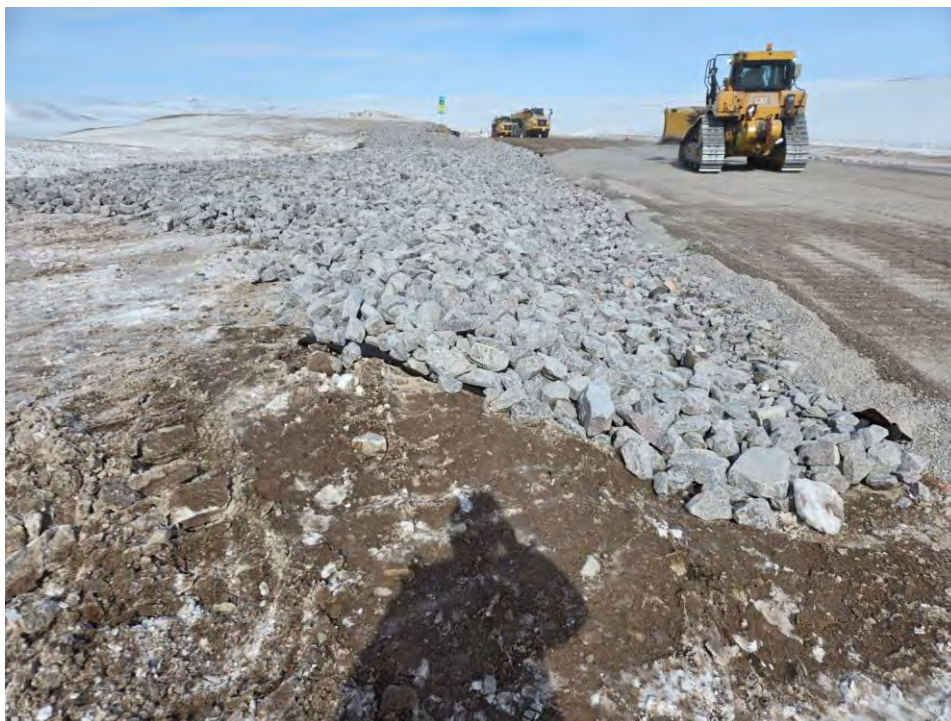
Photo 3

Completed non-woven geotextile and fine riprap slope stabilization placement at CV-102.
Photo taken May 5, 2024, facing north.

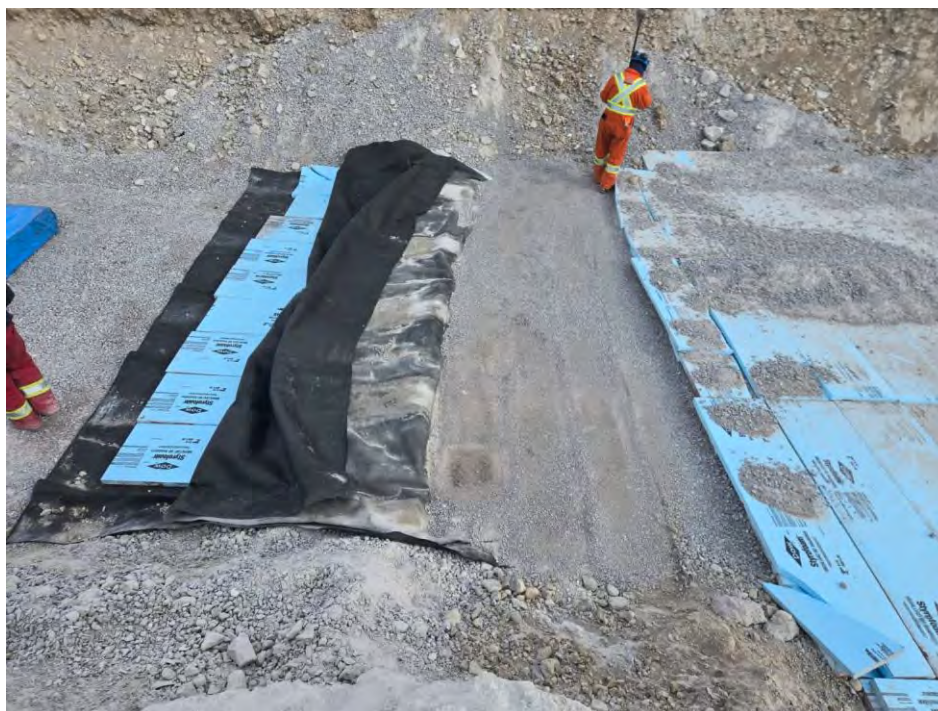
Photo 4

Placed and compacted 3/4 inch material in the inlet anchor-trench at CV-106. Photo taken
May 6, 2024, facing north.

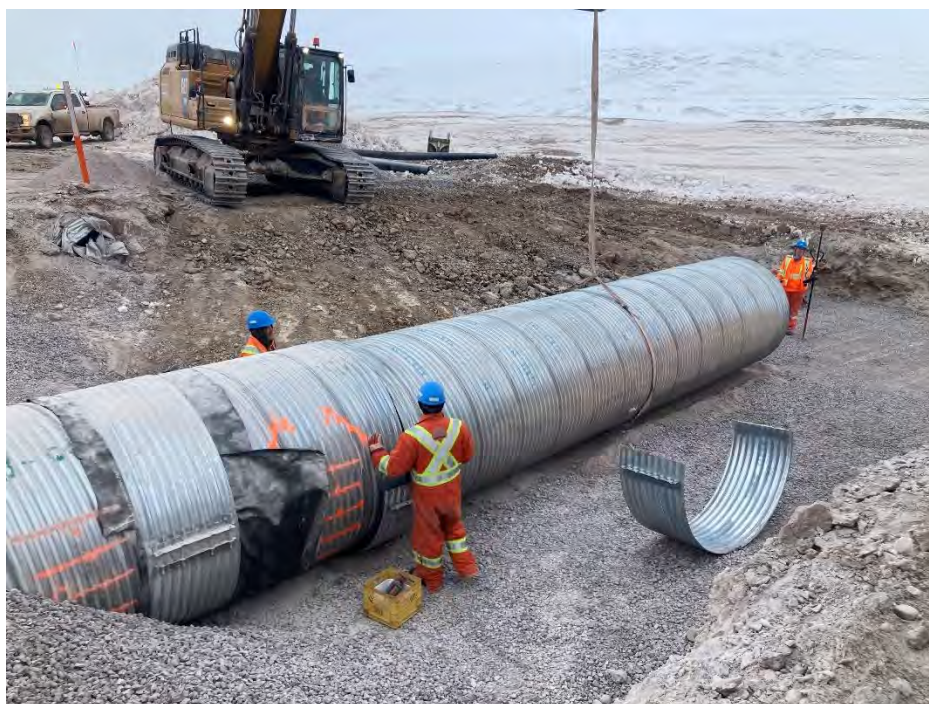
Photo 5 Installation of fourth and final 8.0 m long segment of the 1.8 m diameter low flow CSP culvert at CV-106. Photo taken May 6, 2024, facing southwest.
