MARY RIVER MINE

TOTE ROAD PERMANENT CROSSING PLAN - ROUND CSP CULVERT INSTALLATIONS

WEEKLY PROGRESS REPORT

WEEK 10 – April 14 to April 20, 2024

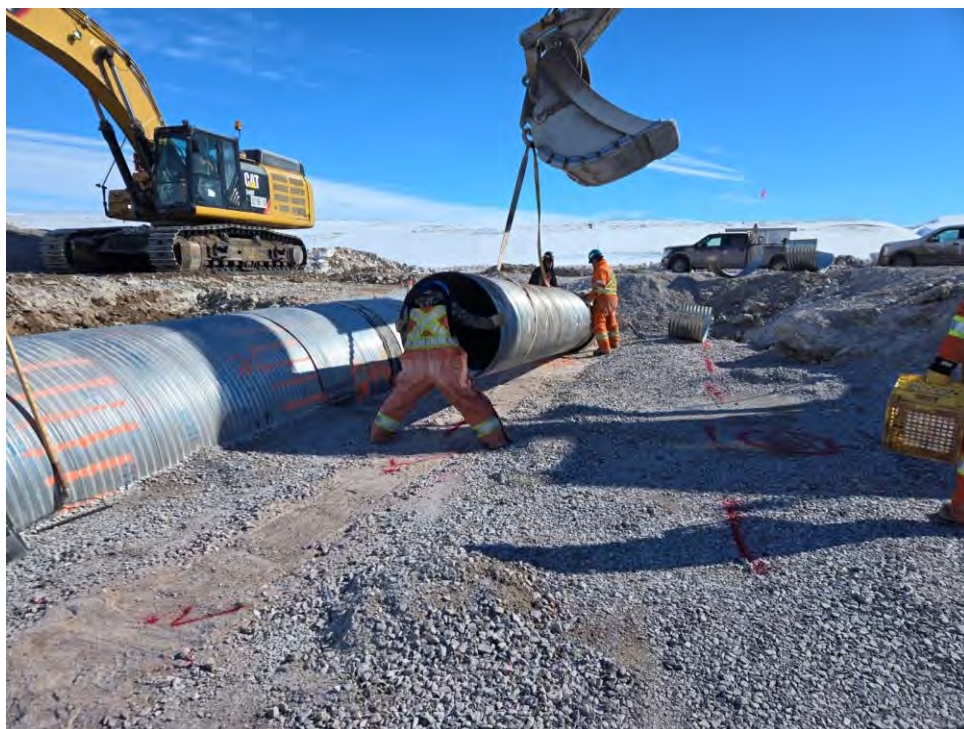
Photo 6 Installation of third segment of 1.0 m diameter high flow CSP culvert at CV-106. Photo taken May 7, 2024, facing east.

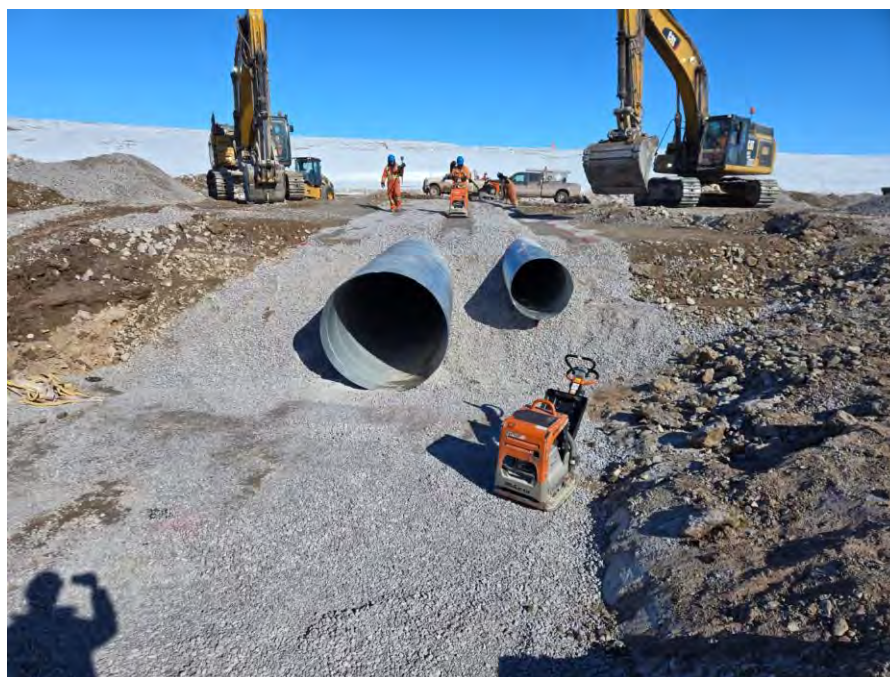
Photo 7 Compacting 32 mm minus material between low and high flow CSP culverts with uncompacted 150 mm zone above the culverts at CV-106. Photo taken May 7, 2024, facing east.

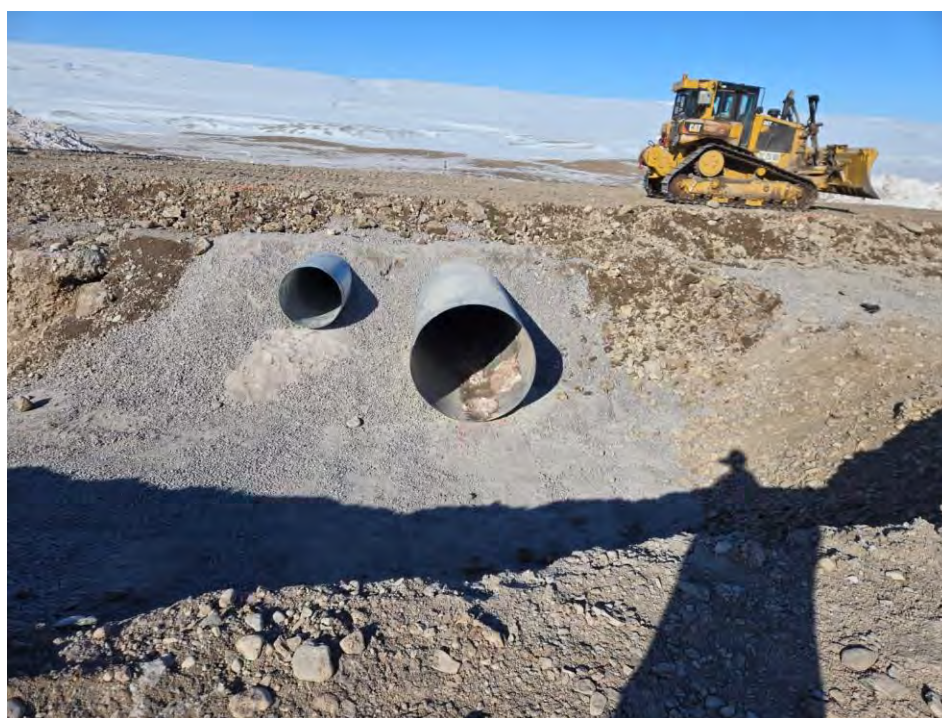
Photo 8 Placing local fill material above the compacted 32 mm minus material and constructing approach ramps at CV-106. Photo taken May 8, 2024, facing west.

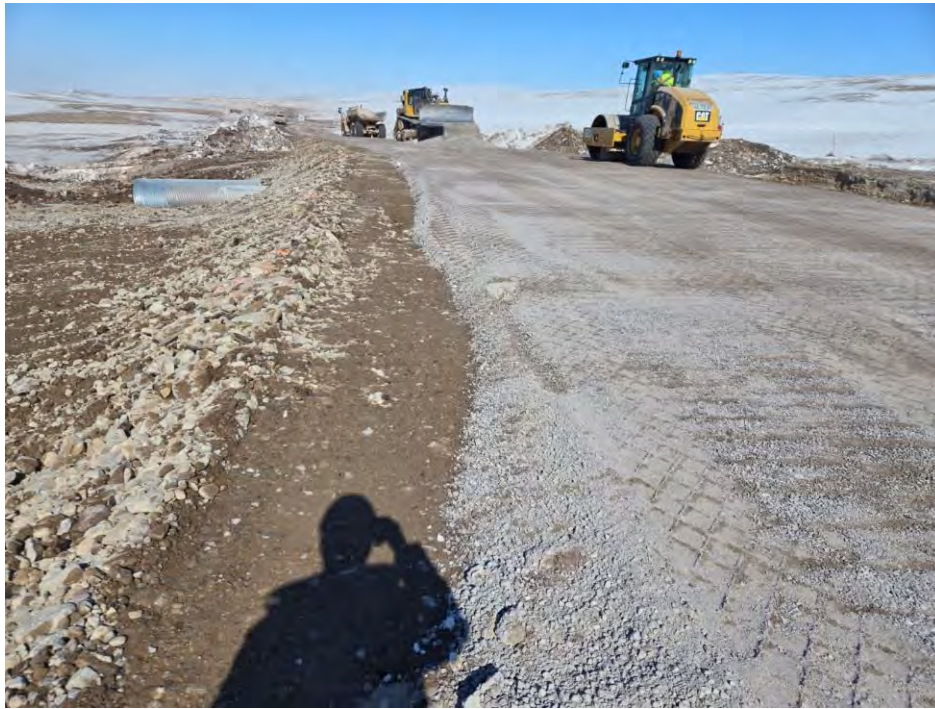
Photo 9 Placing and compacting 3/4 inch road topping material at CV-106. Photo taken May 8, 2024, facing north.

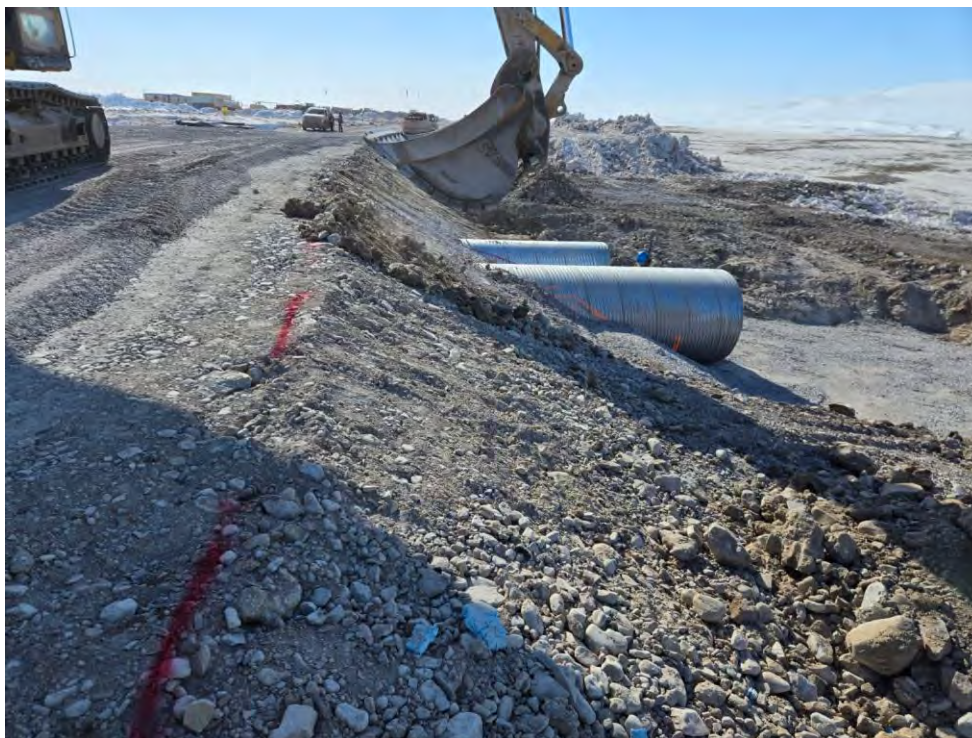
Photo 11 Grading 2H:1V side slopes at CV-106. Photo taken May 9, 2024, facing south.

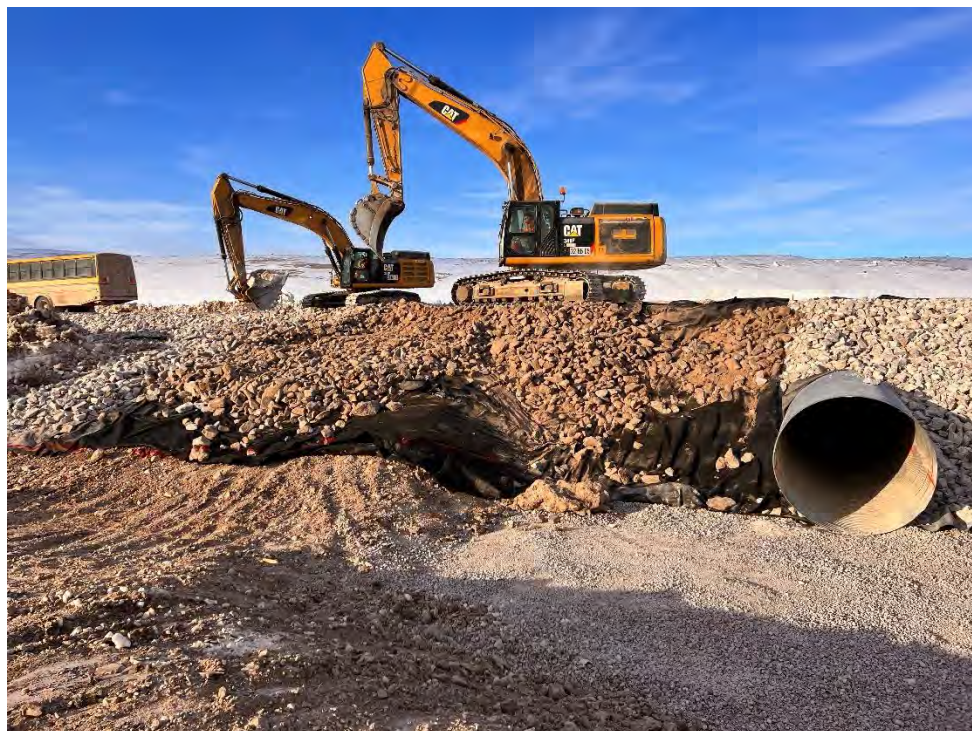
Photo 12 Placement of Fine Riprap on Non-Woven Geotextile on graded 2H:1V side slopes at CV-106. Photo taken May 10, 2024, facing east.

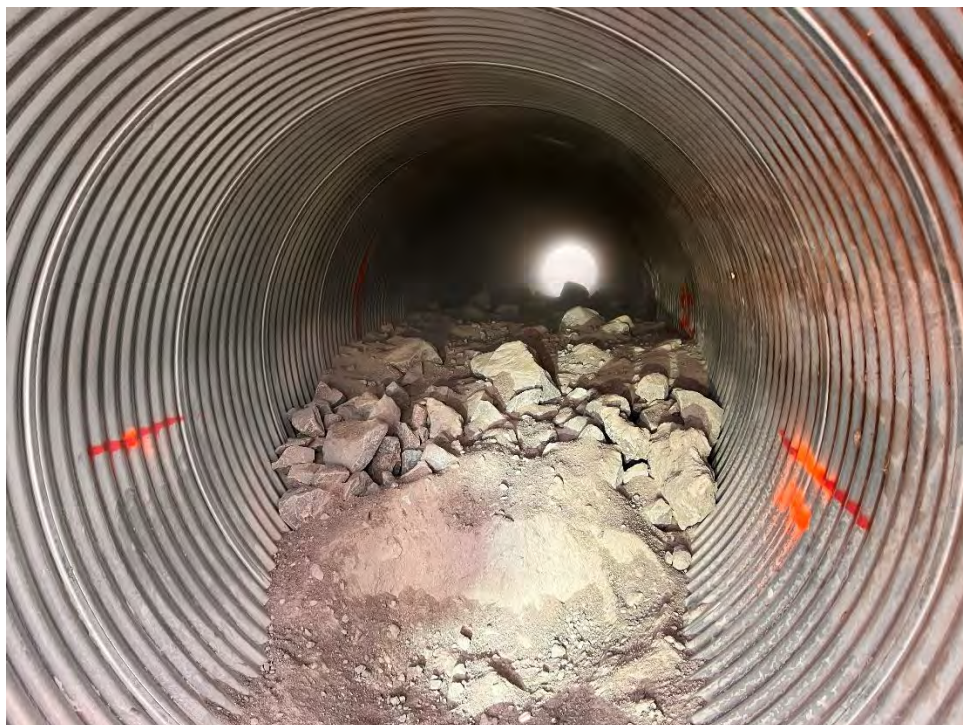
Photo 13

Progress of culvert infilling with Coarse Riprap and 3/16 inch material at CV-106. Photo taken May 10, 2024, facing downstream.

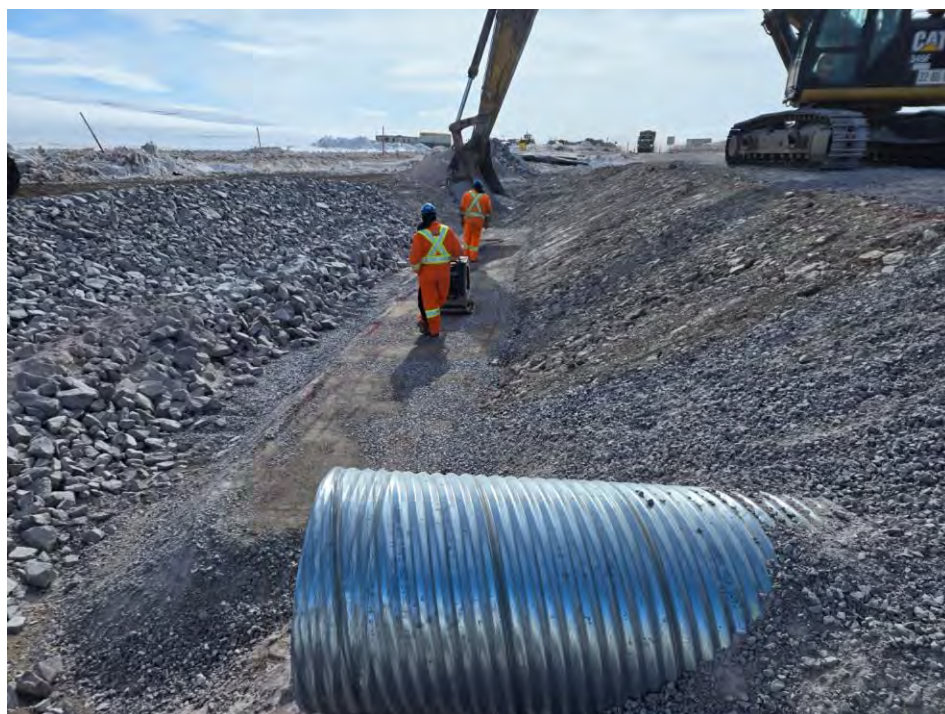
Photo 14

Compacting top of 32 mm minus material for the thermal berm along the inlet apron at CV-106. Photo taken May 11, 2024, facing south.

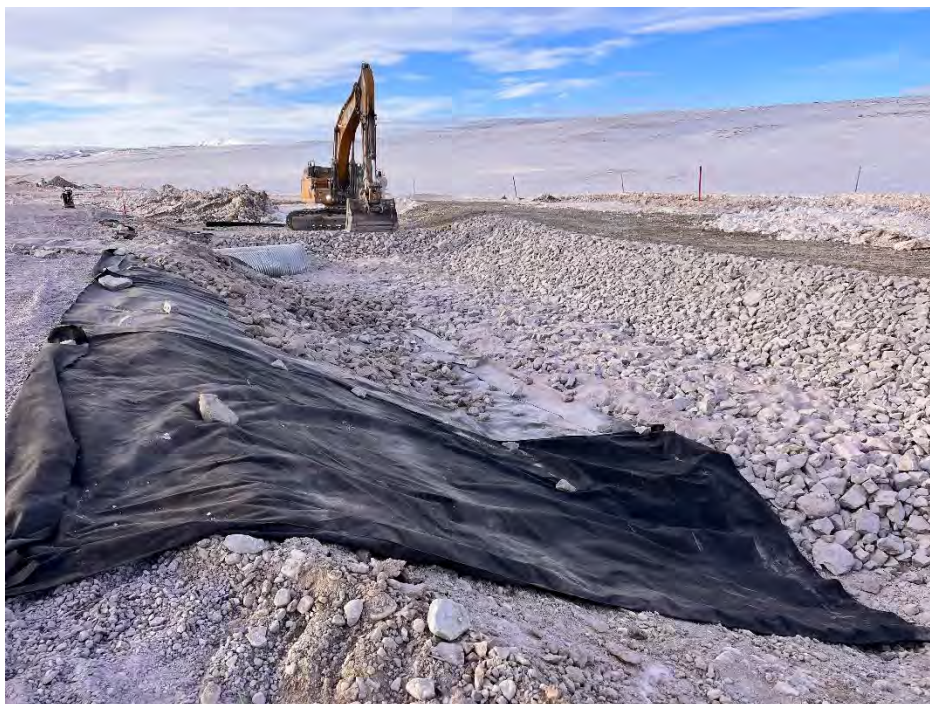
Photo 15 Non-Woven Geotextile placed on 2H:1V side slopes and thermal berm within the inlet apron area at CV-106. Photo taken May 11, 2024, facing north.

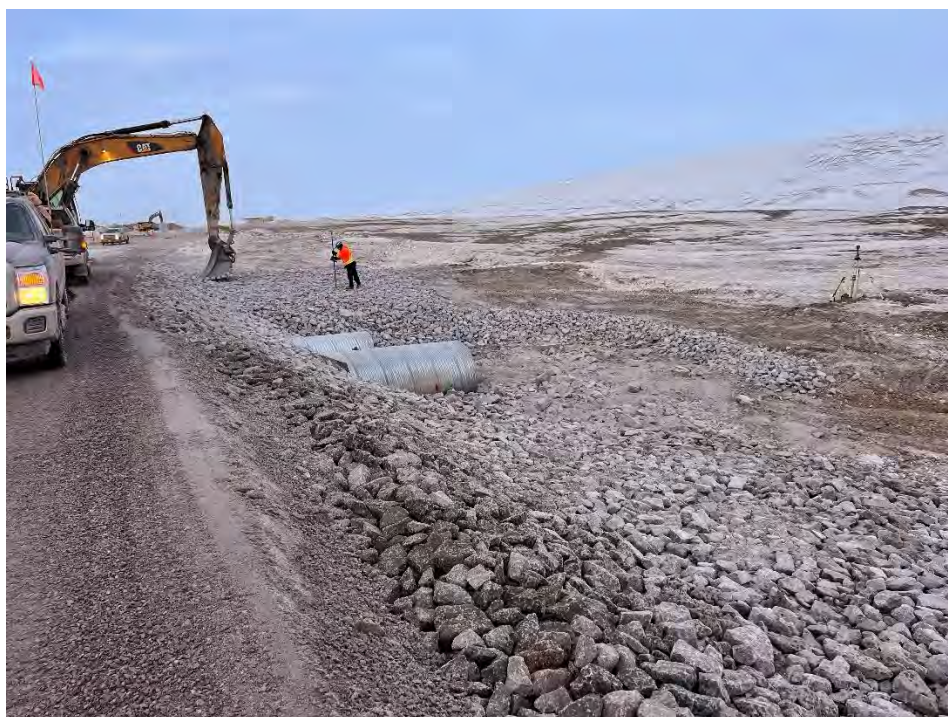
Photo 17 Outlet apron area infilled with Coarse Riprap and 3/16 inch material at CV-106. Photo taken May 11, 2024, facing south.

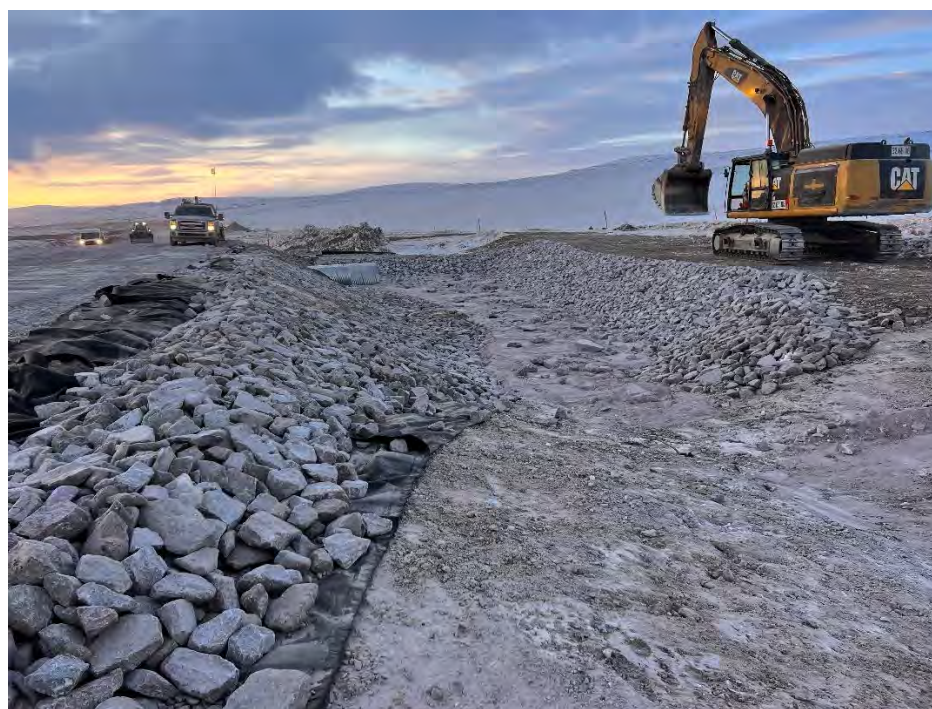
Photo 18 Inlet apron area infilled with Coarse Riprap and 3/16 inch material at CV-106. Photo taken May 11, 2024, facing north.
