APPENDIX C.2  
Geotechnical Inspection Report

**Submission of Annual Geotechnical Inspection – 2024, Mary River Project – Nunavut, Project # CA0039374.4332**

WSP Canada Inc., has completed the required geotechnical field inspection of 2024 at the Mary River Project, which is a condition of the Type “A” Water Licence No: 2AM-MRY1325 – Amendment No.1 (“Water Licence”).

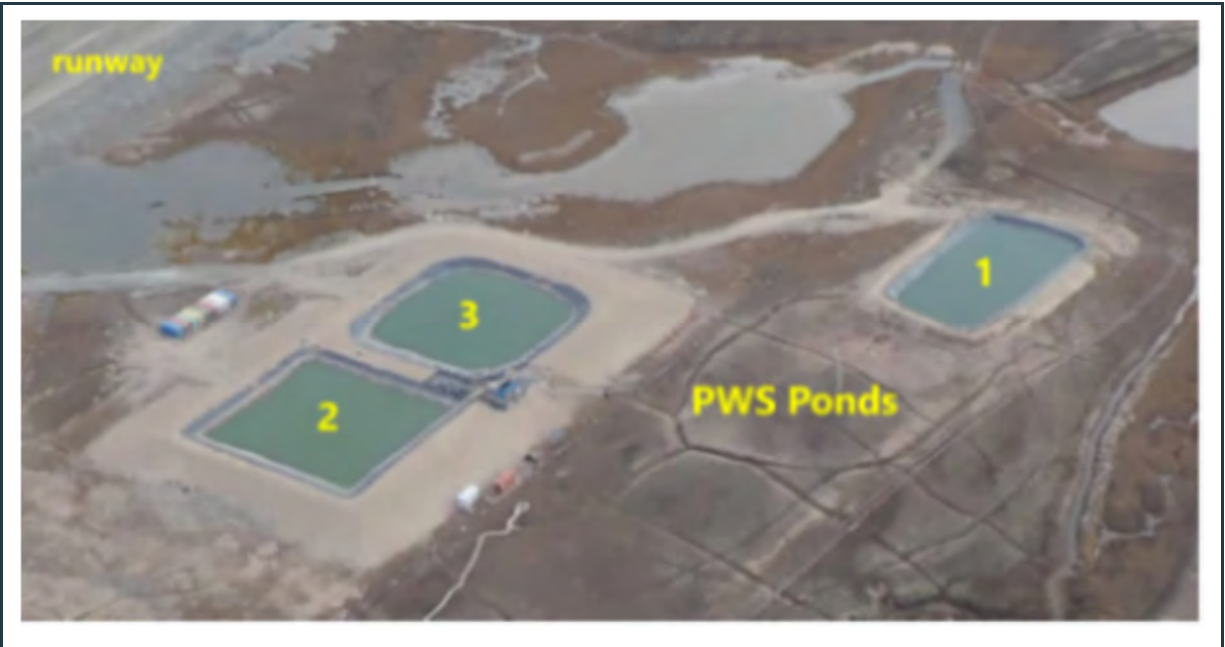
There are three (3) polishing waste stabilization (PWS) ponds, located adjacent to the airstrip, as shown in Figure 7. Pond #1 is a single structure, while Ponds #2 and #3 were constructed as twin-cells, as shown in Figure 13. The photograph in Figure 13 is a historic aerial image (taken by the author of this report in 2020) showing the robust and stable berms around the three stabilization ponds. As mentioned in previous inspection reports, these ponds were associated with the exploration phase of the mine, and currently serve as emergency holding ponds in case problems would arise, which would prevent the discharge of treated effluent directly to the receiving environment. The robust, stable berms around the ponds generally comprise granular materials (rock fill, sand, and gravel), with high density polyethylene (HDPE) geomembrane liners. No damage is visible on the membranes in the cells or on the upstream face of the slopes (see Figures 14 to 16).

Figure 13: Historical aerial image of the layout of the three PSW ponds with robust, stable berms.

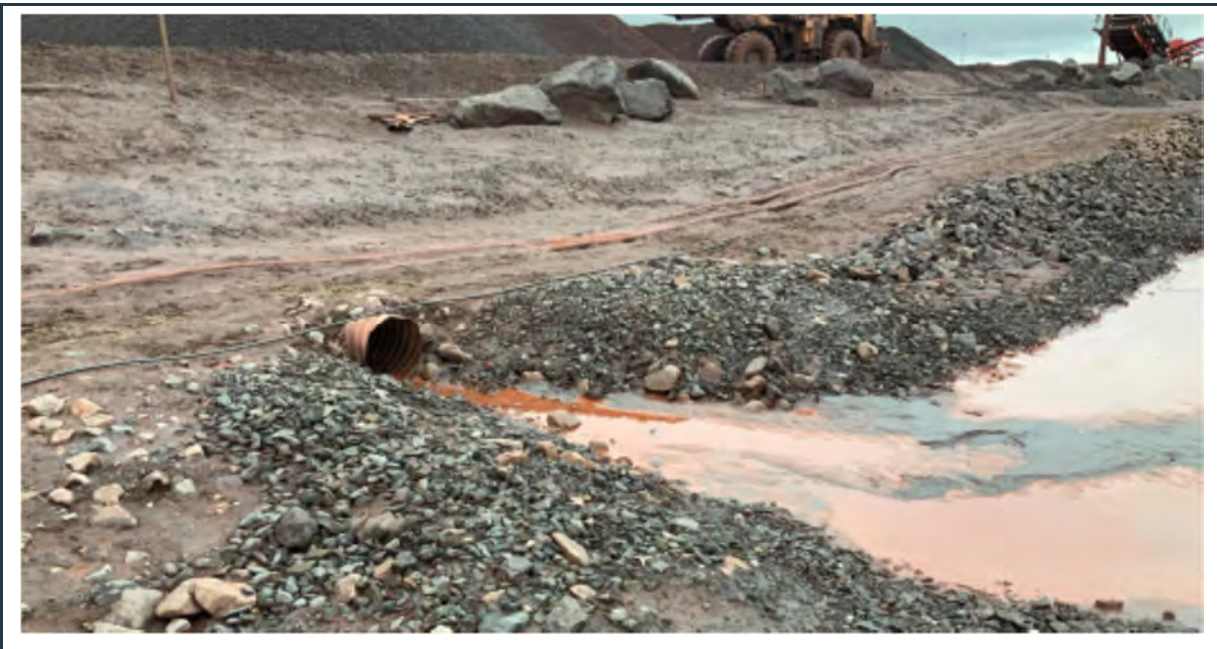
Figure 24: View of the discharge end of the recently cleaned culvert, draining the collected surface water from the crusher pad area to the MS-06 pond.

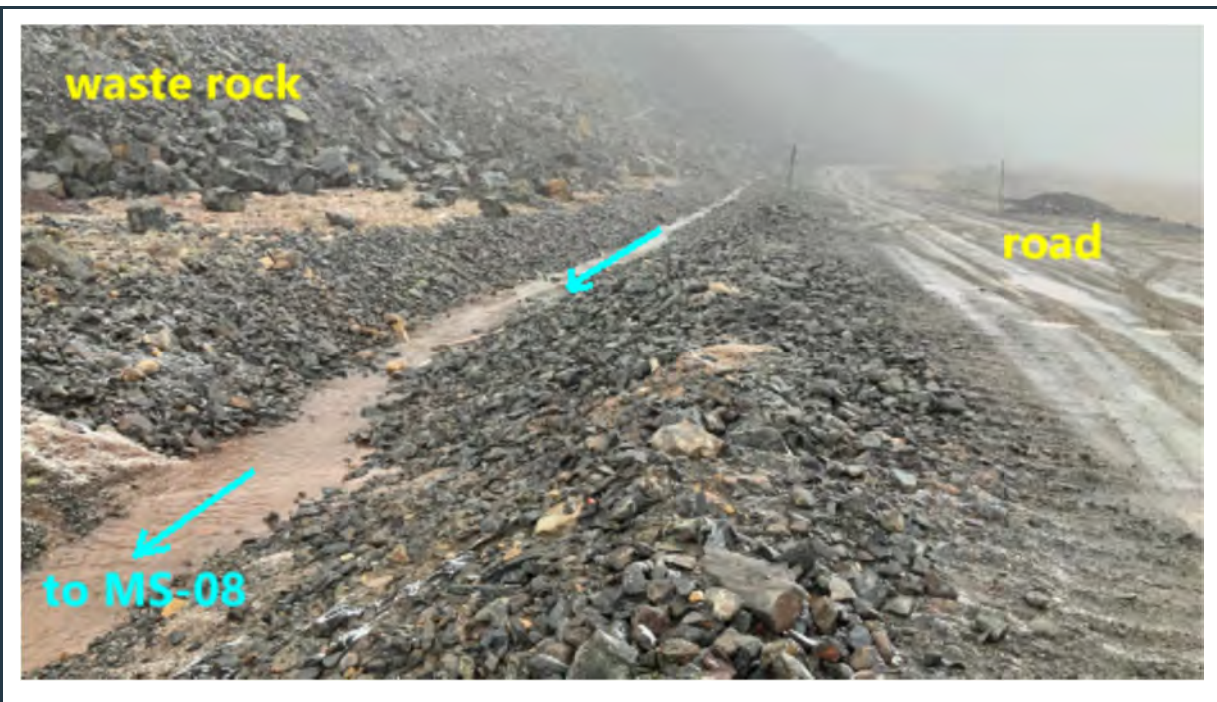
During the August 2024 inspection, the MS-08 pond was almost empty, as shown in Figure 28. Figures 29 and 30 show the well-maintained drainage ditches (east and west) around the waste rock storage facility, conveying the collected surface water to the MS-08 pond.

Figure 29: View of the well-maintained drainage ditch around the west side of the waste rock disposal facility, leading to the MS-08 pond.

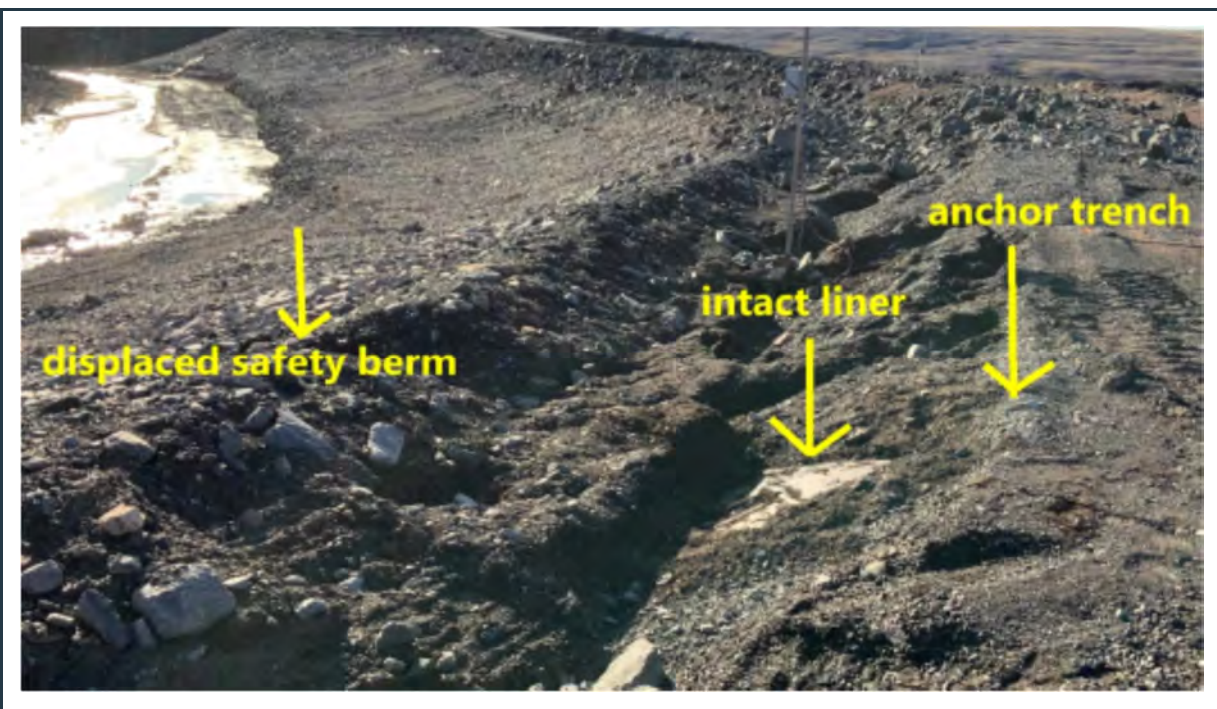
Figure 36 was taken during the recent site visit on August 26, 2024, which shows that the liner beneath the cover layers is still intact and anchored into the anchor trench at the top of the embankment's slope. This indicates that only the cover layers and the safety berm have moved (slipped) in June 2022, and that there was no "classical" slope failure within the embankment at the south pond. It appears that the embankment beneath the liner is stable, and the anchor trench is still at its original position along the edge of the crest (at road level), still supporting the liner as per the original design.

Figure 36: View of the displaced safety berm and the intact liner at the south pond (image was taken on August 26, 2024).

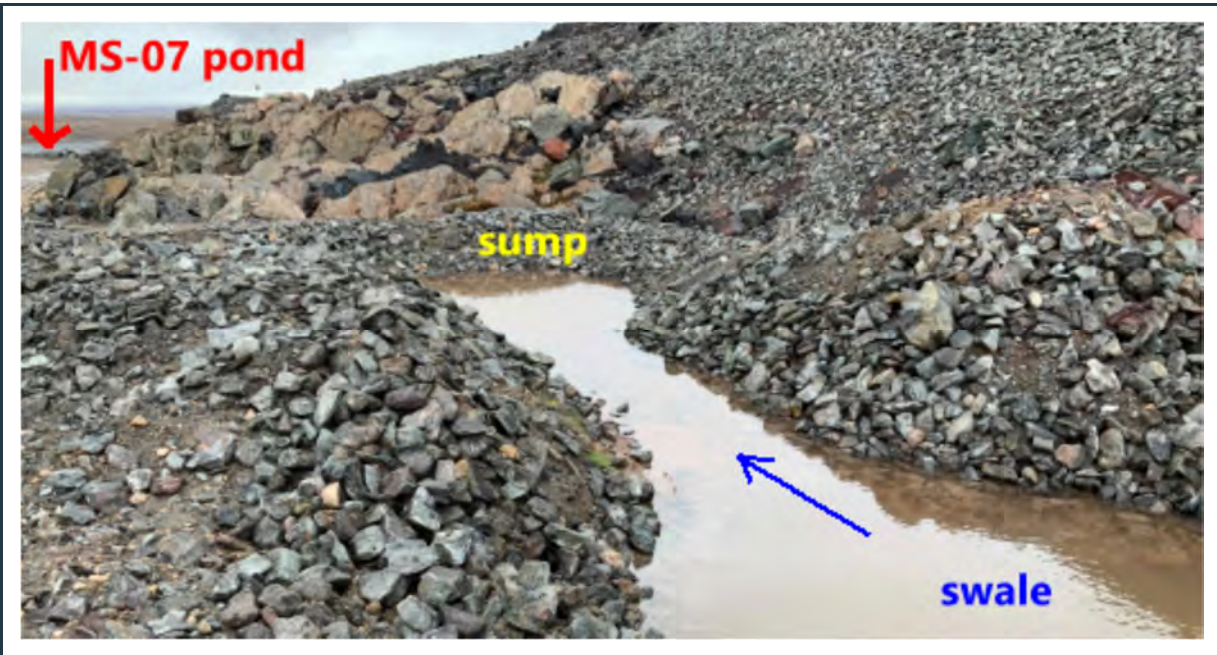
Figure 52: View of the new drainage ditch/swale and sump pit south of the KM-106 ore stockpile area, collecting local run-off. Note the recently completed riprap erosion protection along the sides of the swale and sump. Water from the sump is pumped into the nearby MS-07 pond.

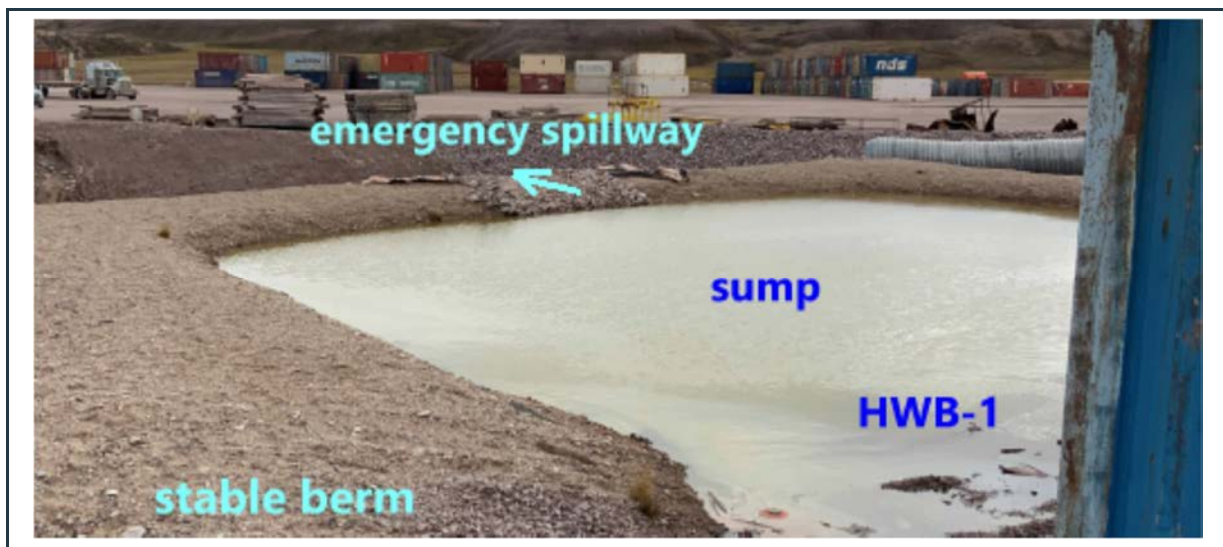
Figure 54: View of the sump and emergency spillway at the back of the HWB-1 cell with stable berm.

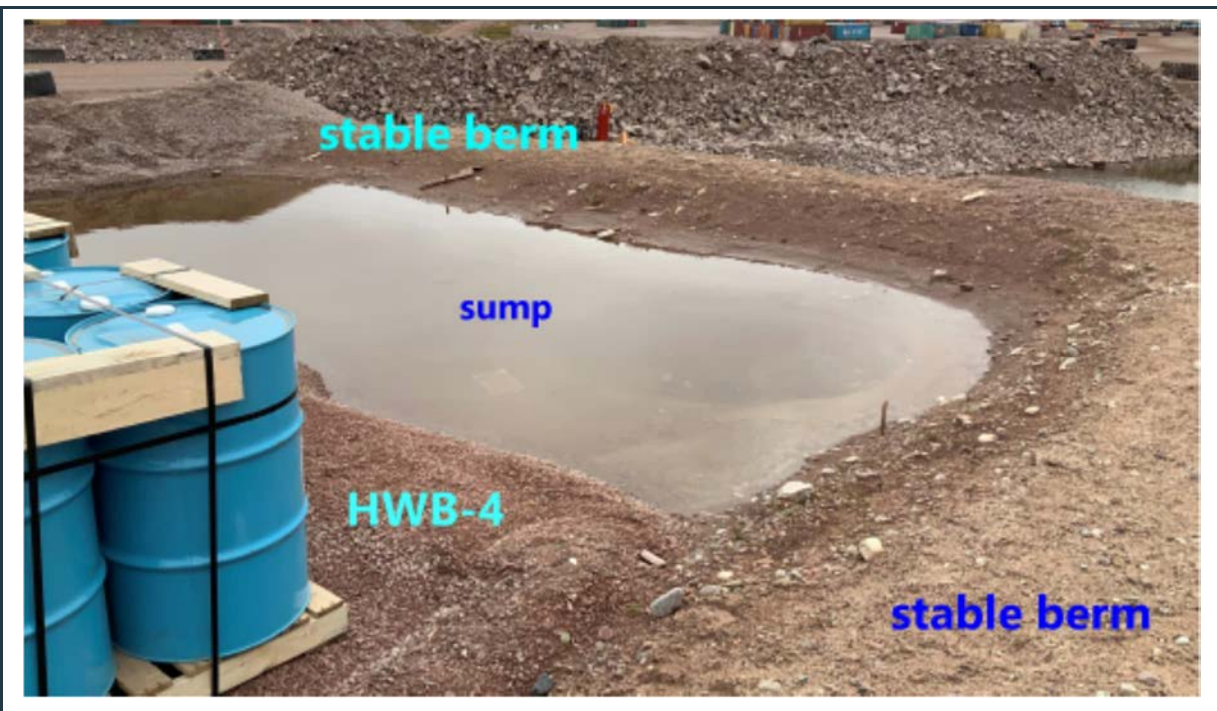
Figure 56: View of stable berm and the sump in the HWB-4 cell, storing jet fuel and shipping containers. Note the improved granular base within the cell, protecting the geomembrane liner.

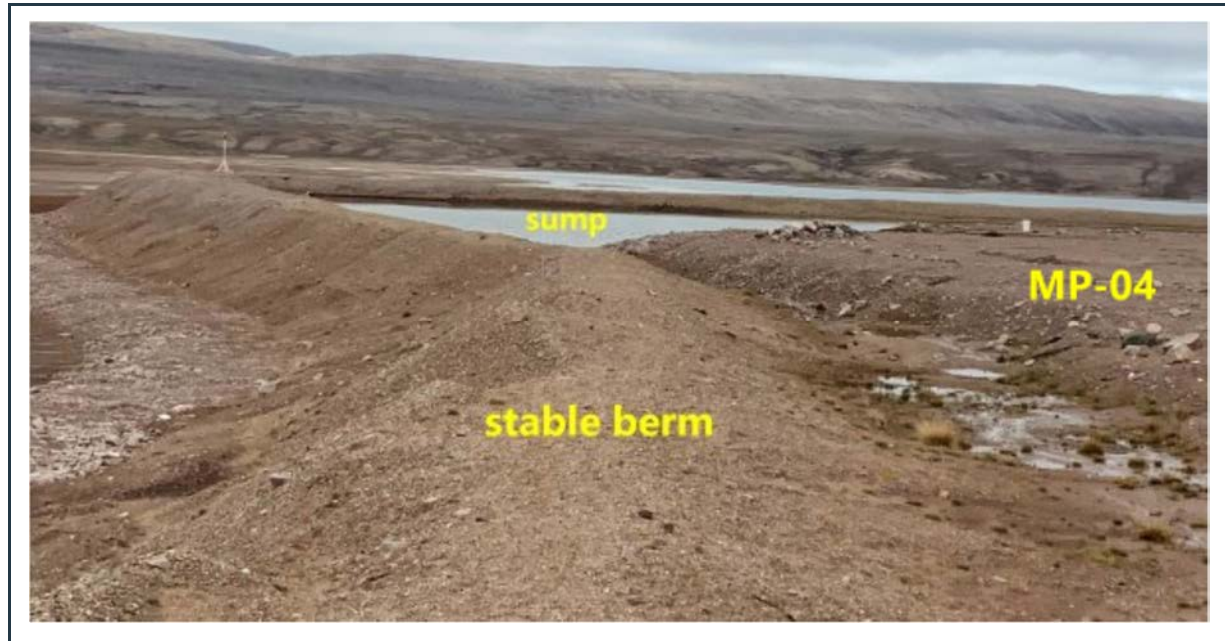
Figure 59: View of stable perimeter berm around the MP-04 landfarm, with ponding water in one corner of the cell (sump). Note the standard soil cover over the buried solid waste.

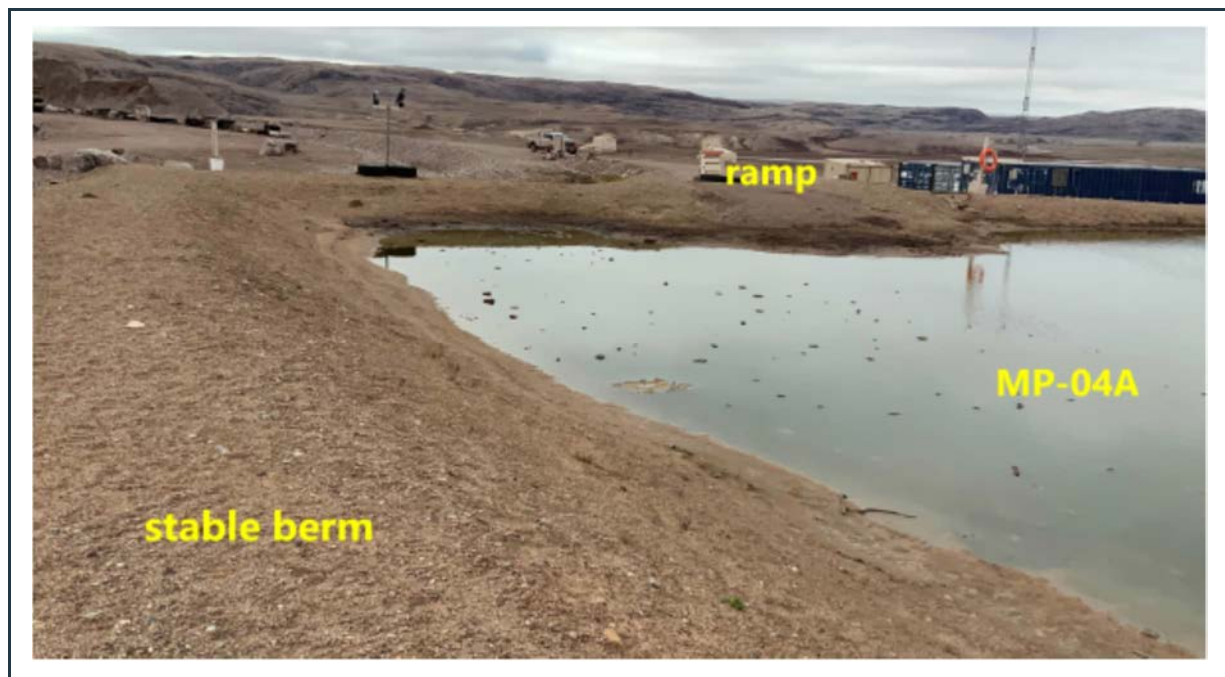
Figure 60: View of the lined MP-04A contaminated snow disposal cell with robust, stable perimeter berm. The ponding water (melted snow) indicates good liner performance. Additional protective layer of sand and gravel fill was placed recently over the access ramp.

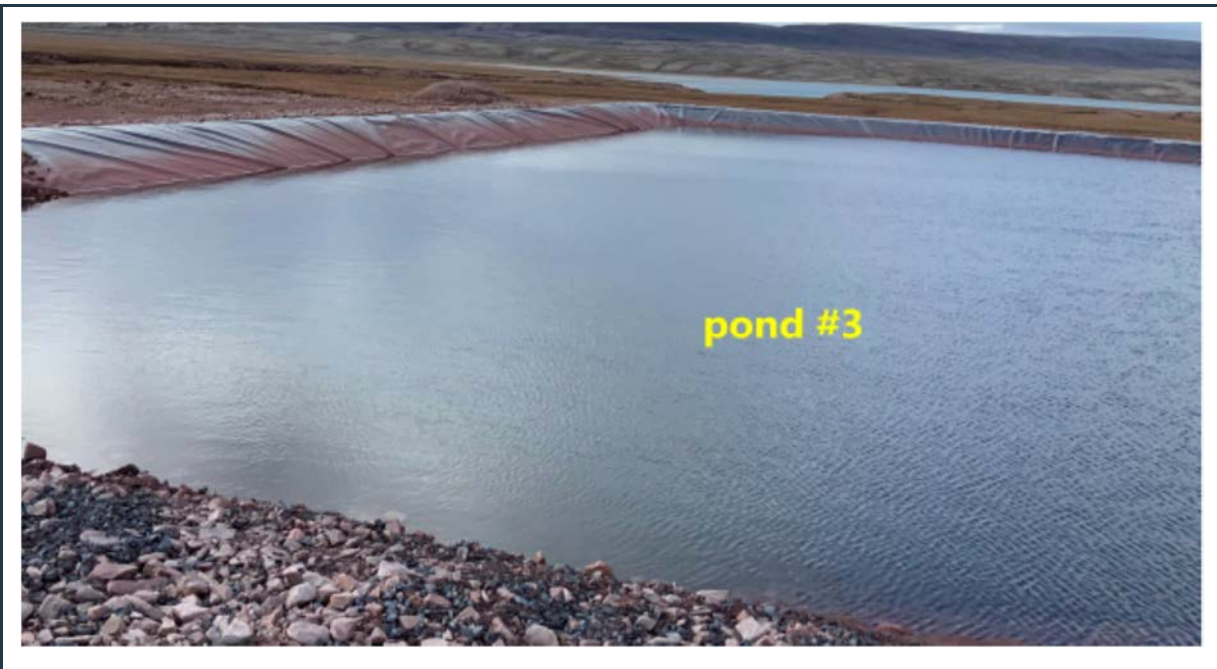
Figure 61: View of surface water management pond #3, with lined, stable berms.

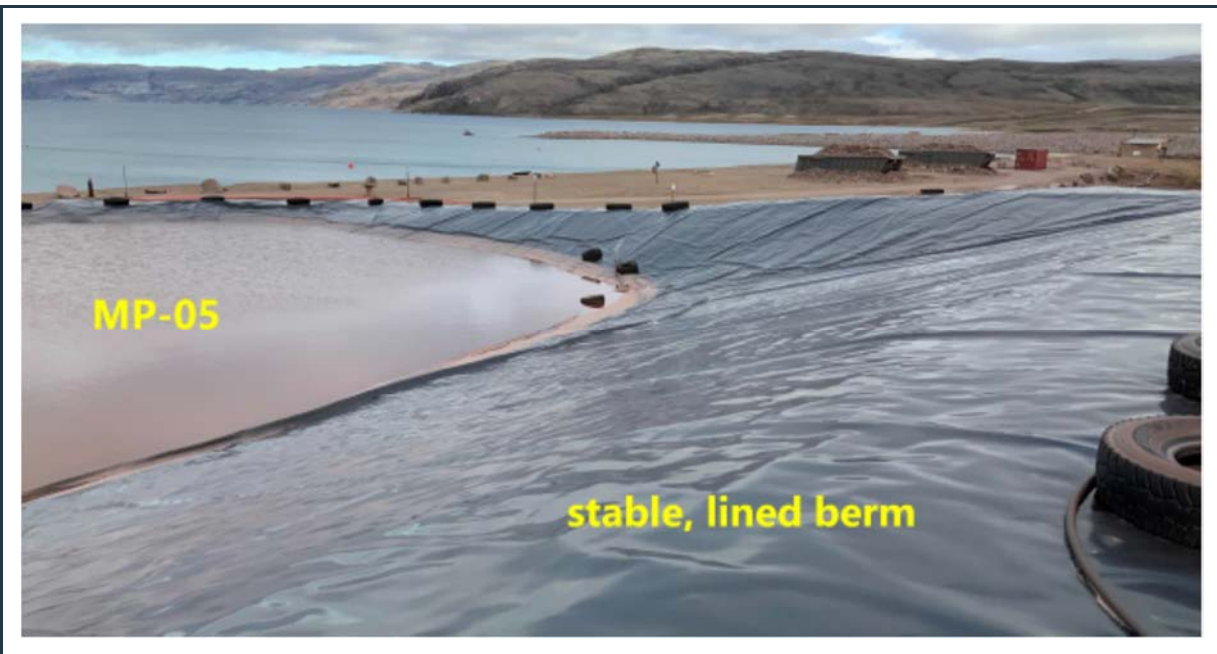
Figure 62: View of the robust, stable perimeter berm and intact liner at the MP-05 pond.

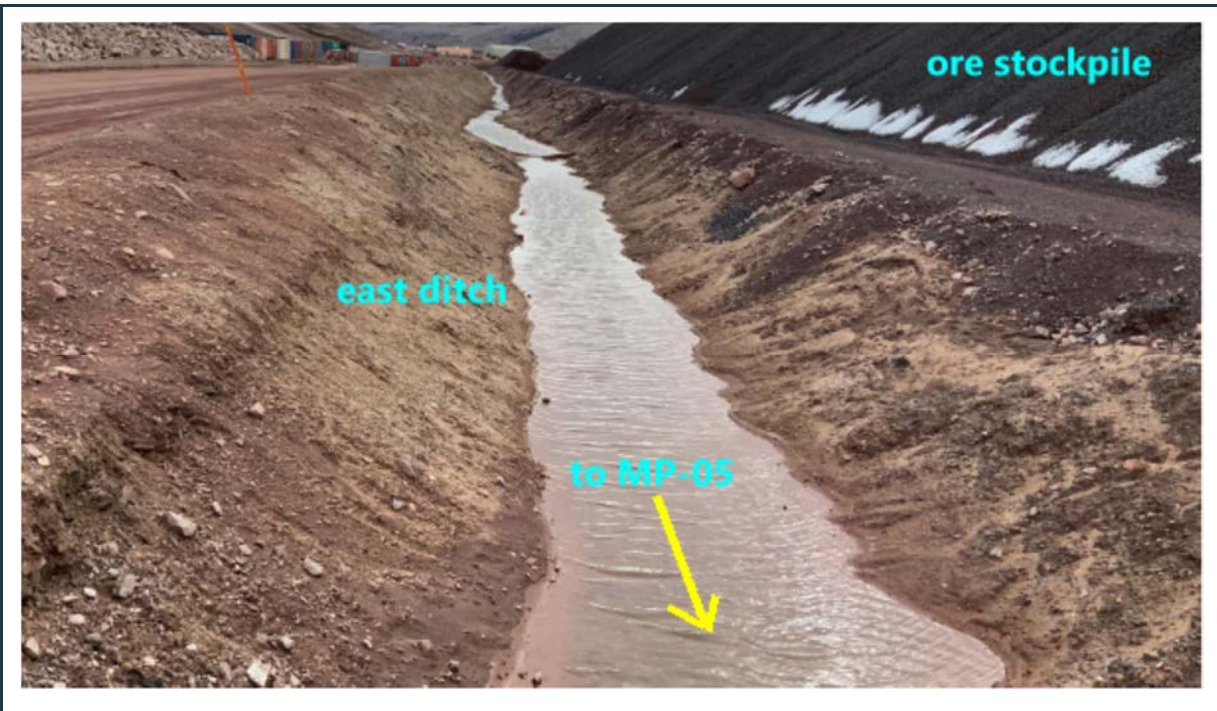
Figure 63: View of the “east” surface water collection ditch adjacent to the ore storage area, draining to the MP-05 pond.

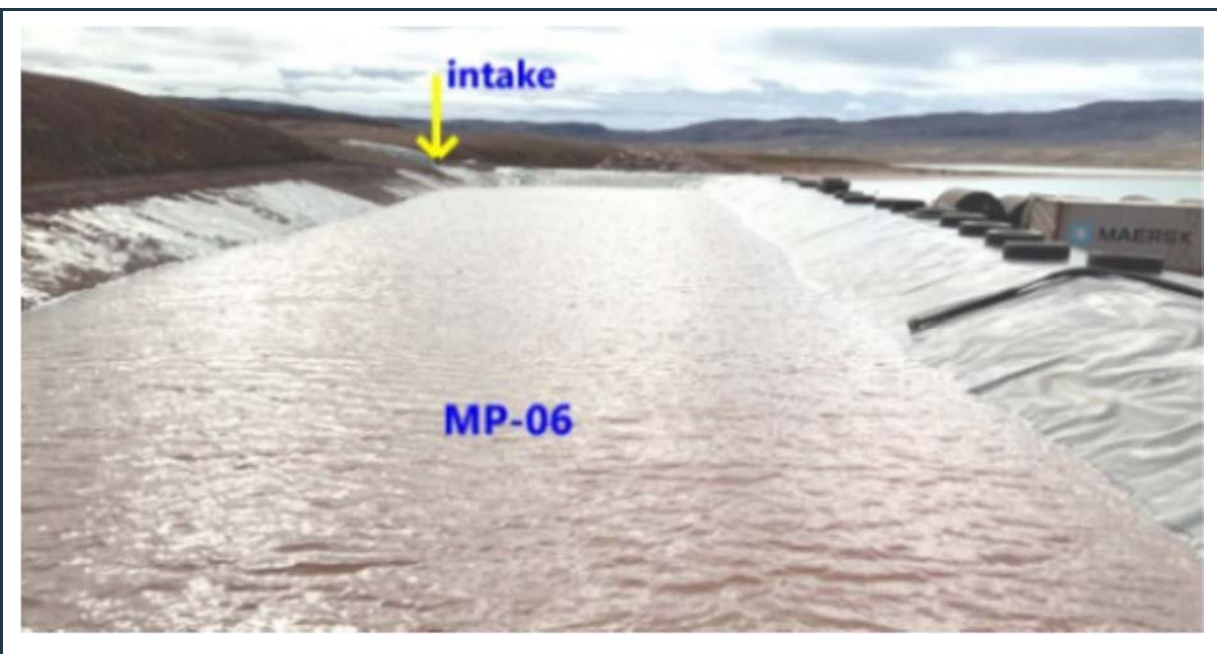
Figure 64: View of the lined MP-06 pond with robust, stable berms. Note the lined intake channel at the far-left end of the pond.

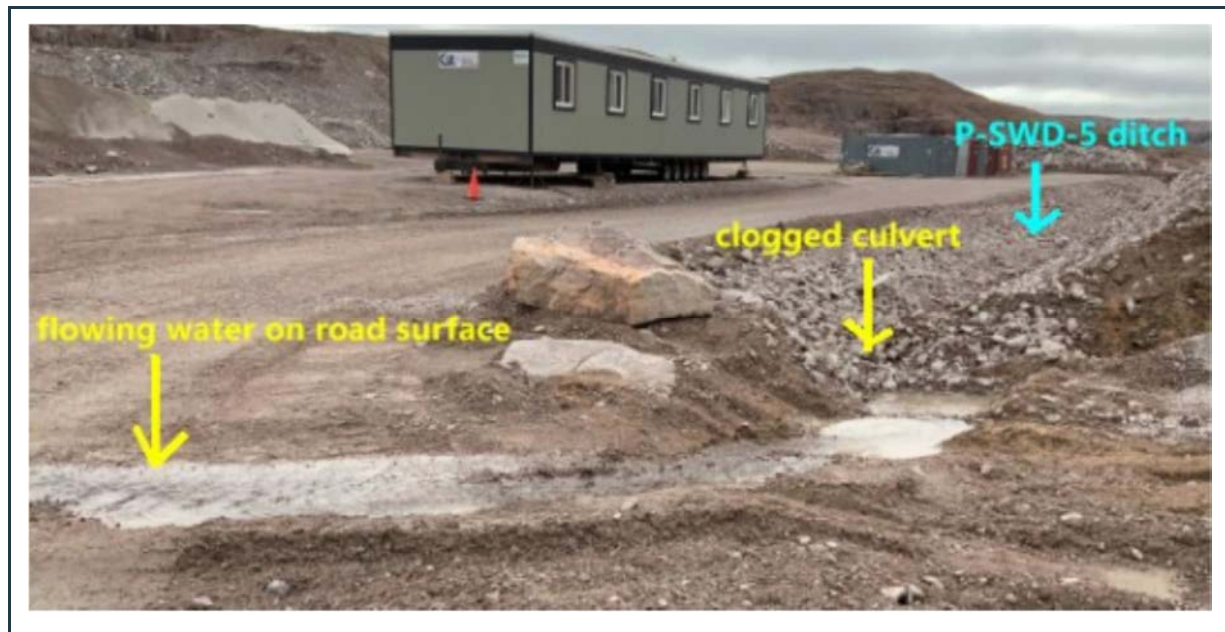
Figure 69: Poor surface water control in many areas of the lower (main) level of the Q01 rock quarry.

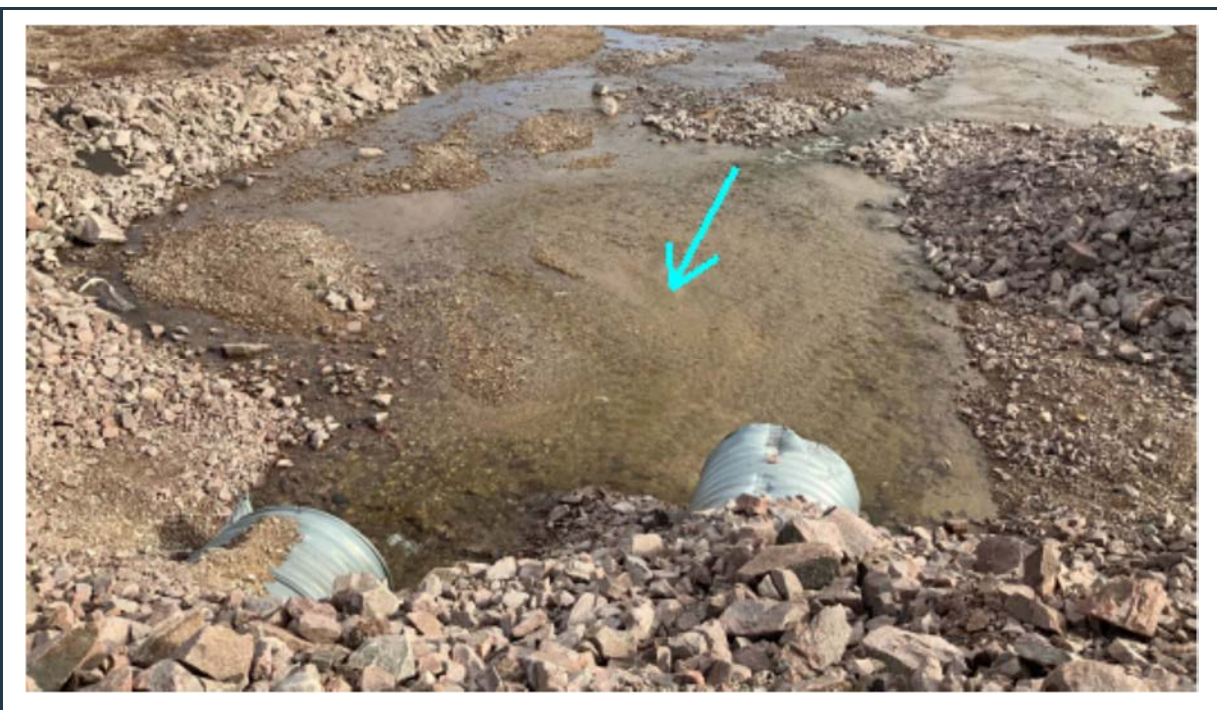
Figure 76: View of the P-SWD-7 surface water collection ditch and culverts (inlet).

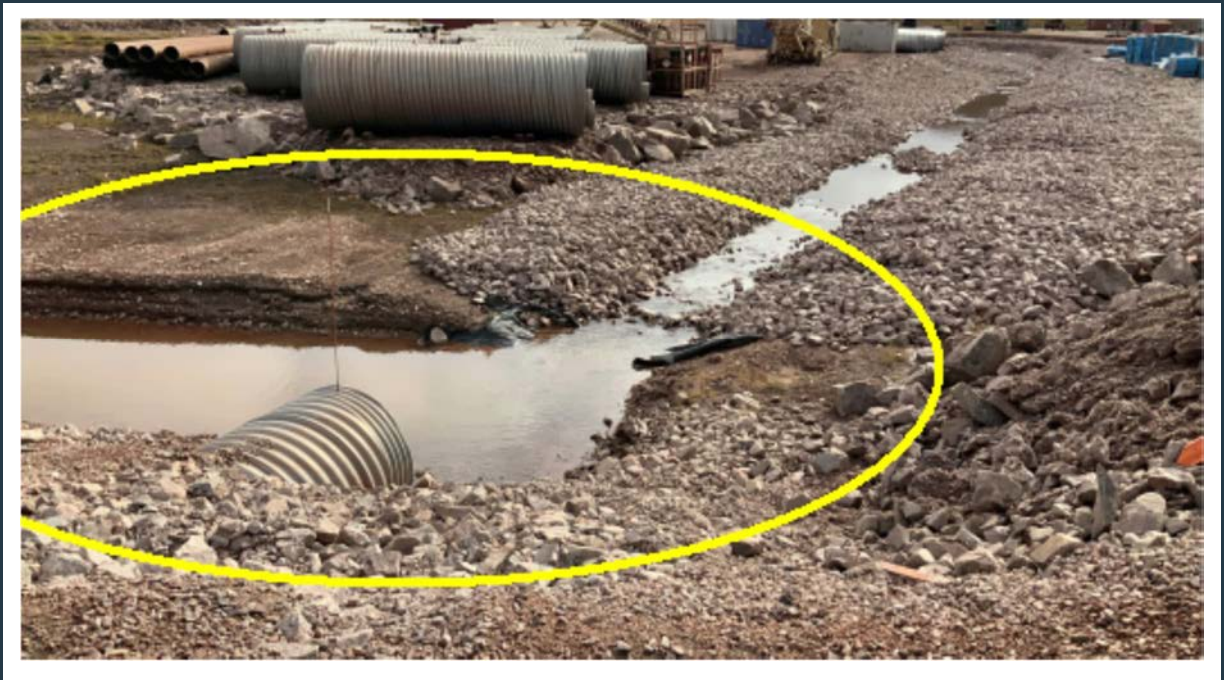
- Figure 78 shows the partially completed W3/W14 surface water collection ditch with crushed rock riprap slope protection. The area around the culvert's inlet and the side-ditch flowing from the left to the culvert, still requires the placement of geotextile and riprap for erosion protection.

Figure 78: View of the partly completed W3/W14 surface water collection ditch with crushed rock riprap slope protection. The area around the culvert's inlet and the side-ditch from the left still require the placement of geotextile and riprap for erosion protection.

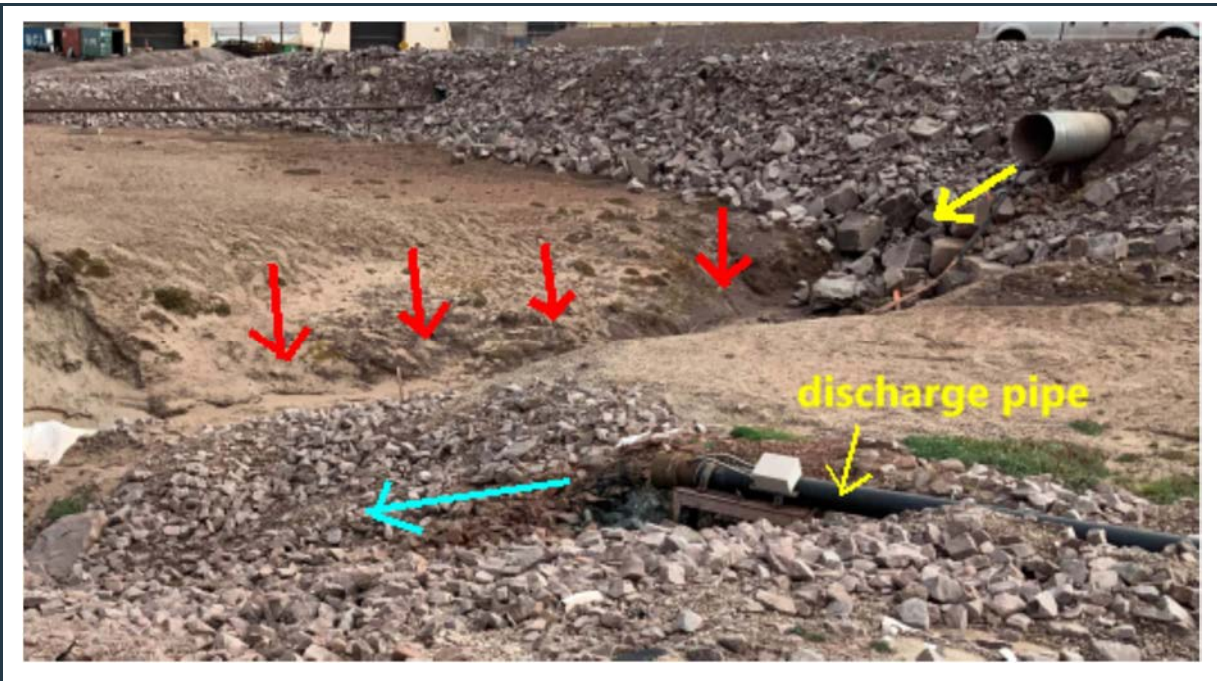
The discharge end of the effluent water pipe in the Port is located just north of the fuel storage facility, as shown in Figure 8. The slope in the immediate vicinity of the discharge point is covered with riprap; however, deterioration of the adjacent slopes of the valley, comprising native sandy and silty soils, is visible as marked by the red arrows in Figure 85.

Figure 85: View of the end of the water discharge pipe (blue arrow) and a nearby culvert (yellow arrow) draining water to the same valley. More ripraps should be placed into the upper section of the valley, marked by red arrows, to prevent erosion of the valley floor and side-slopes.

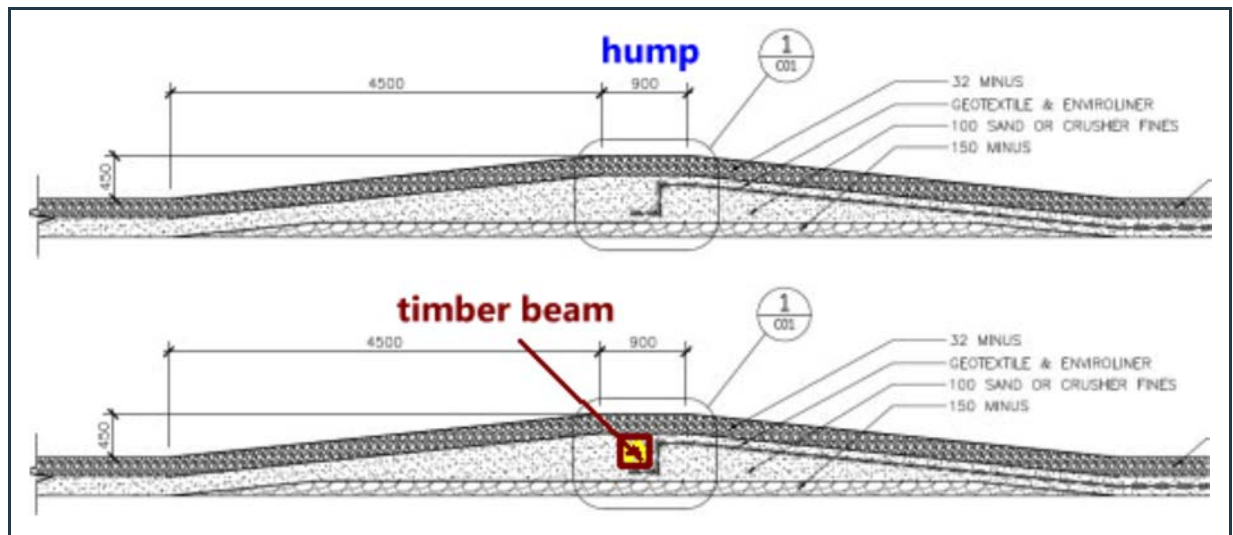
Figure 88: Top image: Section of 900 mm wide (at its crest) drainage control hump with 10H:1V slopes for the Western Globe Fuel Module (WGFM), specified by B.H. Martin Consulting Engineer and Architect, in June 2016. Lower image: A 10" by 10" timber beam should be installed within the humps to prevent the flattening of the granular fill by the heavy trucks. The humps should prevent potential oily surface water escaping the refueling area toward the ends of the WGFM.

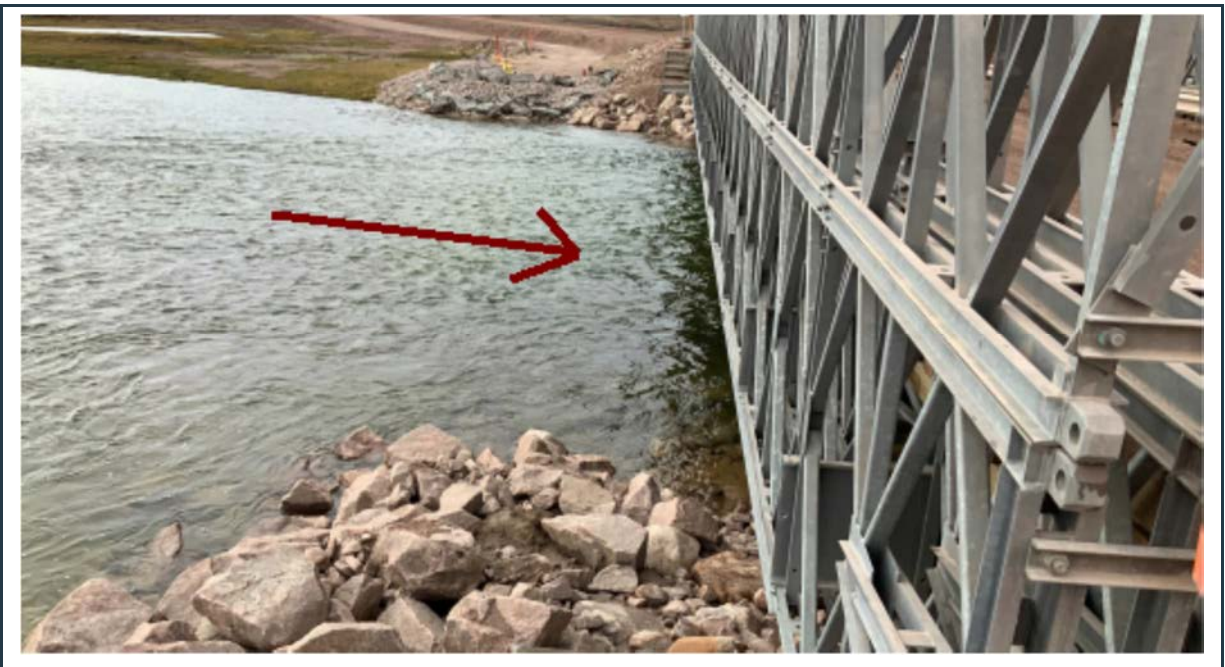
As shown in Figure 89 and Figure 90, the abutments and approach embankments at this bridge appear to be stable, and no scour was noted in the riverbed around the abutments during the August 2024 site visit. The abutments show no visible differential settlement or any structural discrepancy like deterioration of the steel bolt-a-bin abutments or sloughing of the riprap rock fill.

Figure 90: View of the stable abutments with riprap scour protection at the south side of bridge KM-17.

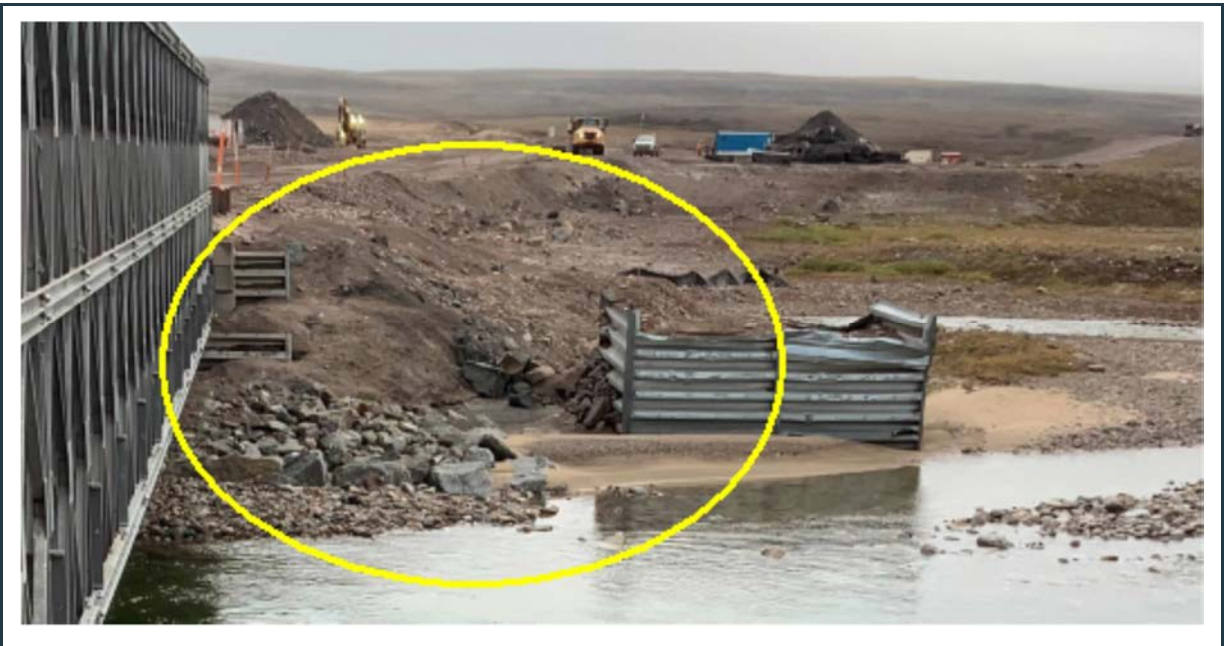
As shown in Figures 97 to 100, the abutments of this bridge appear to be stable and no scour in the riverbed around the foundations and approach embankments was noted during the August 2024 site visit. The abutments show no differential settlement or any structural discrepancy like deterioration of the foundation bins. There are areas at two locations, shown in the zoomed-in Figures of 98 and 100, where some additional rock fill should be placed over fine soils at the surface, to prevent erosion and migration of the finer material into the river.

Figure 98: View the enlarged image of the area between the old and new abutments (yellow circle) where additional rock fill should be placed for erosion protection.

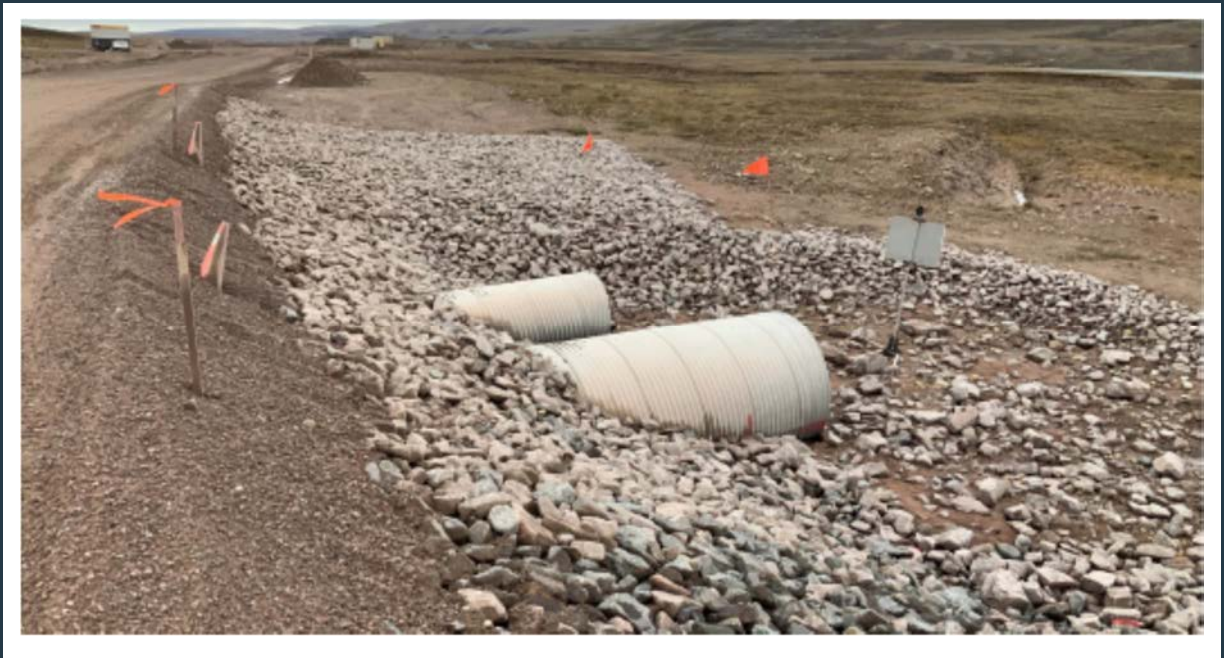
Figures 104 and 105 show the inlet and outlet of the twin culverts at KM 33+100. No water was flowing through the culverts during the August 2024 inspection. It was noted that some sagging of the corrugated pipes beneath the road has occurred at these culverts. It is likely that the subgrade beneath the culverts included ice-rich, thaw-unstable soils. Heat, transferred to this type of subgrade through the pipes during the start of the summer had resulted in thawing of the ice-rich soil, which in turn has resulted in the sagging (differential settlement) of the pipes under the weight of the road embankment. There is potential that these culverts will need to be reinstalled after the removal of the upper zone of the thaw-unstable ice-rich soil. The new culverts will need to be placed over thaw-stable, compacted granular fill as pipe bedding, with a thickness of at least 1.5 m.

Figure 105: View of the outlet of the twin culverts at KM 33+100. No water was flowing through the culverts that show some sagging in their centre, under the weight of the road embankment.

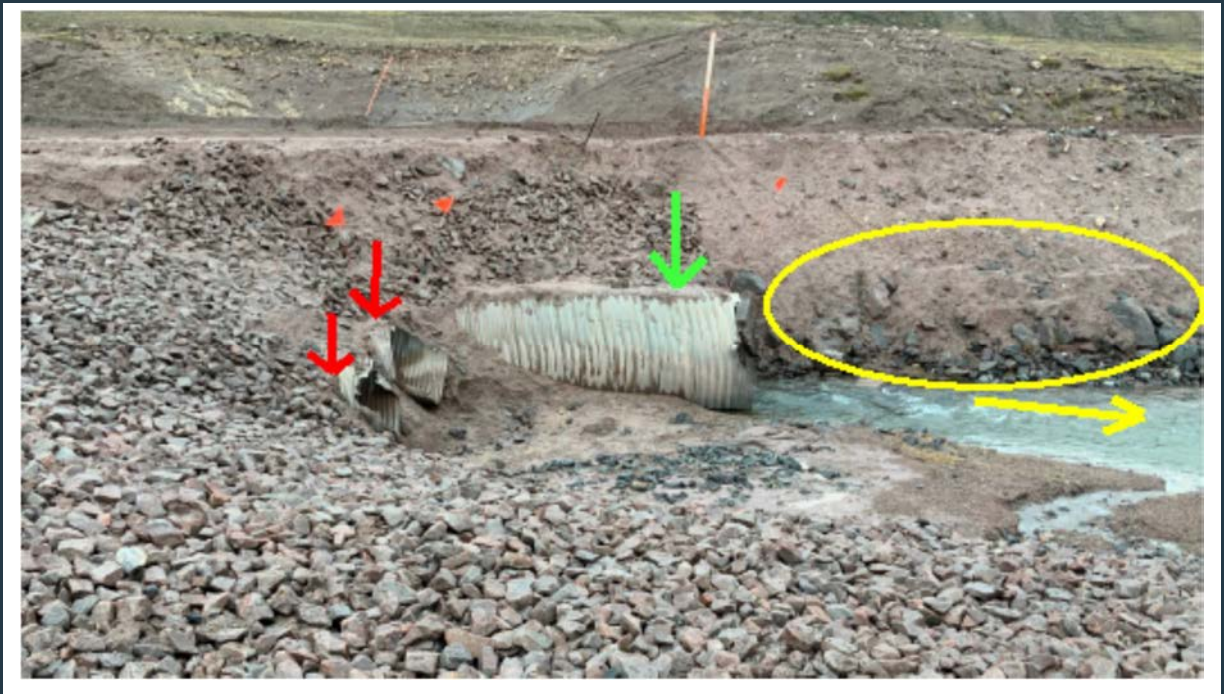
Figures 112 and 113 show the inlet and outlet of three corrugated pipe culverts, one relatively new (green arrow) and two old (red arrows) pipes. As shown in the images, only one of the three pipes is operational. Figure 113 also shows that the operational (green arrow) pipe is not perpendicular to the road, but follows the alignment of the stream, crossing the road at an angle (skewed barrel). Such culvert alignment may often result in increased erosion of the road embankment at the inlet and outlet ends of the culverts (note the yellow circle in Figure 113). It is suggested to closely monitor the embankment at both ends of this culvert and make appropriate steps (if needed) to prevent sloughing of the material at the toe of the road embankment, by lengthening the culvert at both ends, and by placement of additional riprap on the adjacent embankment slopes, particularly at the toe.

Figure 113: View of the outlet of three culverts at KM 90+100. Only one (green arrow) is operational.
