MARY RIVER PROJECT

Spill #2024-367 – Follow Up Report – elevated TSS locations

**Re: Unprecedented Rainfall Event – September 21**  
**Mary River Project - Water Licence No. 2AM-MRY1325**

**Re:** Summary of Tote Road Conditions Following Unprecedented Rainfall Event

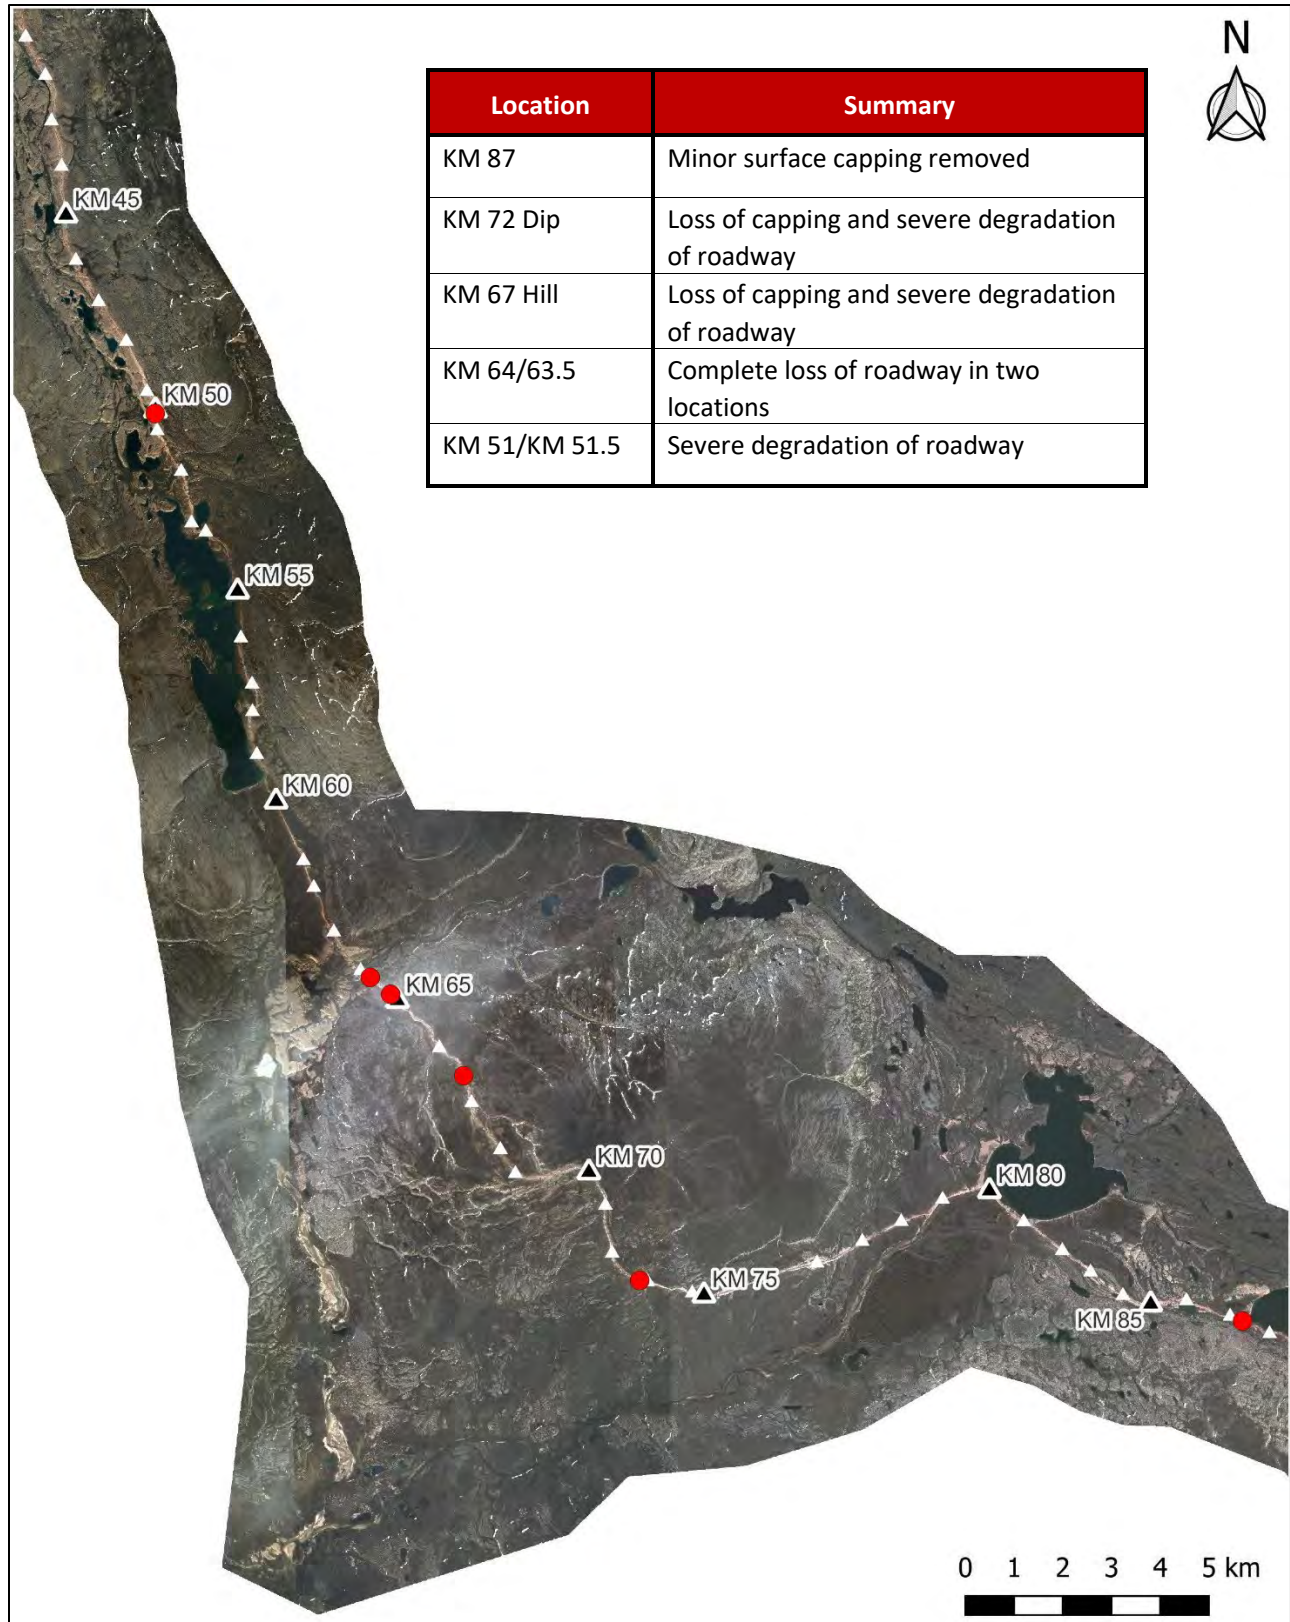
**Figure 1:** Locations of Known Tote Road Infrastructure Issues

At this time, known Tote Road infrastructure issues include damage at km 87, the km 72 dip, the km 67 hill, km 64, km 63.5 and km 51/km 51.5. Further details of each location are provided in the summary below. Figure 1 attached shows the approximate locations of these areas.
