Mary River Project
2025 Borrow Pit Reclamation Report

Baffinland Iron Mines Corporation
Mary River Project

Issue Date: October 28, 2025

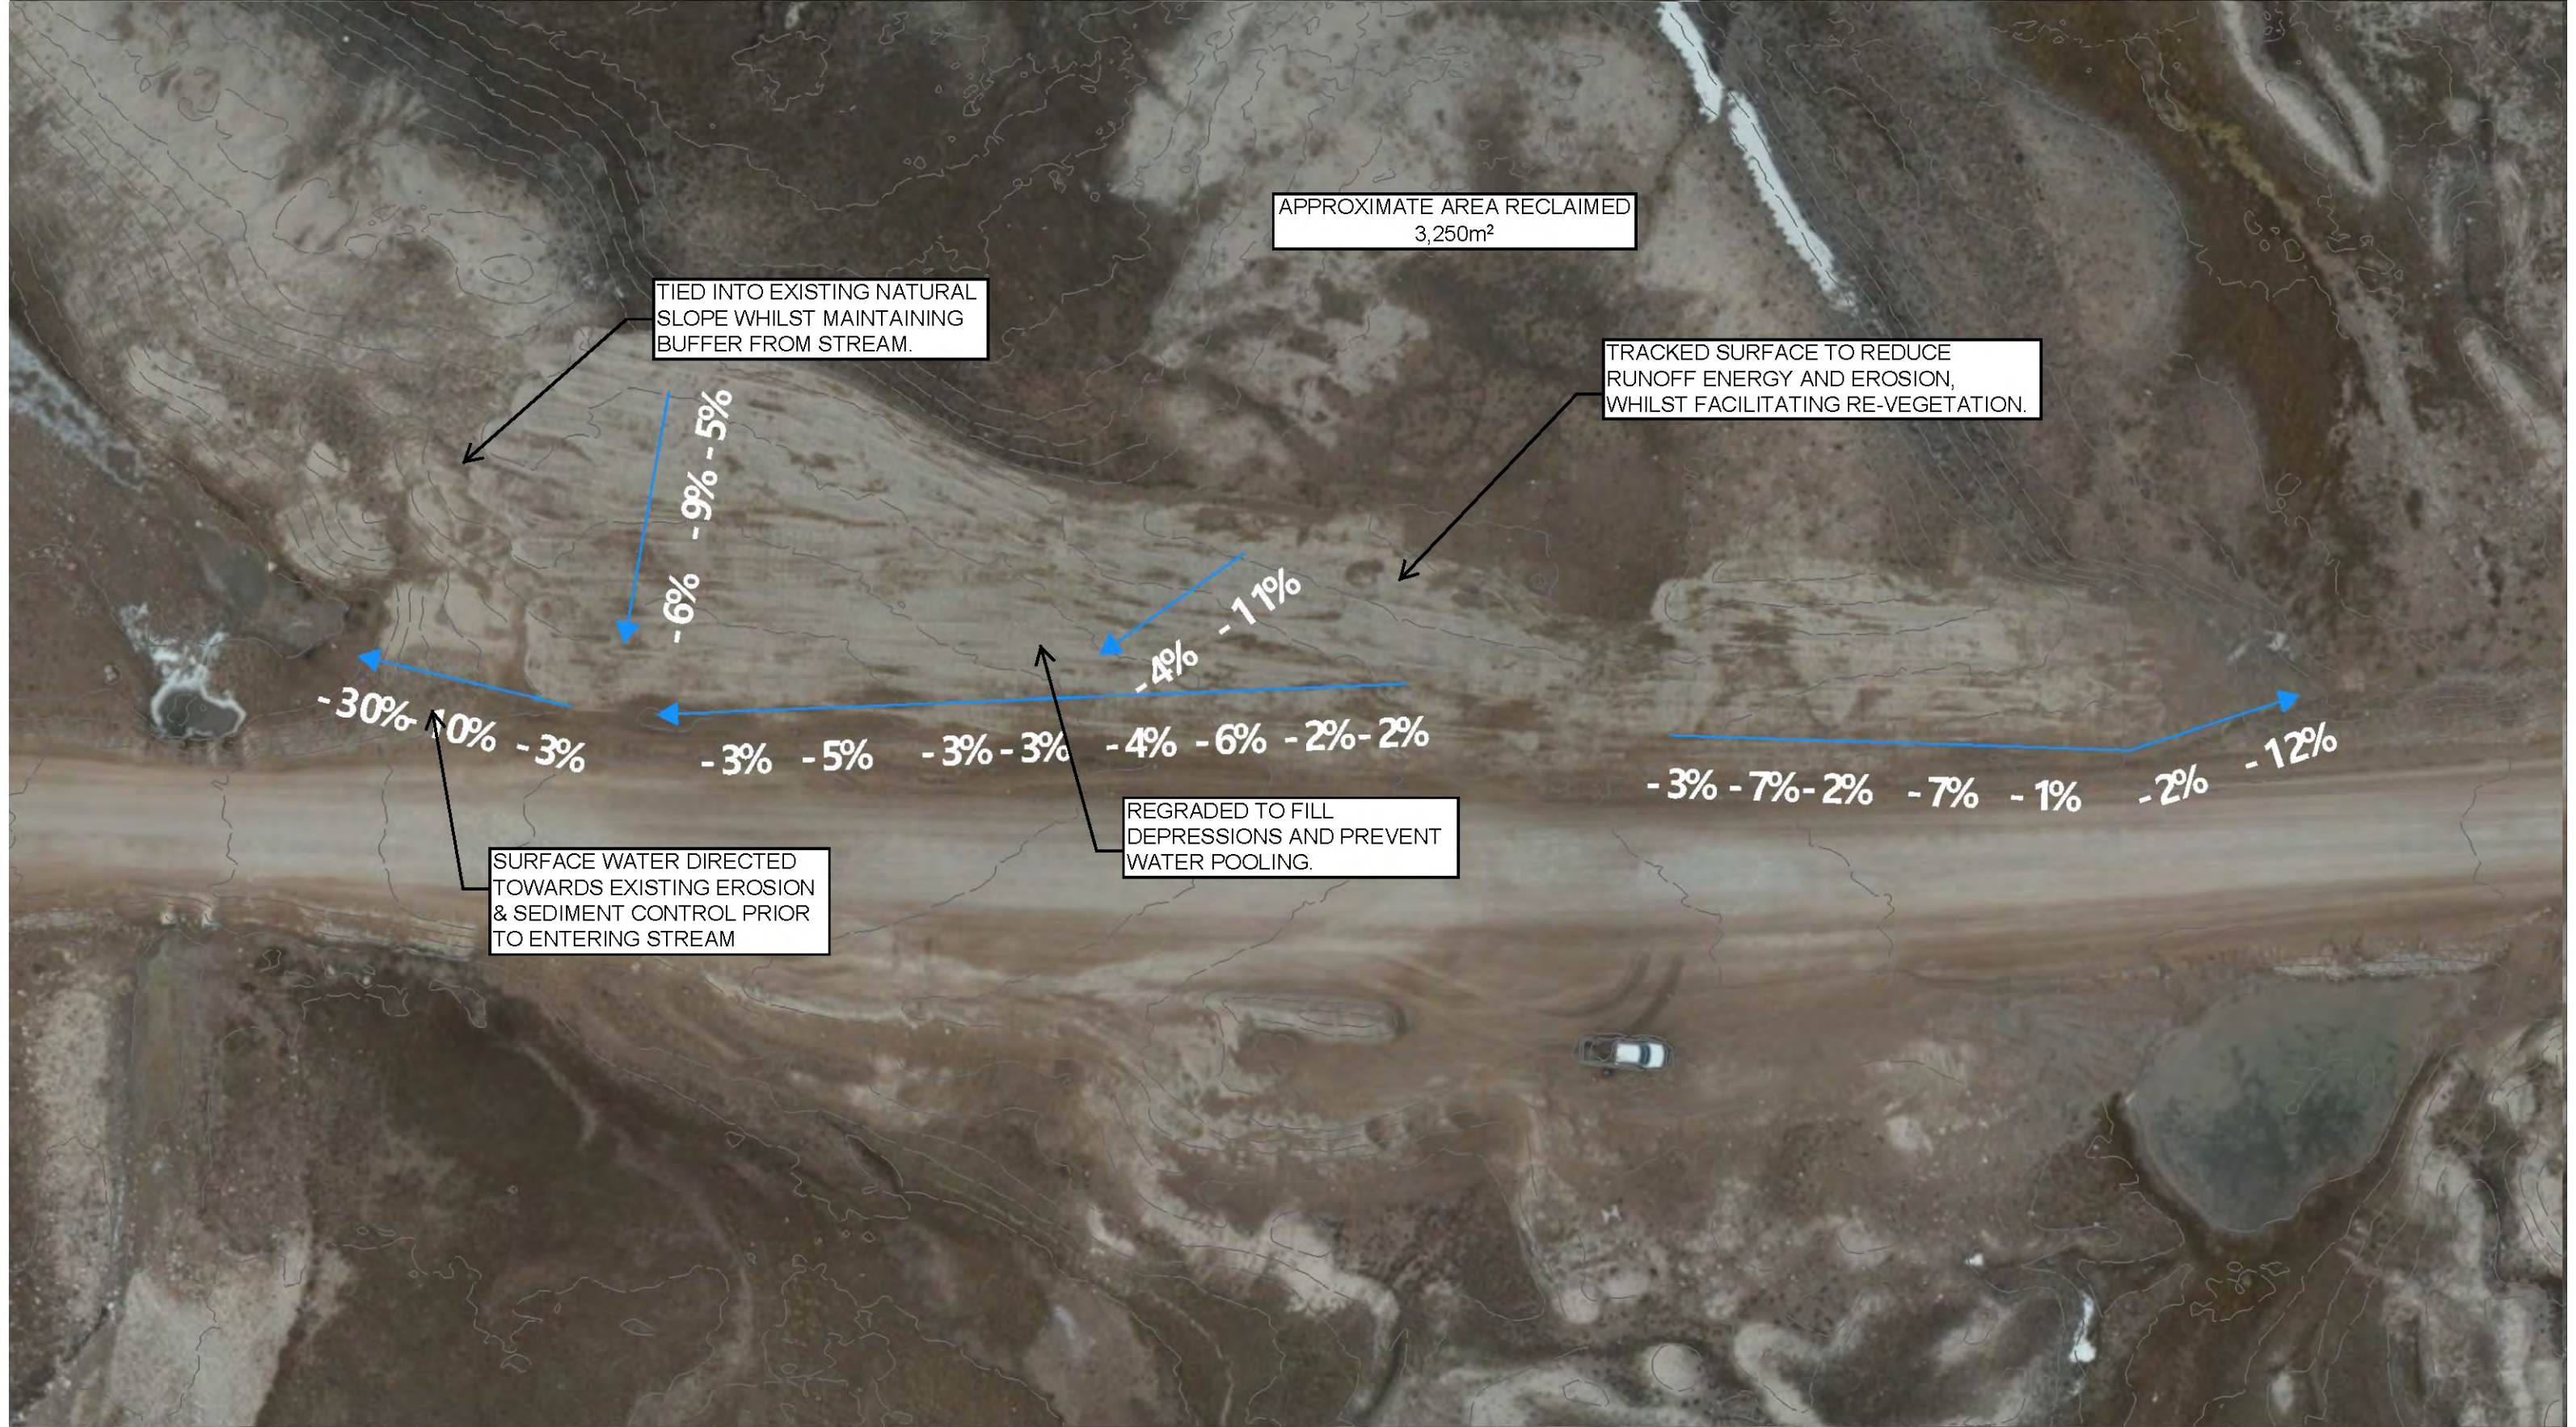
PROJECT: PIT 41 REMEDIATION KM50

MULTIPLE POOLS RESULTING FROM WEDGE ICE MELT AND SETTLEMENT, LEADING TO FURTHER PERMAFROST DEGRADATION.

NOTES: SEPTEMBER 2024 BEFORE REMEDIATION

The total area reclaimed is approximately 4,400m². Photos of the reclamation activities and post-reclamation status are provided in Appendix C1. An overview drone image is provided in the Appendix C2, illustrating the pre- and post-reclamation conditions of the borrow pit.

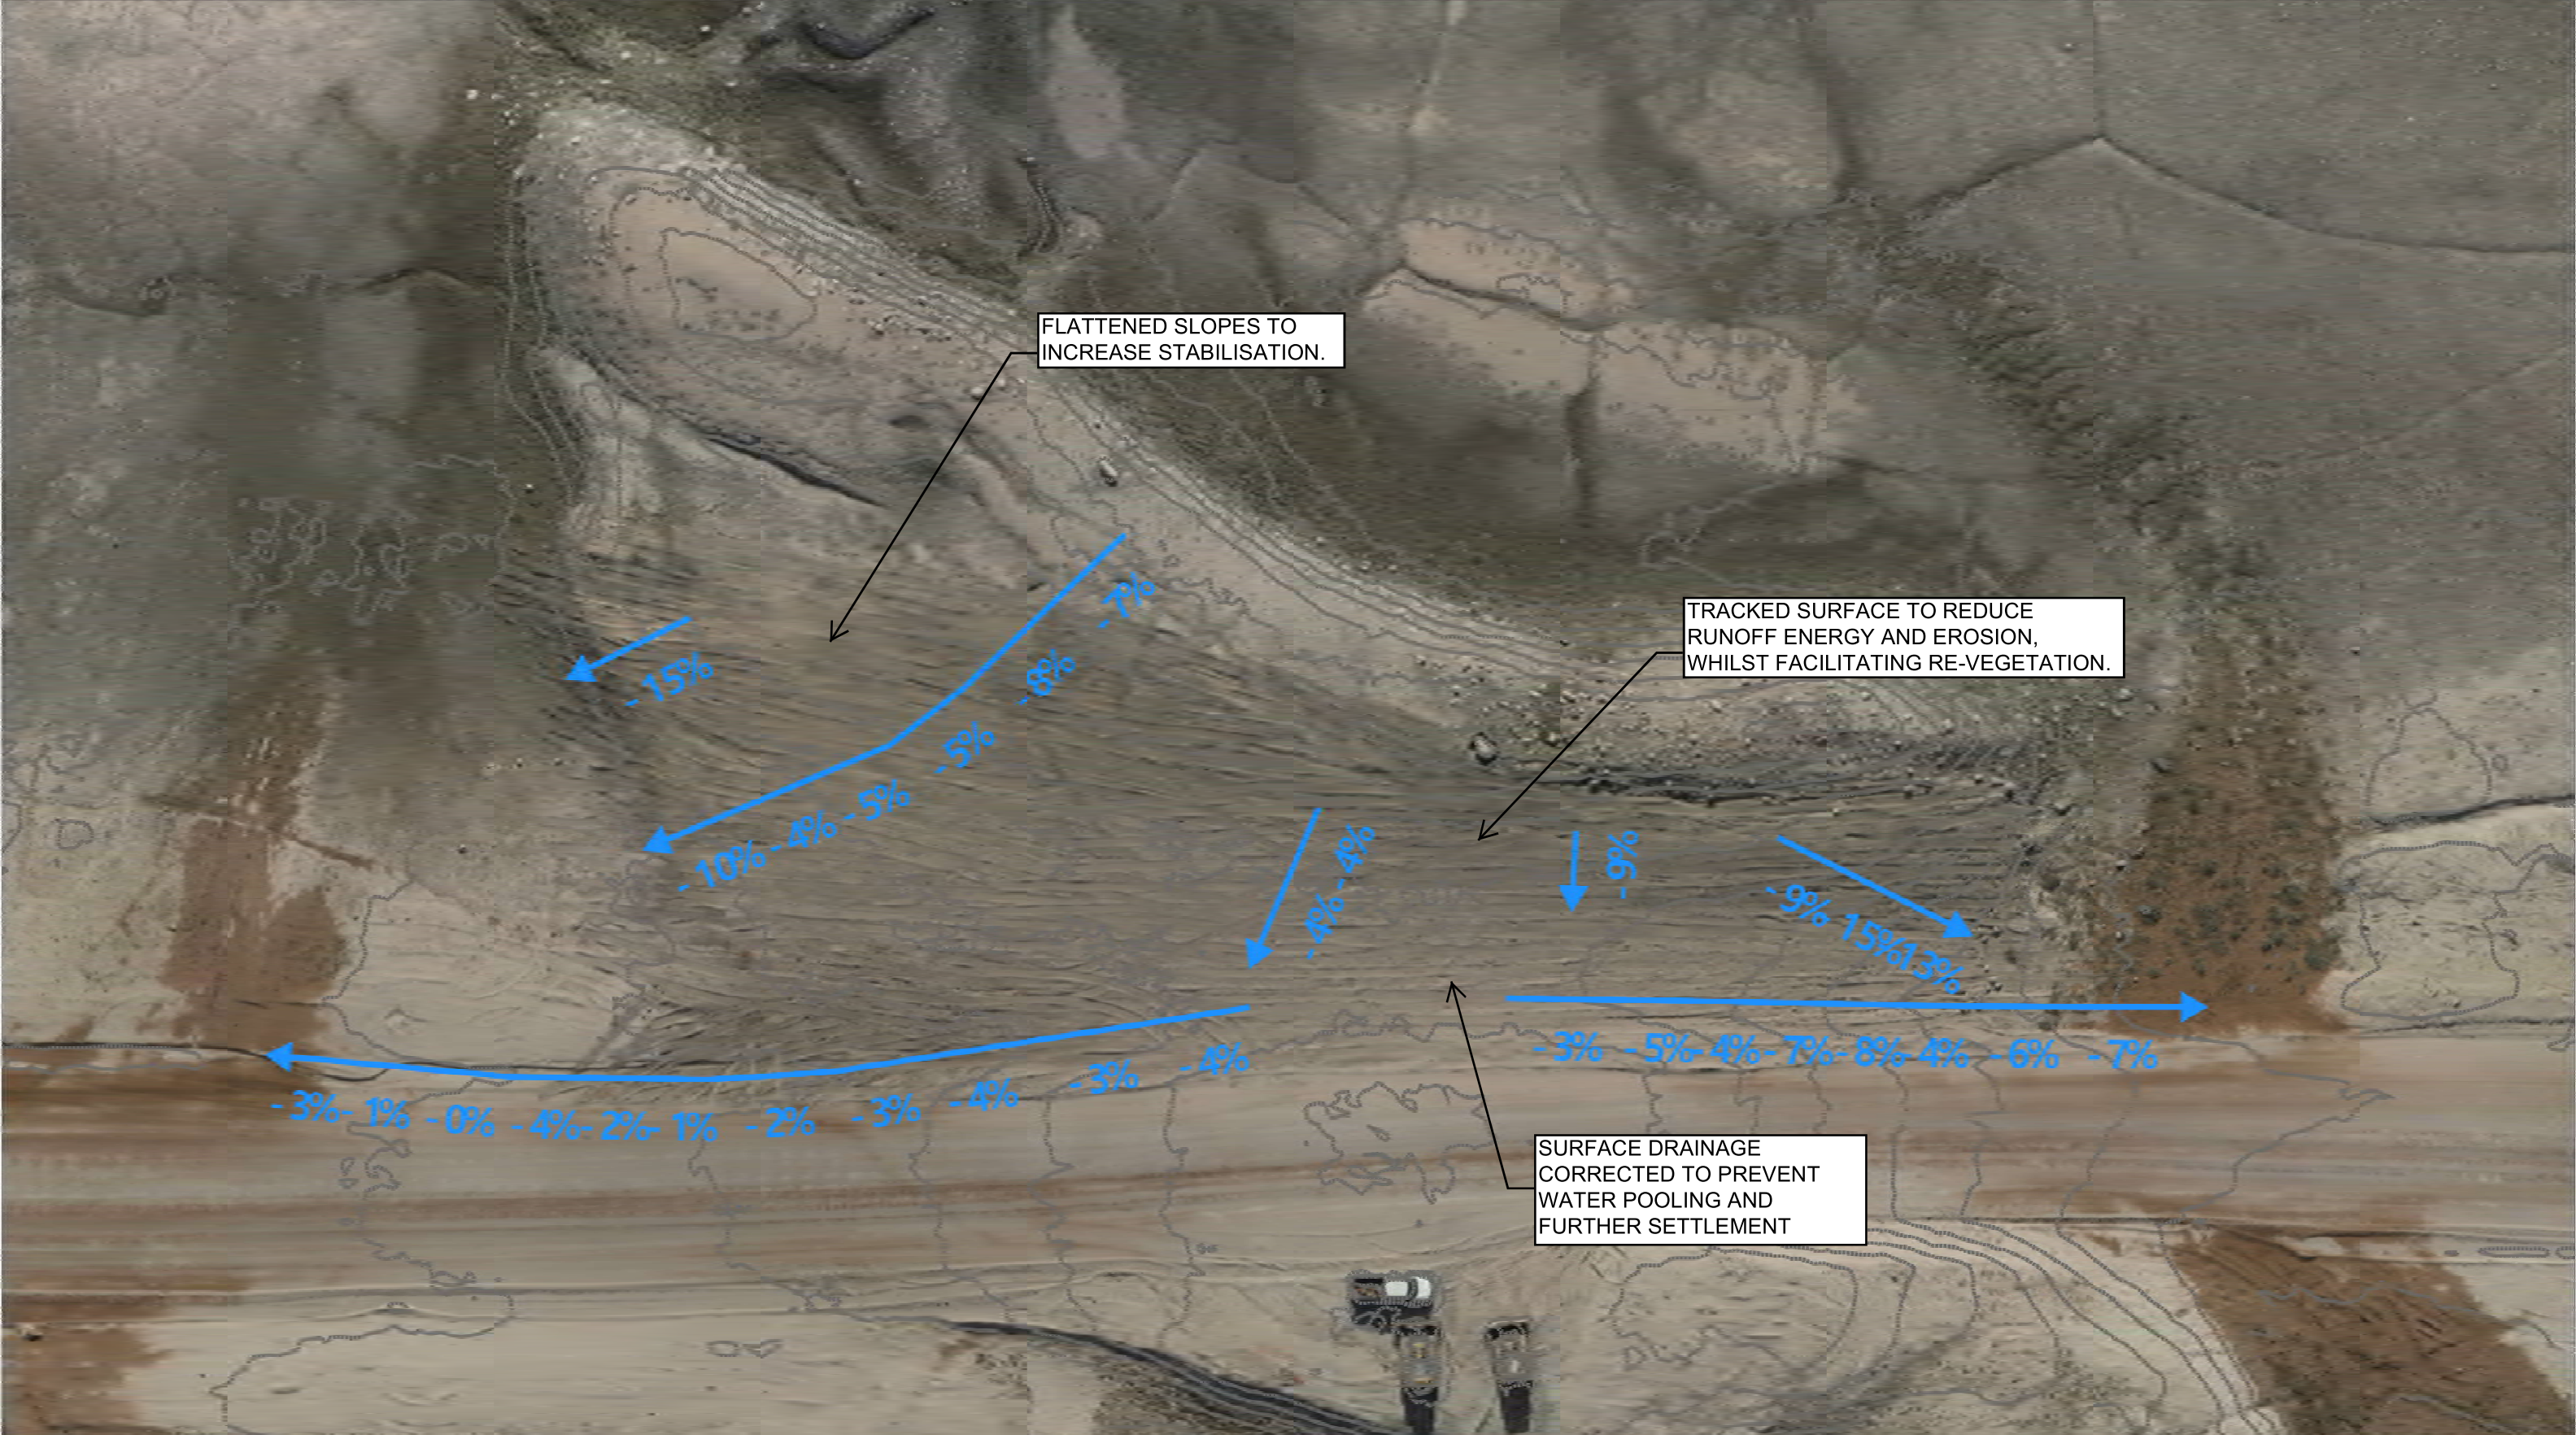
PROJECT:	PIT 71 REMEDIATION KM21
DATE:	2025-08-02

Site 71 is located between chainage 20+500 and 21+000, on the west side of the Tote Road. Its location is shown in the figure provided in Appendix A (TetraTech, 2025). This borrow pit was originally developed as a resource for aggregate to support road construction. At this location, there is a steep and high roadway embankment. During pre-reclamation inspections, water ponding was observed within the borrow pit, indicating the need for re-grading to promote drainage.

The total area reclaimed is approximately 4,290 m². Photos of the reclamation activities and post-reclamation status are provided in Appendix B. An overview drone image is provided in the Appendix C, illustrating the pre- and post-reclamation conditions of the borrow pit.
