## APPENDIX E.8.3

### 2025 Initial and Follow-up Spill reports

**Re: Follow-Up to Spill #2025-091**  
**Mary River Project - Water Licence No. 2AM-MRY1325**

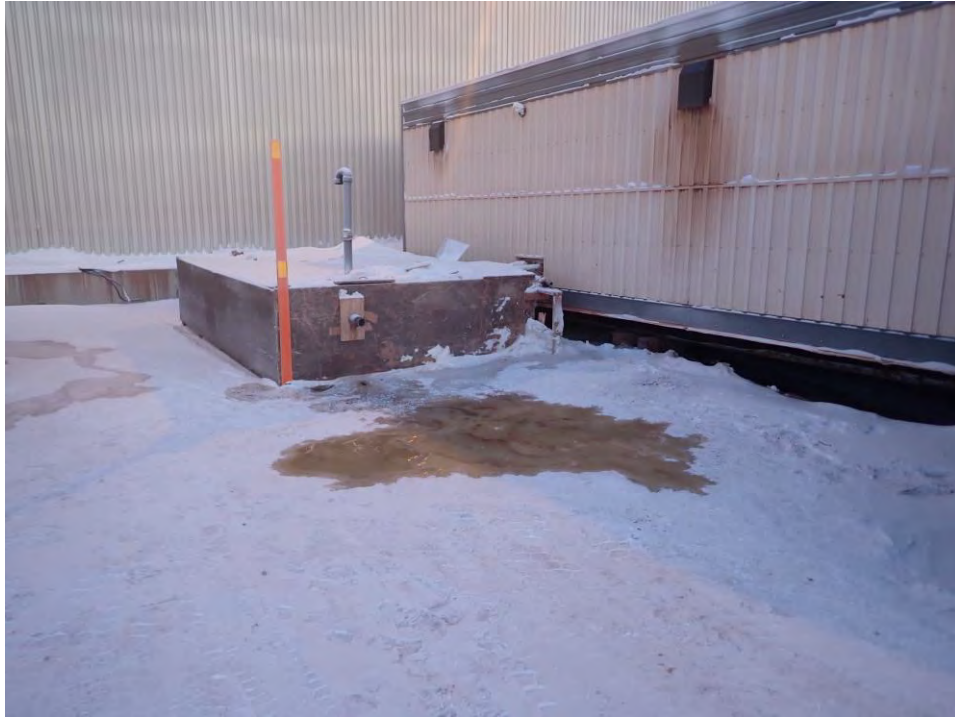
On February 1, a spill of untreated sewage was discovered which resulted from an overflow from the sewage lift station of the Milne Port South Maintenance Shop. Initial investigation shows that the station was not emptied within the appropriate timeframe, which resulted in a spill of approximately 125 liters onto the ground. The station was emptied immediately to prevent further release. The spill was contained to the immediate area around and inside the lift station heated box and did not migrate. The total impacted area is estimated to be 3m<sup>2</sup>. The spill location is approximately 580 meters away from Philips Creek, which is currently frozen.

Upon further investigation, it was discovered that the water pump in the washroom had been replaced. During this replacement, the solenoid that closes the emergency water shut-off valve was disconnected to complete the pump replacement. However, this solenoid was never reconnected. This resulted in the emergency water shut-off valve not closing when the high-high level sewer tank float was activated.

**Photo 1:** Milne Port South Maintenance Shop Lift Station - Sewage Spilled onto Snow, February 1, 2024

Upon discovery of the release by an Operator, the station was emptied to prevent further release. Cleanup was initiated utilizing a Skid steer and shovels to dispose of contaminated snow and ice into a quatrex bag which was brought to the Polishing Waste Stabilization Pond for future treatment during open water season in accordance with the Spill Contingency Plan (BIM-5200-PLA-0012) and the Fresh Water Supply, Sewage, and Wastewater Management Plan (BIM-5200-PLA-0022).

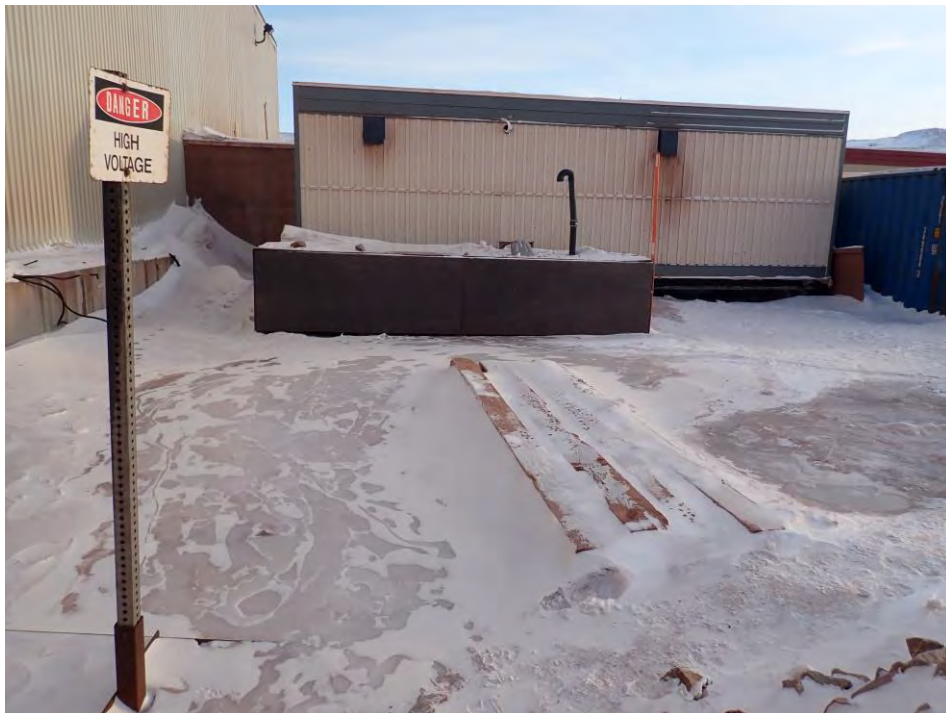
**Photo 2:** Milne Port South Maintenance Shop Lift Station - Clean Potable water is visible February 27, 2024

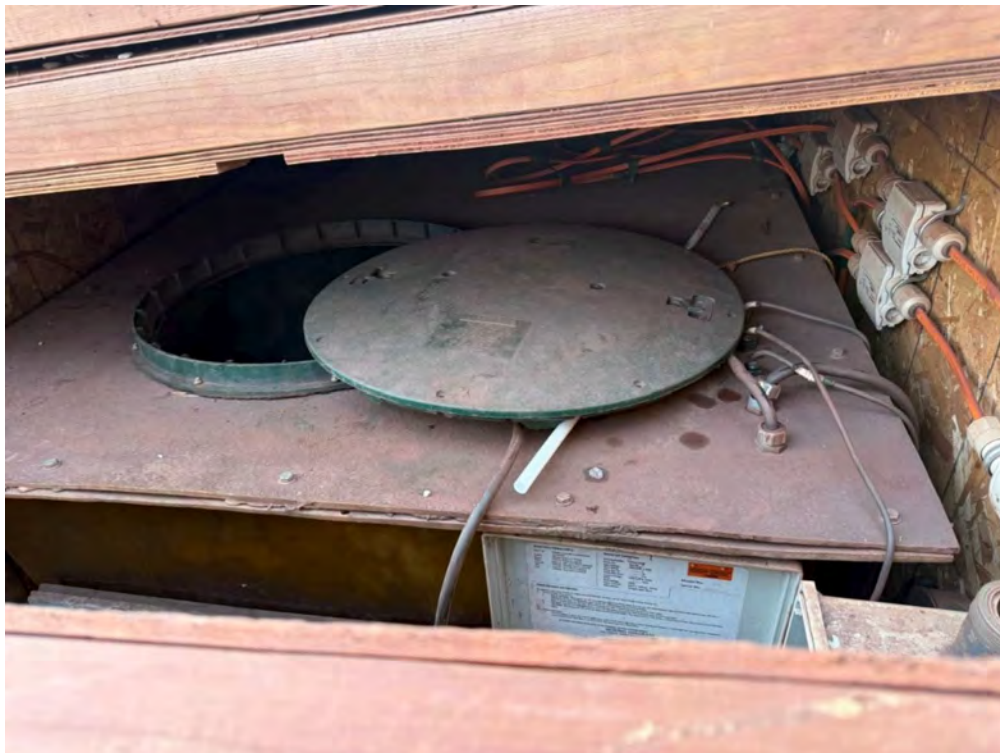
While conducting scheduled inspections on March 29, a housing maintainer observed a flashing warning light signaling for the lift station at the Mine Site Complex (MSC) laundry room. Upon further investigation he discovered that the amperage overload breaker for the low-level pump had tripped, rendering the pump non-operational. The high-level pump was also found to be inactive, though it was noted that the fluid level was insufficient to trigger the high-level pump float. Following this, the maintainer observed frozen untreated sewage near the lift station, estimated to be 195 liters in volume. The maintainer activated both pumps to reduce the fluid level in the tank to prevent the potential for a similar occurrence. The spill was contained to an area approximately 12.2m<sup>2</sup>, and was located approximately 550 meters away from the nearest water body, Sheardown Lake, which is currently frozen.

Following discovery of the release, the station was emptied and cleaned to prevent further release. Further investigation revealed a crack in the lift station tank, which had been previously concealed by an accumulation of sediment and debris, explaining its failure to be detected during previous inspections. The sediment build-up resulted from the tank's design, which does not allow for the debris and material to be removed without entering the tank.

**Photo 4:** Mine Site Complex Laundry Lift Station - March 29, 2025

The immediate corrective actions implemented following the spill included cleaning and reactivating the pumps, as well as relocating the pump floats to a lower level to prevent fluid from rising to the height of the crack in the tank.

Long-term corrective actions implemented to address the root cause of the incident include the replacement of the damaged lift station with a new unit featuring an access port for a vacuum truck operator to remove silt and debris. This debris removal will be conducted on a bi-weekly basis for all lift station tanks across the Mine and Port sites. Additionally, the current weekly lift station inspections will be elevated to a daily task. Finally, a plan will be implemented to replace all lift station tanks that were originally installed in 2013 and 2014 respectively, by January 2026.

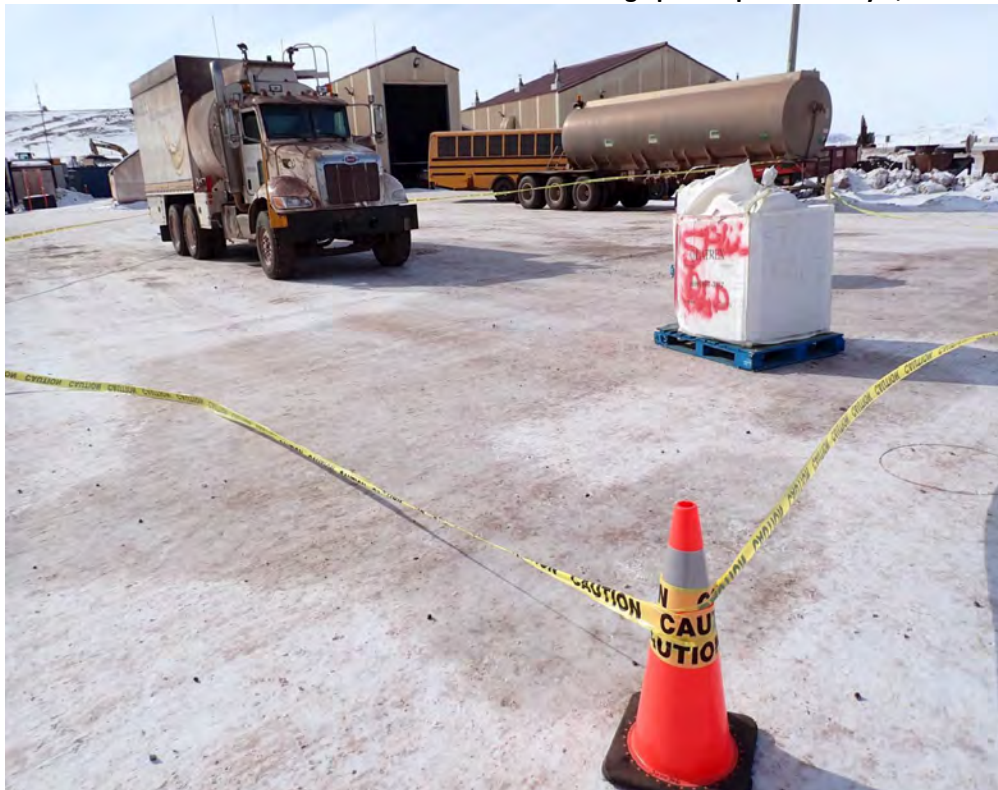
**Photo 3: Excavation of Contaminated Snow & Ice – May 4, 2025**

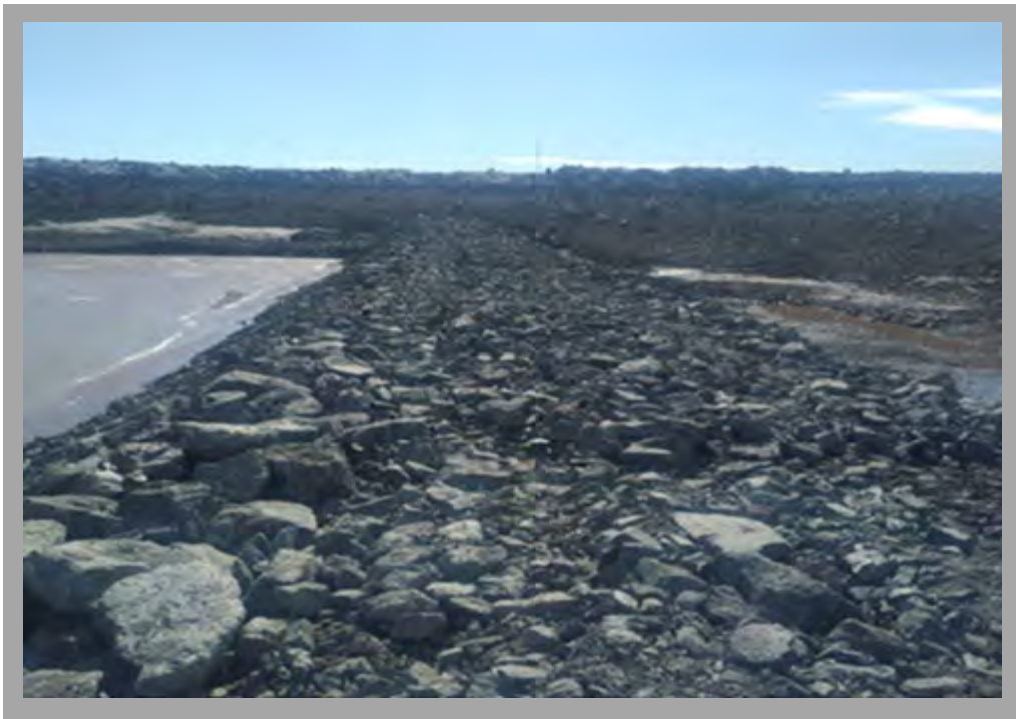
**Photo 8: Filter Berm operating within Km 105 valley infrastructure above SDLT- May 23<sup>rd</sup> 2025**

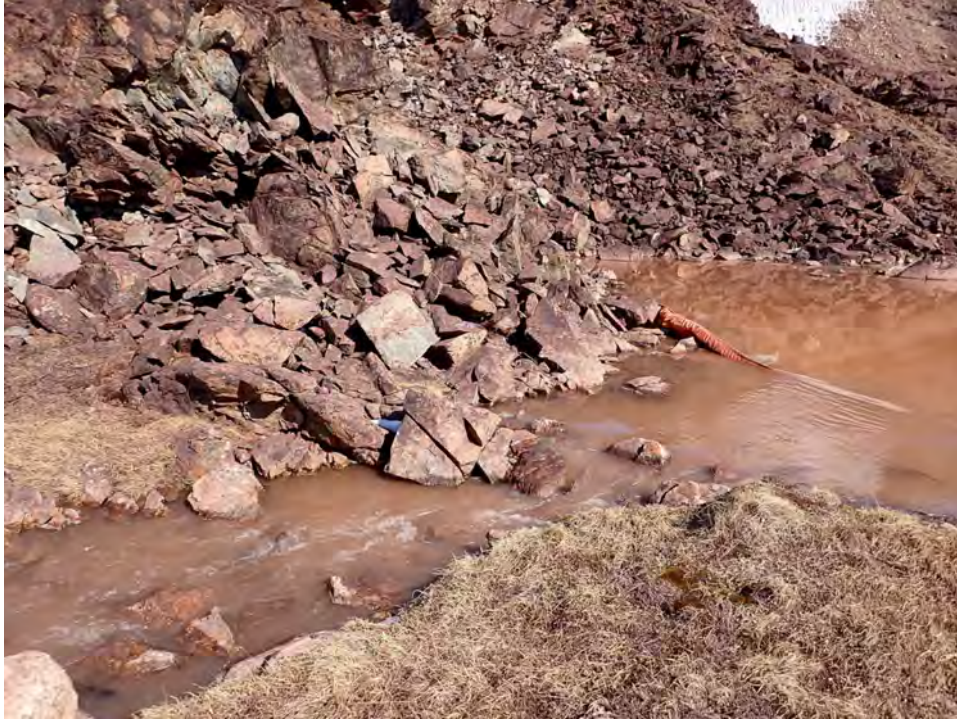
**Photo 1:** Flowing Water at Proposed MS-11 Discharge Point - May 22, 2025

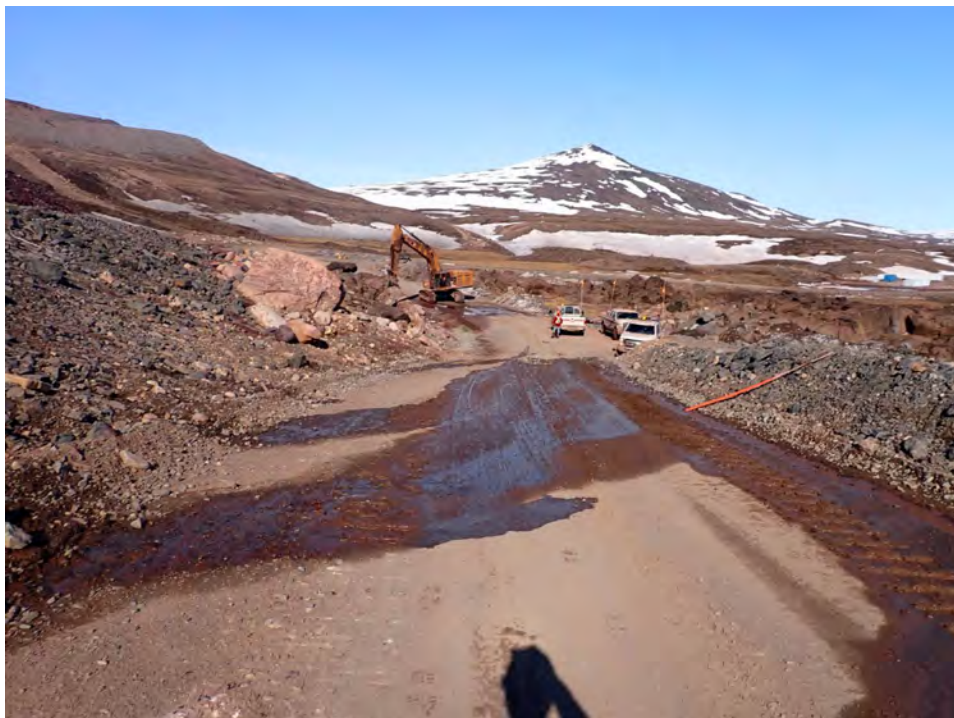
**Photo 2:** Seepage Location, Adjacent to the MS-07 Containment Pond – June 6, 2025

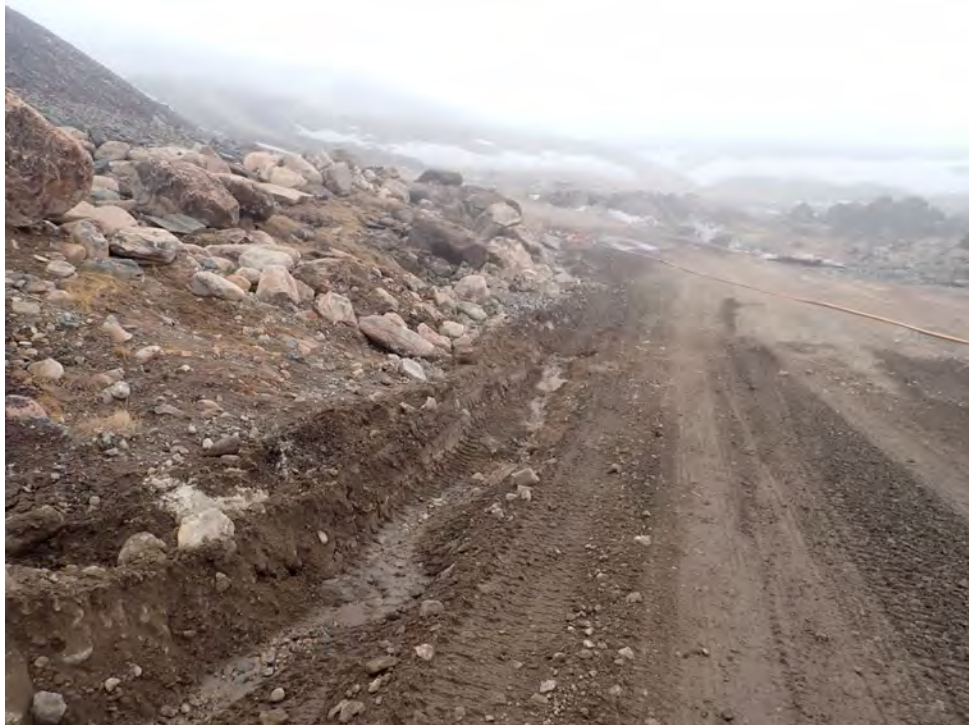
**Photo 3:** End of Observed Flow of Seepage Water, Downgradient of MS-106OS-07 – June 6, 2025

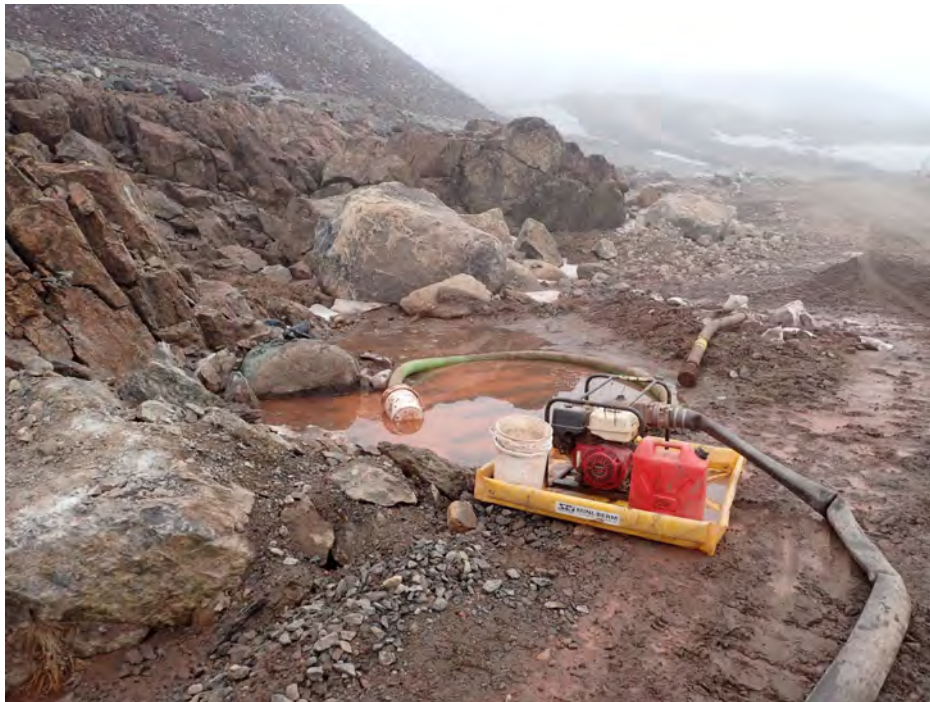
**Photo 4:** Ditch Maintained to Intercept/Redirect Seepage to Existing Containment Sump – June 7, 2025

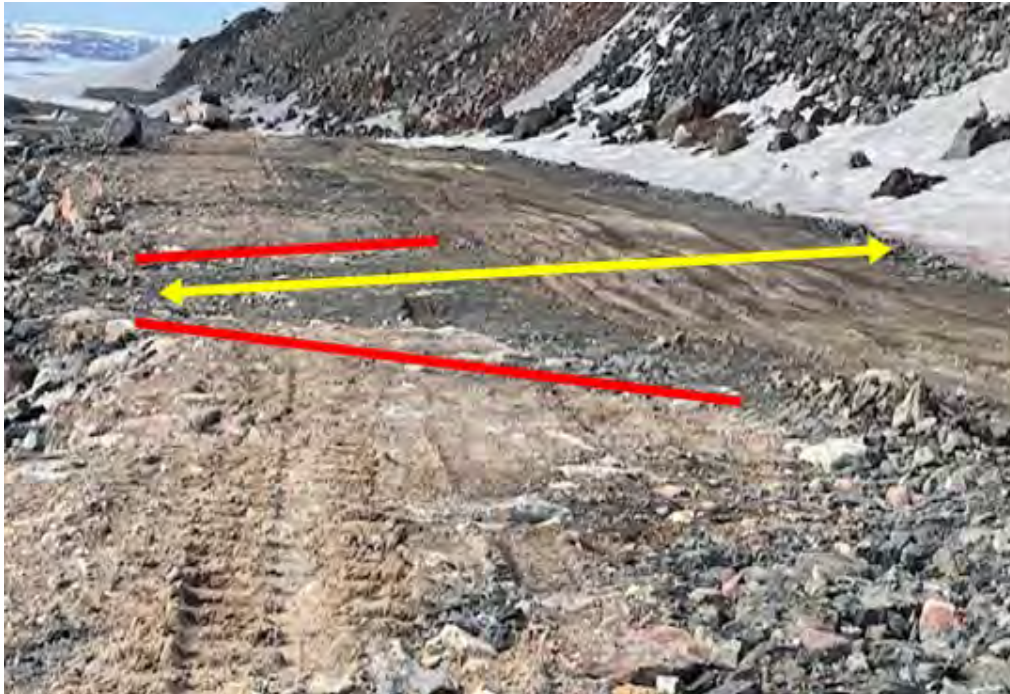
During follow-up investigation, it was found that the seepage occurred from an area where settlement along the west ditch access road had previously occurred, perpendicular to the roadway, and material had previously been placed to address the settlement. The repair runs directly across (perpendicular to) the roadway and intersects the slope of the perimeter ditch. When water levels in the west perimeter ditch rose above the intersection of the repair on the side slope of the west perimeter ditch, water was able to travel along the rock repair in the roadway base and flowed outside of the containment berm. In response to the seepage and in accordance with Baffinland's MDMER Emergency Response Plan, the perimeter ditch was cleared of residual recently accumulated snow to reduce the water elevation in the ditch, and restore the intended water flow along the ditch. The compromised area of the west ditch was then reinforced by packing fine impermeable material into the side of the ditch where the coarse rock fill patch intersects the ditch, fully arresting the seepage. The ditch clearing and repairs were completed without delay and by end of day, seepage was no longer observed from the West WRF ditch.

**Photo 2:** Seepage Location, Adjacent to the WRF West Perimeter Ditch, June 20, 2025

The compromised area of the WRF west perimeter ditch was repaired and no further seepage has been observed from the perimeter ditch. Inspections and monitoring of the WRF will continue on a regular basis. Corrective action implementation is ongoing.

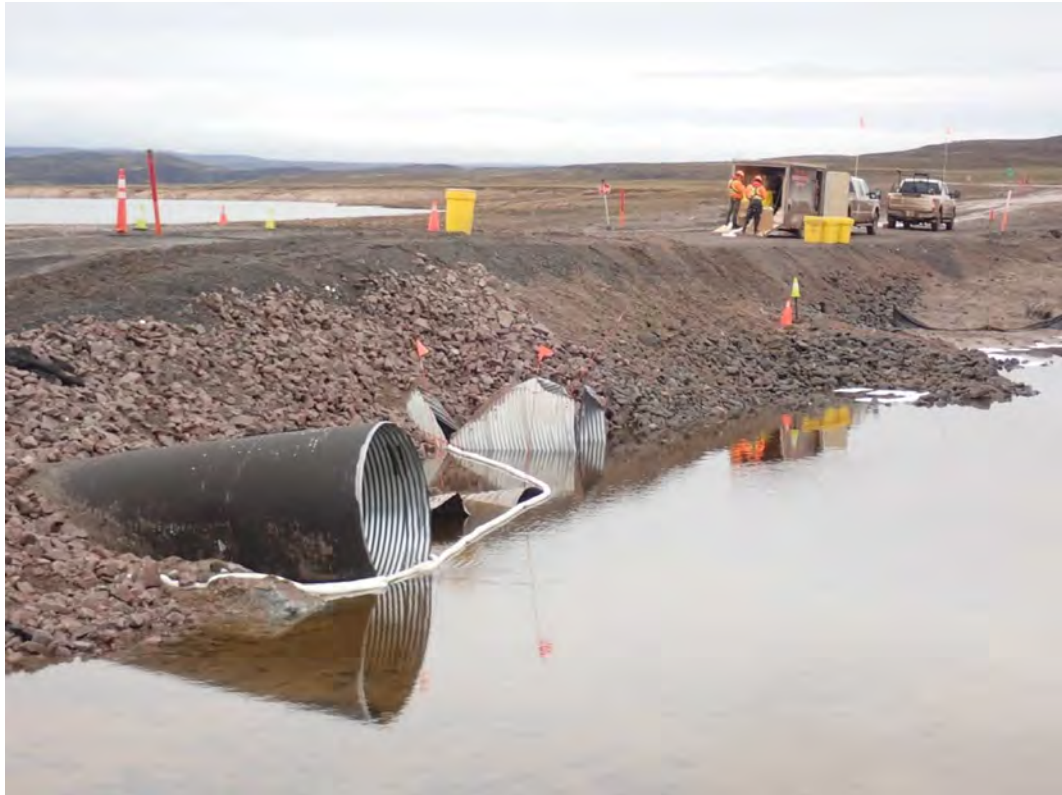
**Photo 2:** Spill Boom Placed Downstream – July 16, 2025

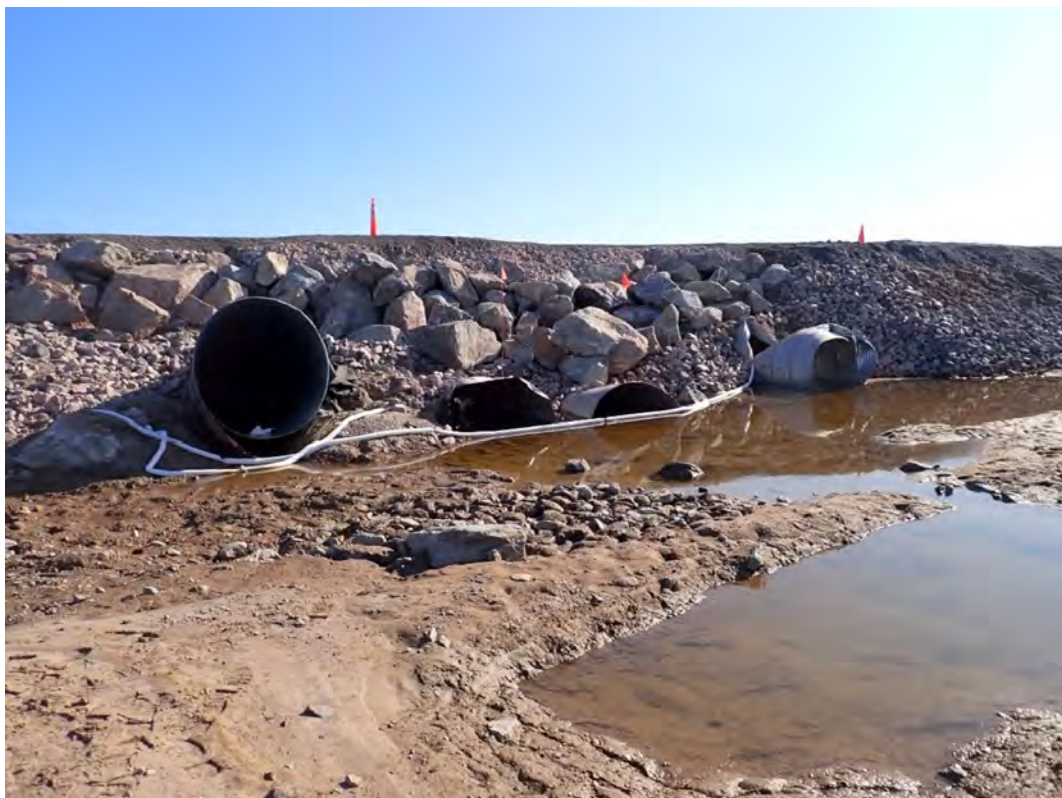
**Photo 3:** Spill Boom Placed Upstream Around Unobstructed Culverts – July 16, 2025

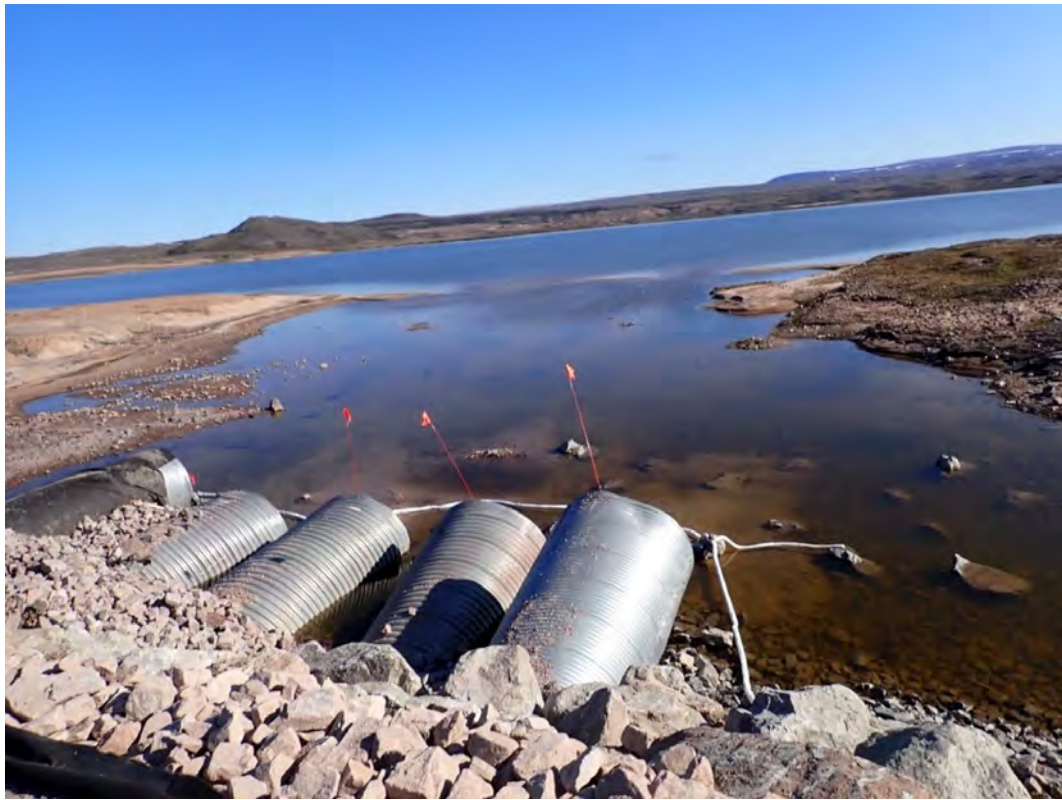
**Photo 6:** Upstream Conditions Prior to Removal of Spill Response Equipment – July 20, 2025

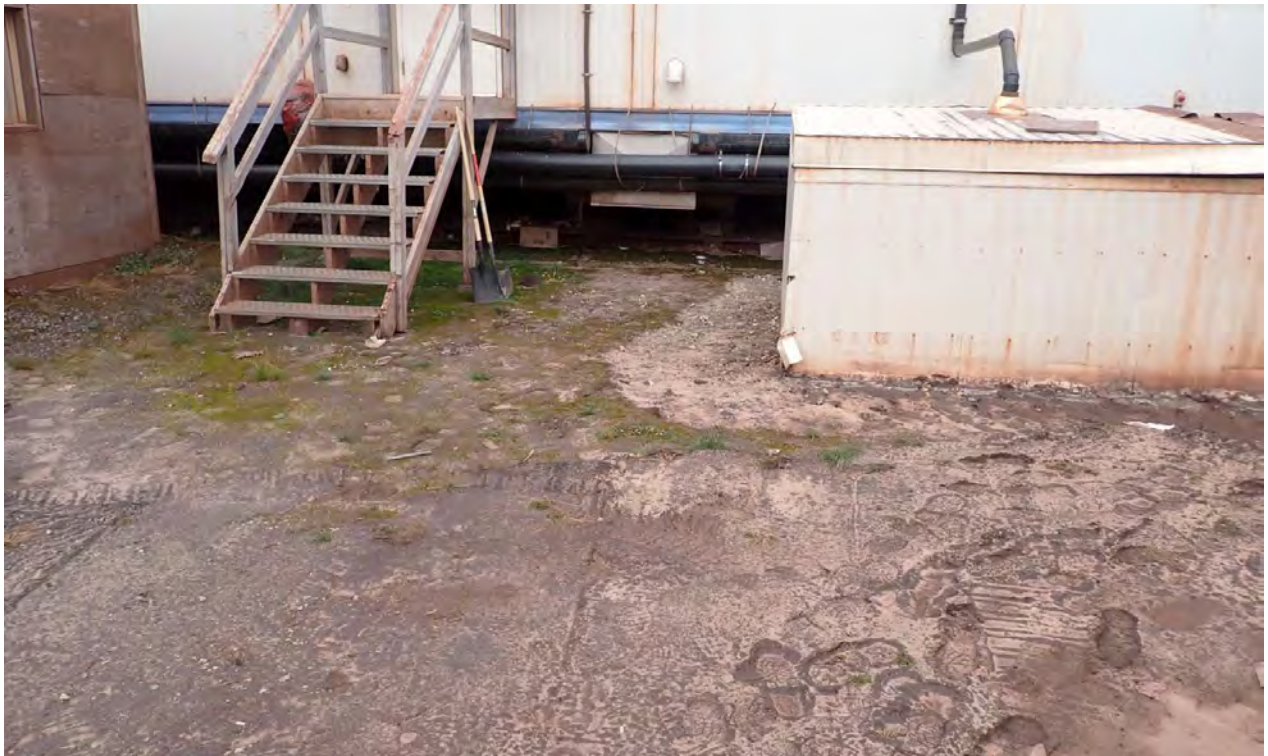
**Photo 1:** MSC Lift Station Release – July 30, 2025

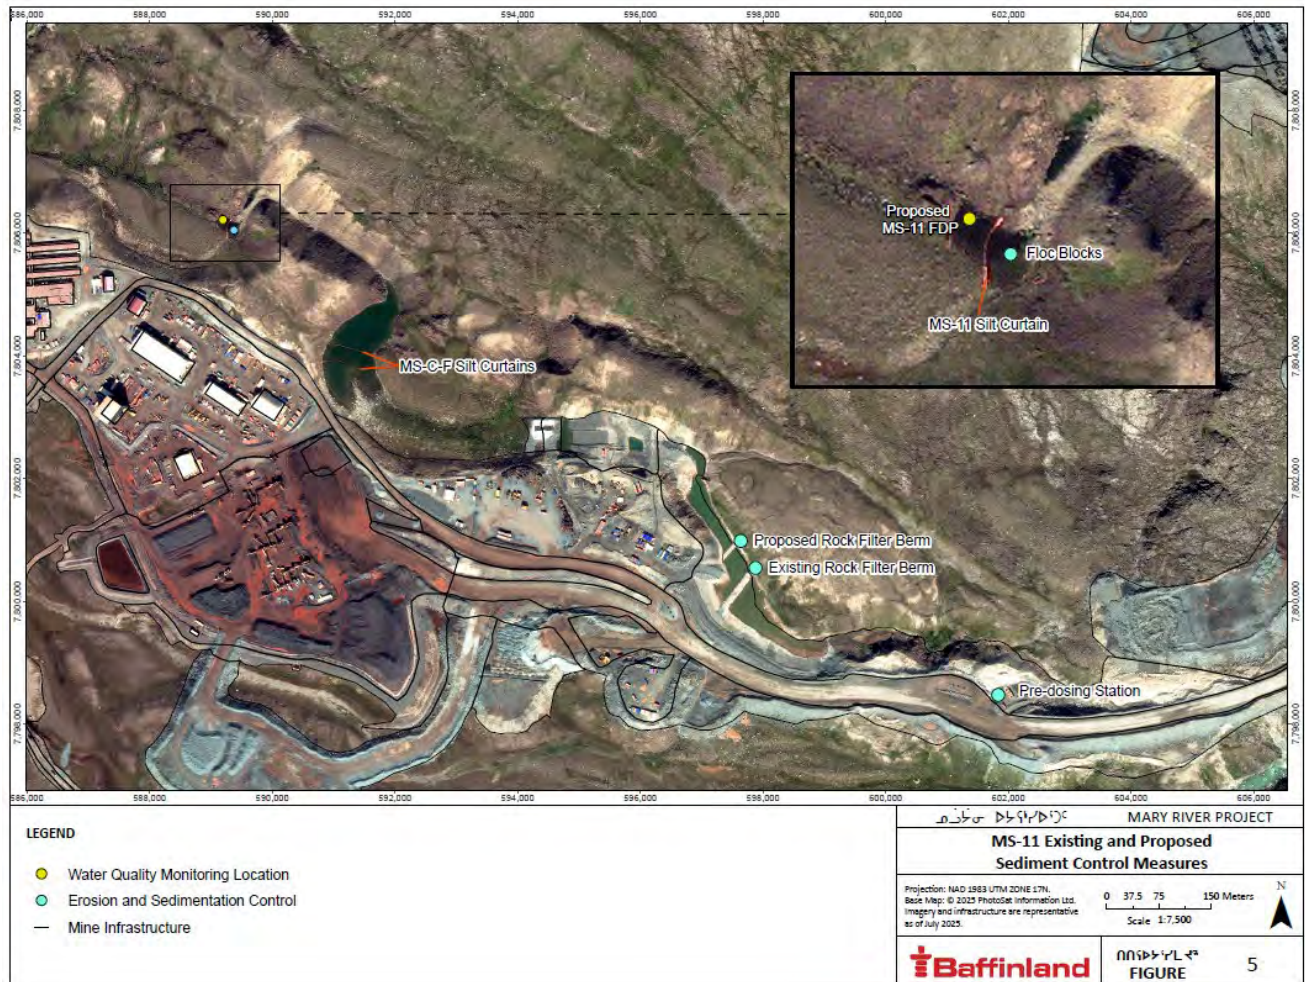
Figure 5 below outlines the components of the sediment control measures proposed. Exact locations and configurations of the infrastructure are still under evaluation by a third-party engineering consultant and will be field fitted during construction.

**Figure 5 – Sediment Control Measures**
