3.03 Generator Fuel Storage Containment

This report is the 7th annual Geotechnical Inspection at Mary River and Milne Inlet completed by this author on behalf of Baffinland Iron Mines Corporation and the first report covering two inspections in one shipping season.

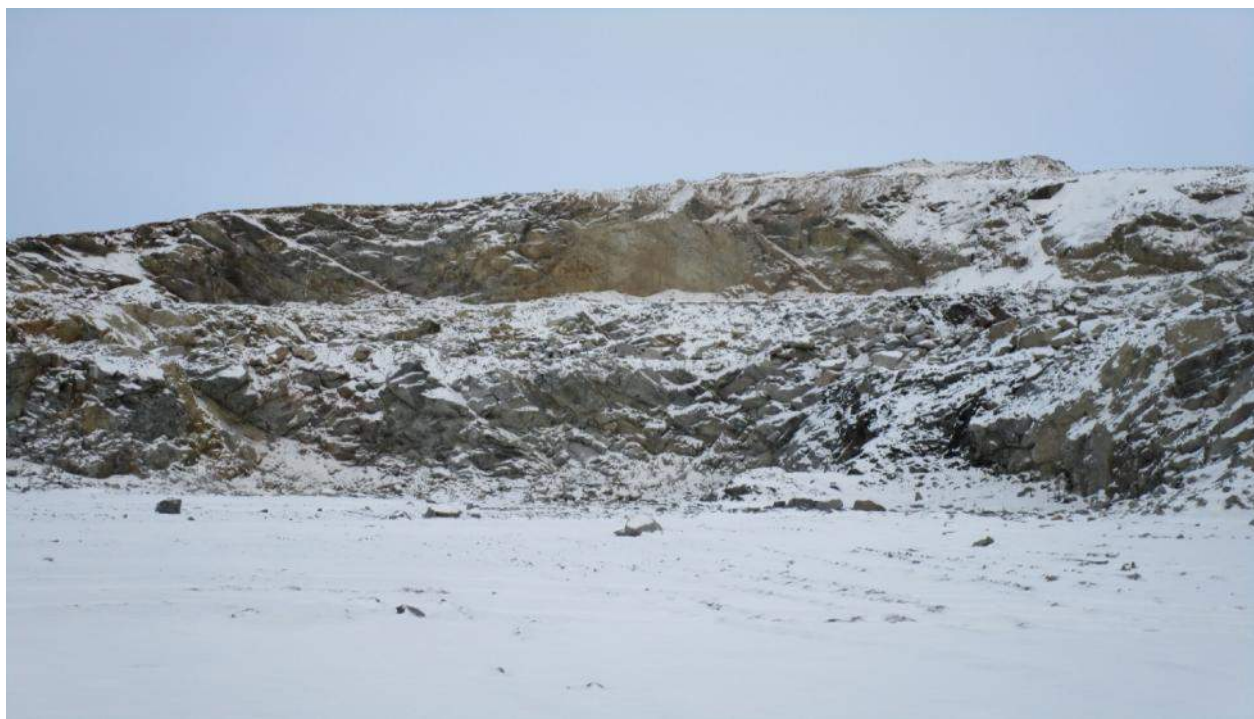
Quarry

The quarry has well defined benches. The quarry faces at the benches shall be scaled when quarry operations cease and the benches shall be cleaned and berms placed at the edges of the bench to control the movement of weather induced loose in the long term.

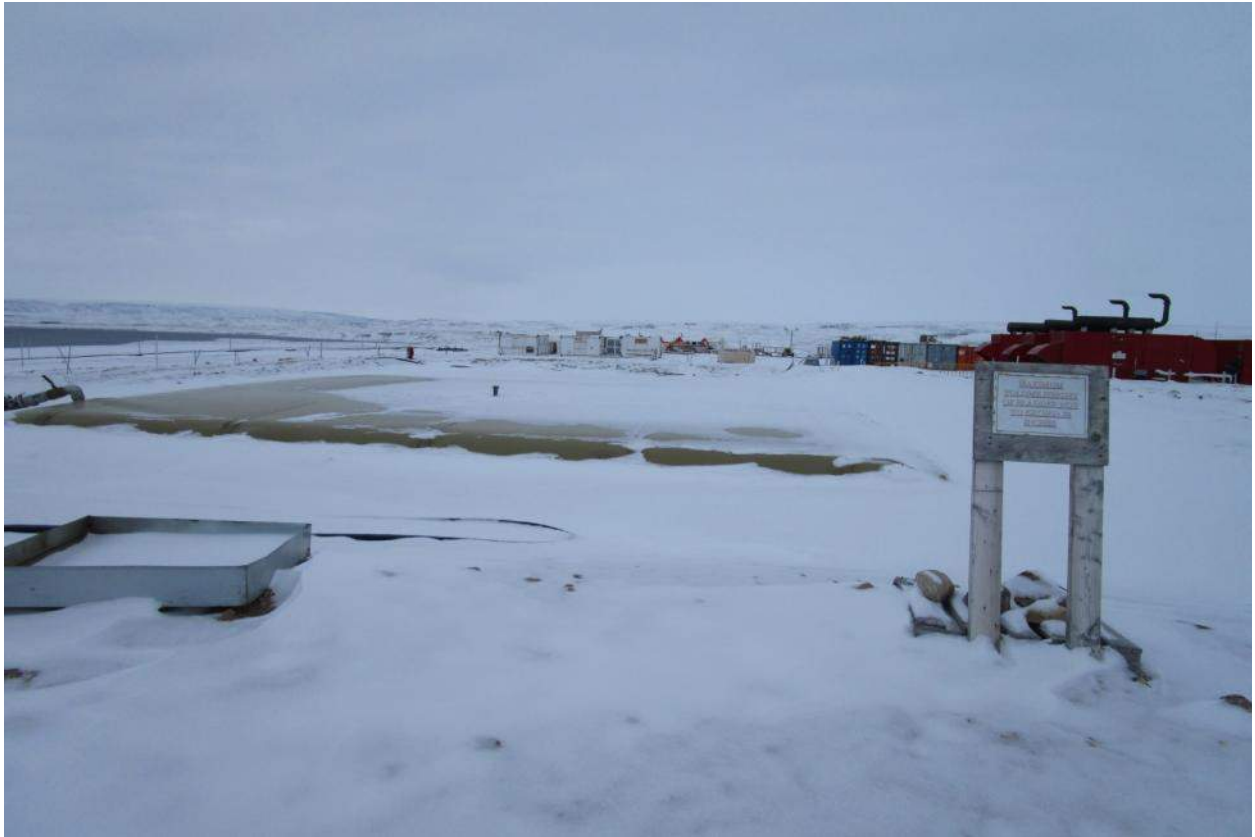
Generator Fuel Containment

There is currently one bladder in this containment facility that has a capacity when full of 120,000 litres. This bladder contains 77,376 litres when the bladder is 32" high. The guideline for Baffinland Iron Mines is to fill this bladder to no more than 76 cm (30") which represents 70,097 litres.

At the time of our visit on August 1, 2013, the bladder height was measured at 21". There was water ponding in the bottom of the containment at the time of our review. At the time of our second review on Sept 26, 2014 the bladder height was measured at 20" and there was ice just above the gravel in the bottom of the containment.

The structure was visually inspected for any signs of subsidence or cracking and no such indications were noted. There was no sign of seepage at the base of the structure noted. The soil structure is considered to be stable in its present condition and is in conformance with our design principles.

We recommended that the water ponding above the bottom of the containment gravel cover be removed regularly by creating a sump in the gravel and pumping out the water to below the gravel surface.

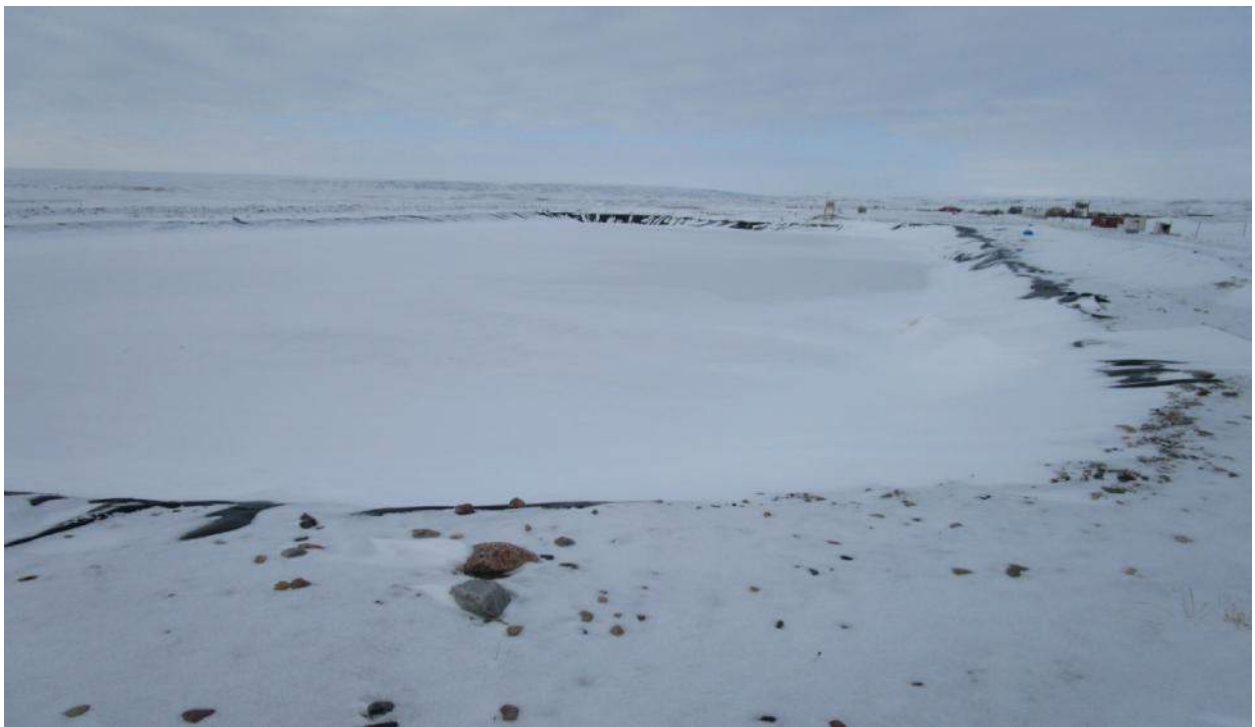
PWSP No 1

These settlements appear to be settlements within the one metre \pm active layer above the permafrost and are of little concern as the PWSP's are temporary structures and the settlements have no effect on the dyke stability.

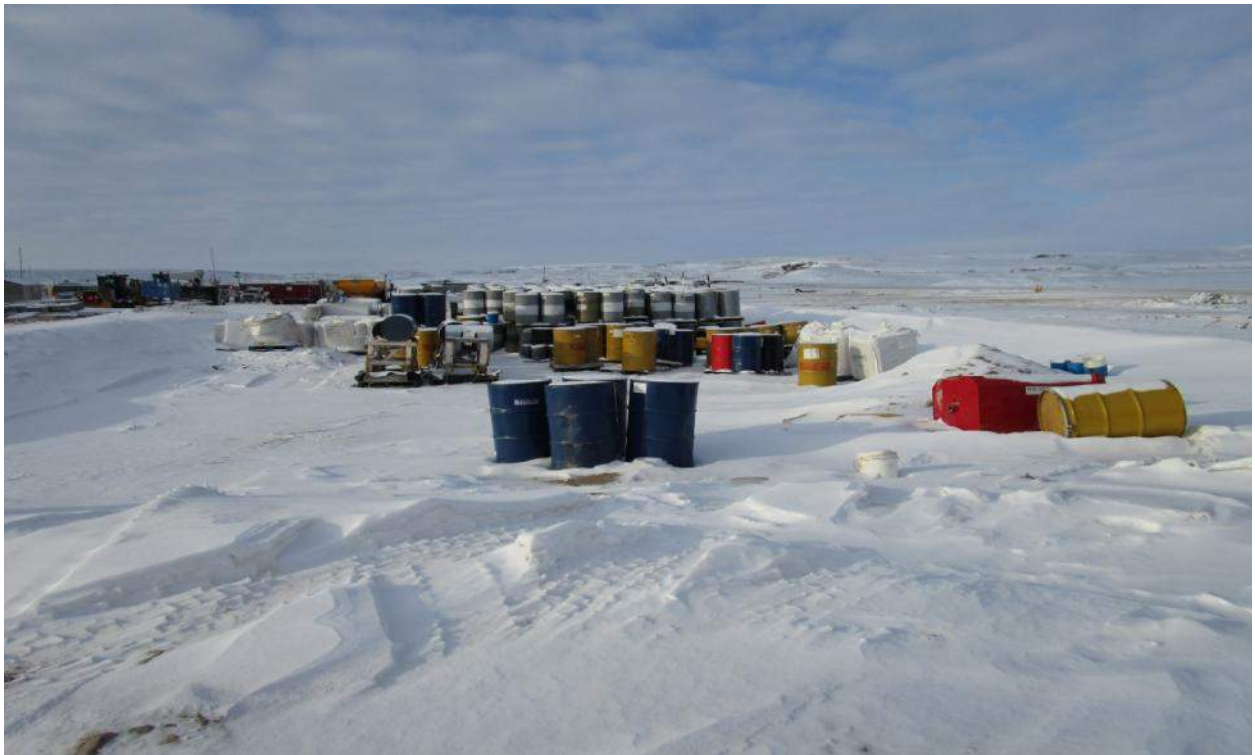
Hazardous Waste Containment

This structure contains barrels and bags of hazardous waste.

The structure appears stable in its present condition.
